CHAPTER 3. CONSTRUCTION OF MODELS

3.1 Construction Sequence

3.2 Aspects of Non-Engineering during Construction

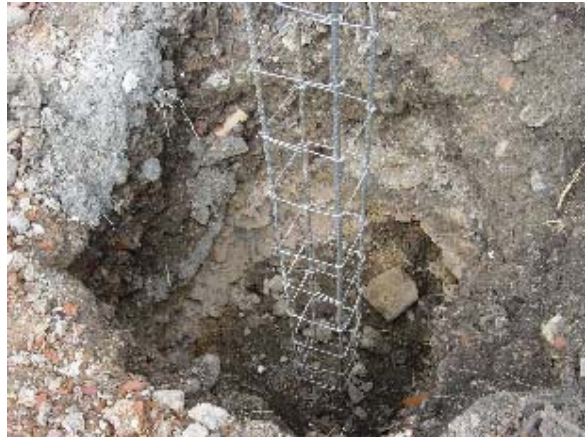
Photo 3.18 Short Column Re-bar

Short lap length of column re-bars is observed. This is by the lack of engineering coordination of re-bar arrangement and position of construction joint (photo 3.18).

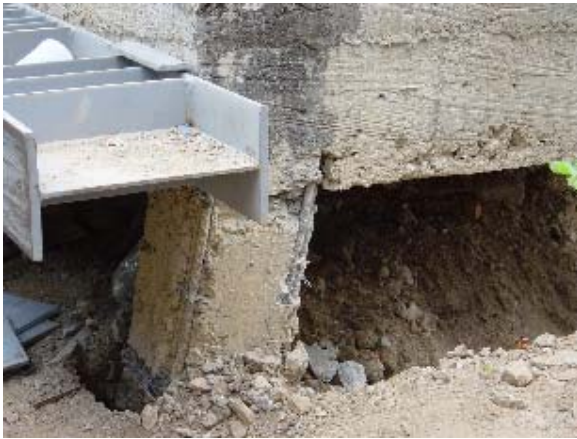
Failure mode of model 1 frame is column collapse mode and plastic hinges are provided at the top of columns. Floor beams are not damaged seriously. Elastic stiffness is 8.25t/cm, and yield strength is 8.75 ton. Maximum strength (max. load) is 10.25ton (photos 6.1~6.4). Deflection at yield strength is 10.6mm, and storey deflection is 1/170 (10.6/1,800) for short column and 1/226 (10.6/2,400) for long column respectively. Deflection at maximum strength is 16.4mm, and storey deflection is 1/110 (16.4/1,800) for short column and 1/207 (16.4/3,400) for long column respectively. Bending failure of columns is occurred at the beginning, and diagonal shear crack of short columns is also observed at mid-span at later stage (photo 6.2).

Photo 6.1 Model 1-Short Column Failure (1)

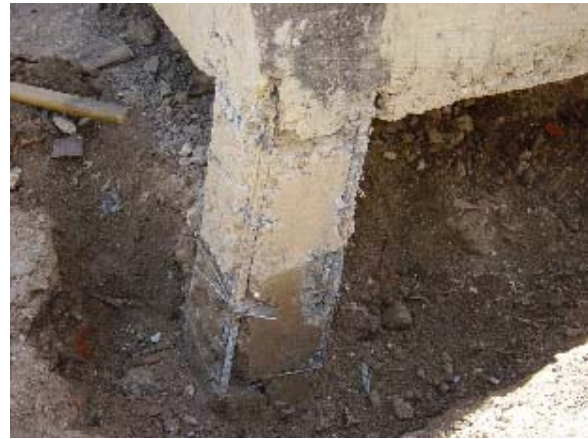
Photo 6.2 Model 1-Short Column Failure(2)

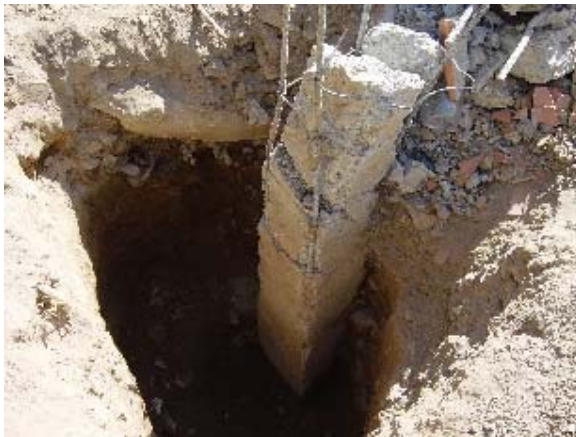
It is confirmed that the bottom of the short column is not damaged by the visual inspection after the excavation (photo 6.3).

Photo 6.3 Model 1-Short Column Failure (3)

(Note) Plastic hinges at top of columns are observed at the test of model 1, while it is not clear at the bottom portion whether plastic conditions are occurred at the ground soil or foundation footing. Columns at the bottom are not damaged by visual inspection after excavation (photo 6.3).

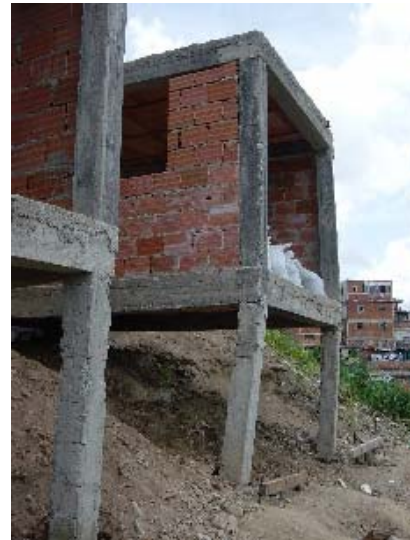
Photo 6.4 Model 1-Long Column Failure

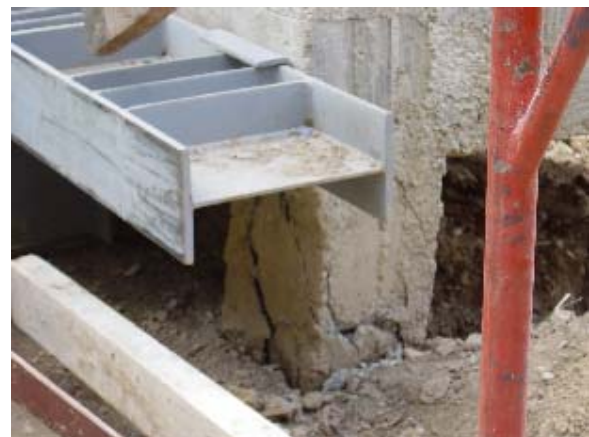
Failure mode of short columns is bending/shear mode at yield strength and shear failure occurs at final stage of test. Failure mode of long columns is bending failure mode, while shear diagonal crack is also observed (photos 6.5~6.10). Yield strength is 10.25 ton, which is 1.17 times of that of model 1. Maximum strength is 14.75 ton, which is 1.44 times of that of model 1. Initial stiffness is increased to 25.0ton/cm, which is 3.0 times of that of model 1. Deflection at yield strength is 4.1mm, and storey deflection is 1/439 (4.1/1,800) for short column and 1/829 (4.1/3,400) for long column respectively. Deflection at maximum strength is 17.6mm, and storey deflection is 1/102 (17.6/1,800) for short column and 1/193 (17.6/3,400) for long column respectively. Deflection at the ground surface (almost same to grade beam) at yield and maximum strength is 2.4mm (lower ground level) and 1.1mm (lower ground level) respectively.

Grade beams are provided so as to maintain ratio of column clear length/column depth is 3.0 to prevent shear failure which is brittle failure. It is assessed that shear failure of short columns occur by the reason of unexpected low strength of concrete which is average $58\text{ kg}/\text{cm}^2$. It is confirmed that the short column under grade beam is not damaged by the visual inspection after the excavation (photo 6.10). Cost impact of strengthening is 5 to 7% of the total cost of building.

Photo 6.6 Model 2-Shear Failure of Short Column (1)

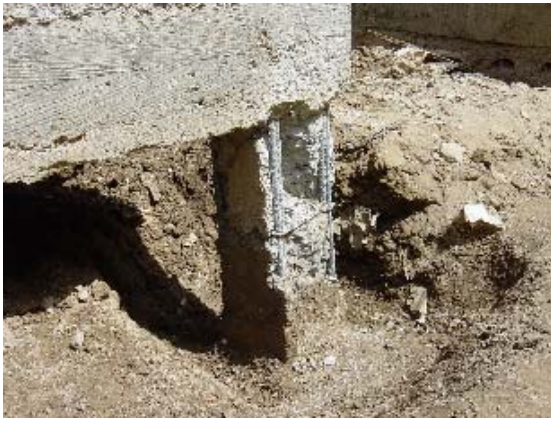
Photo 6.7 Model 2-Shear Failure of Short Column (2)

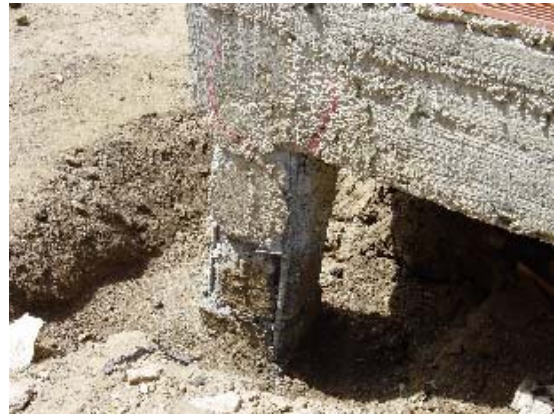
Photo 6.8 Model 2-Shear Crack of Short Column (3)

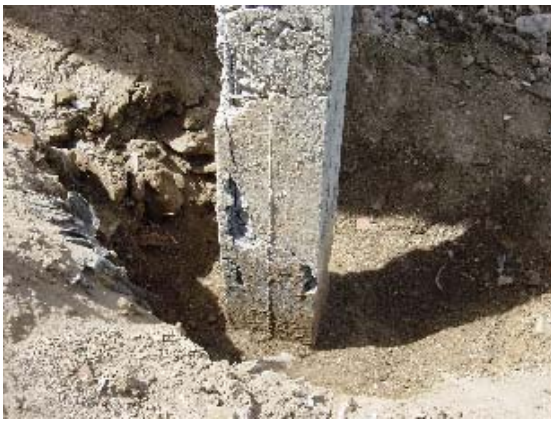
Photo 6.9 Model 2-Long Column Failure

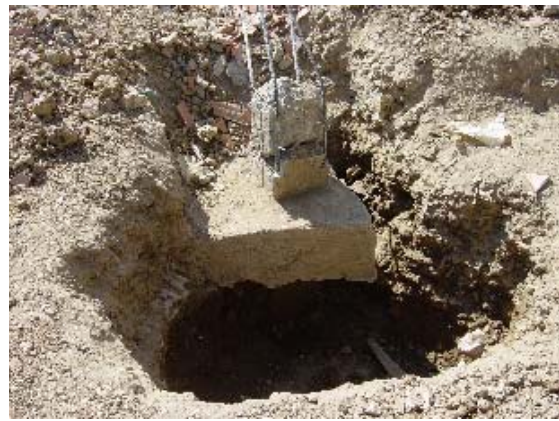
Photo 6.10 Model 2-Short Column under Grade Beam

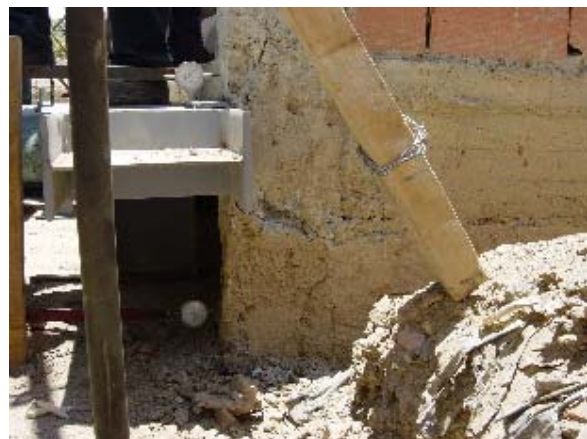
Photo 6.12 Model 3-Diagonal Shear Crack of Short Column

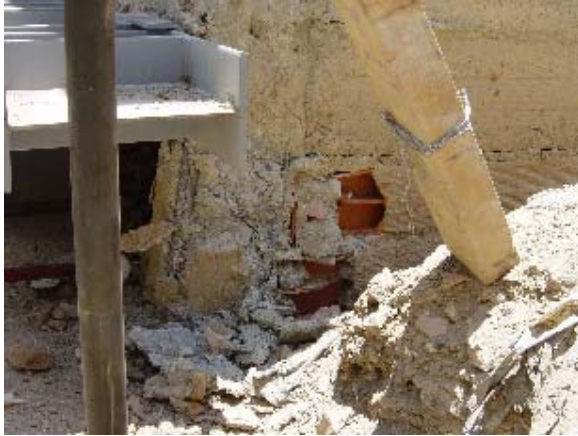
Photo 6.13 Shear Failure of Column and Clay Brick Wall (1)

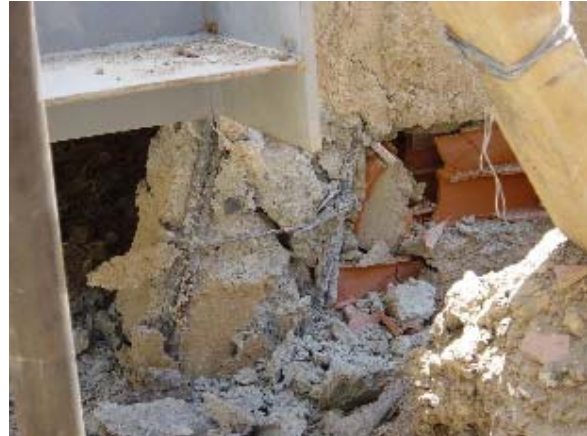
Photo 6.14 Shear Failure of Column and Clay Brick Wall (2)

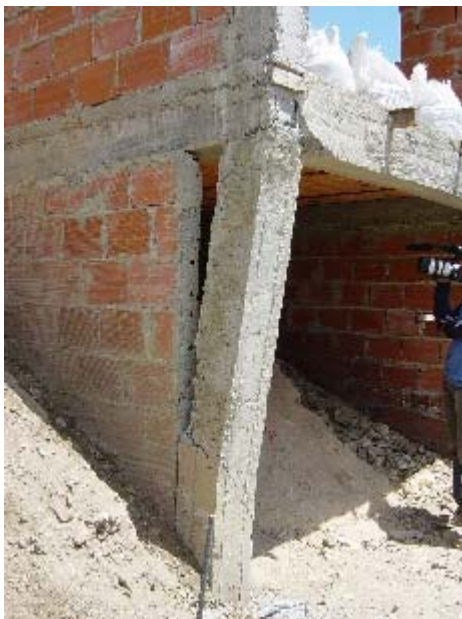
Load deflection curve is similar to that of Model 2. Separation of clay hollow brick walls from columns and beams appears from the beginning of loading and combined effect with frames is not expected. Maximum strength is 16.75 ton, which is 1.13 times only of that of model 2, at the deflection of 17.6mm. It is found that clay brick walls have no contribution to

Photo 6.15 Separation of Wall and Frame

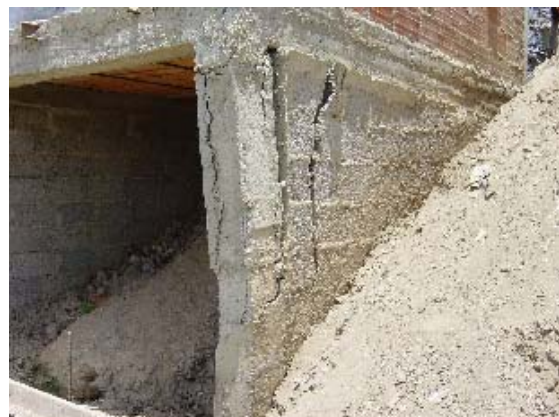
Separation of hollow concrete block walls without re-bars from columns and beams starts at early stage of load 6~7ton. Yield strength appears at the load of 13.75 ton and deflection of 2.7mm, by the separation of hollow concrete blocks with re-bars from columns (photo 6.16~6.21). The maximum strength 15.25 ton is observed at deflection 12.8mm. Initial stiffness is increased by providing hollow concrete blocks, while strength is almost similar to those of Model 2 and 3. Horizontal deflection is increased after the max. strength and is provided more than 100mm as the final stage of loading. It is found that the strength of hollow concrete blocks is low for structural use and for seismic reinforcement. Concrete hollow block wall without re-bars is separated from column/beam at early stage, while wall with re-bars is not separated until lap joint of horizontal re-bars is broken. Strength of concrete block is low, and lower than that of mortar (photo 3.41, 6.21).

Photo 6.18 Failure of Column and Concrete Block Wall

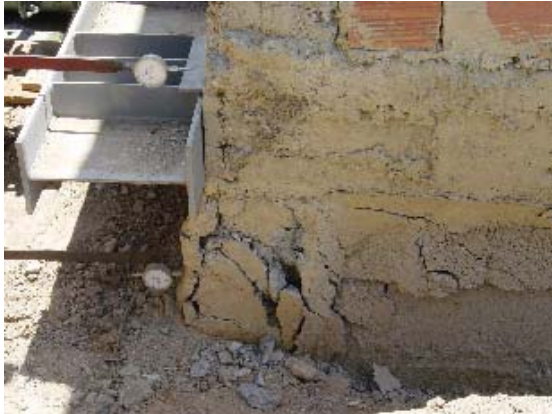
Photo 6.19 Shear Failure of Column and Concrete Block wall with Re-bars (1)

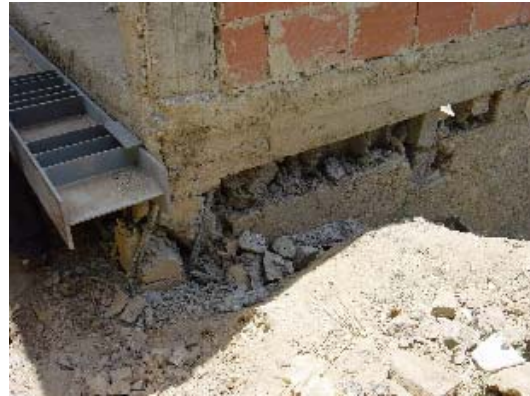
Photo 6.20 Shear Failure of Column and Concrete Block wall with Re-bars (2)

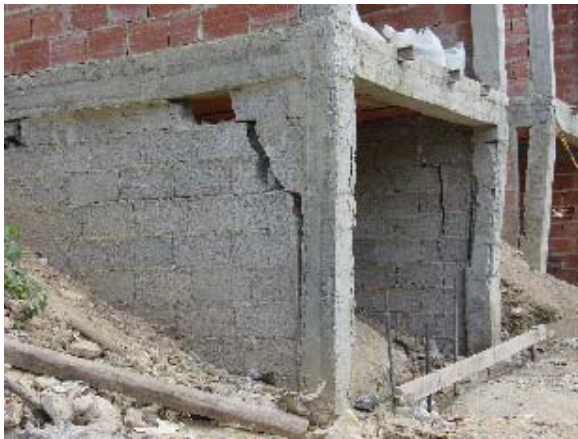
Photo 6.21 Failure of Concrete Block Wall with Re-bars
