CHAPTER 3. STUDY ON VARGAS DISASTER IN 1999 AND MARACAY DISASTER IN 1987

S-11 LAND SLIDE AND STEEP SLOPE FAILURE

The purpose of this study is to identify the slopes that have possibility to collapse and to develop to disaster, and then to make the slope classification map. The slope classification map made by the Study Team in this study shows unstable slopes which would affect inhabitants.

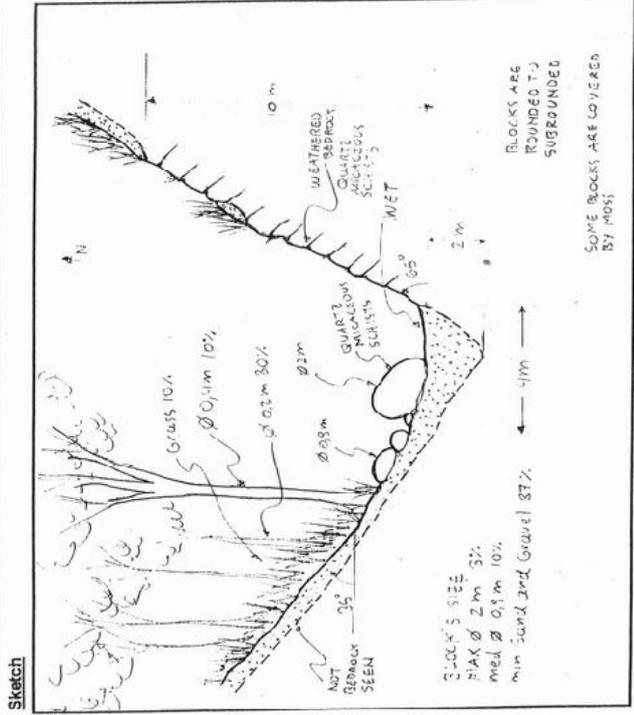
JICA SHEET NO. 7
DEBRIS FLOW INSPECTION SHEET
 Stream Name: CAMBUR (LJ-21) Date: 06/07/03
 Location: 2550 m from Cota Mill Inspected by: Juan C. Suarez N.

Remarks
 ROCKS ARE ROUNDED TO SUBROUNDED
 SOME ROCKS ARE COVERED BY MOSS

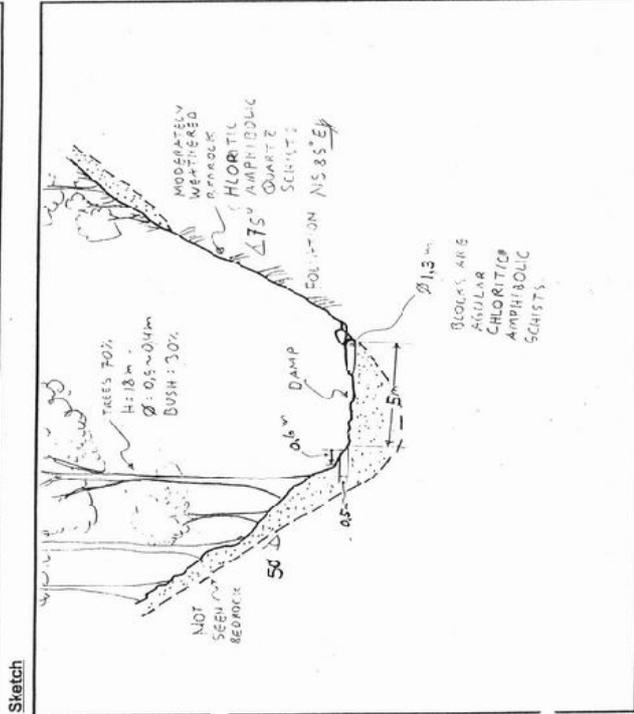
JICA SHEET NO. 4
DEBRIS FLOW INSPECTION SHEET
 Stream Name: CAMBUR (LJ-21) Date: 03/08/03
 Location: 150 m from Cota Mill Inspected by: Juan C. Suarez N.

Remarks
 THE RIVERBED IS DAMP BECAUSE THERE IS A 8 INCHES DIAMETER PIPE RECEIVING ALL THE WATER FROM A DAM LOCATED ON THE UPPER STREAM

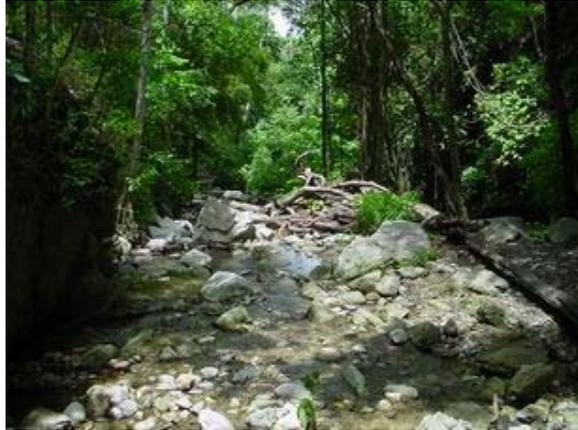
Relatively sand
rich debris in
Chacaito

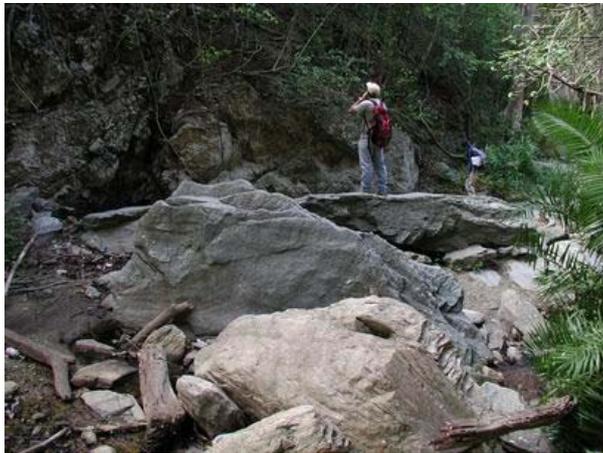
Big Boulders seem to
have fallen from
slope beside of
stream of Tocomé

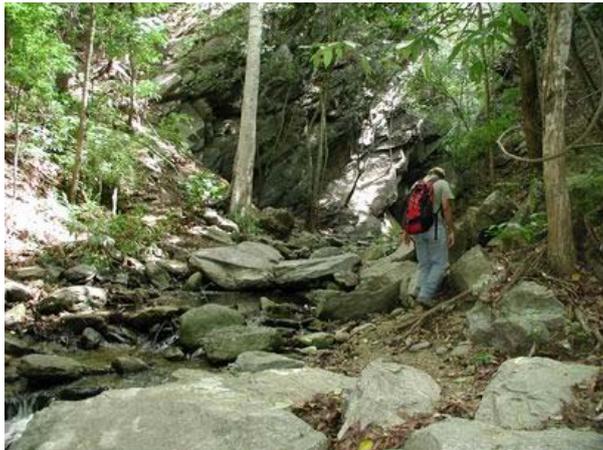
Round boulders
and angular
boulders can be
seen, in Tocomé

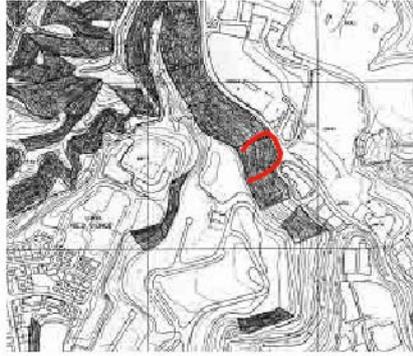
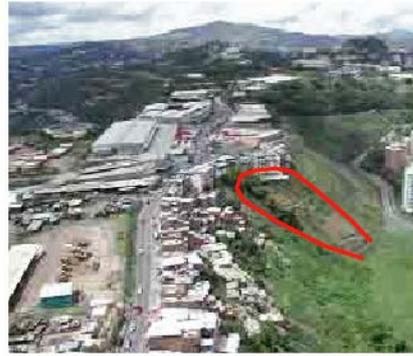
Steep Slope Failure

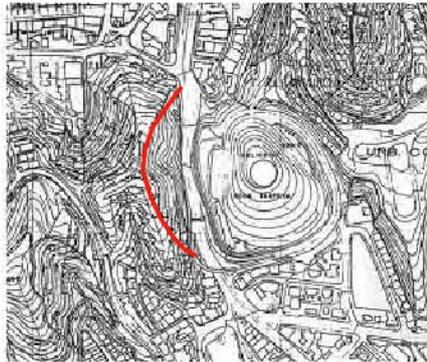
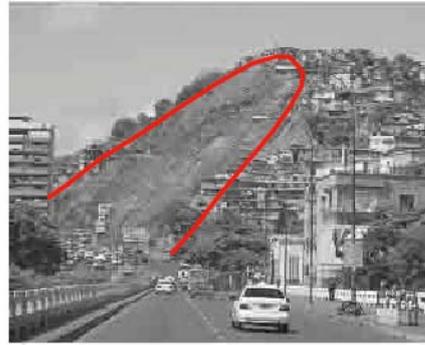
Steep Slope Failure above Road

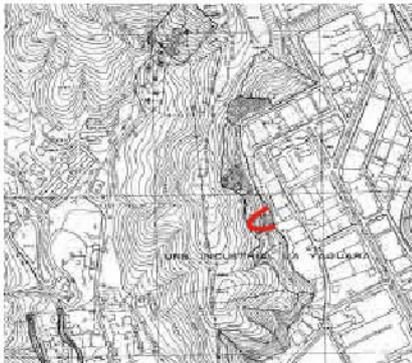
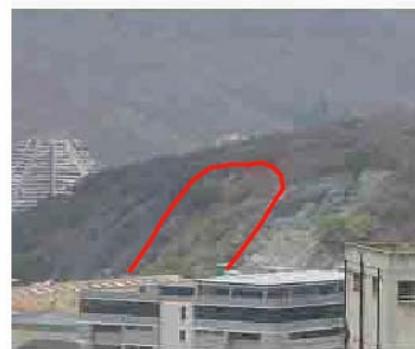
Landslide

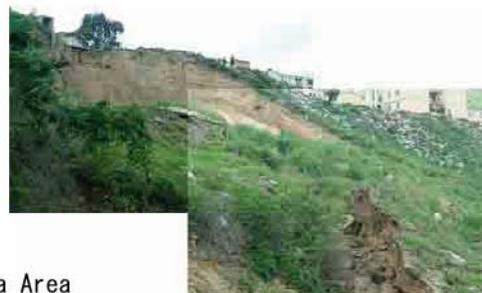
Landslide in Tacagua Area

There are some slope failures in the study area occurred in the 1st study period in Venezuela between May and July in 2003. Loose weathered schist is distributed in these areas. One of these slope failures that occurred in Tacagua area has slip plane that is located on the boundary of bedrock and embankment (refer to Photo S11-3.2.1).

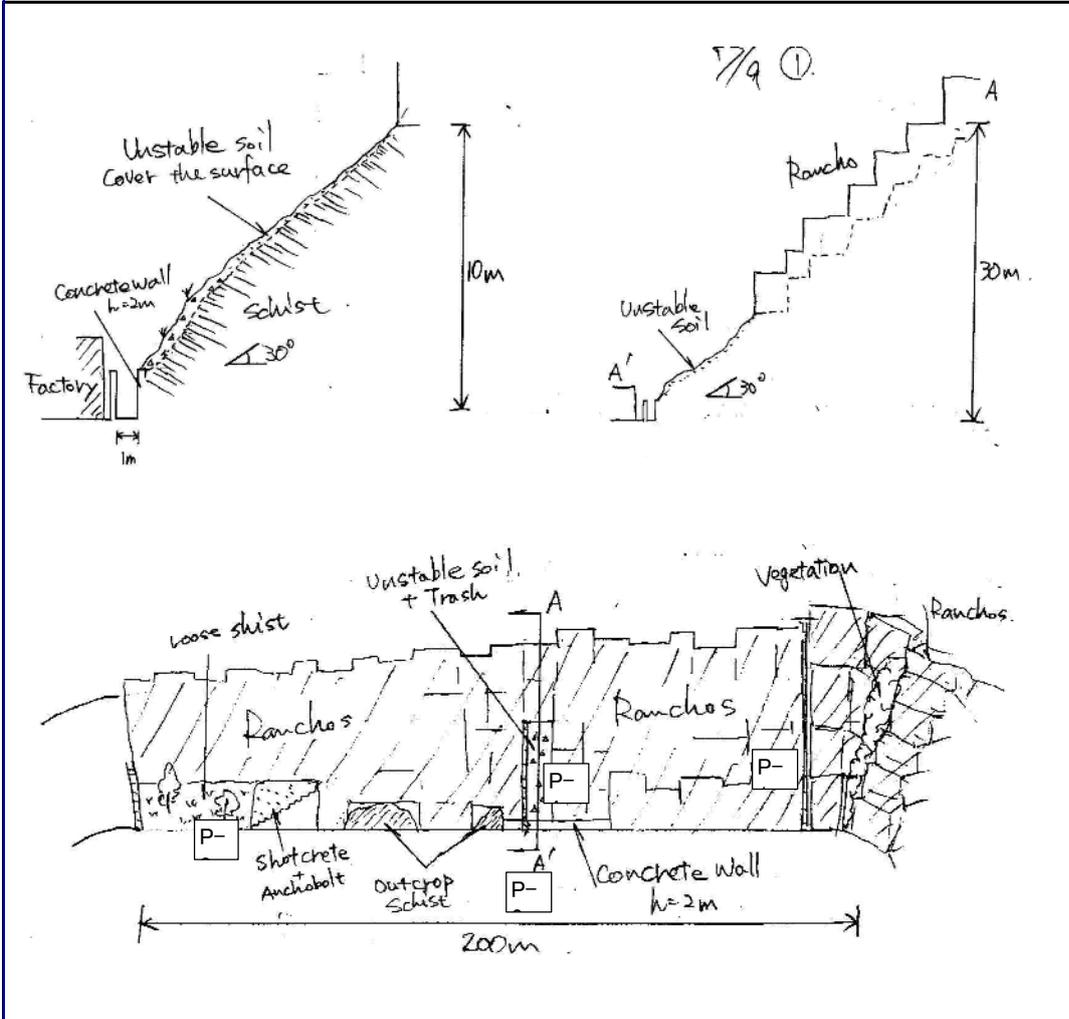
Sketch

- Weathered Schist distributes in this area.
- The almost all surface of the slope is covered with Ranchos.
- Some parts of the slope on which Rancho have not been constructed is covered with unstable soil.
- Some parts of toe of the slope are put countermeasure, but the other parts of toe of the slope still

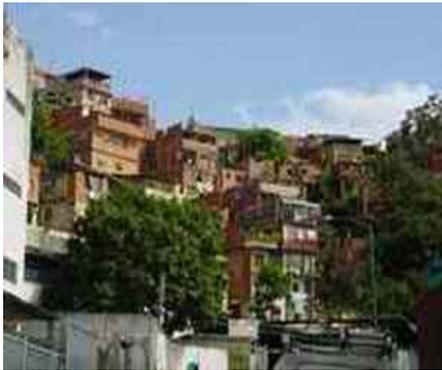
P-1 General View

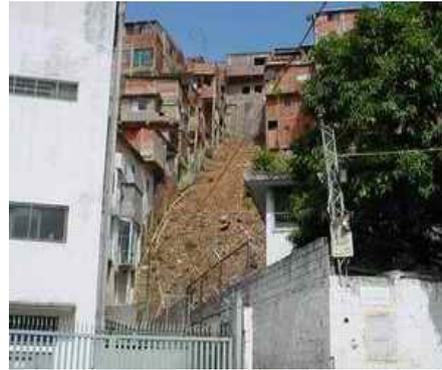
P-2 The bare slope situation

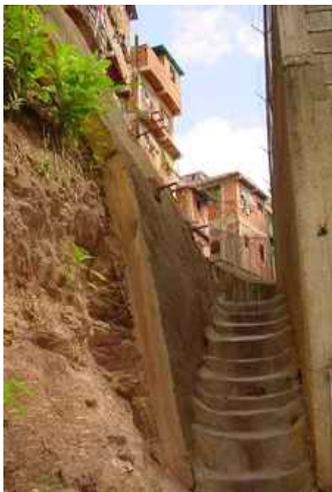
P-3 Existing Countermeasure

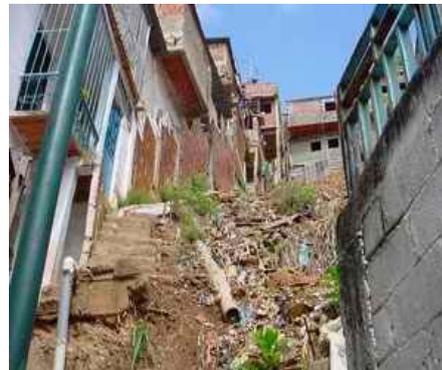
P-4 Close view for the bare slope
