Libro de Datos D

Hoja de Inspección de Pendientes

Tabla DB-2.1 Lista de los Sitios Inspeccionados

SLOPE INSPECTION SHEET

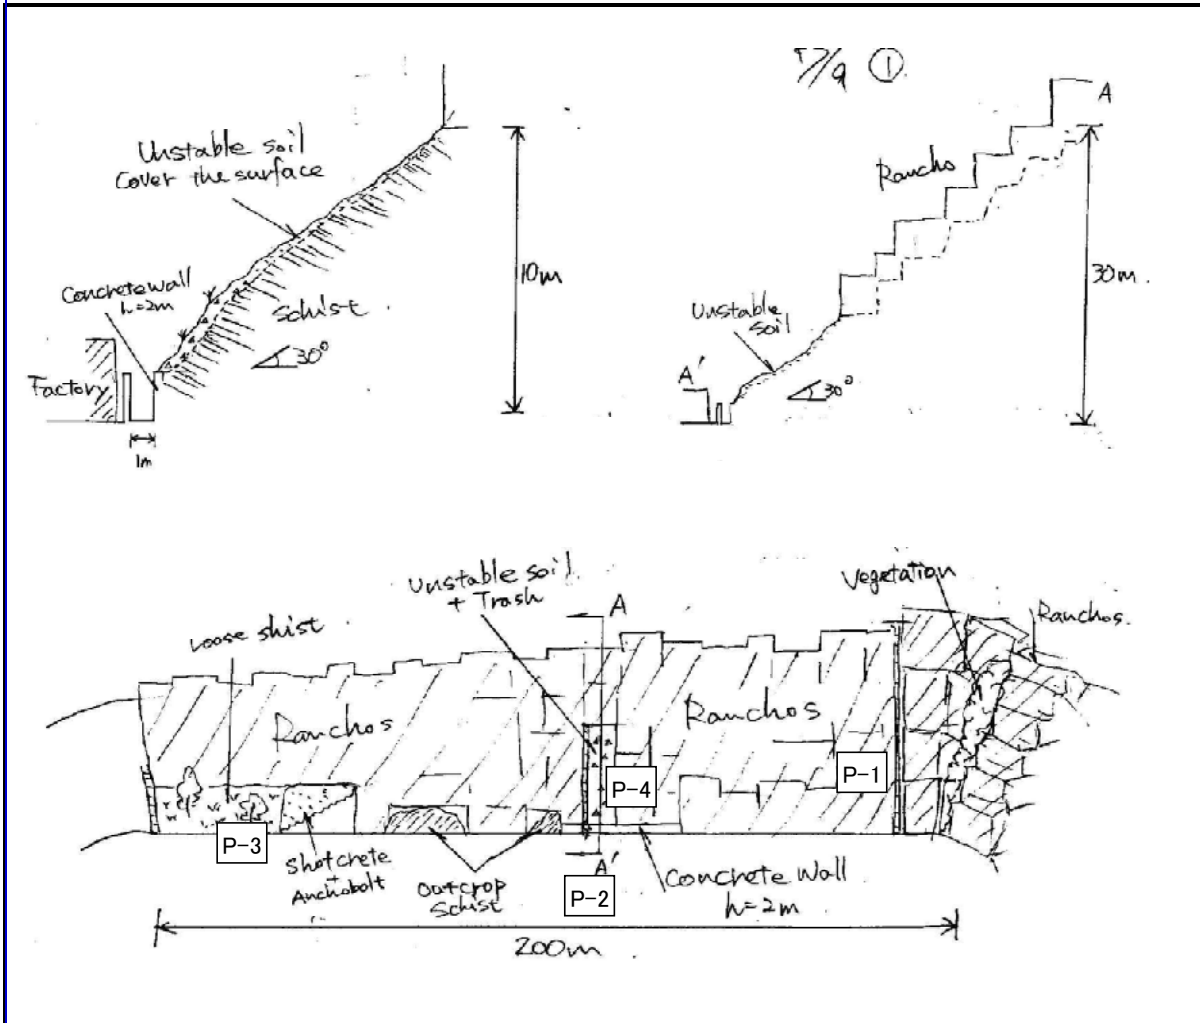
Sketch

| Hazard Score | 54 | Comment: The almost all surface of the slope is covered with Ranchos. Toe of the slope is put some countermeasure partially. | |

- Weathered Schist distributes in this area.
- The almost all surface of the slope is covered with Ranchos.
- Some parts of the slope on which Rancho have not been constructed is covered with unstable soil.
- Some parts of toe of the slope are put countermeasure, but the other parts of toe of the slope still have not been applied any countermeasures.

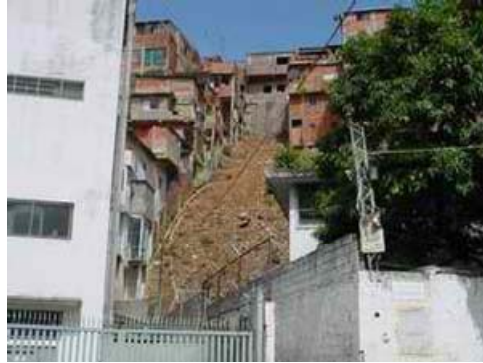
P-2 The bare slope situation

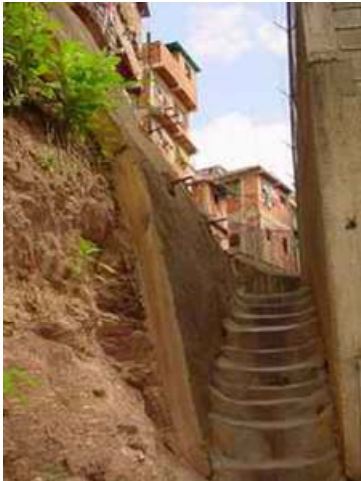
P-3 Existing Countermeasure

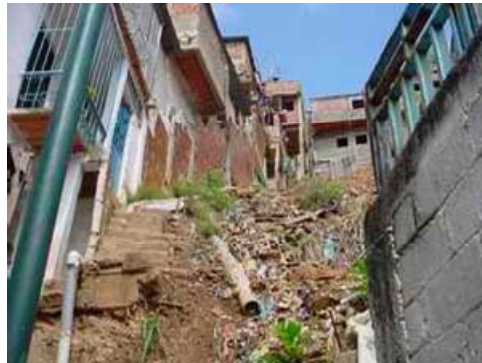
P-4 Close view for the bare slope

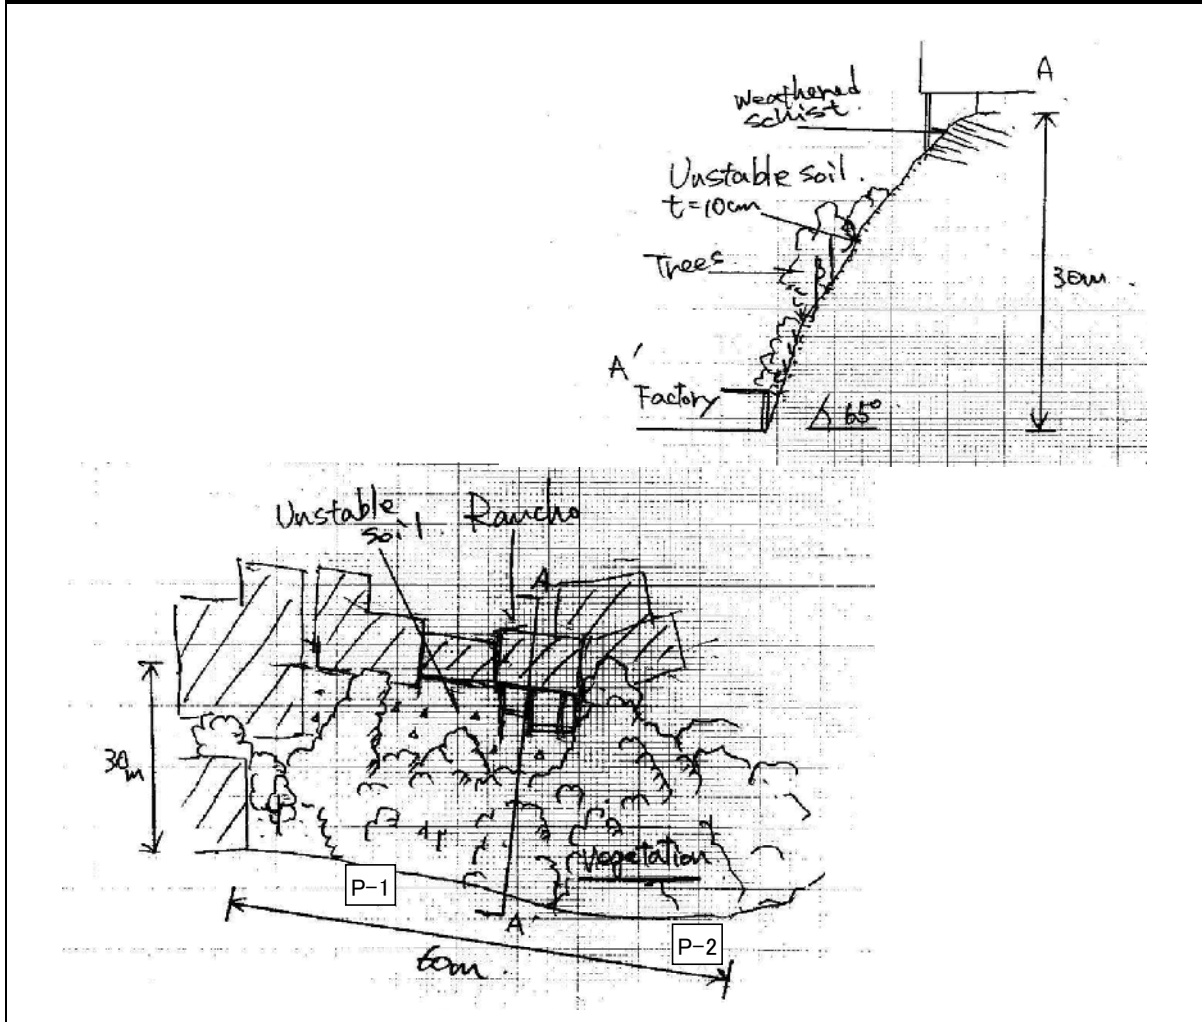
Sketch

| Hazard Score | 63 | Comment : There is unstable soil material on the step slope. | |

- Vegetation (tree and grass) cover almost all surface of the slope.
- Some traces of collapse are found on the slope.
- The surface of the slope is covered with unstable soil

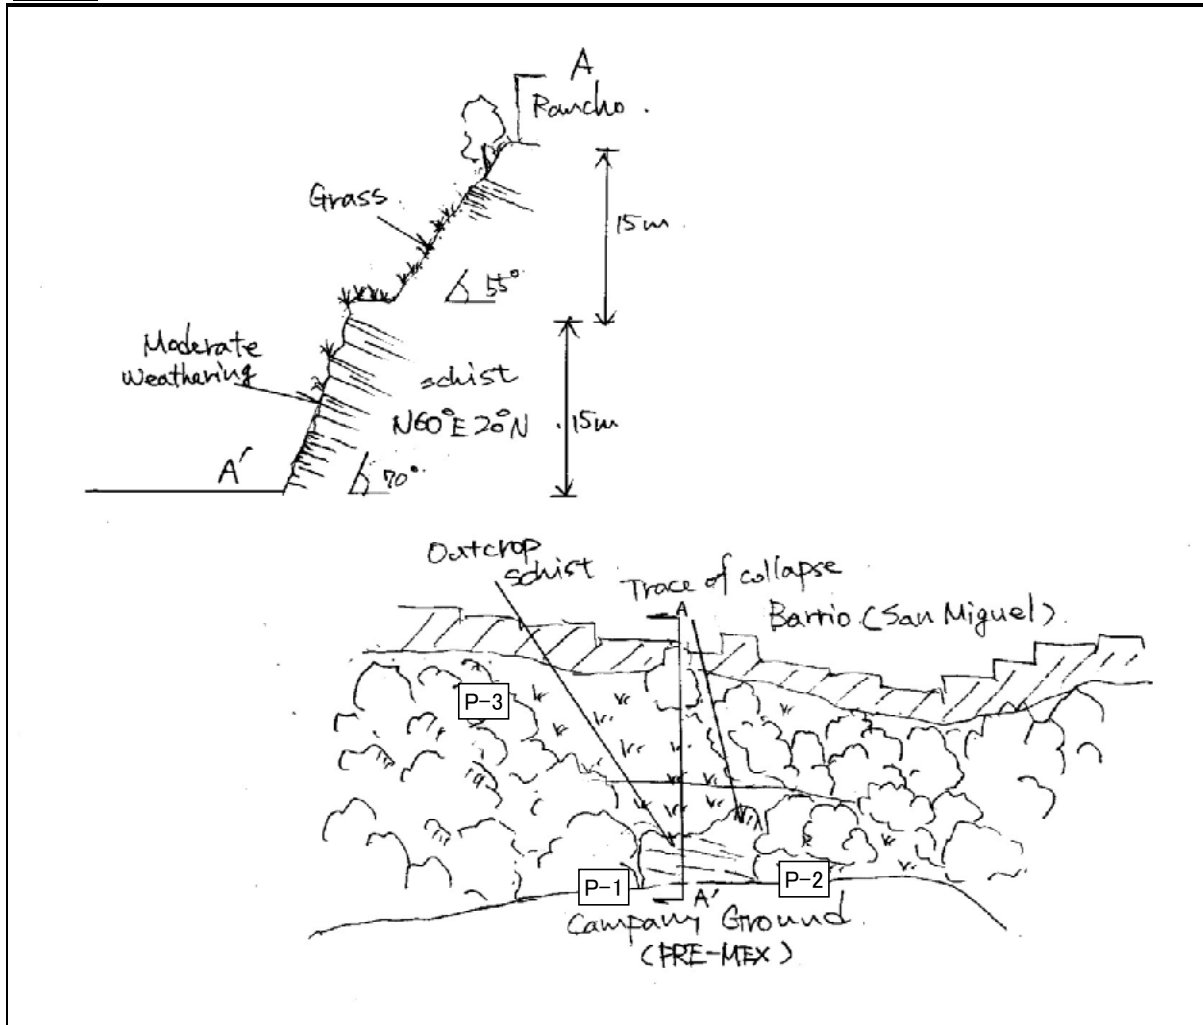
Sketch

| Hazard Score | 58 | Comment: There is the possibility that the trace of collapse extends more due to no countermeasure. | |

- The slope is consisted of moderate weathered schist
- The berm is made on middle of the slope. There is trace of collapse on the lower part of the slope.
- On the upper part of the slope, trace of collapse can not be found.

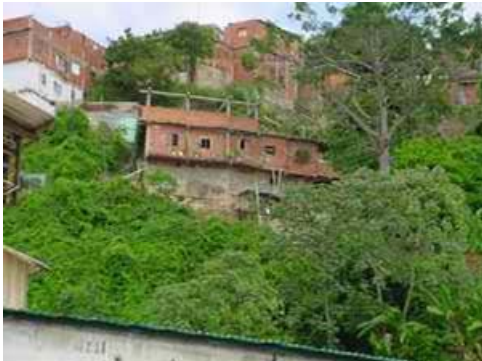
P-3 Situation of Rancho on the slope

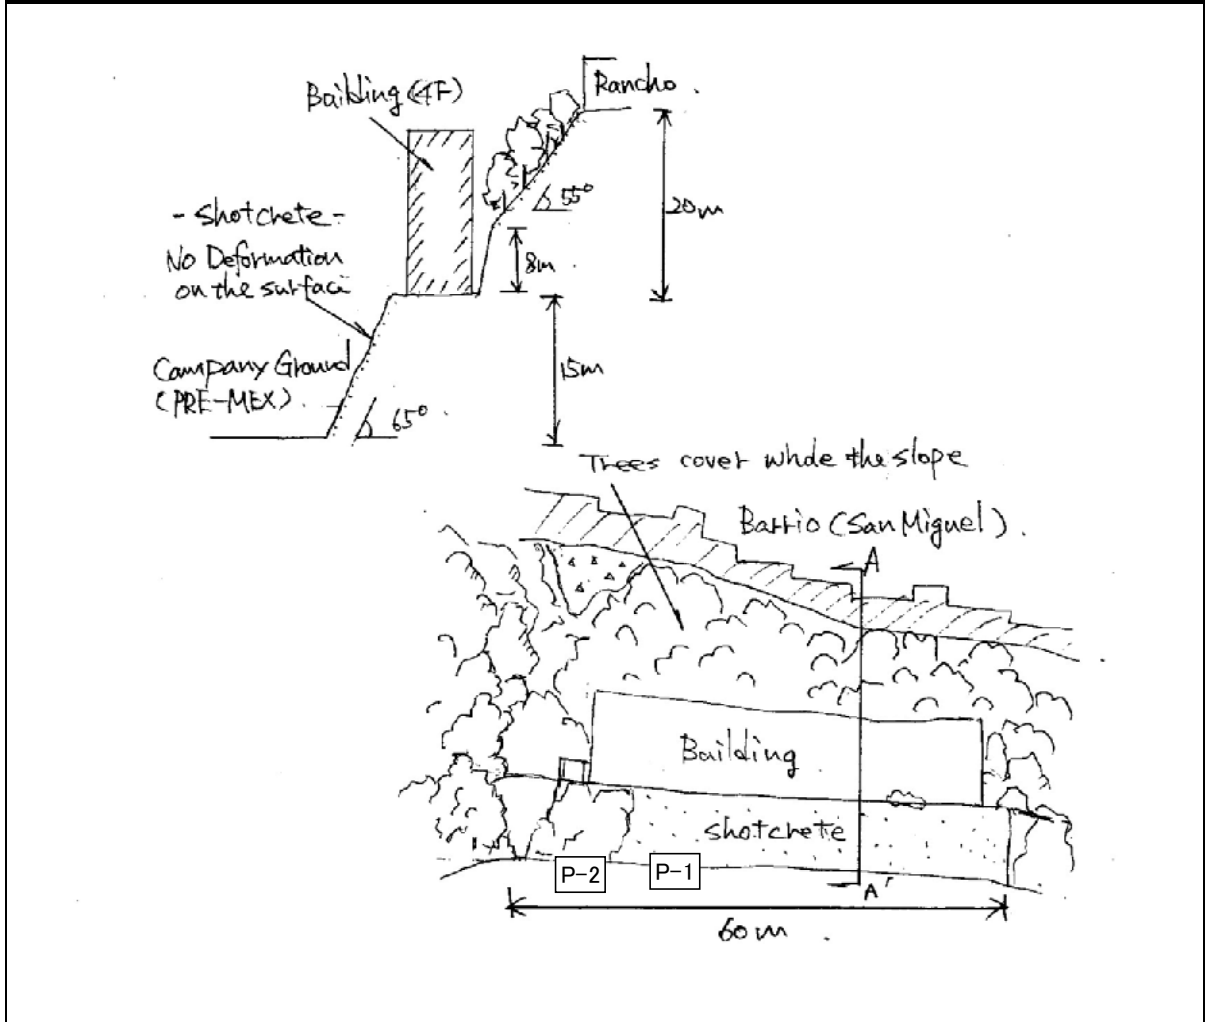
Sketch

| Hazard Score | 39 | Comment: The lower part of the slope shall be stable. There is the possible that some small collapses occure behind the building. | |

-Any deformations are not found on the surface of the lower part of the slope.

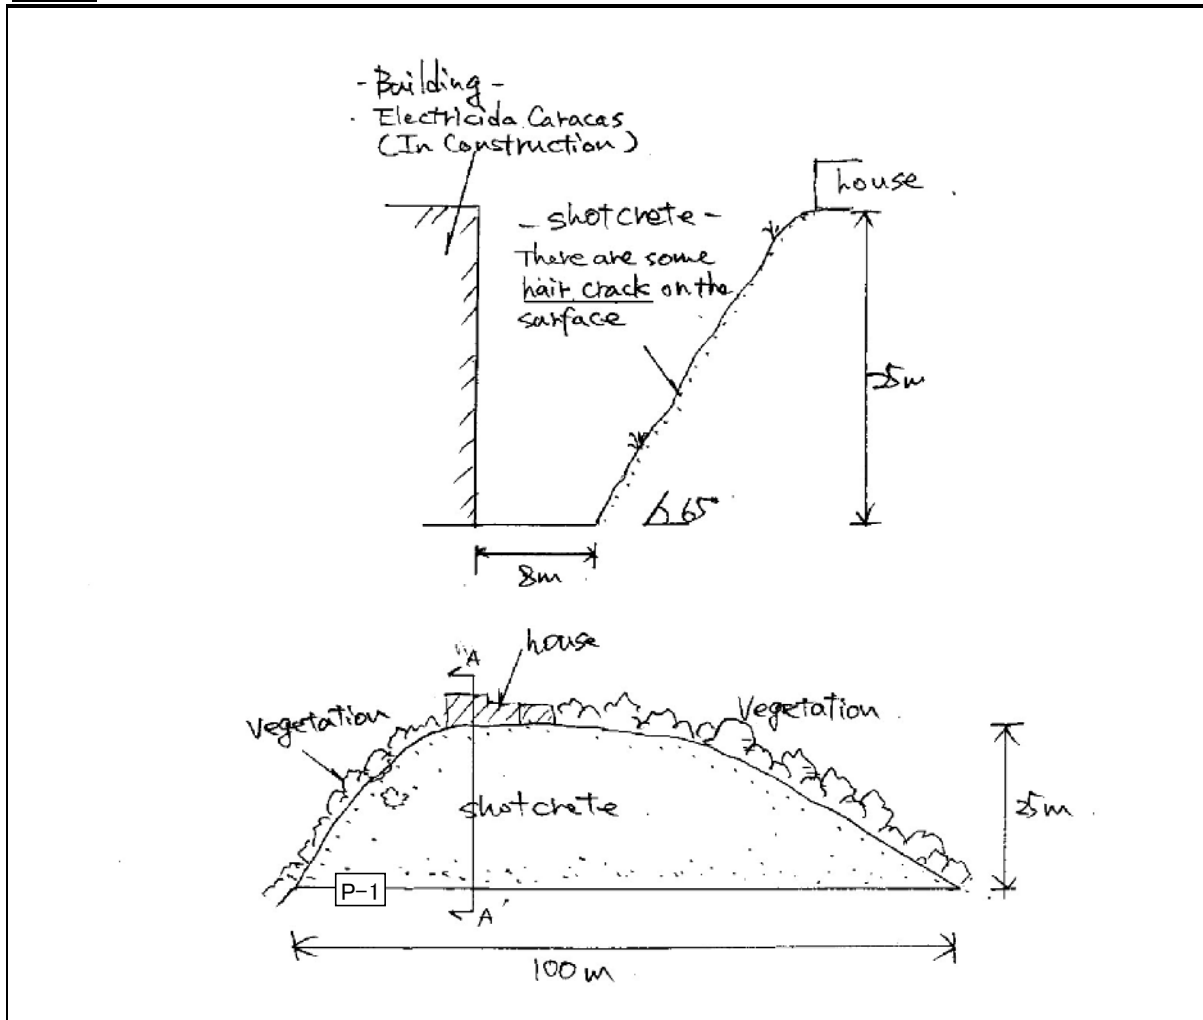
Sketch

| Hazard Score | 15 | Comment: This cut slope is put shotcrete work and there are no deformations on the surface. | |

- The Building that is the target of preservation is in construction. Nobody work in this building so far.
- The slope is put the shotcrete work.
- Any deformations are not recognized on surface of the slope.
- In this time, we could not enter the building site due to no permission.

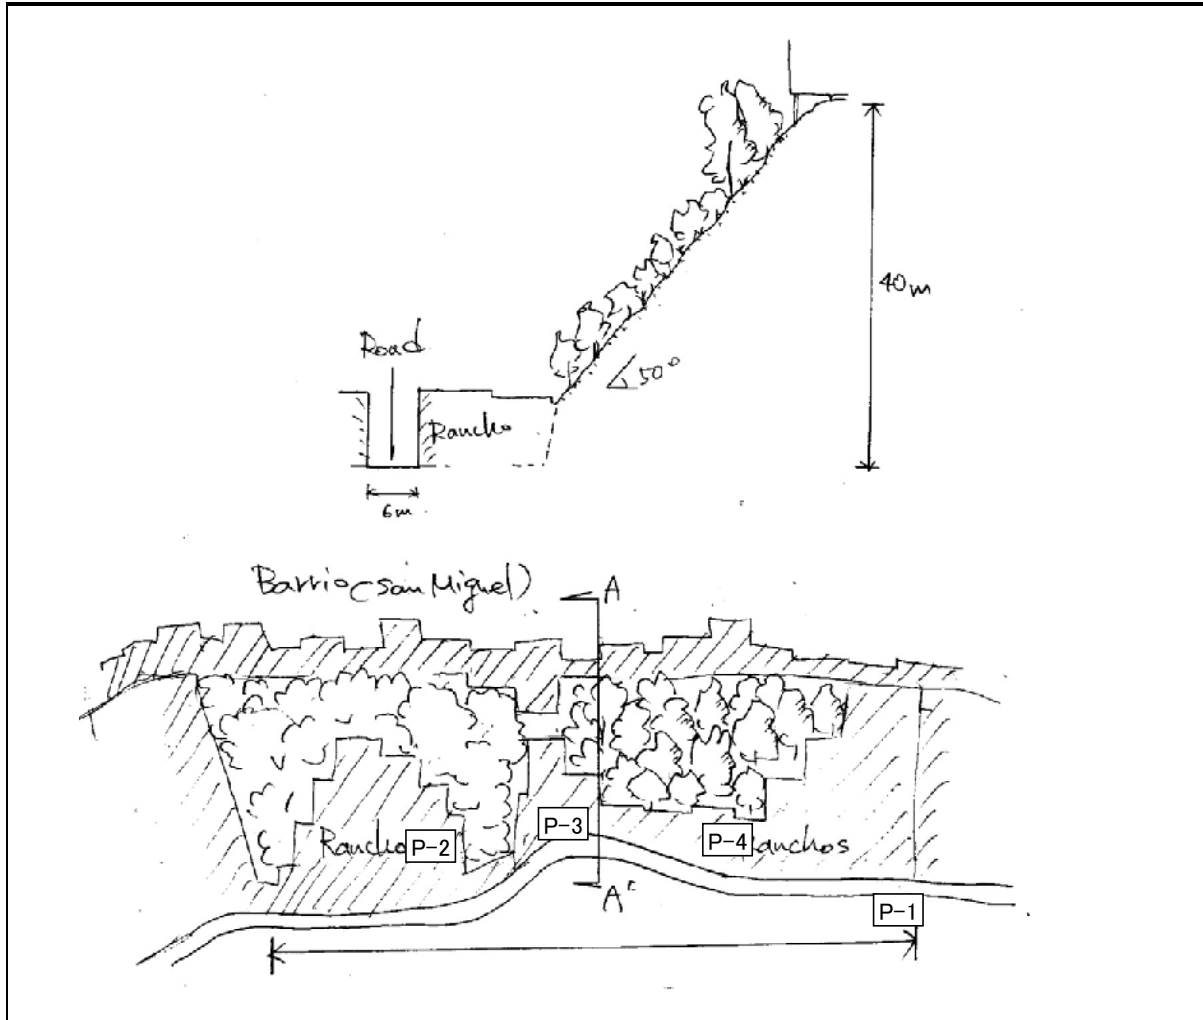
Sketch

| Hazard Score | 57 | Comment: <i>Ranchos are constructed by cutting the slope. Therefore, it is necessary to take notice for the condition of the slope behind ranchos.</i> | |

-Any traces of collapse are not found on the slope.
-There are some drainage system in the barrio.

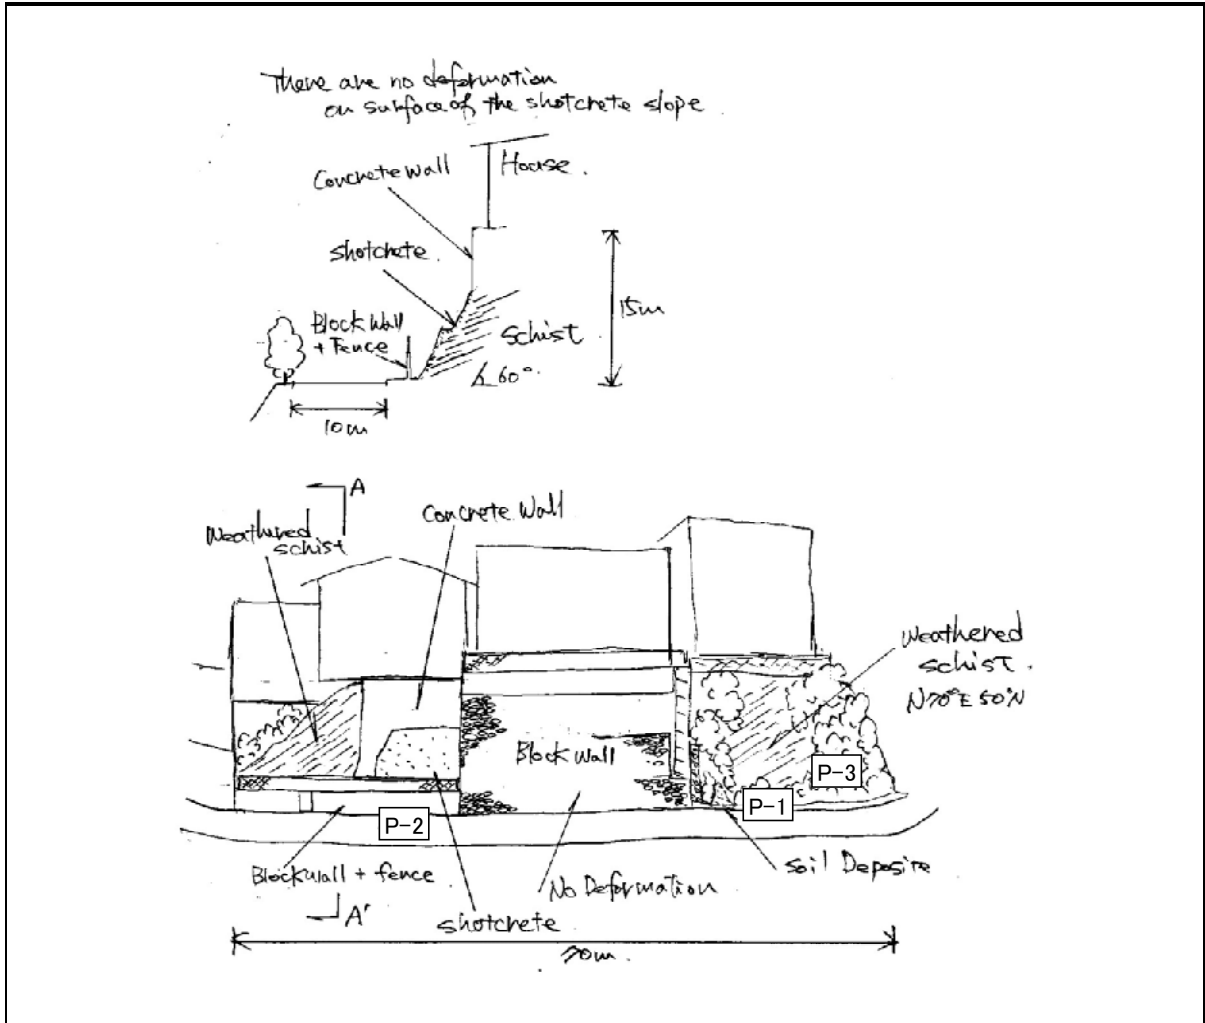
Sketch

| Hazard Score | 46 | Comment: The slope that is put some countermeasure is stable. There is the possible that small collapse occur on the outcrops slope. | |

- The slope is consisted of weathered schist.
- There are no deformation on the existing countermeasures and road.
- Small collapses are found on the surface of the cut slope.

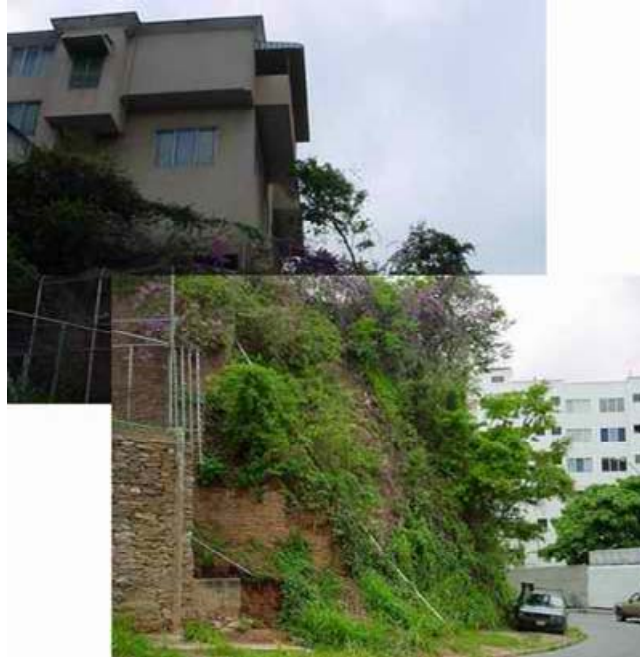
P-1 Situation of the cut slope (South part of the slope)

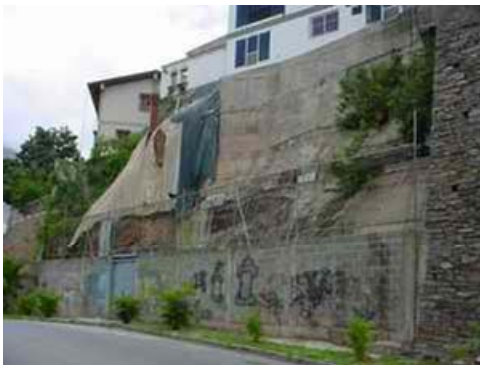
P-2 Existing Countermeasure

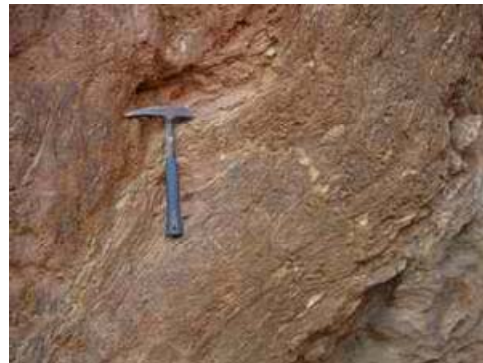
P-3 Outcrops (Weathered Shisit)

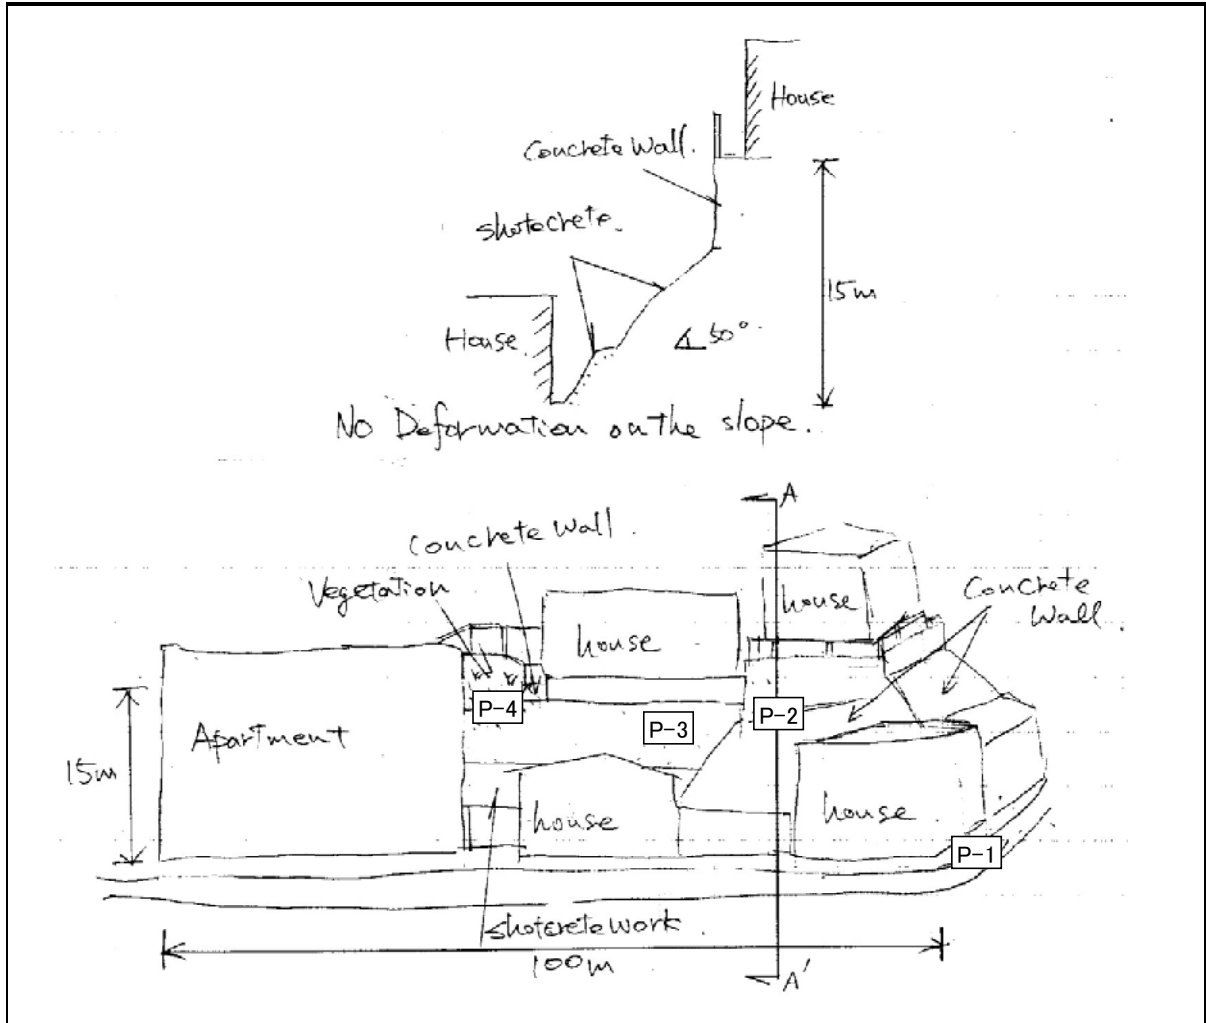
Sketch

| Hazard Score | 23 | Comment: Almost all slope behind houses are put some countermeasures, and any deformations are not found on the slope. | |

- Almost all slope behind the houses are put some countermeasures.
- Any deformations are not found on these countermeasures.

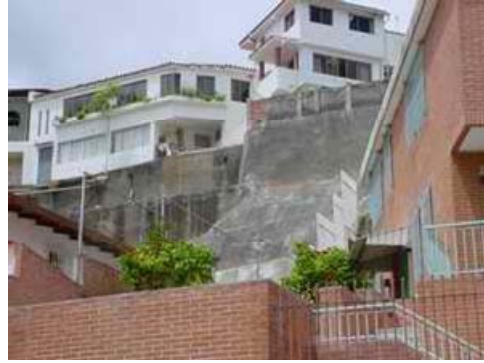
P-2 Existing Countermeasure (Concrete Wall)

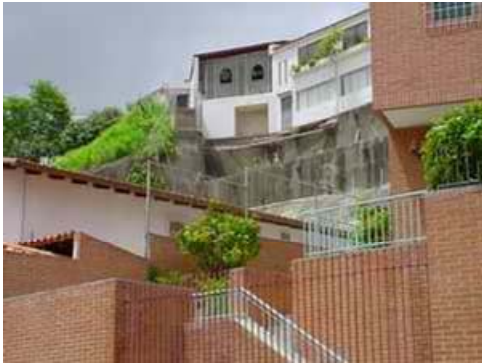
P-3 Existing Countermeasure (Concrete Wall)

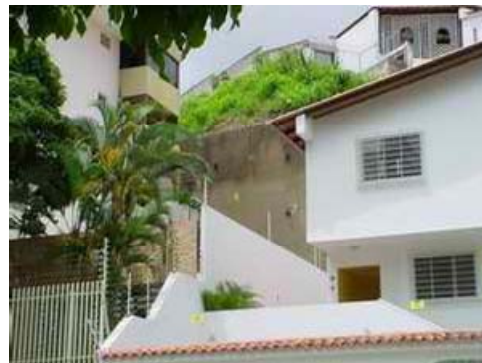
P-4 Existing Countermeasure
(Concrete Wall+Anchor work)
