# SLOPE INSPECTION SHEET

Type of Disaster	<u>Slope Failure</u> / Landslide	Municipality	SUCRE (El Marques)
Slope ID	9		
Date Checked	28/7/2003	Data Inspected	9/7/2003
Checked by	Fumihiko Yokoo	Inspected by	Takashi Hara
Vegetation /Cultivation	Primary Fores( <u>Trees</u> )Grass / Others		
Target of Preservation	<u>Residencial</u> / Hotel / Commercial /Hospital / Factory /School / Others		
Disaster Record	No Records		
Existing Countermeasure	Nothing		
Hazard Score	62	Comment: The direction of geological structure dip against slope direction. Therefore, small collapse shall be easy to occure on the slope.	
Proposed Countermeasure			
Cost Estimation	Quantity	Unit Rate	Amount

Type of Disaster	Slope Failure / <u>Landslide</u>	Municipality	SUCRE (Horizonte)
Slope ID	10		
Date Checked	28/7/2003	Data Inspected	9/7/2003
Checked by	Fumihiko Yokoo	Inspected by	Takashi Hara
Vegetation /Cultivation	Primary Fores / <u>Trees</u> / Grass / Others		
Target of Preservation	<u>Residencial</u> / Hotel / Commercial / Hospital / Factory / School / Others		
Disaster Record	No Records		
Existing Countermeasure	Nothing		
Hazard Score	41	Comment: Some deformations are found the toe of the block wall and ro

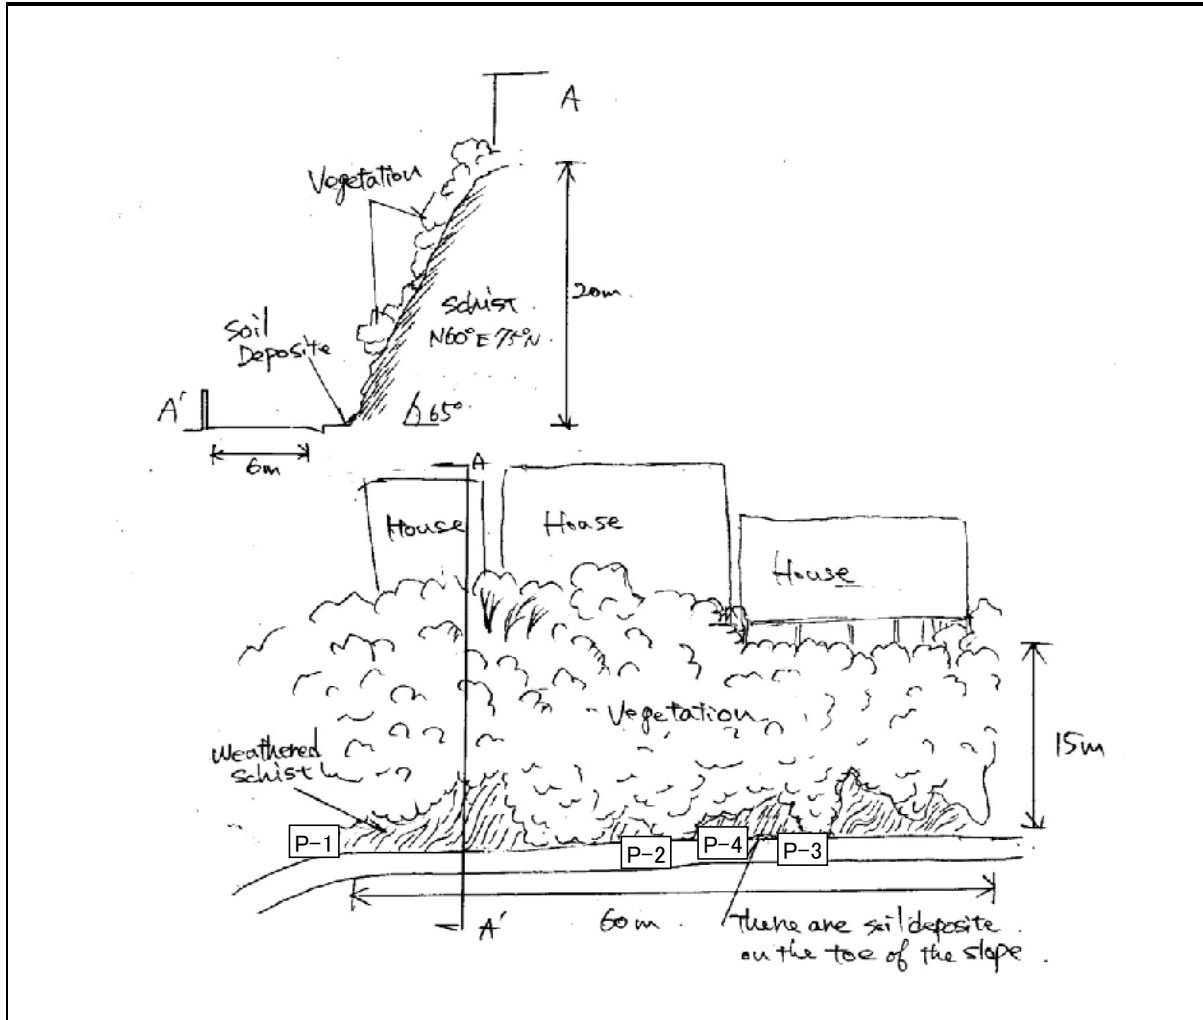
## Sketch

- The slope is consisted of weathered schist.
- The direction of the geological structure dip against the slope direction steeply.

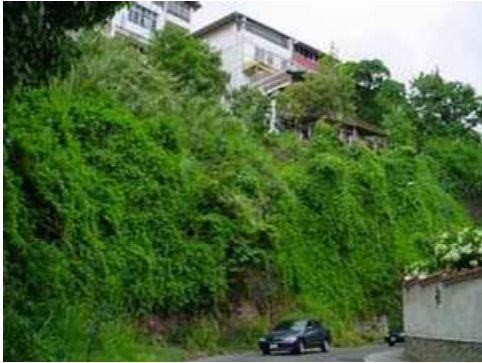
P-1 View of North part of the slope

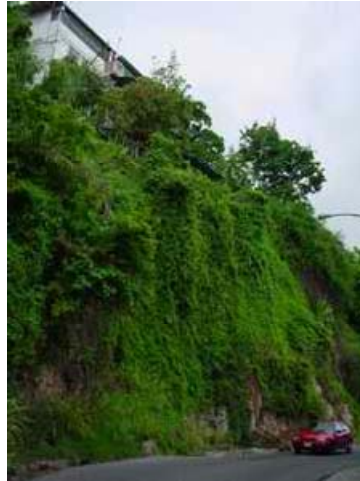
P-2 View of South part of the slope

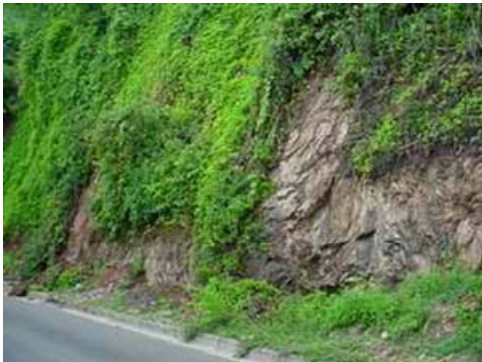
P-3 Outcrops (Weathered mica schist)

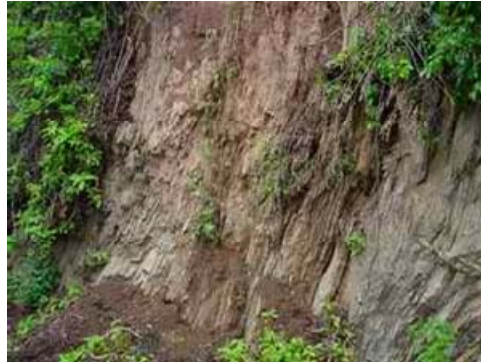
P-4 Surface collapse

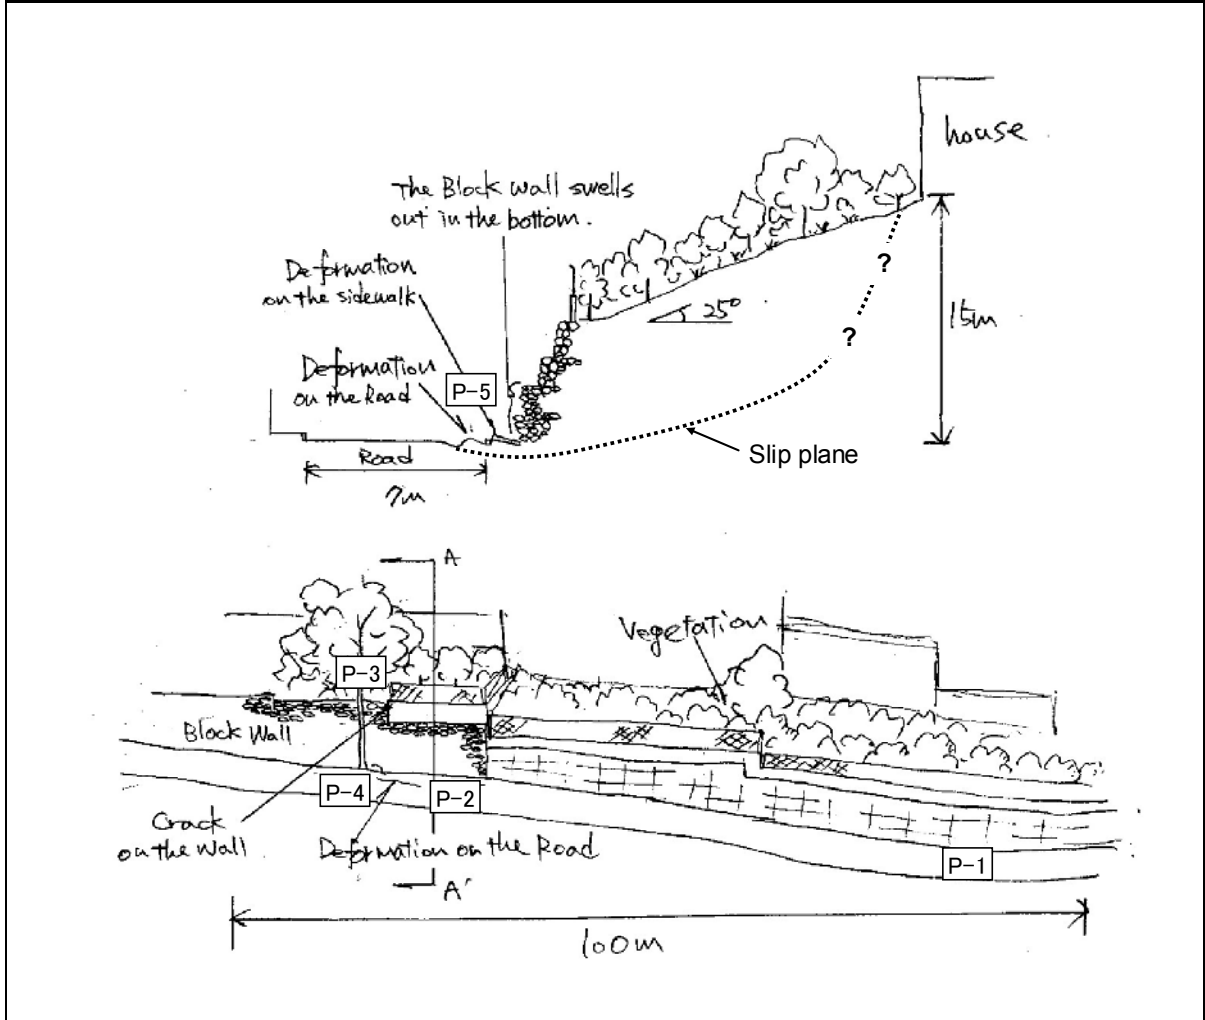
**Sketch**

-Deformation are found on the road.  
 -There are bulging lower part of the stone block wall.

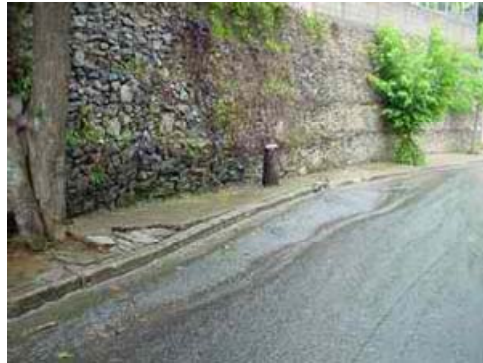
P-2 Deformation on the road

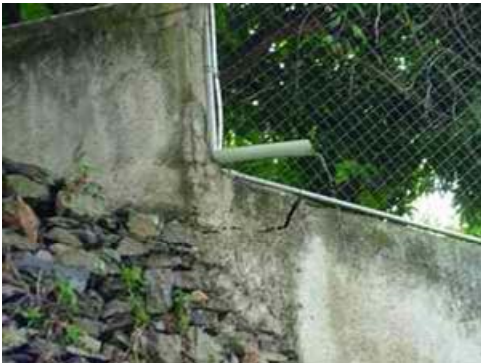
P-3 Crack on the concrete wall

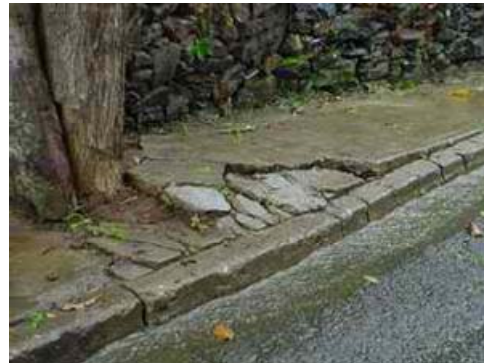
P-4 Deformation on the sidewalk

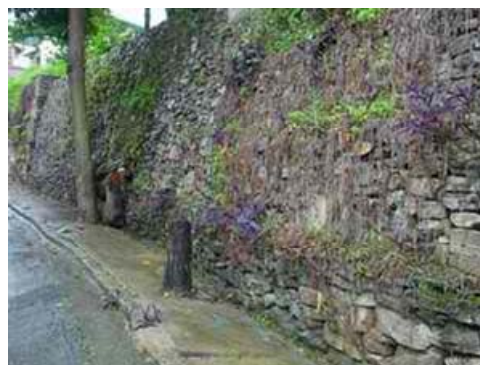
P-5 Bulging at toe of the block wall

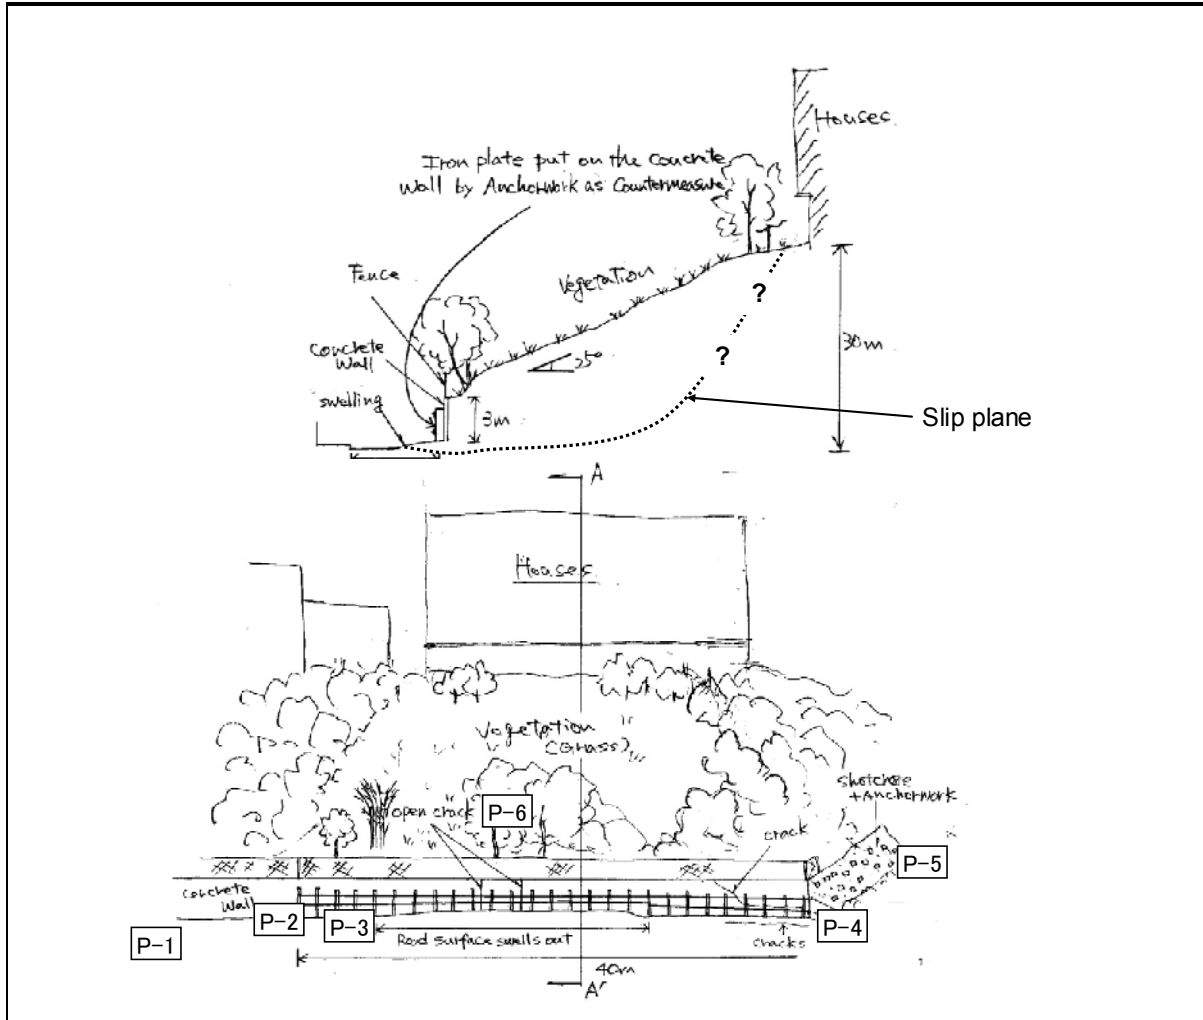
**Sketch**

- Many deformations are found on the road and toe of the slope.
- Open cracks are found on the construction joint of the concrete wall
- North part of the slope is put shotcrete work and Anchor work lately.

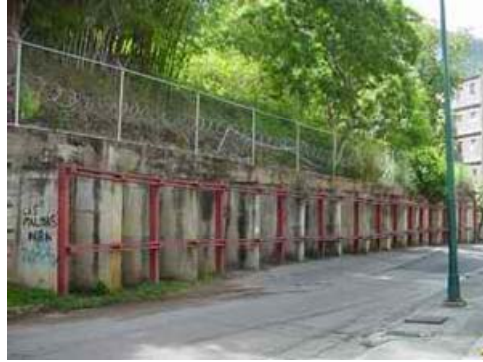
P-2 Existing Countermeasure

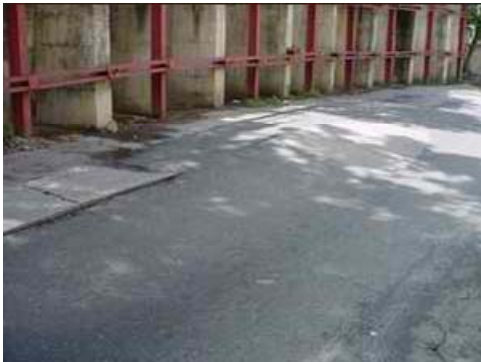
P-3 Deformation on the road

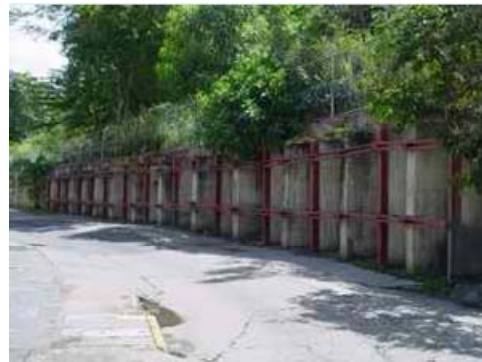
P-4 Cracks on the road

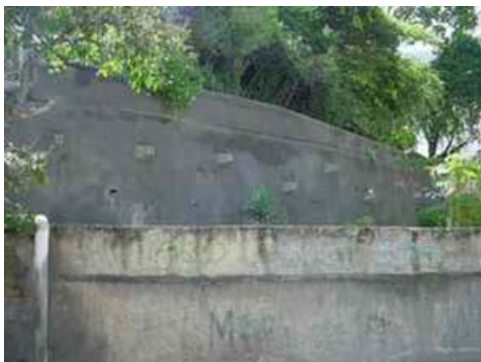
P-5 Existing Countermeasure at North part of the slope

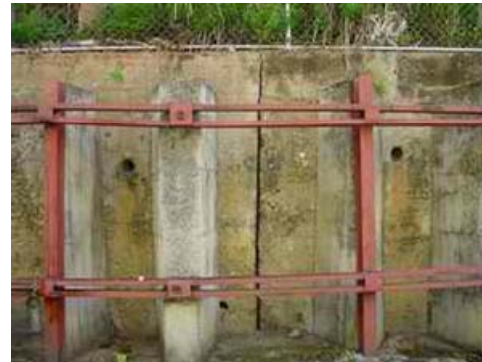
P-6 Crack on the concrete wall
