5.2 Water Quality Investigation

5.2.1 5.2.1 Investigation Background and Purpose

5.3.2.1 Tunnel Remedial Works to Prevent Water Leakage

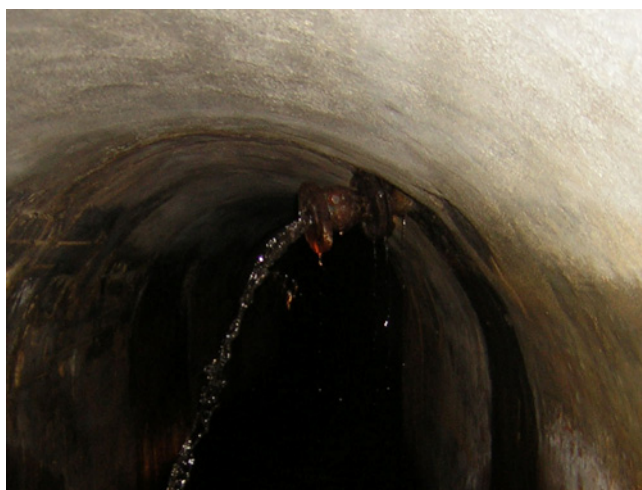
Figure2.1 Water Flooding into Old Tunnel at TD977.5

The investigations showed that water is flooding freely inside the old tunnel a rate of about 1.0 l/s from an old 10 cm steel pipe in the upper right side of the tunnel wall at TD 977.50 as shown in Figure2.1.

Table2.3. shows that there is no remarkable difference in the values of pH, hardness, total dissolved solids, conductivity, bicarbonate and calcium at both Figeh entrance and Wali exit and water flooding inside the tunnel at TD977.5. Water leaking inside the old tunnel is in low rate and of high quality, and in spite that the flow in the tunnel is small; it has no negative effect on the water quality running through the tunnel. However, from safety management point of view, allowing water into the tunnel without purification is an important issue which requires the immediate shut down of the water pipe at TD977.5.

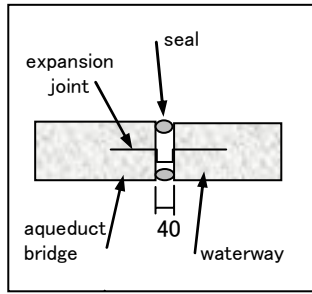
Replace of Waterstop at Joint

There are four aqueducts in the old tunnel. At the joint of aqueduct No.1, 2 and 3, waterstops were damaged and deteriorated. Some leakage also was observed at ground surface around the aqueduct No.3. These waterstops shall be replaced.

These aqueducts (No.1 to No.3) were improved in 1960's. At the aqueduct No.3, however, concrete girder was again damaged where surface is flaked and peeled and exposed reinforcement bars.

Since it is dangerous to cut concrete and replace reinforcement bars, carbon textile ($0.29\text{m} \times 48.9\text{m} \times 2\text{lines} = 28.13\text{m}^2$) is placed on the bottom surface of the girder. There are two purposes to use carbon textile. One is to prevent deterioration caused of water and oxygen, and another is to improve strength instead of corroded reinforcement bars. Therefore, two direction fibrous carbon textile (200 g/m^2) is selected.

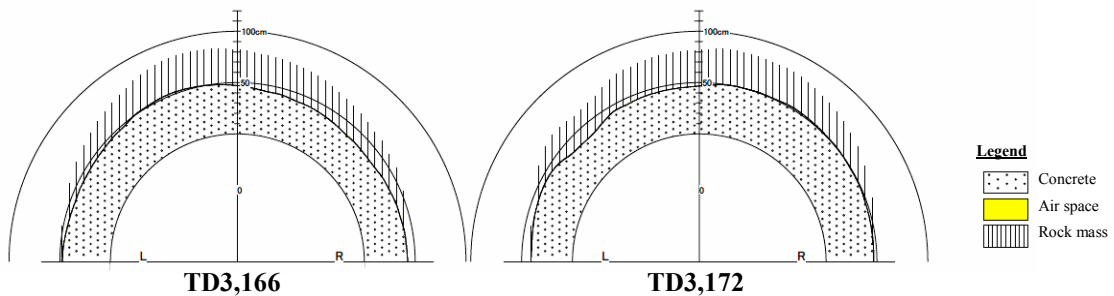
Existing Lining Thickness of Existing Lining to be Improved Section

From TD3,166 to TD3,172 (6m length), on the other hand, surface of concrete was deteriorated and changed into soft and breakable. This chemical corrosion probably caused of acid contents from the surrounding ground.

Chemical corrosion of concrete was observed on all surfaces except invert, and its depth was 15cm approximately. This section will be improved after concrete are chipped off with 15cm thickness and cleaned. Thickness of existing lining to be improved section is shown below.

Both sections have 40cm thickness of concrete, therefore, 25cm thickness can be kept as design concrete thickness after deteriorated surfaces were chipped off.

FRP (Fiber Reinforced Plastic) panel will be installed at inner surface, and polymer cement mortar will be injected behind of FRP. In addition, staggered drain holes with 20cm diameter will be provided on FRP to prevent further chemical corrosion at inside. Surface of FRP panel shall be kept cleaned by DAWSSA's periodical inspection.

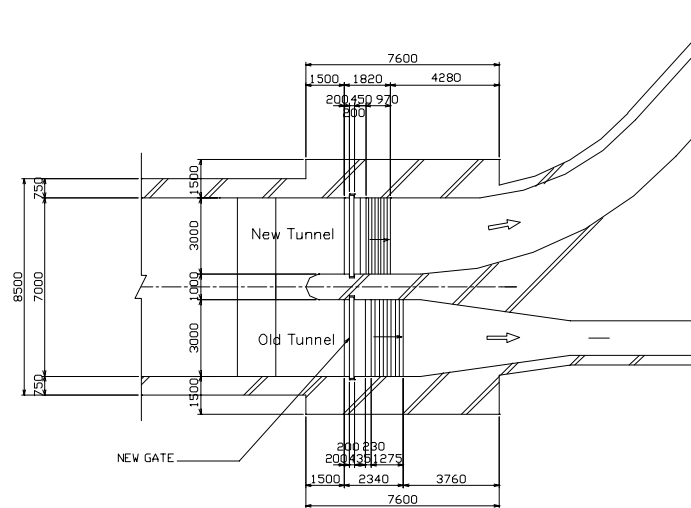
Location of Intake Gate at Fiegh

There was leakage at the intake gate ($W=3m$, $H=1.5m$) of Fiegh, so that it is inconvenient to operate and maintain by DAWSSA. Therefore, it was understood that gate slots and leaf should be replaced.
