スリランカ国
水力発電最適化計画調査に関する
フォローアップ調査
(ケラニ川水系水力発電所
リハビリテーション)

ファイナル・レポート
Vol. II
付 録

APPENDIX A-1
地質調査等

3. New Laxapana 発電所調圧水槽付近

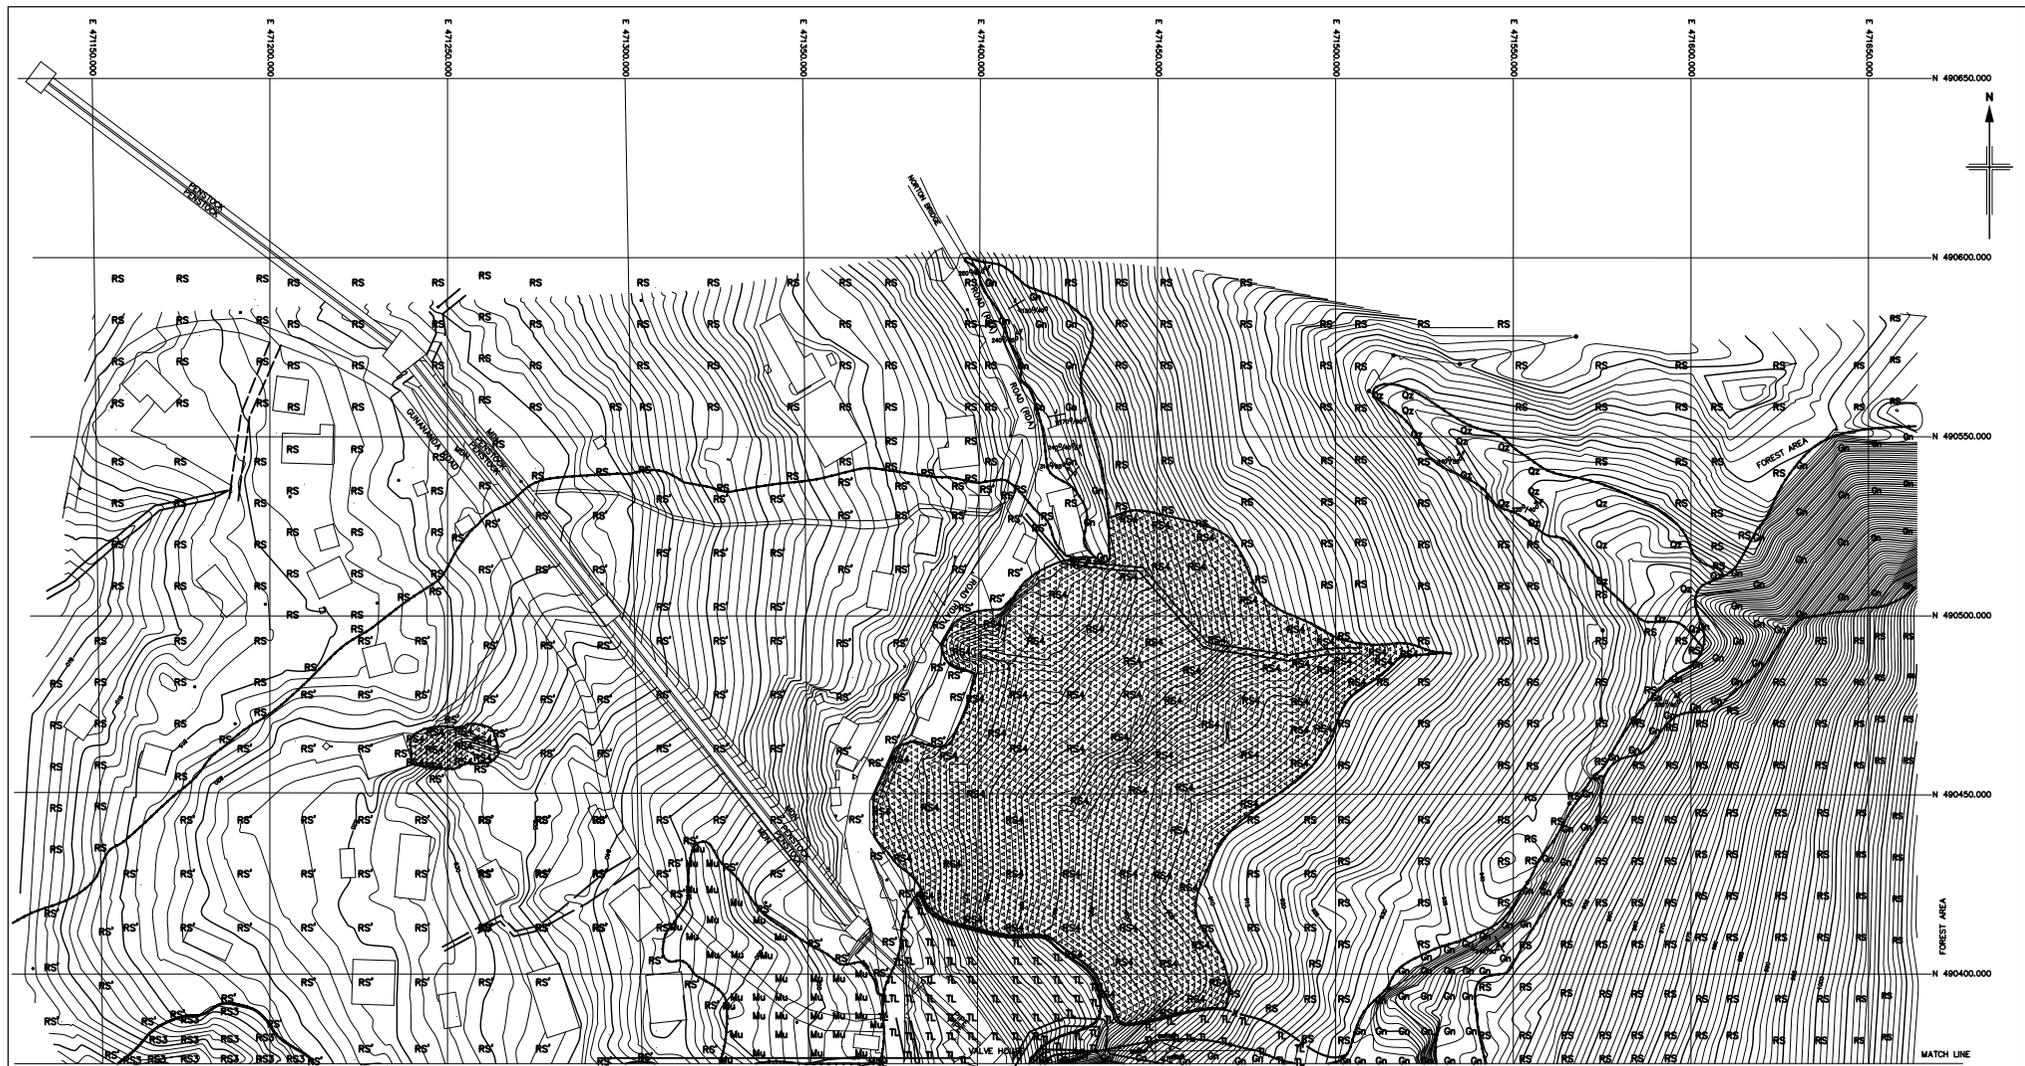
Figure 3.1 Geo Map (New Laxapana - 1)

調圧水槽周辺の地質踏査は2005年1月から2月にかけて実施され、作成された地質図を Figure 3.1 に示す。

岩盤はチャーノカイト質片麻岩、チャーノカイトおよびコーツァイトから構成され、その片理はN20～50°W、30～50°の走向傾斜を示し、斜面の平均傾斜方向よりやや上流に向かって斜面と同じかやや急な角度で傾斜している。

斜面を覆って分布する堆積物は、その構成物資や表面の状態により Table 3.1 のように区分される。それには New Laxapana 発電所トンネルの掘削ズリが含まれている。その表には堆積物の推定形成時期も示されている。

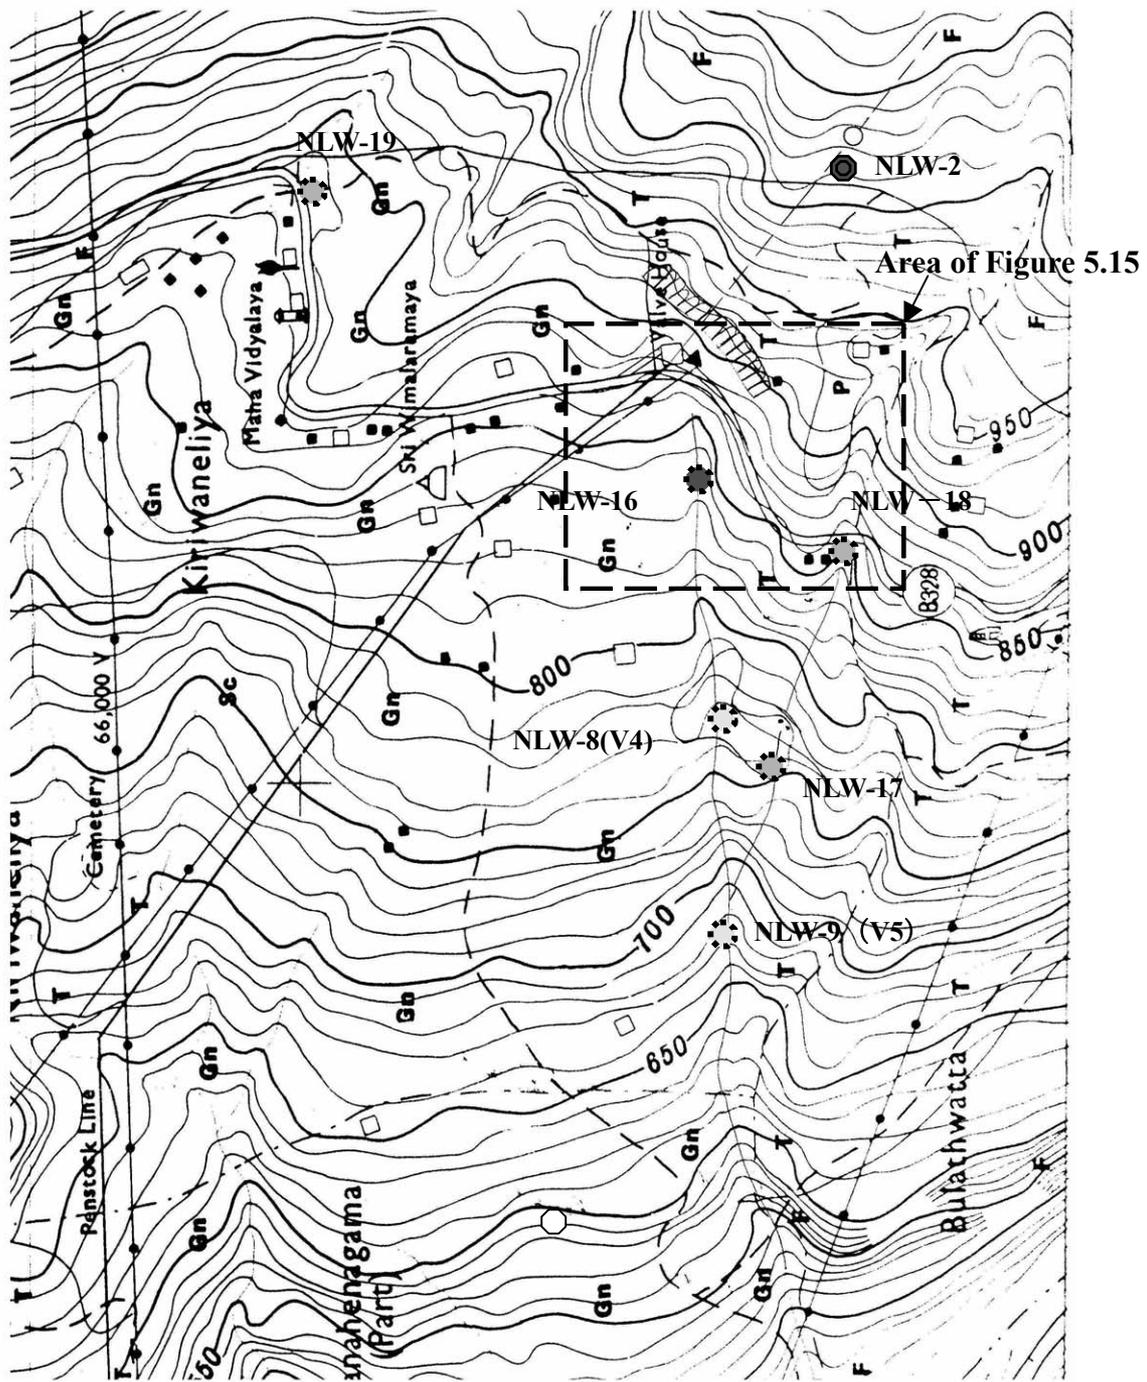
Figure 3.3 Electrical conductivity

測定・分析項目のうち、電気伝導度に着目する。電気伝導度は水路の水で $20\mu\text{S}$ を示し (NLW-1、2)、水路付近やそれより斜面下方の湧水や沢水は $20\mu\text{S}$ あるいは $20\sim 10\mu\text{S}$ を示し、水路から斜面を側方に離れた位置の沢水で $10\mu\text{S}$ 以下と低くなっている Figure 3.3、3.4。水路付近やそれより斜面下方の湧水や沢水は水路の水とほぼ同じか、それが多く混入している事を示唆する。

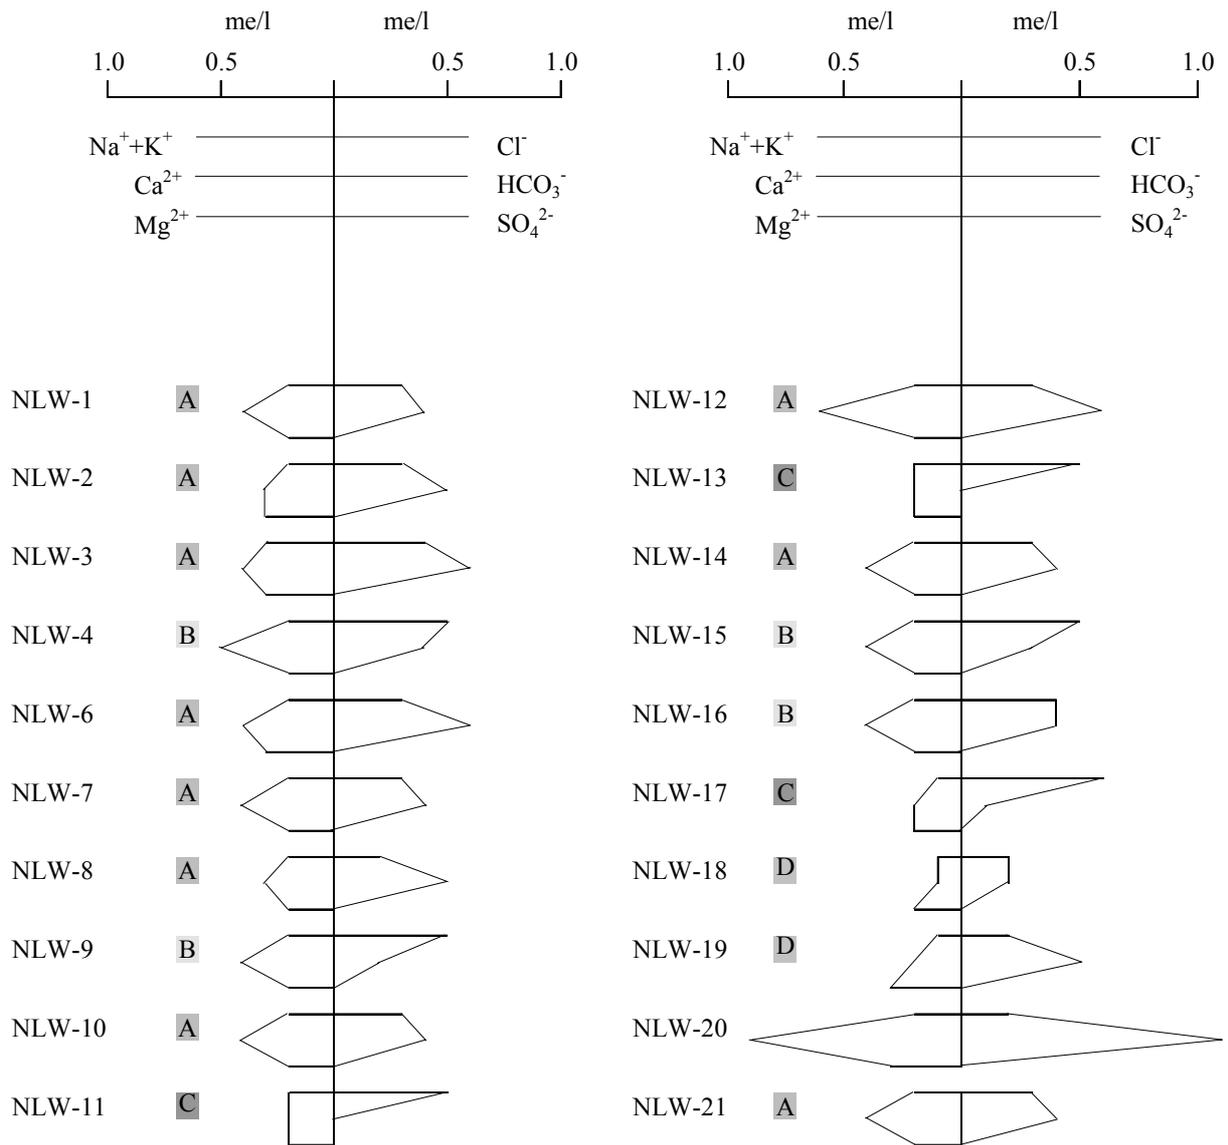
Figure 3.5 Water Quality by Hexadiagram

次に化学成分について、重量濃度 (ppm = g/リットル) を当量で除した濃度 (me/リットル) で、ヘキサダイアグラム Figure 3.5 で検討する。採取地点と水路の位置関係も考慮すると、以下の4つの水質に分けられる。その分布を Figure 3.6、3.7 に示す。

A は水路の水およびこれに近い水である。C は A とは全く異なる水で、地山に長時間滞留していた水の可能性が高い。B は A と C が混合したものと思われる。D は降雨に近い水と思われる。(降雨の試料：NLW-20：はイオン濃度が水路の水すなわち河川本流の水より高く異物が混入していると思われる)。

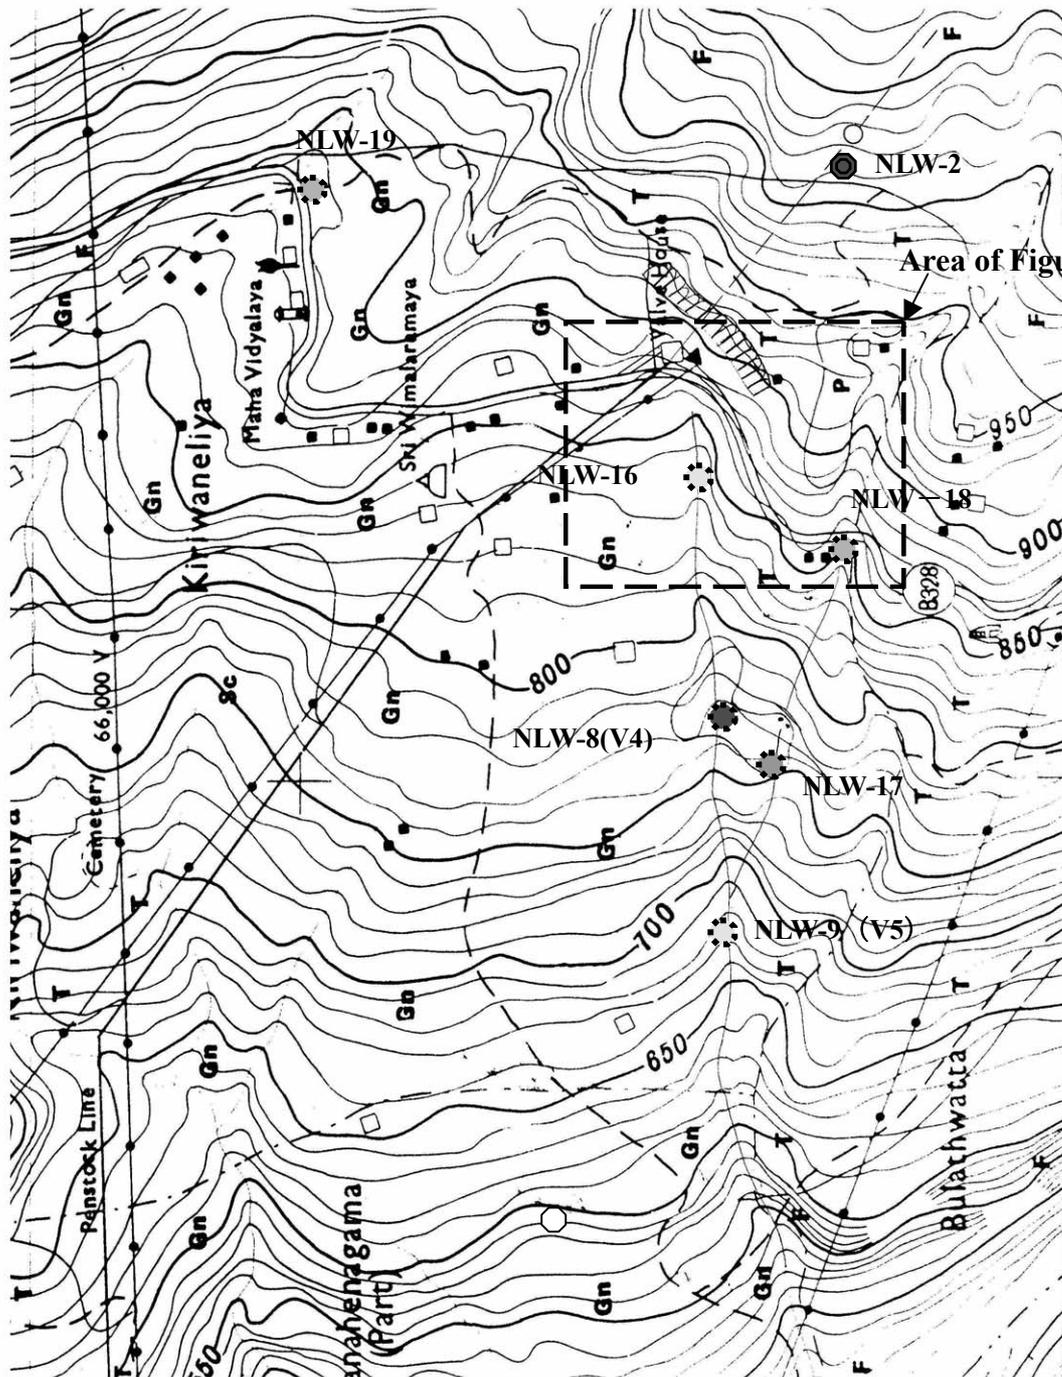
Figure 3.6 Water Quality

- ◆ A (図中に赤で示す) Ca^{2+} が多い水
- ◆ B (図中に黄で示す) Ca^{2+} が多く Cl も多い水
- ◆ C (図中に緑で示す) Ca^{2+} が少なく Cl が多い水
- ◆ D (図中に青で示す) Ca^{2+} が少なく Cl も少ない水

トンネルからの漏水は A (図中に赤で示す) のタイプの水であり、すなわち、NLW-10、12 および 14 の湧水がこれにあたる。車道脇の沢も水量の殆どが漏水に由来することを示している (NLW-6 および 7)。それらの下流の沢では、地下水と混合した B タイプを示すが、途中の NLW-8 が A タイプに戻り、途中で漏水が多量に混合している事を示唆している。
