**THE FOLLOW-UP STUDY  
ON  
THE REHABILITATION OF  
HYDROPOWER STATIONS IN THE  
KELANI RIVER BASIN  
FOR  
HYDROPOWER OPTIMIZATION  
IN  
SRI LANKA

FINAL REPORT  
SUMMARY**

**JAPAN INTERNATIONAL COOPERATION AGENCY  
ECONOMIC DEVELOPMENT DEPARTMENT**

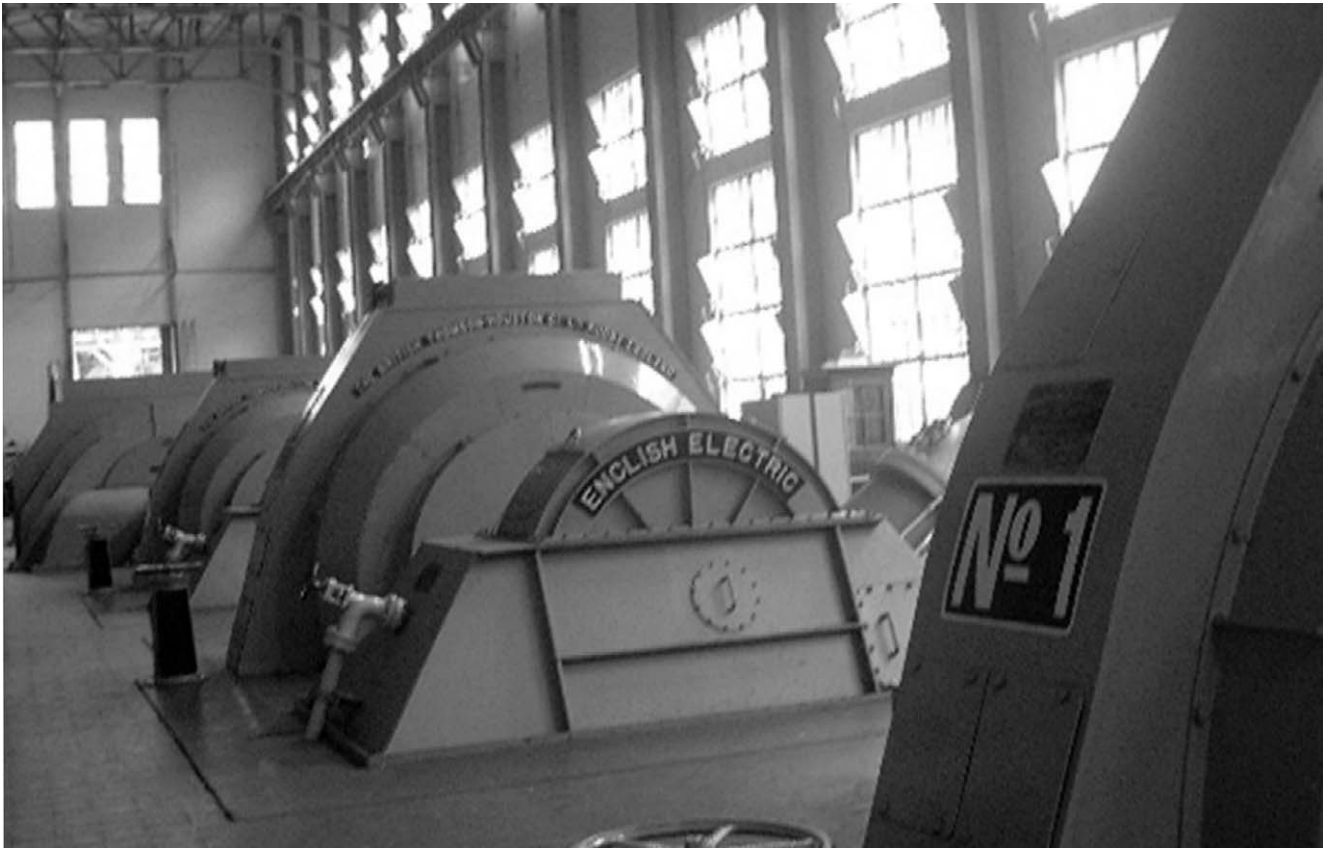
**Turbines and Generators in Old Laxapana Hydropower Station**

The Stage I plants (Units 1 to 3 with capacity of 8.33MW for each) of the Old Laxapana Hydropower Station has been operated for more than 54 years. It is recommended to replace all the turbines and generators, because the efficiency of the turbines has decreased by more than 10% than the original and supply of the spare parts of the plants can not be expected because the original manufacturer closed its business.

Incremental capacity from 8.33MW to 9MW due to improvement of their efficiencies is expected in case of the replacement.
