## **6. *HYDRO-MECHANICAL EQUIPMENT***

The outline of the site survey results for hydro-mechanical equipment is as follows. Also, attached are the main features for the hydro-mechanical equipment.

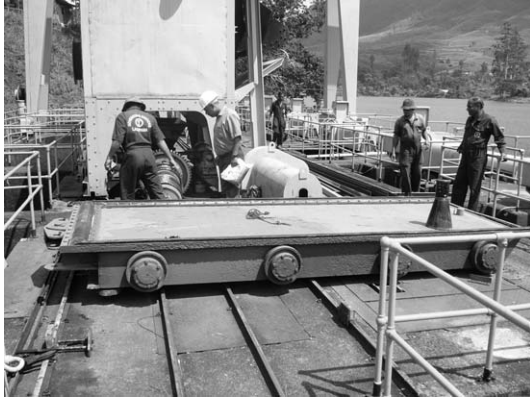
**Picture 6.3** Repairing of Intake Equipment

The intake tower is located on the right side bank of the reservoir. The intake equipment consists of intake gates, bulkhead gates, intake trashracks, trash rakes, and a gantry crane. That equipment has been repaired by CEB.

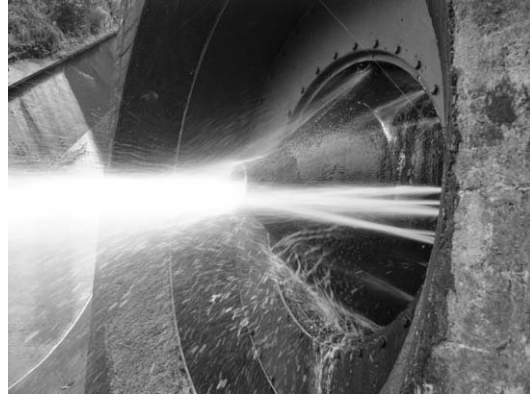
**Picture 6.4** Leakage from needle valve

The bottom outlet works consist of a roller gate and a needle valve. The needle valve was leaking at a rate of a few liters per seconds. The seals of the needle valve will be repaired by CEB.

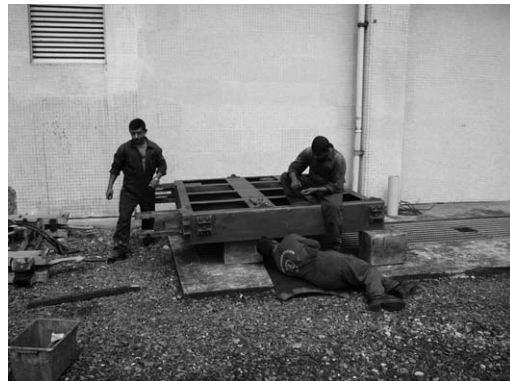
**Picture 6.14 Repairing the tailrace gate by CEB**

Tailrace gate was repaired by CEB.

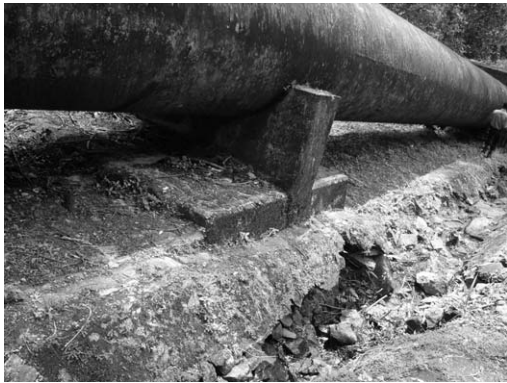
**Picture 6.17 Repair work of drain**

Eroded drain gutters should be repaired immediately due to the high risk of concrete saddles sinking.

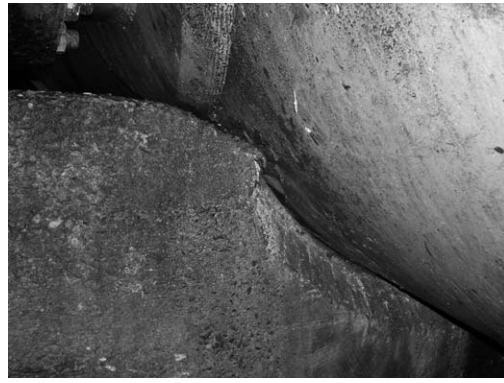
**Picture 6.18 Filler material of concrete saddle**

Deteriorated filler material between the concrete saddles and penstock should be changed due to the influence that is present to the expansion joint leak.

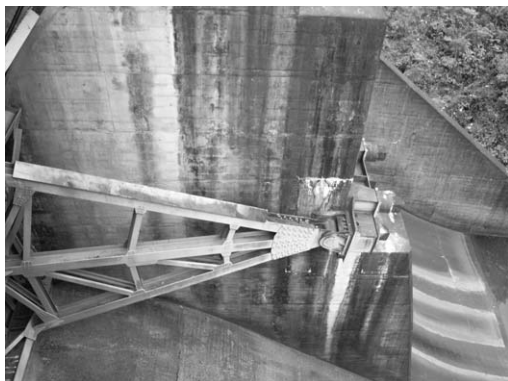
**Picture 6.25** Trunnion requires access facility

The trunnion is an important part that bears the concentrate load during high pressure. The inspection and maintenance, such as a lubrication of trunnion parts, are necessary. It is recommended to install access bridges, ladders, stairways, handrails etc. to allow inspection. Water tends accumulating on sections of gate arms and main girder was observed. It is recommended to regularly clean the drain holes or to provide new drain holes. Touch up painting is also required for some corroded portions on the gate leaf.

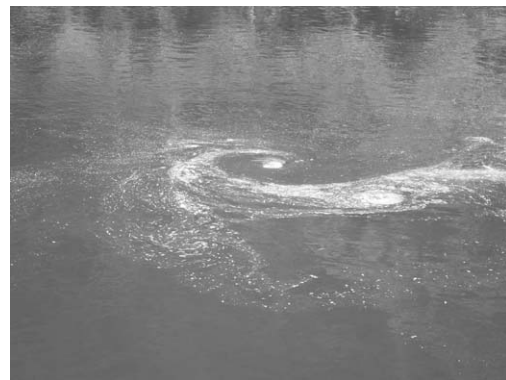
**Picture 6.30 Vortex on the Surface**

Air-entraining caused by vortexes decreases turbine efficiency, vortexes pull floating debris into the turbine (or onto the trashrack) creating the turbine operation to be rough.

A countermeasure against the vortex at the intake will be also investigated.

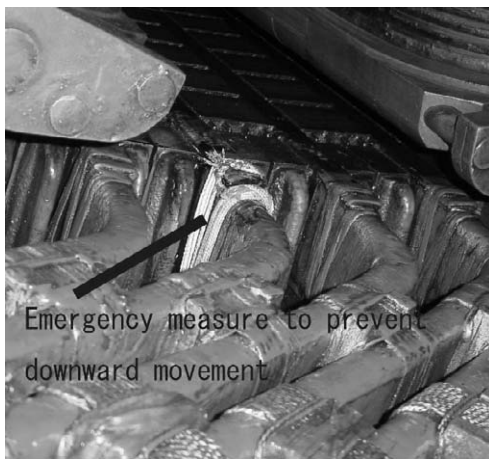
**Picture 7.1 Present Status of the Unit 1 Stator**

The insulation resistance values of the stator coil satisfy the requirement of over 100M Ohm as specified by Japanese criteria. The polarization index values are over the 1.5 stated in the Japanese criteria, for all generators. Based on these findings, the status of the stator coils is judged to be "good."

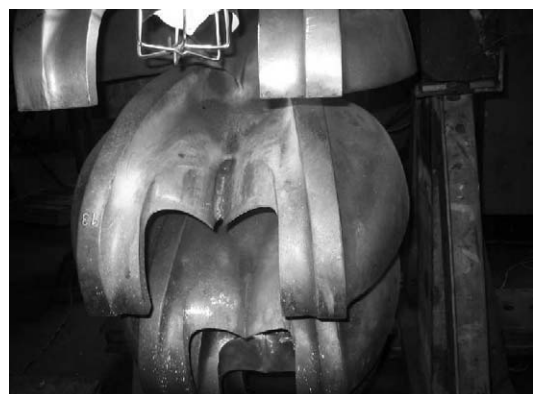
**Picture 7.4 Repairing of Runner Crack of Old Laxapana Stage I**

On twelve occasions, repairs have been performed on six runners of Stage I, i.e. three operating and three spare runners, over 12 years, according to the record. Repair work on the runners is carried out approximately once a year. However, individual detailed records on six runners are not available.

Repeating weld repairs increase the residual stress and worsen the cracks and ruptures that are observed on the runner bucket in Stage I (Units 1 to 3). Pictures 7.4 to 7.6 indicate runner cracks and repairs.

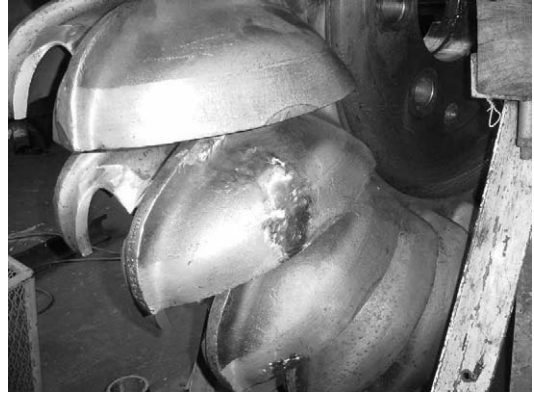
**Picture 7.5** Repaired Runner Bucket of Old Laxapana Stage I

Cavitation erosion on the runner bucket has been repaired by welding at the powerhouse maintenance shop. However, cavitation erosion is less serious than that in Stage I (Units 1 to 3). The material of the runner is 13 % Cr–4% Ni stainless steel. The runner is composed of 18 buckets. Runner cracks are not revealed by visual inspection.

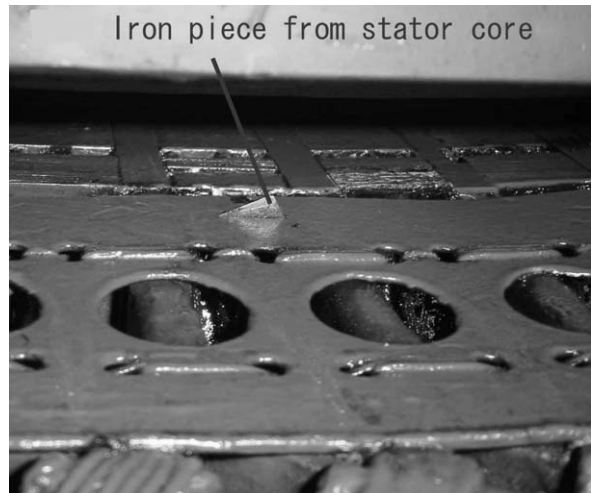
**Picture 7.7 Slipped iron piece**

- It was found that a piece of piled core iron slipped out of the stator core in February 2004. It seems that a loose stator clamp and/or superannuation of the iron core caused the slippage. Picture 7.7 shows the accident. There is concern that the iron piece may cause serious damage to the generator, resulting in a long-term operation stoppage. Further, wedge loosening was found also on stator in the both units as well as in the generators at the Wimalasurendra hydropower station.
