**THE FOLLOW-UP STUDY  
ON  
THE REHABILITATION OF  
HYDROPOWER STATIONS IN THE  
KELANI RIVER BASIN  
FOR  
HYDROPOWER OPTIMIZATION  
IN  
SRI LANKA**

**FINAL REPORT  
Vol. II  
APPENDIX**

**JULY 2005**

***APPENDIX A-1***  
***GEOLOGICAL INVESTIGATIONS***

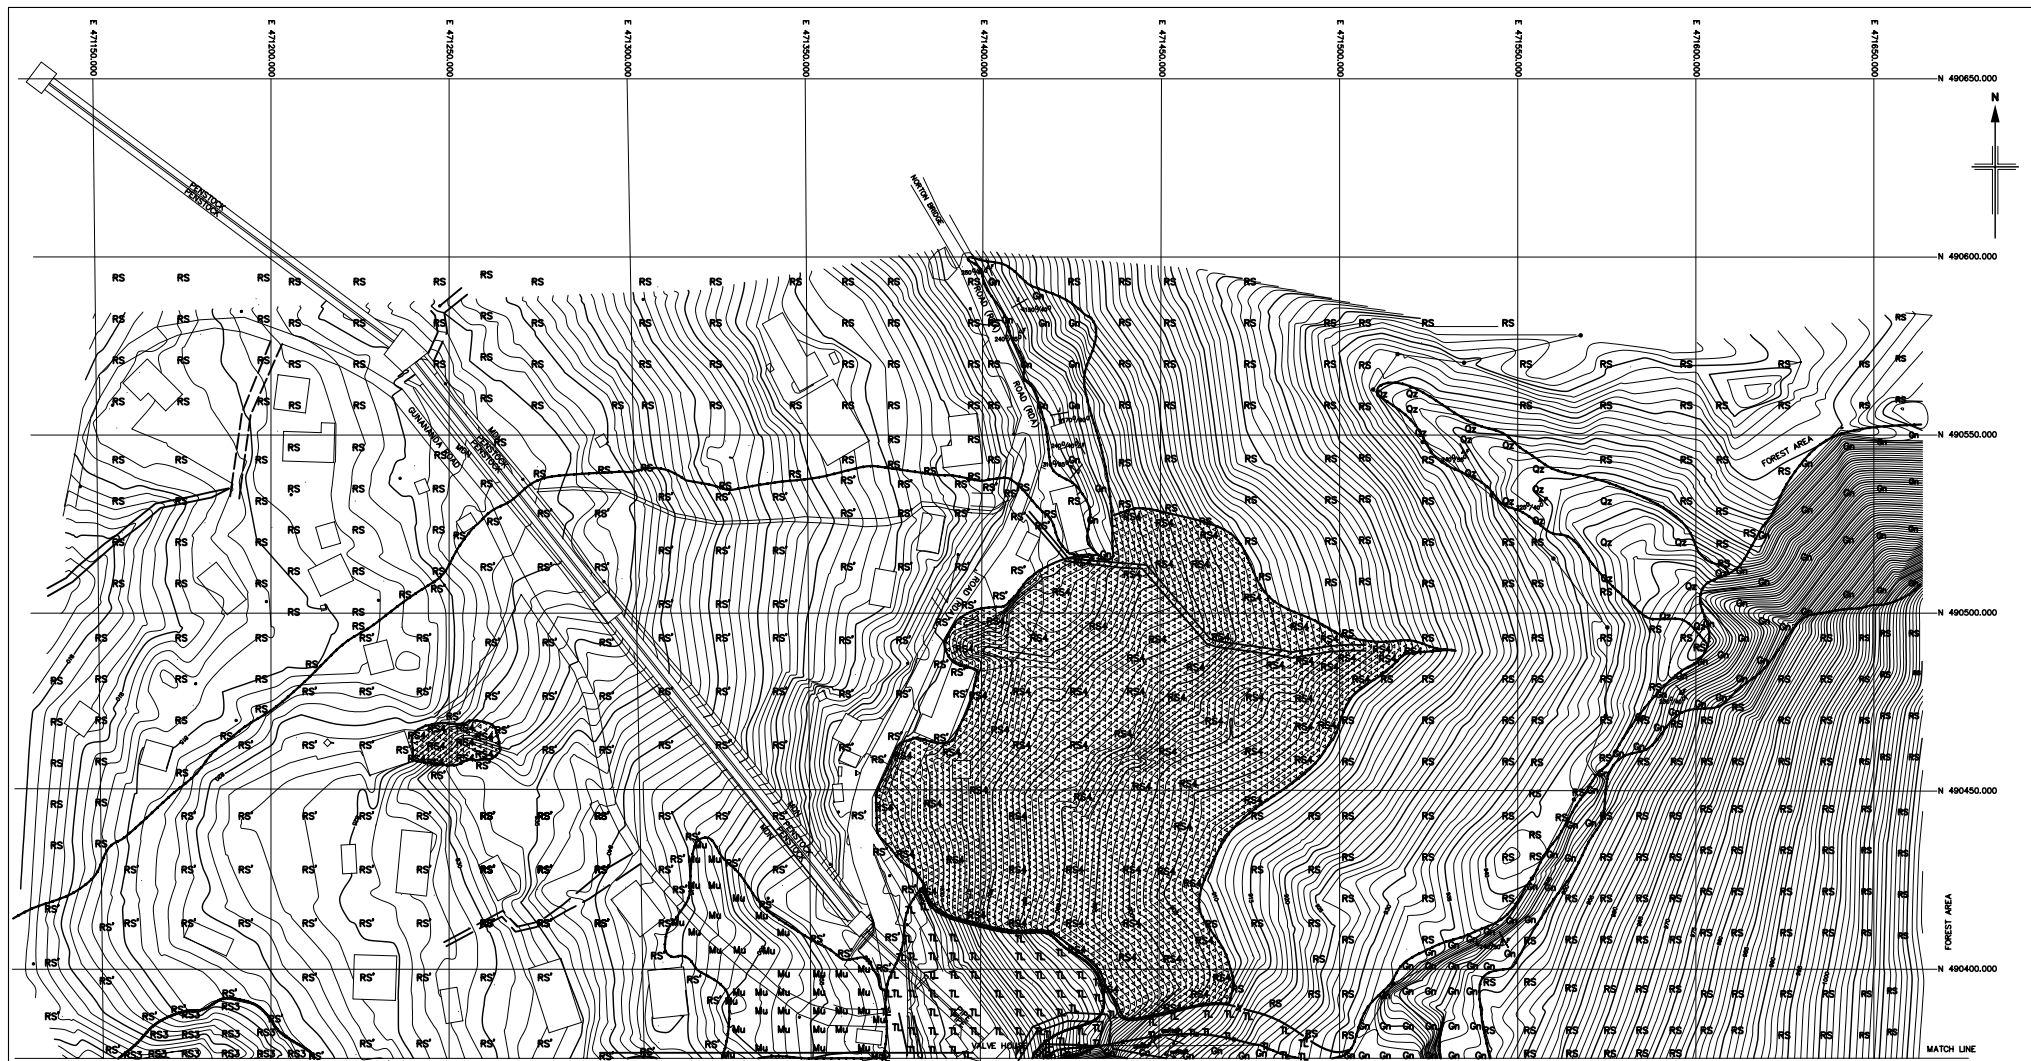
Figure 3.1 Geo Map (New Laxapana - 1)

Geological mapping around the surge tank was carried out in January and February, 2005, and provided the geological map of Figure 3.1.

Bedrock is composed of charnockitic gneiss, charnockite and quartzite. The dip angle of foliation of bed rock varies from 30 – 50 degrees which is about the same or steeper than the slopes. The dip direction of foliation falls in a narrow band from 220 – 250 degrees which are somewhat oblique to the downslope direction.

Within the mapped area some manmade fill also can be seen. This fill is made of the rock material that came from the excavation of tunnel and adits of the New Laxapana hydropower project. Estimated age of occurrence of slips forming debris material is tabulated in that table.

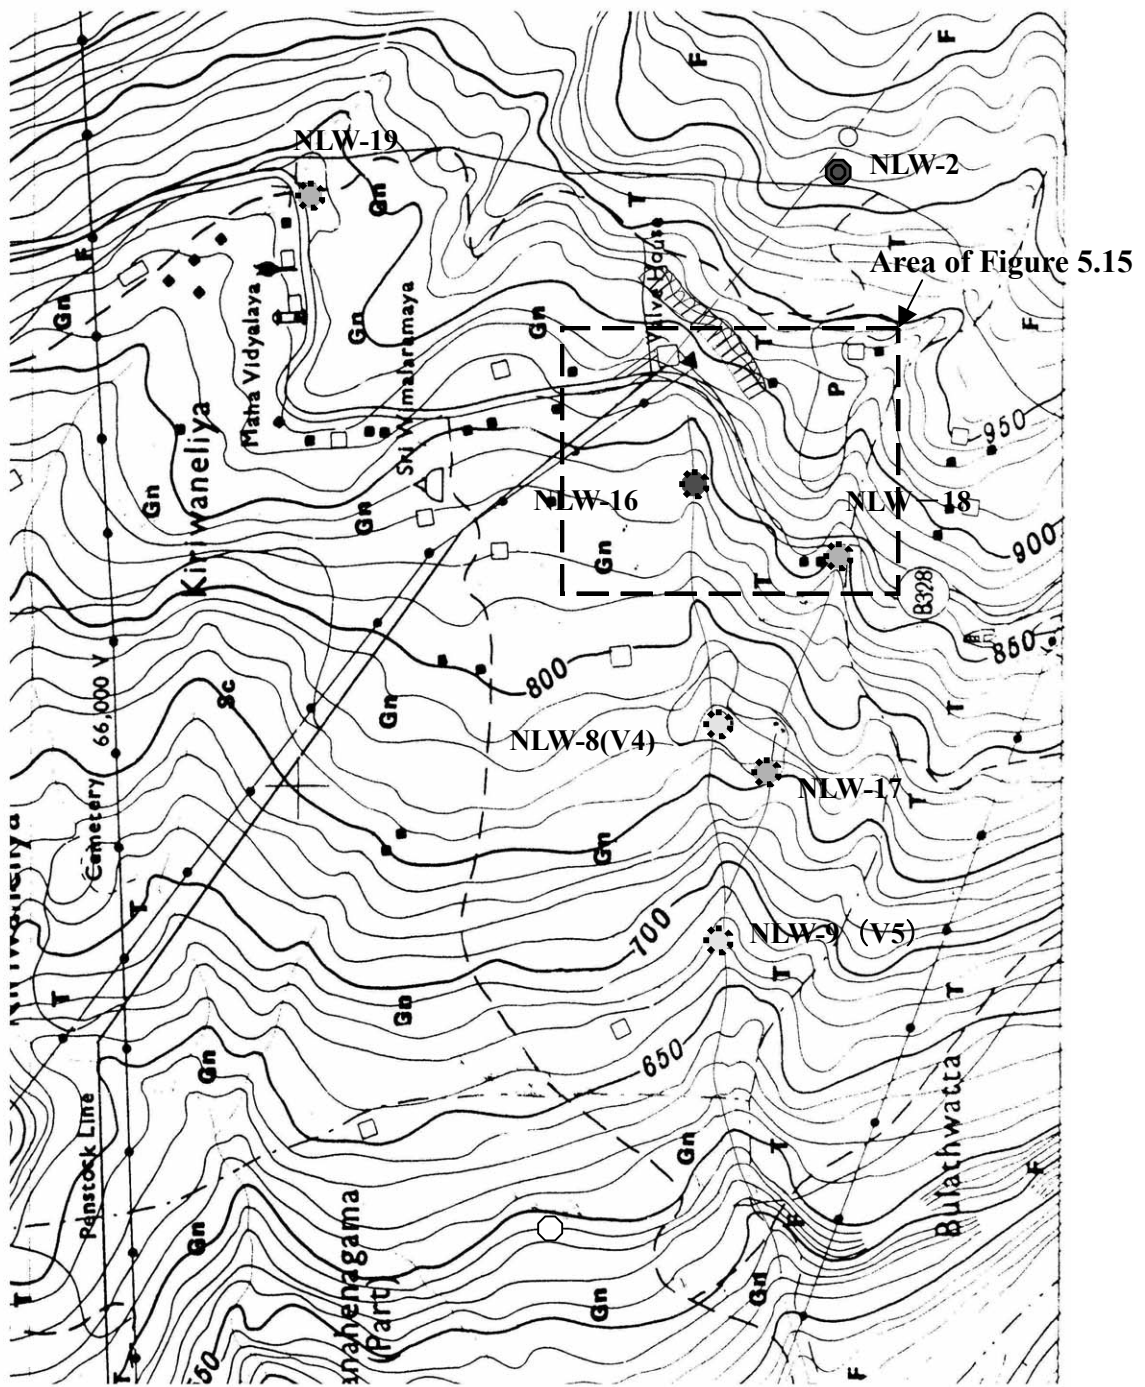
**Figure 3.3 Electrical conductivity**

Electrical conductivity of water of the waterway is 20 $\mu$ S (NWL – 1, NWL – 2). That of springs and streams around or downslope of the surge tank is 10 to 20 $\mu$ S. Streams distant from the waterway are less than 10 $\mu$ S (Figure 3.3 and Figure 3.4). Electrical conductivity indicates that the water of springs and streams around or downslope of the surge tank resemble to or contain much water of the waterway.

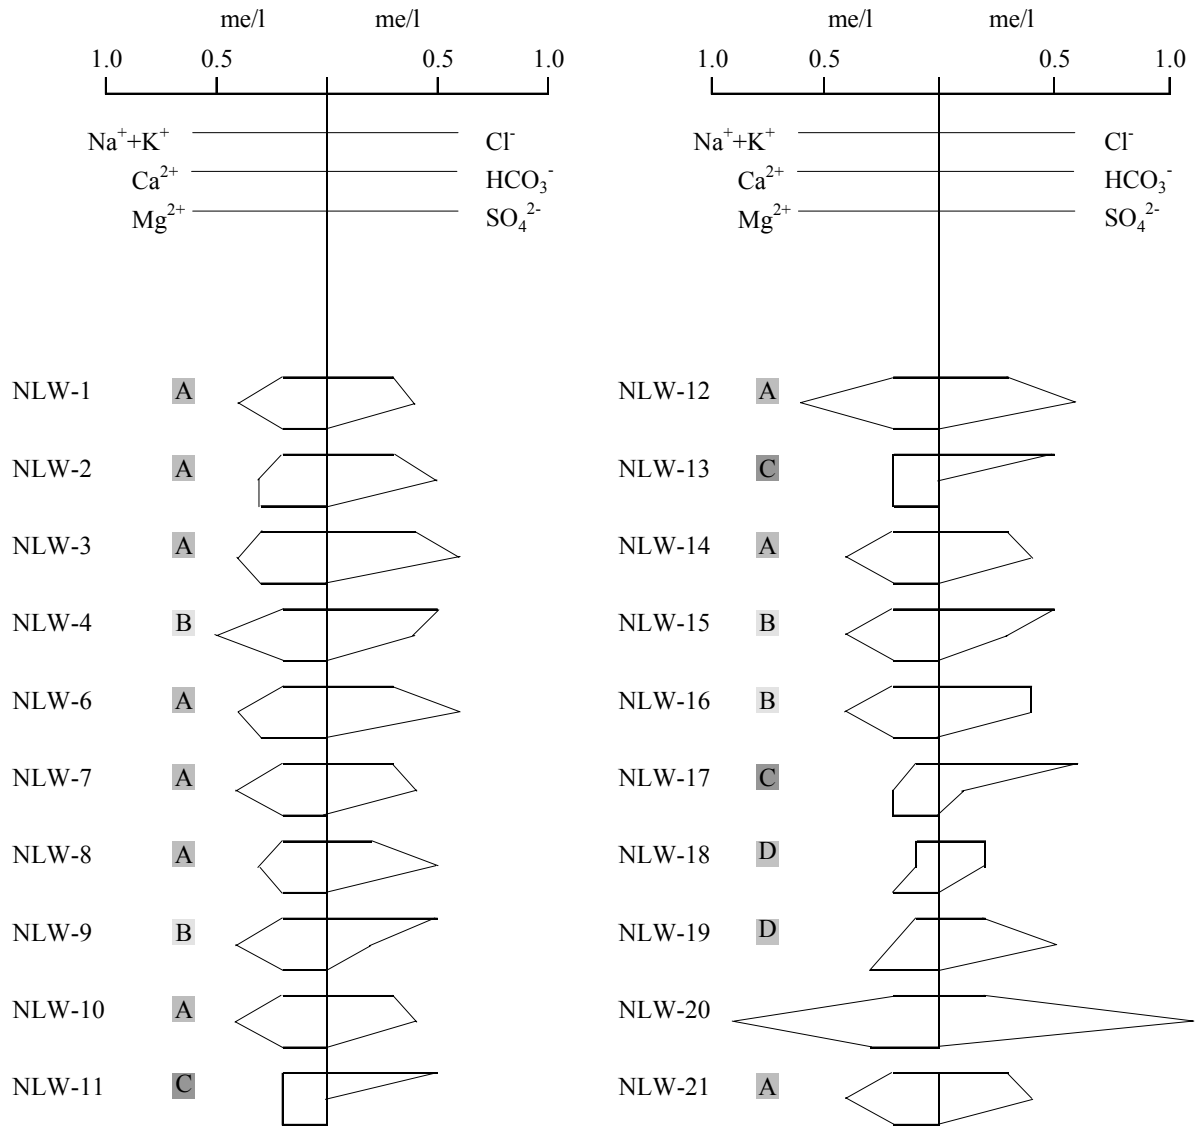
Figure 3.5 Water Quality by Hexadiagram

Chemical quality is shown in pattern diagram in Figure 3.5. This diagram is shown in milligram equivalent per liter, which is obtained by dividing concentration of ion by the equivalent weight of that ion. Judging from patterns in this diagram and location of water samples, waters collected at this time are divided in 4 chemical quality groups. Their distribution is shown in Figure 3.6 and Figure 3.7.

Group A is the same or almost the same as the water of the waterway. Group C is quite different from Group A and likely to be water traveling underground for a long time. Group B seems to be a mixture of Group A and Group C. Group D resembles rain water. (NLW – 20 is rain water. But its ion concentration is higher than usual rainwater. This sample may contain contaminated materials.)

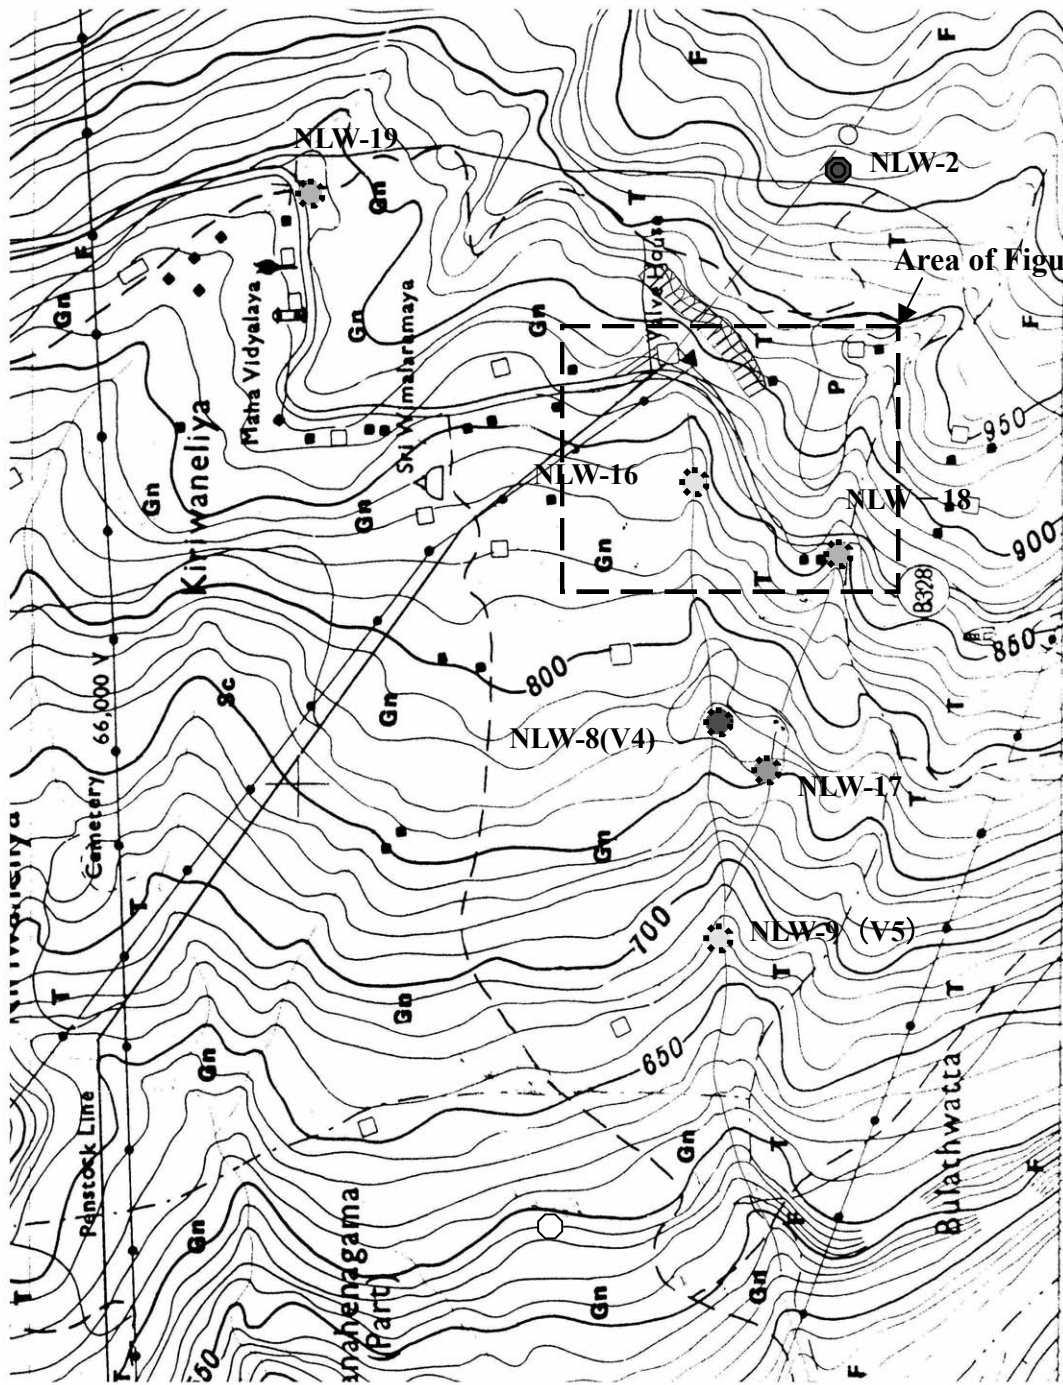
**Figure 3.6 Water Quality**

Water leaked from the tunnel belongs to Group A. NLW - 10, NLW – 12 and NLW – 14 are spring water and belong to Group A. Stream waters near the road such as NLW – 6 and NLW – 7 are mostly composed of leaked water. Downstream, stream waters belong to Group B except NLW – 8, which belongs to Group A indicating the presence of a large amount of leaked water in the stream.
