JICA STUDY TEAM
 (ELECTRIC POWER DEVELOPMENT CO., LTD)
 INVESTIGATION WORKS FOR THE FOLLOW-UP STUDY ON
 HYDROPOWER STATIONS IN THE KELANI RIVER BASIN FOR
 HYDROPOWER OPTIMIZATION IN SRI LANKA
 GEOLOGICAL MAP
 POLPITIYA INTAKE AREA

This report presents the status of the headrace tunnel and the recommendation of the remedial works based on the inspection performed by the JICA study team.

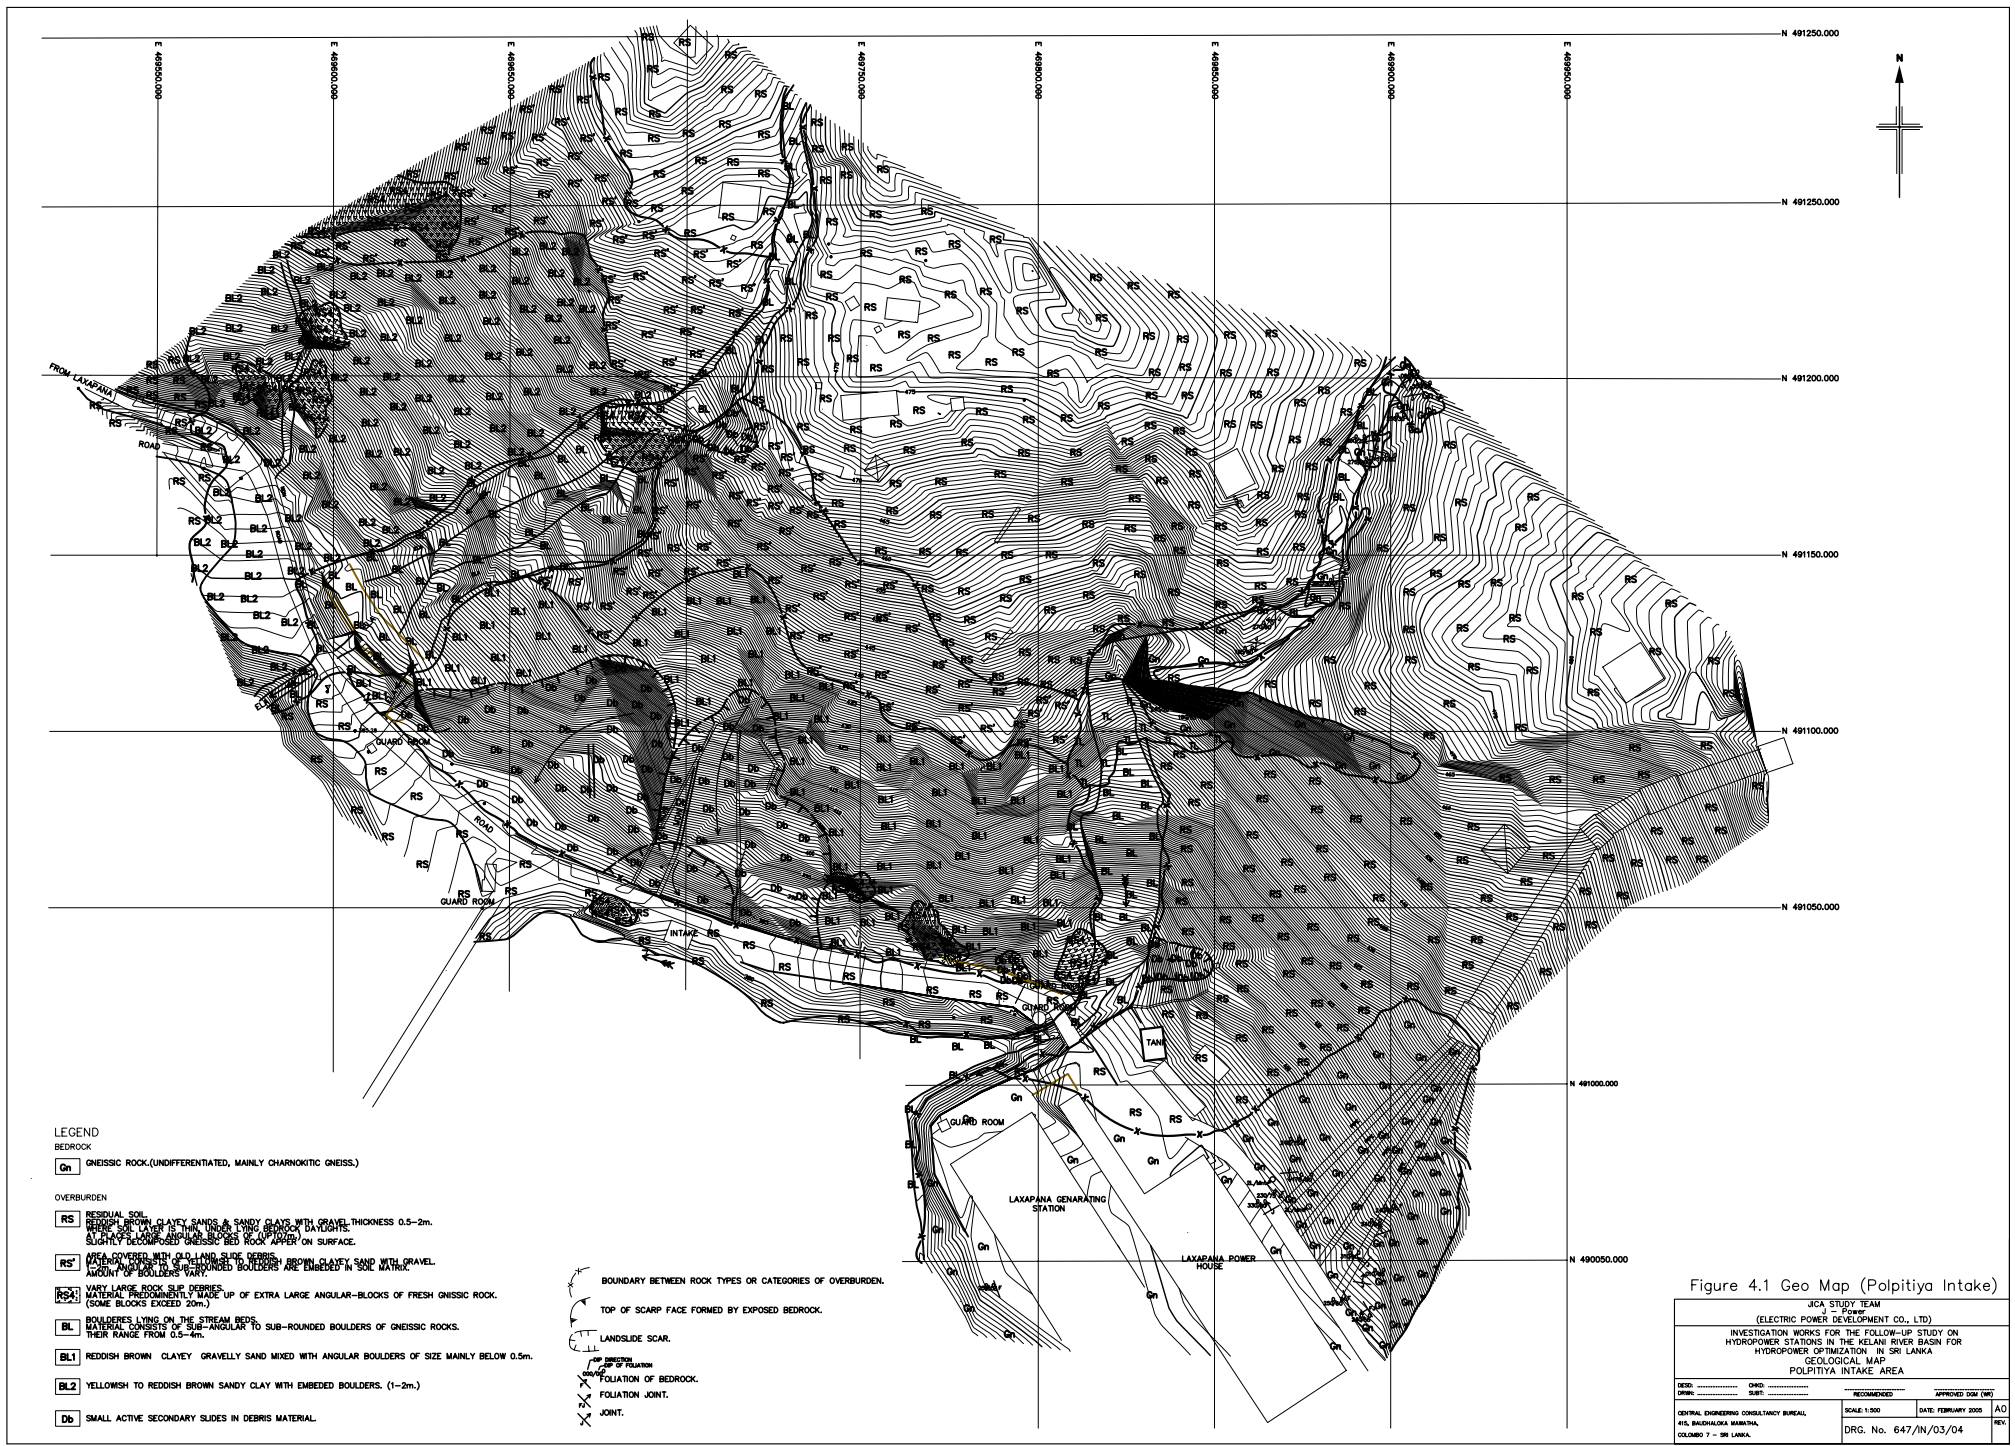
Figure 4.1 Geo Map (Polpitiya Intake)

Slopes around the intake are covered by thick landslide deposits. Steep slopes below about 475 m in elevation are formed by collapse of landslide deposits. Though there are no data showing the relation between slope movement and reservoir level, small fluctuations of the reservoir level indicate that the slopes instability is caused by rain. To stabilize the slopes, preventing rain water infiltration into the landslide areas would be effective. Because the topography of the slopes is illustrated by the topographic 1:500 scale map, it would be a good idea to make foot passes for inspection of the slope during heavy rain, and the information would be applied for remedial measures such as suitable drains.

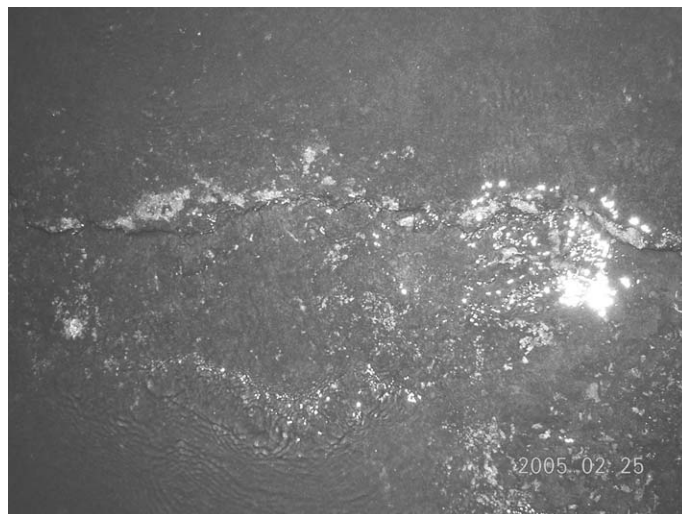
Aspect: There is uplift and a crack approximately 30 m in length in the invert concrete around the tunnel distance of 1,230 ft.

Possible Cause: External loads such as groundwater pressure, earth pressure, etc.

When it occurred: It appears that the crack was not developed in the course of the dewatering due to backpressure acting on the concrete lining. The color of the concrete surface in the crack seems to be old.

Uplift and Crack

Countermeasures: The JICA team does not recommend immediate repair of the uplift and crack in the invert concrete because the tunnel seems to be in stable condition. If CEB wants to repair it, of course the team agrees to repair it.

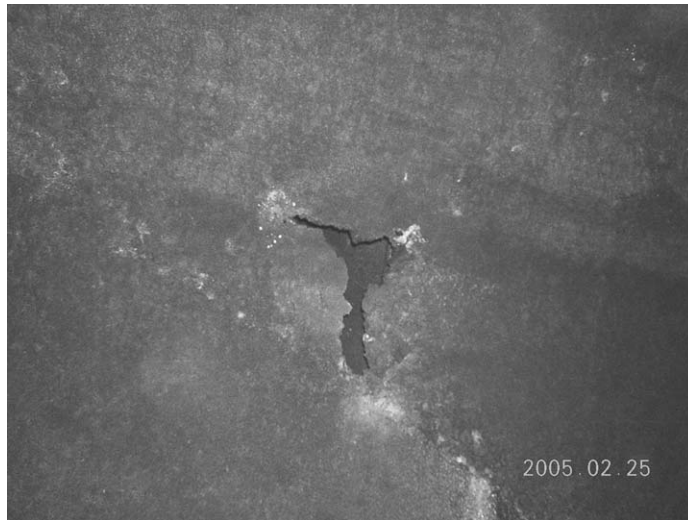
Aspect: There are 4 cavities observed in the tunnel. Certain areas of the concrete lining peeled off and the surface of the rock behind the lining appeared at all locations of the cavities. One of them at the tunnel crown at around the tunnel distance of 3,350 ft appears to be deep. This cavity is the most likely cause of the muddy water observed in 2001. Some amount of accumulated mud was found on the invert concrete under the cavity.

Possible Cause: Earth pressure, thin concrete, defect of concrete

Cavity at TD 3,350 ft.

Countermeasures: The JICA study team recommends repairing all cavities.

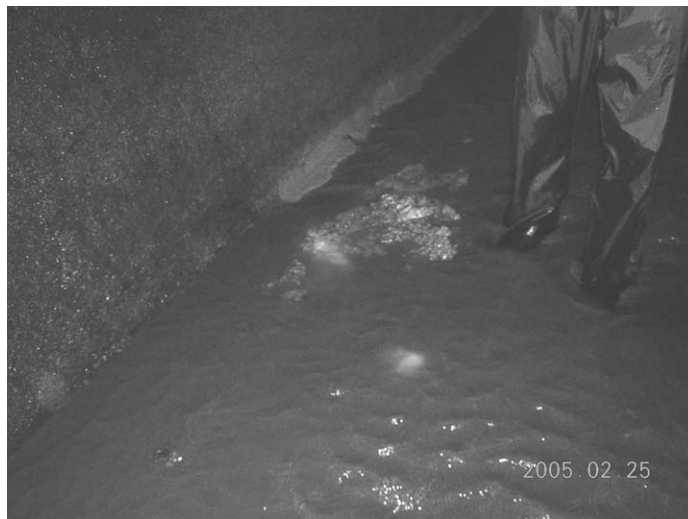
Mud at TD 3,350 ft.

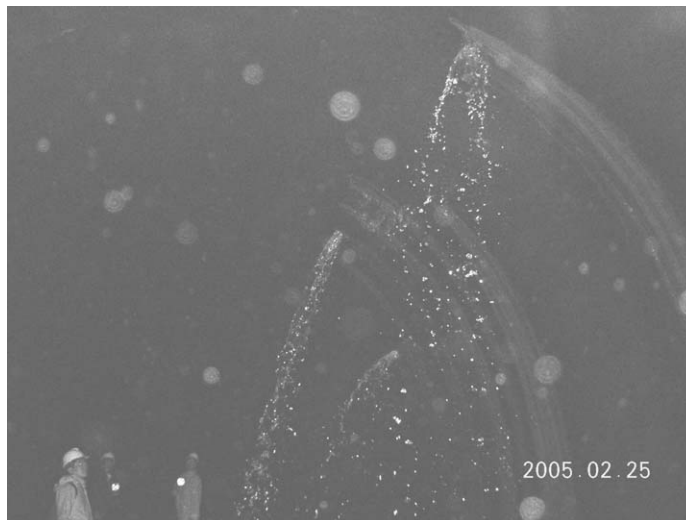
Possible Cause: Groundwater

Seepage

Countermeasures: The JICA study team recommends not repairing the seepage, subject to the seepage water containing no mud. If the seepage is stopped with repair work, the groundwater level at the tunnel surroundings goes up and sequentially external pressure acts on the lining concrete. Mud is a sign of erosion behind the concrete.
