PAST EARTHQUAKES AND TSUNAMI IN INDONESIA

PROJECT ROAD DAMAGE BY TSUNAMI

4.1 MAGNITUDE OF DAMAGE

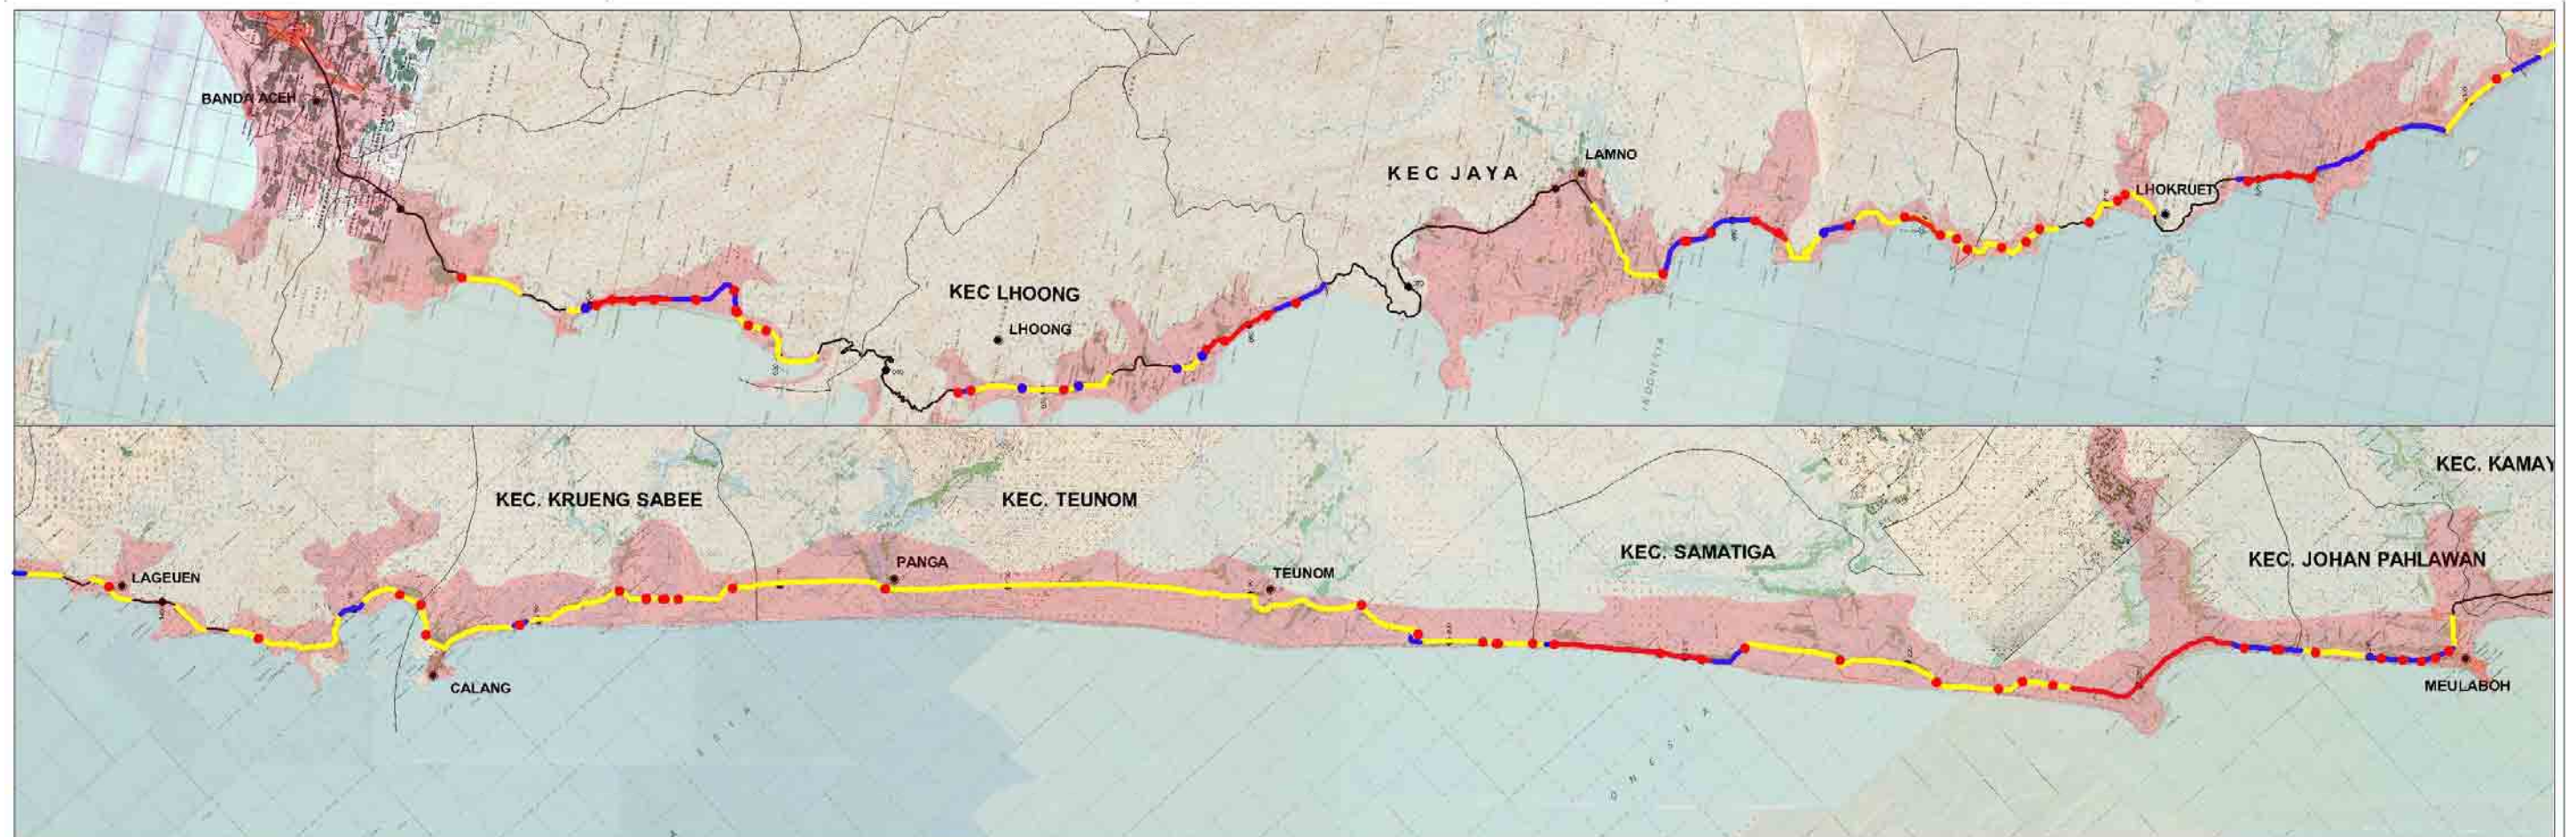
Figure 4.1-2 TUSUNAMI AFFECTED AREA AND ROAD/BRIDGE DAMAGE

Just after tsunami, the Public Works Office of Banda Aceh undertook the damage survey and damages of the West Coast Road from Banda Aceh to Meulaboh (Total Length = 247km) were identified as follows:

- Impassable 89.7 km
- Passable but damaged 94.1 km
- No damage 63.2 km

<u>No.</u>	<u>Length (m)</u>
• Washed out or collapsed	76	2,300
• Damaged	7	118
• No damage (mostly outside <u>Tsunami affected area)</u>	59	900

Tsunami affected areas which were delineated based on satellite photographs, and road/bridge damaged sections are shown in **Figure 4.1-2**.
