SUMMARY OF SITE INVESTIGATION

THE BASIC DESIGN STUDY ON THE PROJECT

**IMPROVEMENT OF KARARO – WAD SECTION
OF NATIONAL HIGHWAY N-25
IN THE ISLAMIC REPUBLIC OF PAKISTAN**

JANUARY 2005

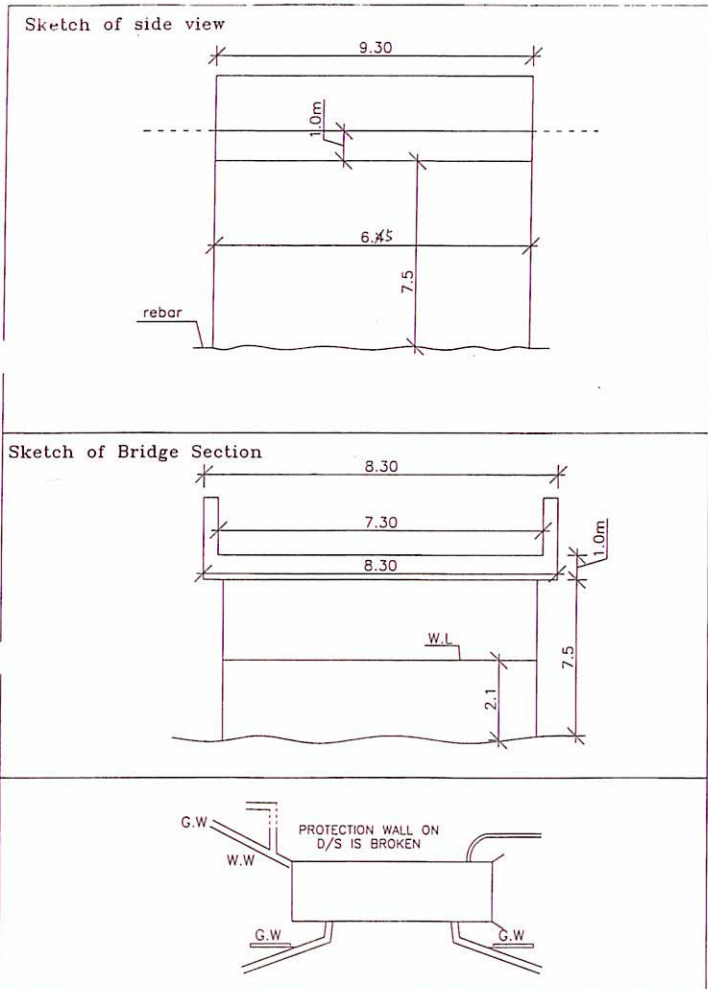
BRIDGE NO:1 (STATION NO: I+964)

Bridge Name: Bridge No. 1					
Distance: Km from Karachi, River Name:					
Identified No.: -	Station No.: I+964				
Type of Bridge: Slab Bridge	Year of Built: 1960				
Number of Lane: 2	Availability of detour: No / Yes (0.2 Km from Bridge)				
Bridge Length: 01 Span @ 6.5 m = 6.5 m	Skew: 90 degree				
Bridge Width: 7.3 m (Carriageway), - m (Sidewalk), 7.3 m (Total)					
Maximum Flood Level: - m (above / under) the bridge surface					
Bridge Conditions (G: good, C: Cracked, P: Partly lack, R: Re-bar Exposed, B: Broken, S: Scored, E: Eroded, V: Vegetated)					
Extent and Degree (X: Serious Condition, M: Moderate Condition, O: Sound Condition)					
Surface:	Carriageway (Asphalt Pavement / Concrete Pavement), Damage (G)				
	Sidewalk (Asphalt Pavement / Concrete Pavement), Damage (No Side Walk)				
Deck Slab:	RC Slab / Damage (C,M)				
Girder	Type: RC / Other (-)	Abutment:	Type: RC		
	Damage:	Left G1 (-)	Damage:	Karao A1 (G)

G2 (-)		Wad A2 (G)	
		G3 (-)	Pier:	Type: RC / Other (-)	
		G4 (-)		Damage:	Karao P1 (-)
		G5 (-)			P2 (-)
		Right G6 (-)			P3 (-)
	Cross Beam:	Type: RC / Other (-)		P4 (-)	
		Damage:	Karao Side B1 (-)		P5 (-)
			B2 (-)		P6 (-)
			B3 (-)		Wad P7 (-)
			B4 (-)	Wing Wall:	Type: RC
			B5 (-)		Damage:
			B6 (-)		Wad Side (G)
B7 (-)			Hand Rail:	Type: RC	
B8 (-)				Damage:	Left Side (C,O)
B9 (-)				Right Side (C,O)	
B10 (-)	Revetment:		Type: RC		
B11 (-)		Damage:	Karao Side (S,M) (Up / Downstream)		
B12 (-)			Wad Side (S,M) (Up / Downstream)		
B13 (-)		Rever Bank:	Damage:	Karao Side (G) (Up / Downstream)	
B14 (-)			Wad Side (G) (Up / Downstream)		
B15 (-)					
Utility Line: None / Electric/Water / Gas / Telecommunication / Optical fiber / Others (None)					
Attached Photos (General view, Side view (Left and Right), Defects, Damages, etc..)

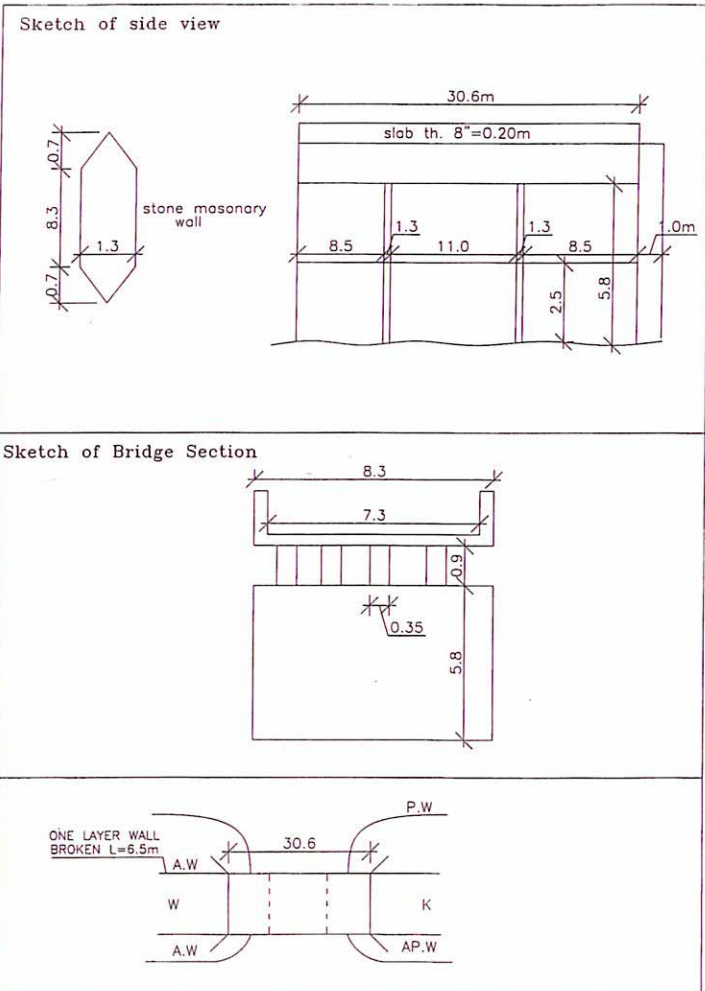
BRIDGE NO:2 (STATION NO: 3+625)

Bridge Name: Bridge No. 2			
Distance: Km from Karachi, River Name: Jani Nadi			
Identified No.: -	Station No.: 3+625		
Type of Bridge: RC Grider	Year of Built: 1960		
Number of Lane: -	Availability of detour: No / Yes (No Km from Bridge)		
Bridge Length: 03 Span, 9.15m + 12.3m + 9.15m = 30.6 m	Skew: 90 degree		
Bridge Width: 7.3 m (Carriageway), - m (Sidewalk), 7.3 m (Total)			
Maximum Flood Level: - m (above / under) the bridge surface			
Bridge Conditions (G: good, C: Cracked, P: Partly lack, R: Re-bar Exposed, B: Broken, S: Scored, E: Eroded, V: Vegetated)			
Extent and Degree (X: Serious Condition, M: Moderate Condition, O: Sound Condition)			
Surface: Carriageway (Asphalt Pavement / Concrete Pavement), Damage (G)			
Sidewalk (Asphalt Pavement / Concrete Pavement), Damage (No Side Walk)			
Deck Slab: RC Slab, Damage (C,M)			
Girder	Type: RC	Abutment: Type: S.M	
	Damage: Left G1 (C,M)	Damage: Karao A1 (P,M)

G2 (C,M)	Wad A2 (P,M)	
	G3 (C,M)	Pier: Top Face Broken Weep Holes in Middle	
	G4 (C,M)		Type: S.M
	G5 (-)		Damage: Karao P1 (B,M)
	Right G6 (-)		P2 (B,M)
			P3 (-)
			P4 (-)
			P5 (-)
			P6 (-)
			Wad P7 (-)
Cross Beam:	Type: RC / Other (R.C)		
Damage: Kararo Side B1 (C,M)			
B2 (C,M)			
B3 (C,M)			
B4 (C,M)	Wing Wall: Type: RC		
B5 (C,M)	Damage: Karao Side (G)		
B6 (C,M)	Wad Side (G)		
B7 (C,M)			
B8 (C,M)	Hand Rail: Type: RC / Other (S.M)		
B9 (C,M)	Damage: Left Side (B,M)		
B10 (-)	Right Side (G)		
B11 (-)			
B12 (-)	Revetment: Type: RC		
B13 (-)	Damage: Karao Side (C,O) (Up / Downstream)		
B14 (-)	Wad Side (C,O) (Up / Downstream)		
B15 (-)	Rever Bank: Damage: Karao Side (G) (Up / Downstream)		
Wad Side B15 (-)	Wad Side (G) (Up / Downstream)		
Utility Line: None / Electric/Water / Gas / Telecommunication / Optical fiber / Others (None)			
Attached Photos (General view, Side view (Left and Right), Defects, Damages, etc..)

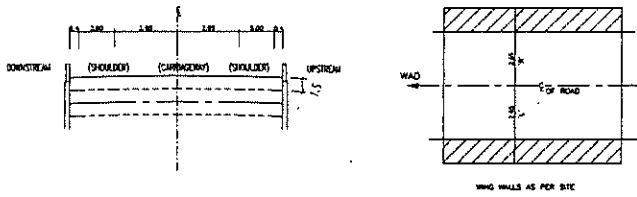
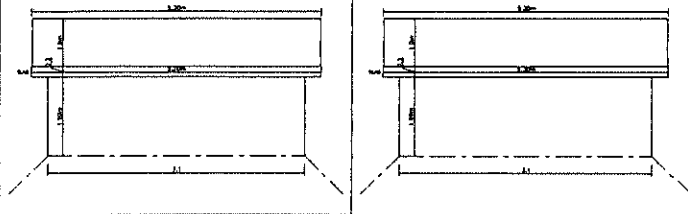
Distance :	km from Karachi, River Name :
Identified No. :	Station No. : 00+115
Type of Culvert : Box/Pipe/Other: (SAR)	Year of Built : OVER 20 YEARS
Road Width : 5.30 m(Carriageway), 2.80 m(Sidewalk), 13.1 m(Total)	
Number of Cell : 01	Skew : 90 degree
Size of Culvert : Inner: 2.10 m x 1.90 m, Thickness: top: 0.40 m, Vertical:, Bottom:, Total Width : 21.20 m	
Length : From inlet to outlet : 21.2 m	Earth covering :
Maximum Flood Level :	
Culvert Conditions: (G: Good, C: Cracked, P: Partly lack, R: Re-bar exposed, B: Broken, S: Scored, E: Eroded, V: Vegetated) Extent and Degree: (X: Serious Condition, M: Moderate Condition, S: Sound Condition)	
Headwall : Type : RC / Steel / Other (SM) Damage : Upstream (00%) , Downstream (00%)	
Inlet : Type : RC / Steel / Other (RC) Damage : (PM) 90%	
Outlet : Type : RC / Stone / None / Other (SM) Damage : (00%)	
Erosion : Damage : None / Upstream (50) , Downstream (50)

Net Opening : 100% , Sedimentation : None / Yes (YES m from the top of inner)	
Hydraulic capacity: Inadequate / Adequate	
Frequent of flood: No-flooding / Once a year / Frequent (once year)	
Attached Photos (General View, Inlet, Outlet, Defects, Damages, etc..)

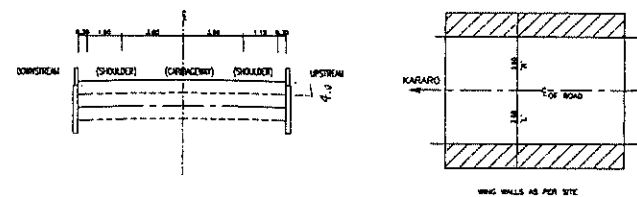
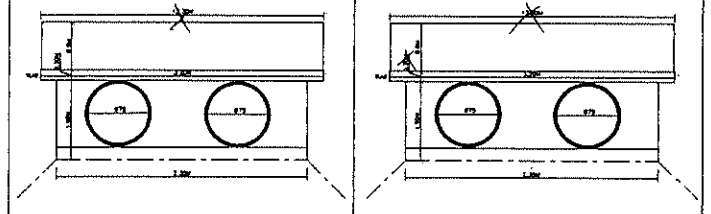
Distance :	km from Karachi, River Name :
Identified No. :	Station No. : 00+775
Type of Culvert : Box/Pipe/Other: (PG)	Year of Built : OVER 20 YEARS
Road Width : 6.20 m(Carriageway), 3.05 m(Sidewalk), 9.25 m(Total)	
Number of Cell : 01	Skew : 92 degree
Size of Culvert : Inner: 2.30 m x 1.90 m, Thickness: top: 0.30 m, Vertical:, Bottom: 0.30 m, Total Width : 9.55 m	
Length : From inlet to outlet : 22.7 m	Earth covering : 4 m
Maximum Flood Level :	
Culvert Conditions: (G: Good, C: Cracked, P: Partly lack, R: Re-bar exposed, B: Broken, S: Scored, E: Eroded, V: Vegetated) Extent and Degree: (X: Serious Condition, M: Moderate Condition, S: Sound Condition)	
Headwall : Type : RC / Steel / Other (RC) Damage : Upstream (00%) , Downstream (00%)	
Inlet : Type : RC / Steel / Other (RC) Damage : (G) 80%	
Outlet : Type : RC / Stone / None / Other (RC) Damage : (00%)	
Erosion : Damage : None / Upstream (50) , Downstream (50)

Net Opening : 90% , Sedimentation : None / Yes (YES m from the top of inner)	
Hydraulic capacity: Inadequate / Adequate	
Frequent of flood: No-flooding / Once a year / Frequent (once year)	
Attached Photos (General View, Inlet, Outlet, Defects, Damages, etc..)

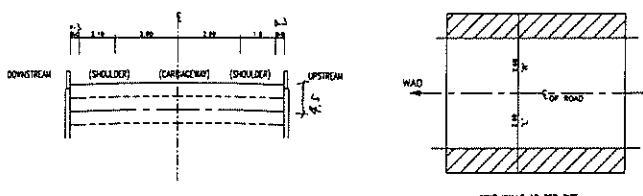
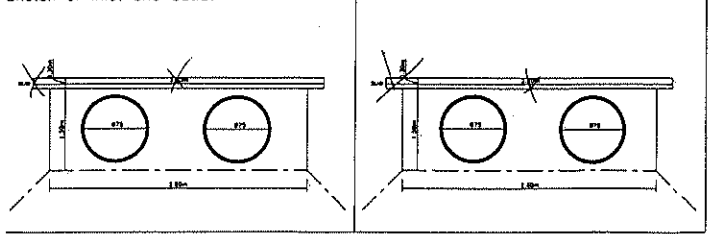
Distance :	km from Karachi, River Name :
Identified No. :	Station No. : 00+590
Type of Culvert : Box/Pipe/Other: (PIPE)	Year of Built : OVER 20 YEARS
Road Width : 3.20 m(Carriageway), 3.10 m(Sidewalk), 8.30 m(Total)	
Number of Cell : 01	Skew : 90 degree
Size of Culvert : Inner: 2.80 m x 1.5 m, Thickness: top: 0.30 m, Vertical:, Bottom:, Total Width : 8.90 m	
Length : From inlet to outlet : 8.90 m	Earth covering :
Maximum Flood Level :	
Culvert Conditions: (G: Good, C: Cracked, P: Partly lack, R: Re-bar exposed, B: Broken, S: Scored, E: Eroded, V: Vegetated) Extent and Degree: (X: Serious Condition, M: Moderate Condition, S: Sound Condition)	
Headwall : Type : RC / Steel / Other (RC) Damage : Upstream (00%) , Downstream (00%)	
Inlet : Type : RC / Stone / None / Other (RC) Damage : (B) 50%	
Outlet : Type : RC / Stone / None / Other (RC) Damage : (100%)	
Erosion : Damage : None / Upstream (50) , Downstream (50)

Net Opening : 50% , Sedimentation : None / Yes (YES m from the top of inner)	
Hydraulic capacity: Inadequate / Adequate	
Frequent of flood: No-flooding / Once a year / Frequent (once year)	
Attached Photos (General View, Inlet, Outlet, Defects, Damages, etc..)

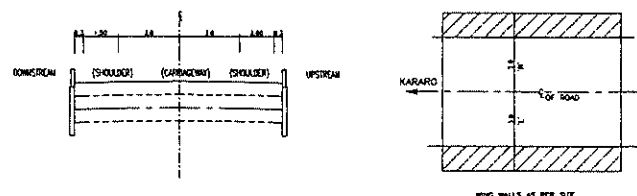
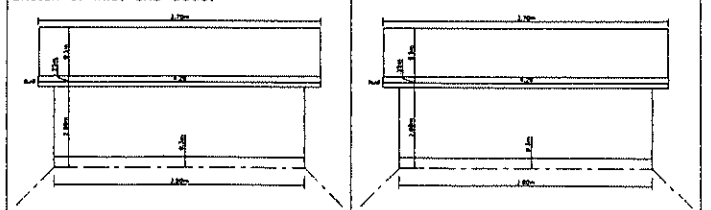
Distance :	km from Karachi, River Name :
Identified No. :	Station No. : 00+995
Type of Culvert : Box/Pipe/Other: (BRICK)	Year of Built : OVER 20 YEARS
Road Width : 5.0 m(Carriageway), 4.1 m(Sidewalk), 9.1 m(Total)	
Number of Cell : 01	Skew : 90 degree
Size of Culvert : Inner: 3.80 m x 2.80 m, Thickness: top: 1.45 m, Vertical:, Bottom: 0.3 m, Total Width : 10.1 m	
Length : From inlet to outlet : 10.1 m	Earth covering : 0.5 m
Maximum Flood Level :	
Culvert Conditions: (G: Good, C: Cracked, P: Partly lack, R: Re-bar exposed, B: Broken, S: Scored, E: Eroded, V: Vegetated) Extent and Degree: (X: Serious Condition, M: Moderate Condition, S: Sound Condition)	
Headwall : Type : RC / Steel / Other (BRICK) Damage : Upstream (00%) , Downstream (00%)	
Inlet : Type : RC / Steel / Other (RC) Damage : (R) 90%	
Outlet : Type : RC / Stone / None / Other (SM) Damage : (G) 90%	
Erosion : Damage : None / Upstream (70) , Downstream (50)

Net Opening : 90% , Sedimentation : None / Yes (YES m from the top of inner)	
Hydraulic capacity: Inadequate / Adequate	
Frequent of flood: No-flooding / Once a year / Frequent (once year)	
Attached Photos (General View, Inlet, Outlet, Defects, Damages, etc..)
