BASIC DESIGN STUDY REPORT
ON
THE PROJECT FOR REHABILITATION OF DILI PORT
OF
THE DEMOCRATIC REPUBLIC OF TIMOR LESTE

NOVEMBER 2005

JAPAN INTERNATIONAL COOPERATION AGENCY

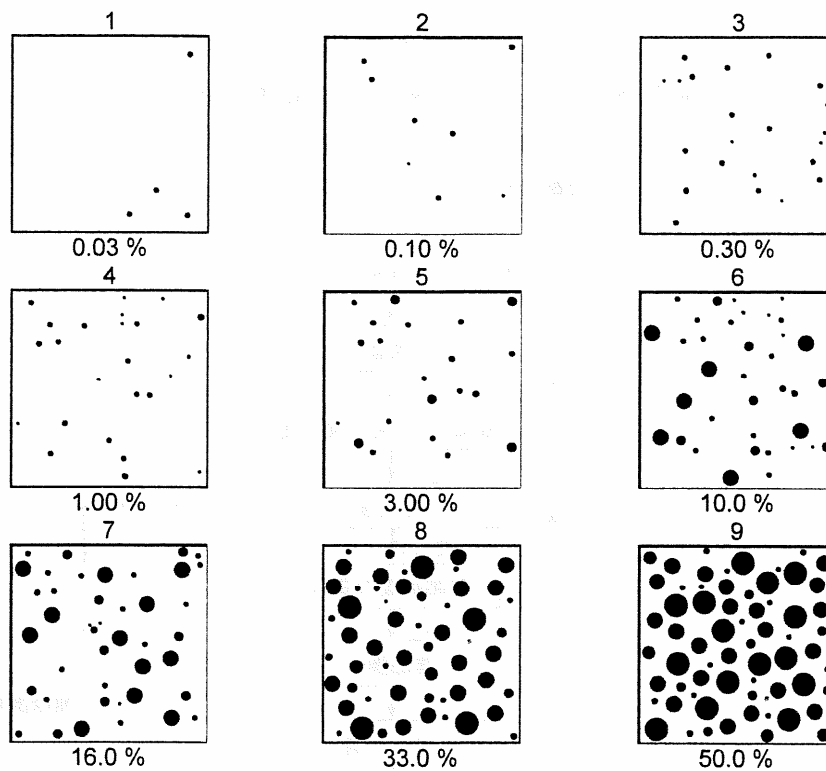
Fig. 2-2-1.8 Rate of Rusty Area (ASTM-D610)

There are no fixed manuals to judge the deterioration of the structure. So, the “Manual on Maintenance and Repair of Port Facility in Japan” issued by THE PORT AND HARBOUR RESEARCH INSTITUTE in July 1999 is used to evaluate the deterioration. **Table 2-2-1.11** represents the “Degradation Criteria”, and **Fig. 2-2-1.8** shows the illustrated “Rate of Rusty Area”

Category	A		B		C	
Criteria		I	II	III	IV	V
Corrosion of Steel Bar	None 0.03%	Spotted Rust Stain 0.30%	Some Rust Stain 1%	Much Rust Stain 10%	Degradation 16%	Much Degradation 50%
Crack	None	Spotted Crack	Some Crack	Much Crack	Much Crack With few mm Width	Some Collapsed Crack
Loss/Fall of Concrete Reinforcement	None	None	Some Loss/Fall	Loss/Fall Partially	Loss/fall Sporadically	Much Loss/Fall
Judgment*	No Need to Observation In Details		Observation in Details		Repair Works/Reinforcement

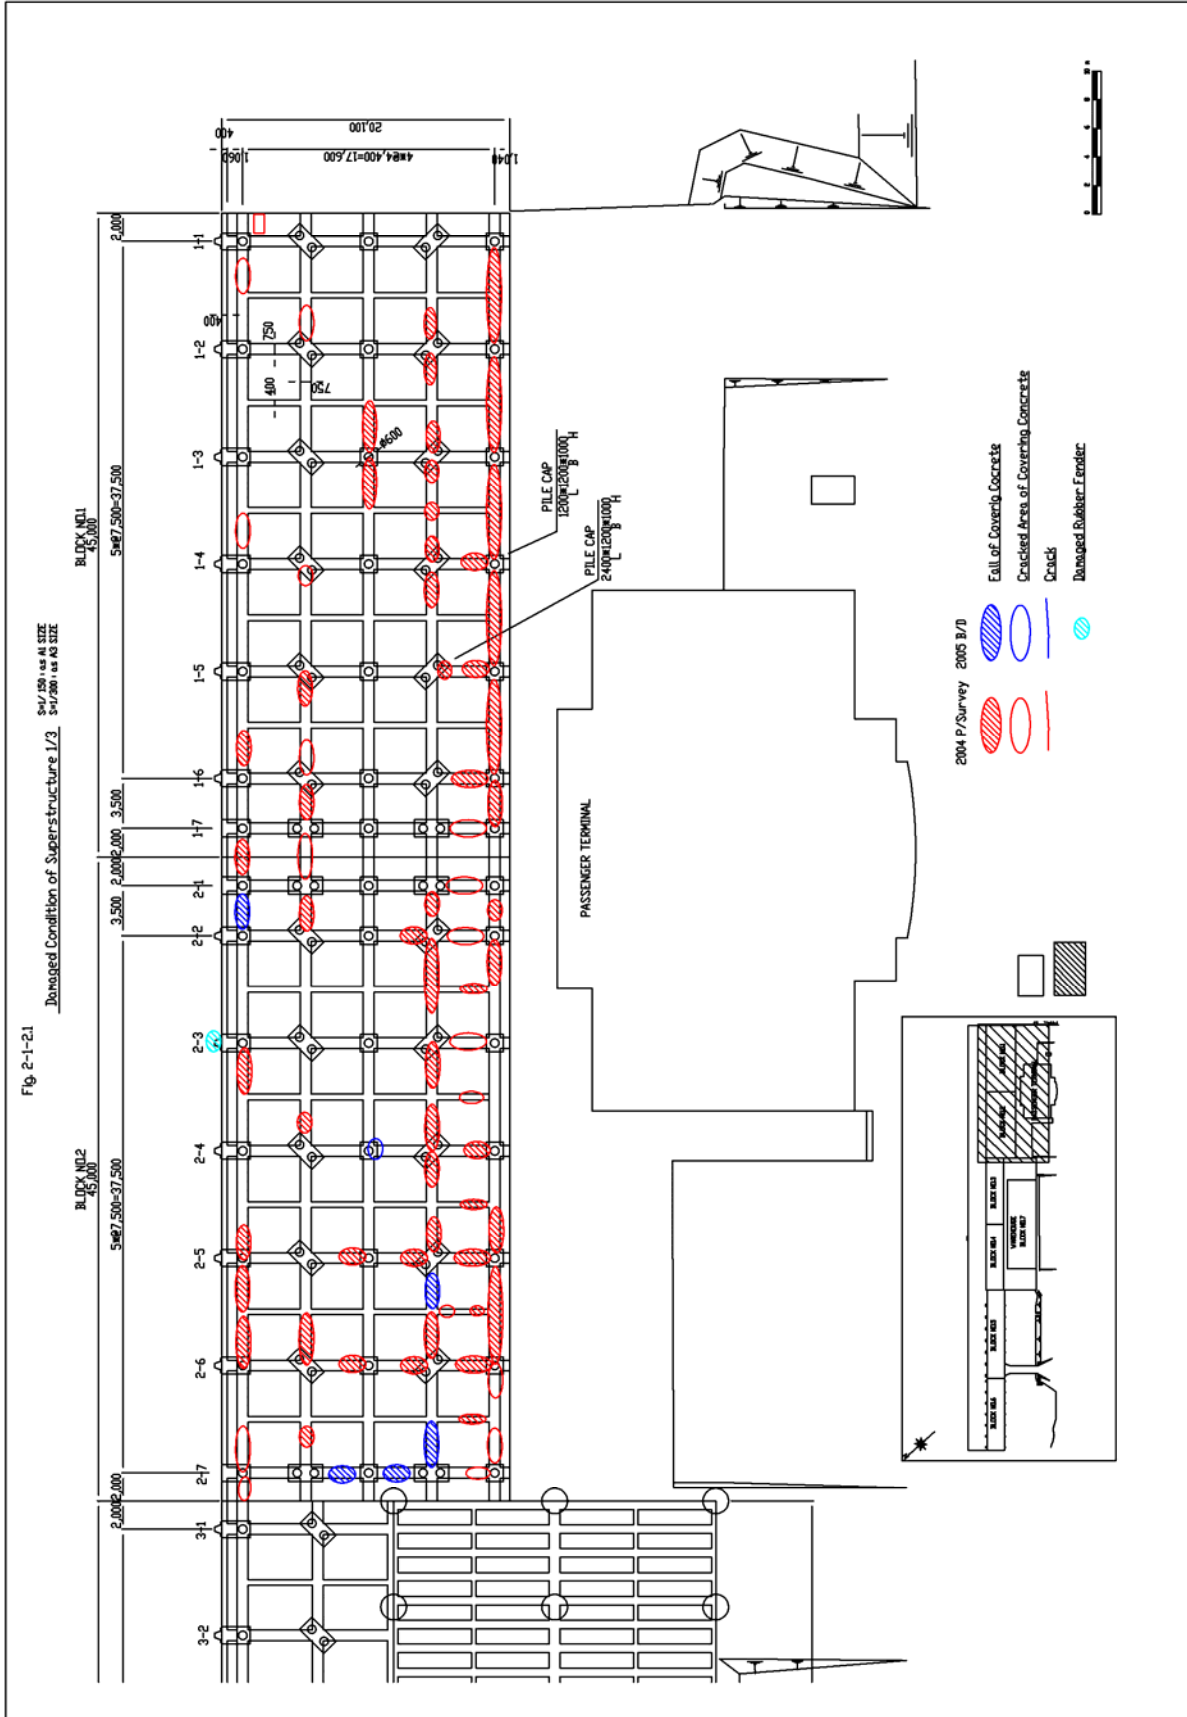
Fig. 2-2-1.9 Damaged Condition of Superstructure (1)

BL No.	Component	Q'ty piece	Deteriorated (piece)		Deteriorated (rate)		Urgency
			Sep. 2004	Mar. 2005	Sep. 2004	Mar. 2005	
1	Beam	78	19	19	24%	24%	⑥
2	Beam	78	30	35	38%	45%	④
3	Beam	36	14	15	39%	42%	③
	Slab	22	2	8	9%	36%	
4	Beam	36	24	28	67%	78%	①
	Slab	22	6	7	27%	32%	
5	Beam	73	2	2	3%	3%	⑧
6	Beam	63	4	6	6%	10%	⑦
7	Beam	30	17	24	57%	80%	②
	Slab	22	6	7	27%	32%	
8	Beam	10	0	0	0%	0%	⑨
9	Beam	37	—	14	—	38%	⑤
	Slab	43	—	5	—	12%

BL No,	Condition	Ref.
1	Cracks are found along the both sides of slabs.	Rehabilitation. is needed
2	Steel bars are exposed due to the concrete covering.	ditto
3	Steel bars are exposed at the center of the slabs.	ditto
4	Ditto	ditto
5	Some rainfalls are expected during the concrete setting.	
6	None	
7	Some damages caused by cargo handling equipment are found.	
8	None	
9	Not clear

If the deterioration condition is in progress at some blocks, the blocks should be dissolved and rehabilitated. In that case, local repairing to be taken could be the temporary countermeasures, not permanent one
