**THE STUDY ON IMPROVEMENT OF  
WATER SUPPLY SYSTEM  
IN MANAGUA IN THE REPUBLIC OF  
NICARAGUA**

**FINAL REPORT**

**Supporting Report No.4  
Leakage Survey**

**DECEMBER 2005**

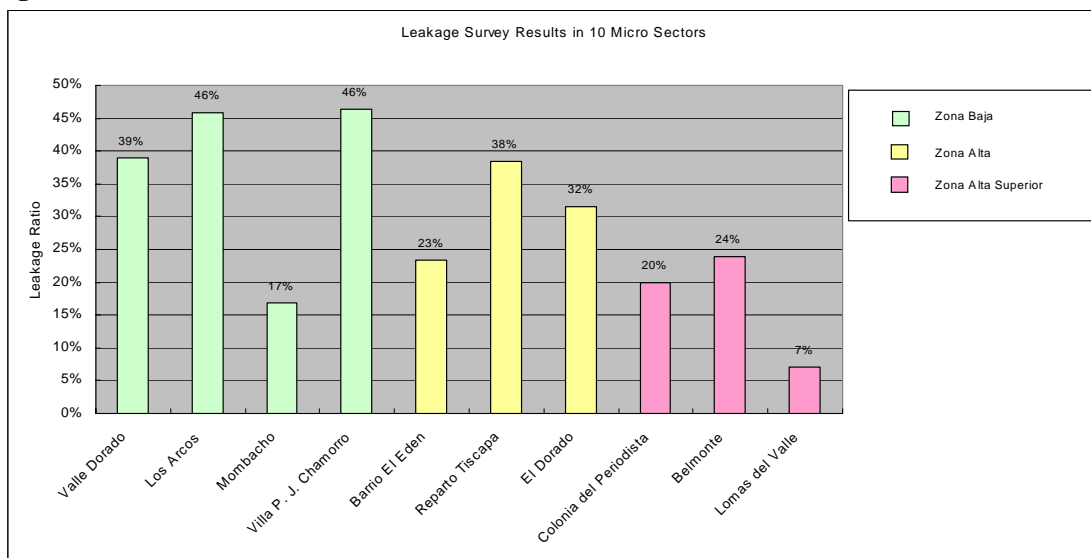
**Figure 4.5 Leakage Levels in the Ten Micro Sectors Surveyed**

The leakage ratio in each micro sector was calculated from the converted MNF, and expressed using percentage of quantities supplied. The leakage ratio differs area to area ranging from 7% to 46% as shown in **Figure 4.5**, and the average ratios in the three zones of different elevations; Zona Baja, Zona Alta, and Zona Alta Superior were 41%, 30% and 17%, respectively as shown in **Figure 4.6**.

There is a tendency that the lower the zone the higher the average leakage ratio. The overall leakage ratio for the ten micro sectors surveyed was 30% on average.

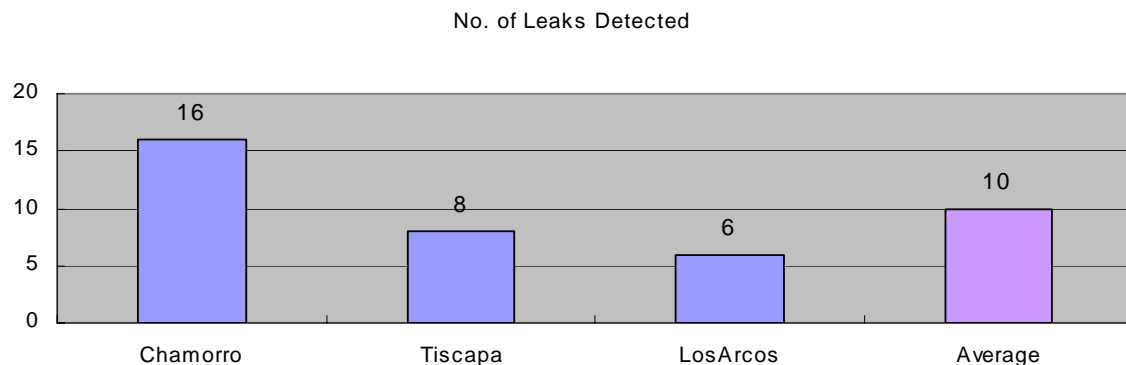
**Figure 4.8 Leaks Detected in the Selected Three Micro Sectors**

The leaks found out during the survey are summarized in the **Figure 4.8**. All these detected leaks were derived from the service pipes.

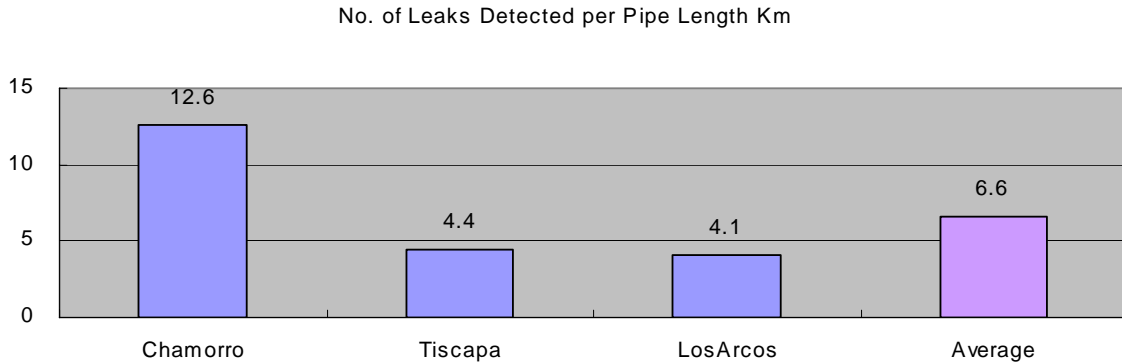
**Figure 4.9 Leaks Detected per Unit Pipe length**

The average number of cases detected, expressed as leaks detected per unit pipe length, was 6.6 per km. If this rate is simply applied to the total pipe length of 1,328 km within the range of diameter less than 6” in the entire Managua system, there would exist approximately 8,800 leaks.

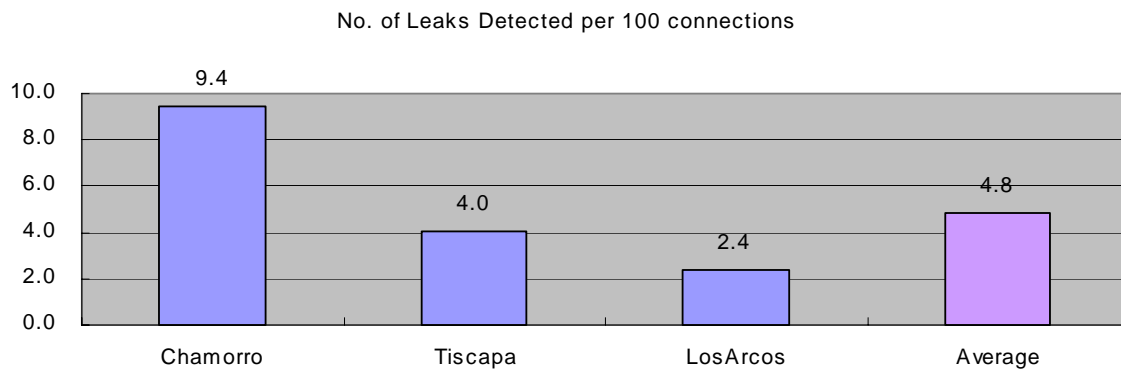
**Figure 4.10 Leaks Detected per 100 Connections**

The average number of cases detected, expressed as the number of leaks detected per 100 connections, was 4.8. If this rate is simply applied to the total connections of 169,843 in Managua system there would be approximately 8,150 leaks. Whereas, Gerencia Operación of ENCAL reported approximately 24,000 of cases have been repaired in the year 2003. Among which, the leaks from the pipes with the diameter less than 6” amounts to 99.5% of the total cases repaired according to the Departamento de Agua Potable.

The above discussion would indicate that in spite of the present efforts of ENACAL approximately more than 8,000 to 9,000 leaks in number could be detected additionally if leak detection by such a regular sounding is introduced. These leaks are presumed presently left without being attended resulting in making it difficult to decline the leakage level further down below the present level.

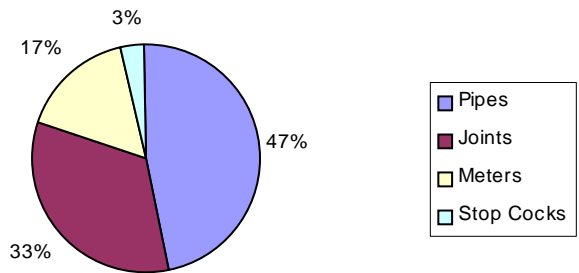
**Figure 4.11 Positions of Leaks Found out on the Service Pipes**

All the leaks detected during the survey were located on service pipelines. This result corresponds to that information obtained from the Departamento de Agua Potable. **Figure 4.11** breaks down the positions of leaks found out on service pipes.

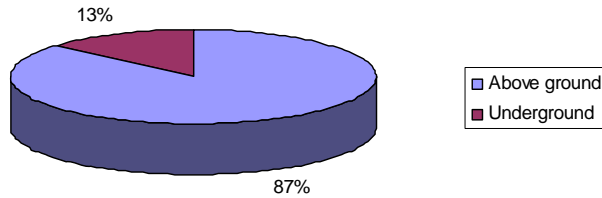
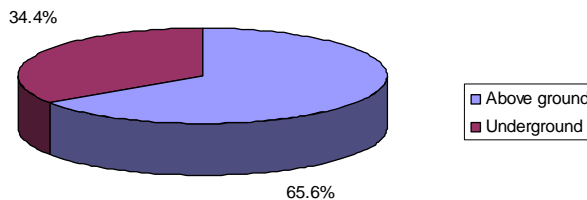
**Figure 4.12 Proportion of Above Ground and Underground Leakages**

Although underground leakage contributes 13% in number to the total cases of leaks found out during the survey, it contributes 34% in quantity to the total water loss by all the leaks detected as shown in **Figure 4.12**. It is indicative that many large underground leaks have been left without being detected since ENACAL has not introduced underground leak detection technique using listening devices.

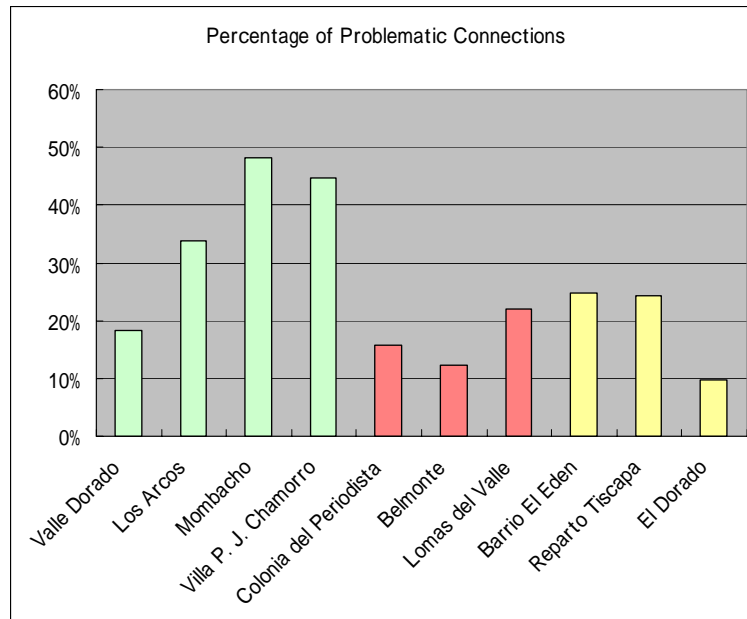
**Figure 4.14 Percentage of Problematic Connections in Each Micro Sector**

- Many meters seem to be left without reading for a long period of time. There are many water meters not functioning and some are covered with soil or submerged in water with offensive dirt. Such situation is likely to discourage meter readers to make appropriate reading.

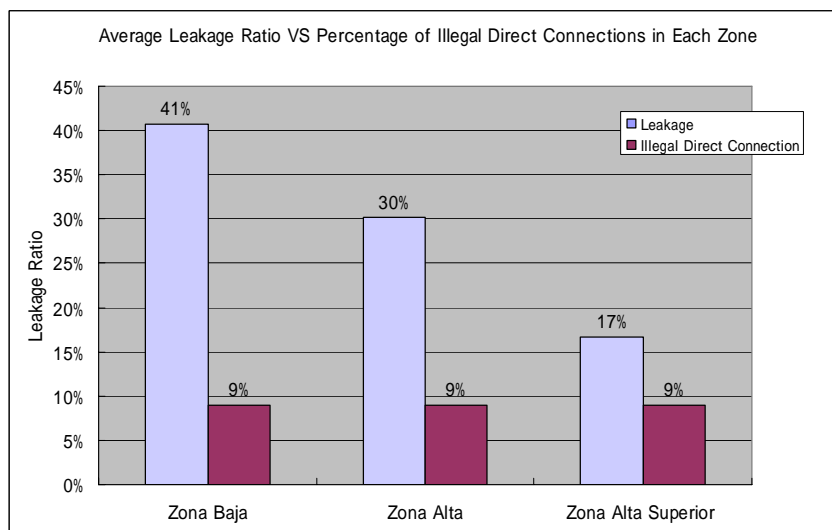
**Figure 4.15 Incidences of Illegal Connections Compared with the Average Leakage Ratios in Different Elevation Zones**

The direct connections are significant in number in several micro sectors as shown previously in **Table 4.6**, and the volume of water consumption through such connections is likely to be also considerable. As actual water flows were often observed in such houses during mid-night time indicating that lots of water is considered being wasted probably from abused taps for no useful use. Approximately 9% of the total connections in the ten micro sectors are regarded as illegal direct connections.

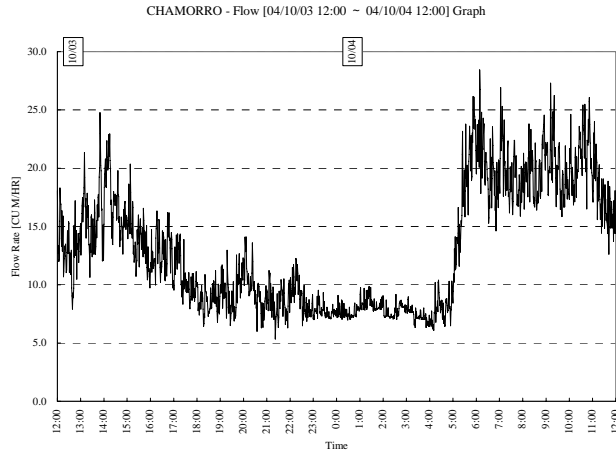
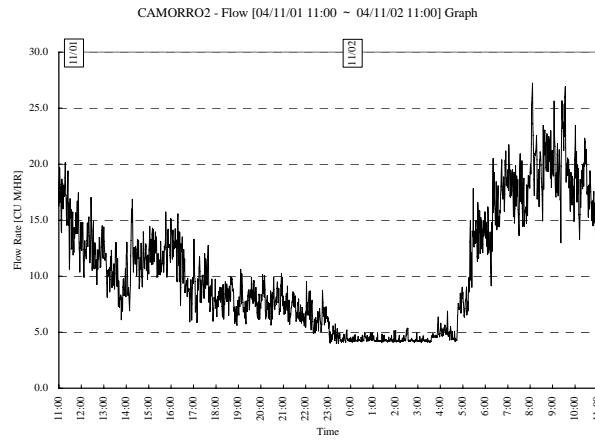
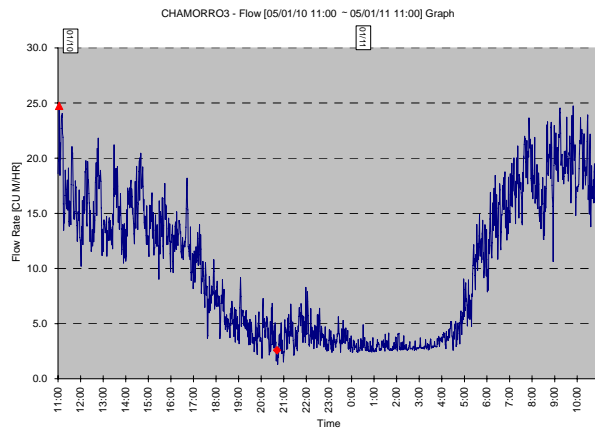
**Figure 4.16 MNF Reductions in the Series of Leakage/NRW Survey in Villa P. J. Chamorro**

Minimum Night Flow		
Measurement Press.	0.50	[Mpa]
Conversion Press.	0.38	[Mpa]
Minimum Flow	6.872	[CU M/HR]
Conversion Flow	5.991	[CU M/HR]
Leakage Ratio	46.17	%

Minimum Night Flow		
Measurement Press.	0.50	[Mpa]
Conversion Press.	0.40	[Mpa]
Minimum Flow	3.983	[CU M/HR]
Conversion Flow	3.563	[CU M/HR]
Leakage Ratio	34.34	%

Minimum Night Flow		
Measurement Press.	0.45	[Mpa]
Conversion Press.	0.30	[Mpa]
Minimum Flow	2.519	[CU M/HR]
Conversion Flow	2.057	[CU M/HR]
Leakage Ratio	20.65	%

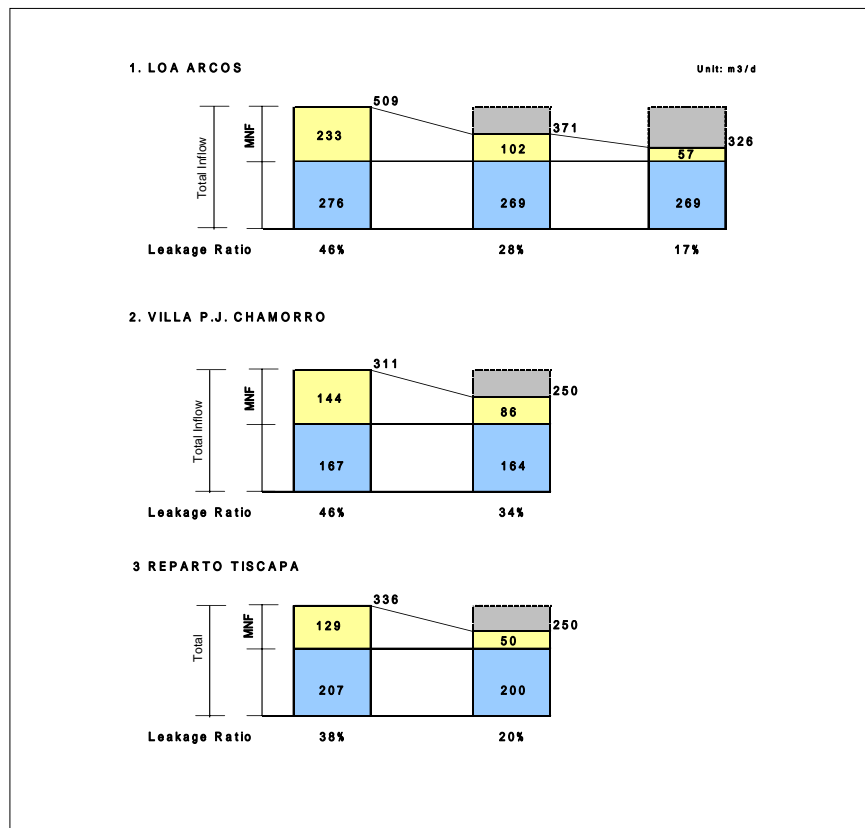
**Figure 4.18 Effectiveness of Leak Detection and Repair Work in the Selected 3 Micro Sectors**

The Team carried out leak detection surveys during the midnights using leak detectors and listening bars in the most aggravated three areas among the 10 micro sectors. As a result the average leakage ratio of 44% for the three micro sectors was reduced to 27%. **Figure 4.18** illustrates the reduction of leakage ratios in the three micro sectors after these works.

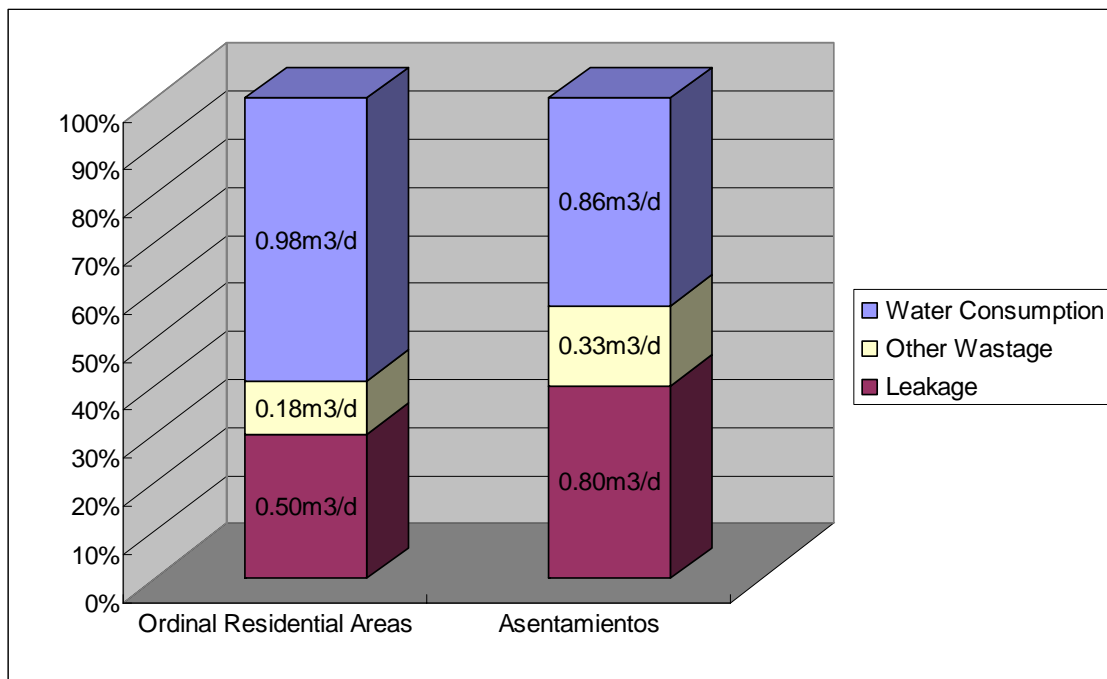
**Figure 4.19 Water Consumption and Wastage per Connection in Ordinal Residential Areas and Asentamientos**

Wastage other than leakage is considerable in some areas such as Asentamientos. Comparison of the 24 hour flow measurement and MNF analysis revealed that significant amount of water is wasted both in ordinal residential areas and Asentamientos.
