5.5 RESULTS OF PRESSURE MEASUREMENT

5.6 FLOW PATTERN IN THE STUDY AREA, EVALUATION OF WATER SUPPLY CONDITIONS AND IDENTIFICATION OF PROBLEMS

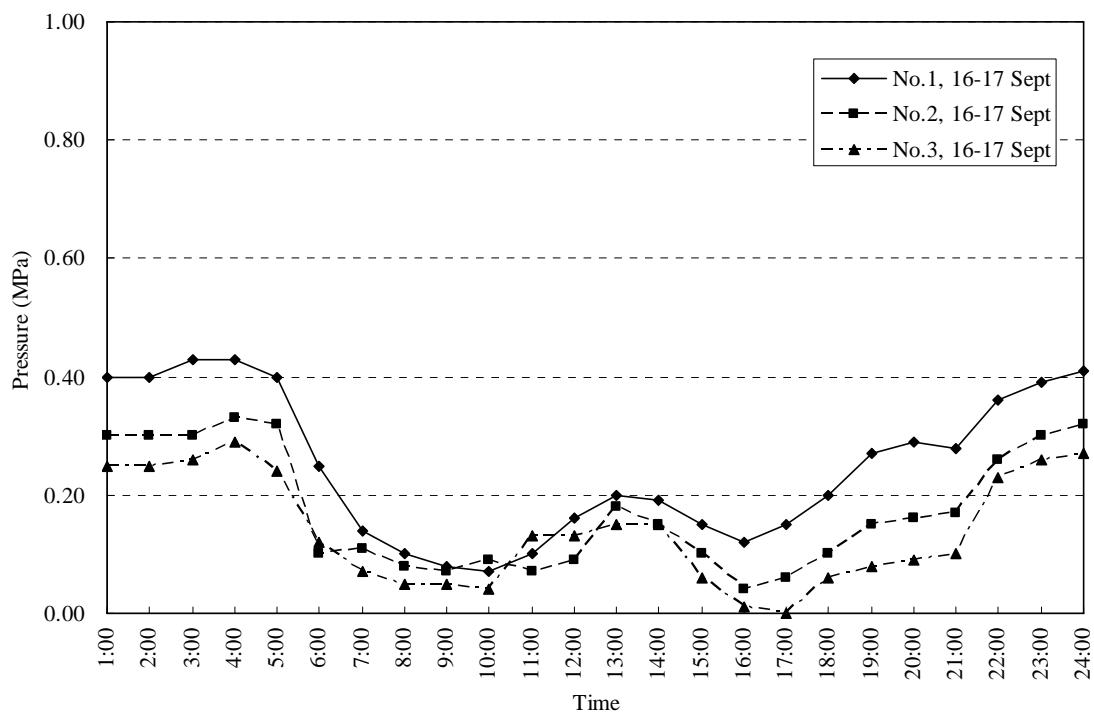
Figure 5.5.1 Water Pressure in Zona Baja Oeste

As shown in **Figure 5.5.1** Zona Baja Oeste has relatively enough water pressure except in the morning and in the evening. In general it is an ideal to maintain water pressure of about 0.10 – 0.15 MPa at tap.

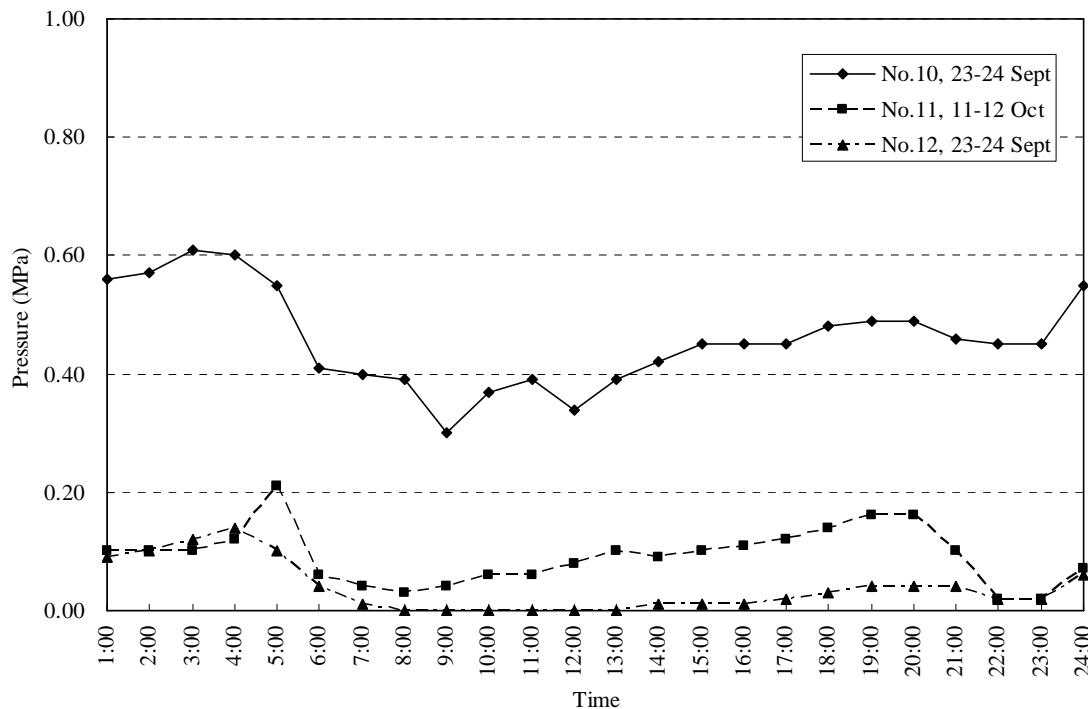
Figure 5.5.7 Water Pressure in Zona Alta Oeste

As shown in **Figure 5.5.7** lower area of Zona Alta Oeste (Location No.10) has enough water pressure throughout a day. On the other hand higher area of Zona Alta Oeste (Locations No.11 and No.12) has not enough water pressure. Especially Location No.12 has no water during daytime and there is not enough water pressure even night time.

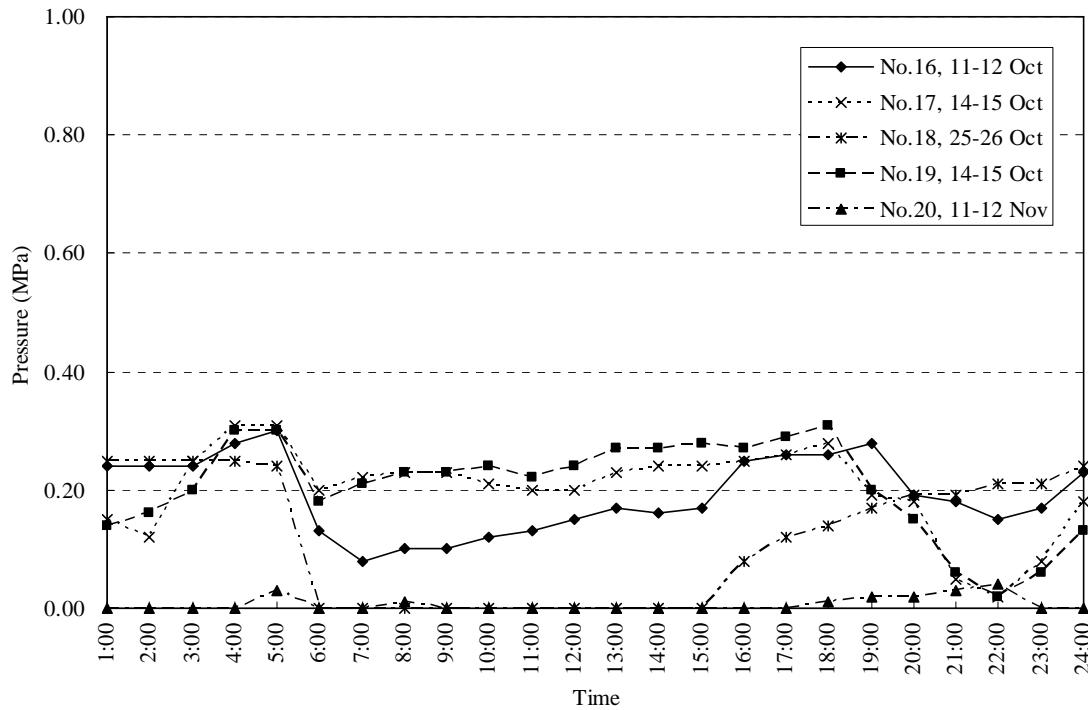
Figure 5.5.11 Water Pressure in Zona Alta Este

As shown in **Figure 5.5.11** Zona Alta Este except Location No.20 has relatively enough water pressure throughout a day. Las Americas Tank and Sabana Grande Well Field supply water to this area.

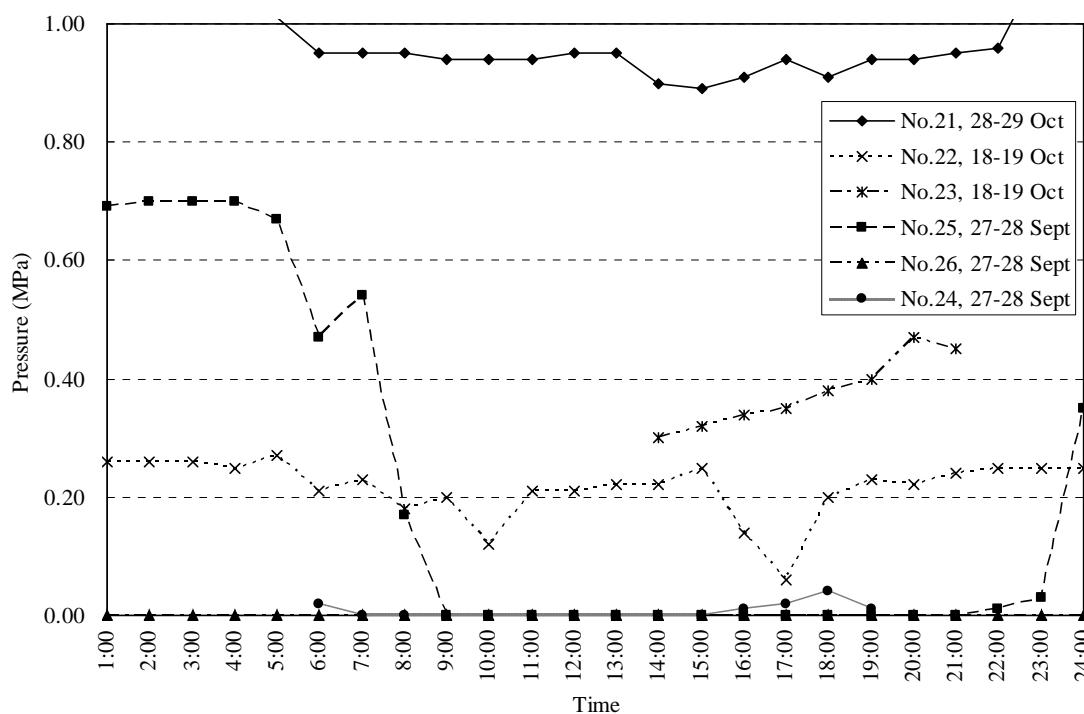
Figure 5.5.13 Water Pressure in Zona Alta Superior Oeste

At Location No.21 along Carretera Vieja Leon located at the west of Km9.2 Carretera Sur Tank, extremely high water pressure of 1 MPa and more was observed. The height difference from well seems to cause. In general for water supply facilities it is undesirable that the water pressure exceeds 0.75 MPa. Location No.22 has relatively enough water pressure throughout a day.

As shown in **Figure 5.5.13** other three locations except No.23, Locations No.24 – 26, have been faced to the problem of bad water supply condition. Especially Locations No.24 and No.26 have no water all day long continuously. As for this area, water is supply from San Judas Tank. As described in previous section, “5.4 Results of Flow Measurement”, enough water which was planned by Managua I Project was not transmitted from Santo Domingo Tank to San Judas Tank. Therefore, there is not sufficient water to supply this area.

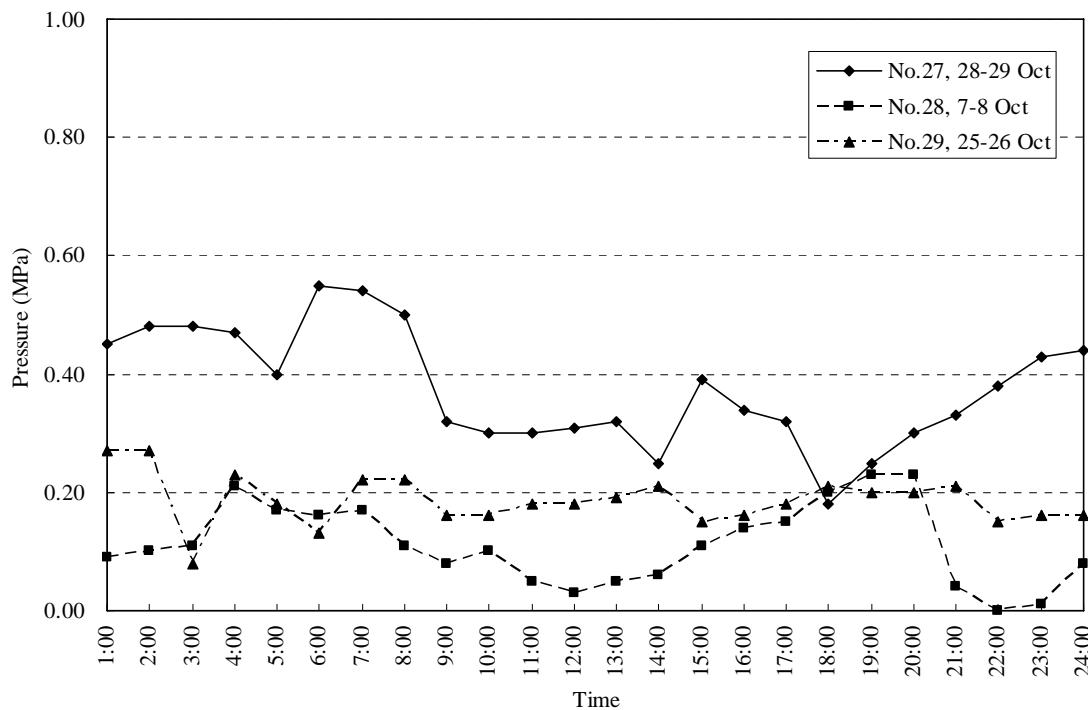
Figure 5.5.15 Water Pressure in Zona Alta Superior Centro

As shown in **Figure 5.5.15** Locations No.27 and No.29 have relatively enough water pressure throughout a day. Location No.28 has little water according to time.

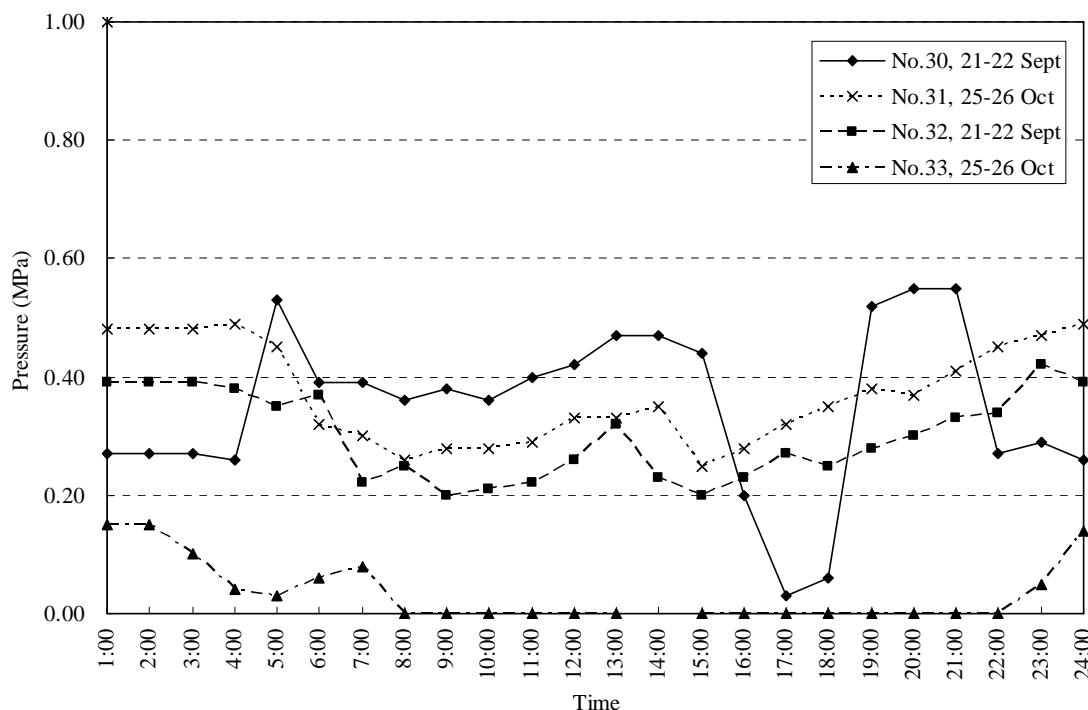
Figure 5.5.17 Water Pressure in Zona Alta Superior Este

As shown in **Figure 5.5.17** Zona Alta Superior Este has relatively enough water pressure throughout a day except Location No.33. Location No.33 is supplied from Schick Tank planed and constructed by Managua I Project. As described in previous section, “5.4 Results of Flow Measurement”, enough water which was planned by Managua I Project was not transmitted from Santo Domingo Tank to Schick Tank. Therefore, there is not sufficient water to supply this area.

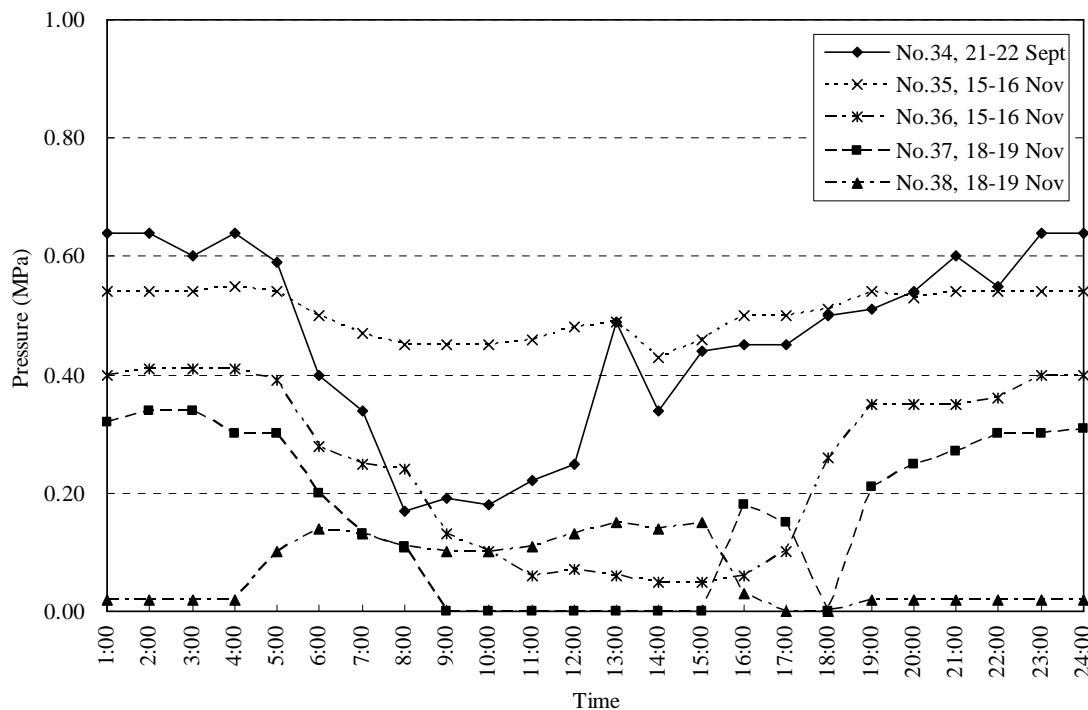
Figure 5.5.19 Water Pressure Outside Managua

As shown in **Figure 5.5.19** Locations No.34 and No.35 has enough water pressure throughout a day. Especially water pressure at Location No.35 (Veracrus area) was maintained at 0.4 MPa and more. Locations No. 36 (Ticuantepe) and No.37 has no water during day time but has enough water during night time. On the other hand at Location No.38 (Nindiri) enough water with enough water pressure was necessarily supplied.

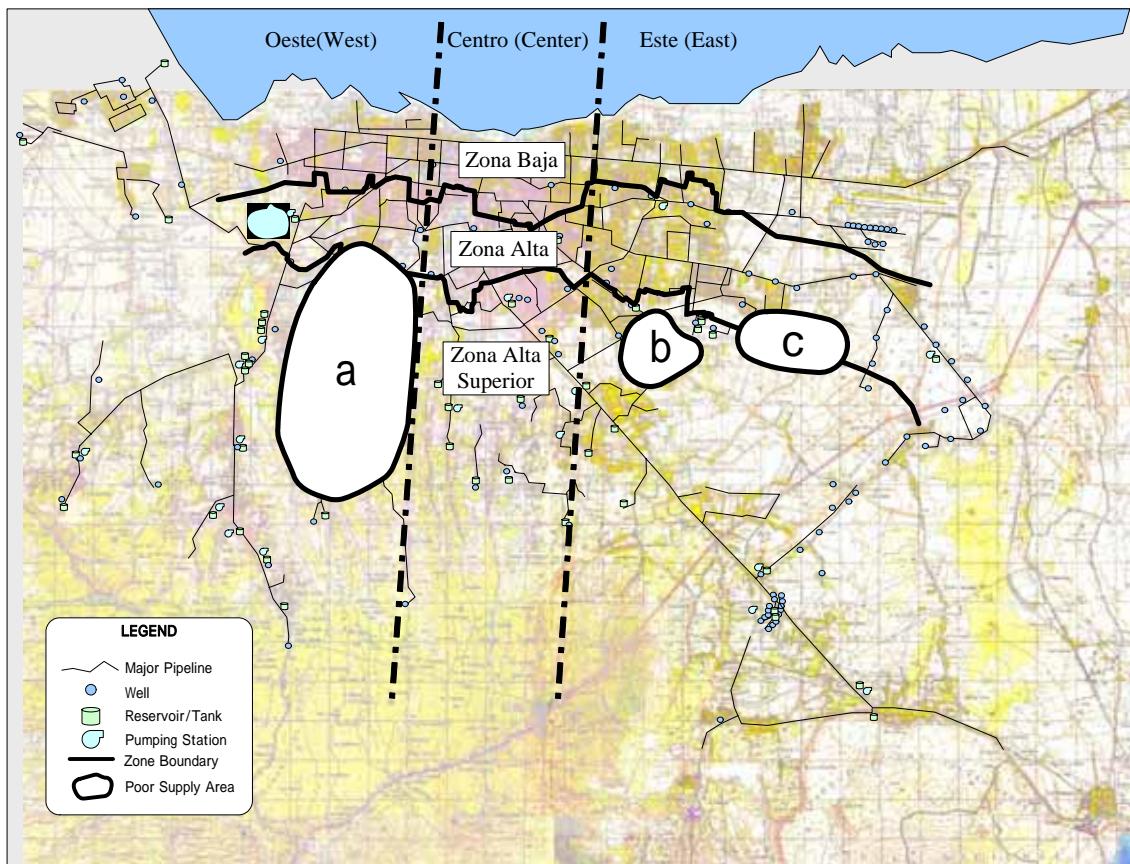
Figure 5.6.2 Poor Supply Areas

In Managua, as the results of the flow and pressure measurement most area in the Study Area has no serious problem in water supply condition, however, mainly 3 areas listed below and shown in **Figure 5.6.2** are facing the problem of poor service, such as lack of enough water continuously for 24 hours with enough pressure.

- a. Area supplied from San Judas Tank (eastern part of Zona Alta Superior Oeste and part of higher area of Zona Alta Oeste)
The reason the water supply condition of this area is bad is that enough water does not come to San Judas Tank from Santo Domingo Tank.
- b. Area supplied from Schick Tank (lower area of Zona Alta Superior Este)
This area is facing the same problem as area supplied from San Judas Tank. Problem is that there is not enough water for proper water supply from Schick Tank.
- c. Area supplied by Sabana Grande Well Field (eastern part of Zona Alta Este)
This area has no appropriate distribution network, so water can not be distributed to all of this area with enough water pressure. In addition this area has problems on illegal connection and asentamientos.

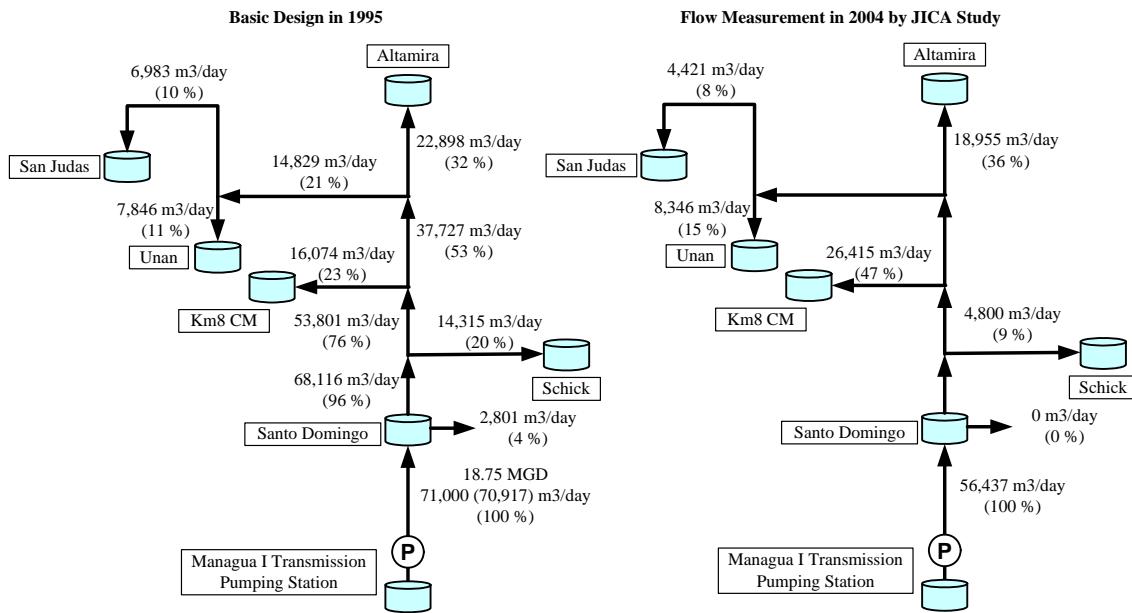
Figure 5.6.3 Flow Measurement Results for Managua I System

The result of evaluation for Managua I System by comparing the flow measurement by the Study and design capacity is summarized in **Figure 5.6.3**. As the results, water of 56,400 m³/day was pumped to Santo Domingo Tank from Managua I Transmission Pumping Station. Design capacity of the station is, however, 71,000 m³/day.
