## **Annexe B Rehabilitation Works for Khettaras**

### **Contents**

## B.1 Present Condition of Khettaras

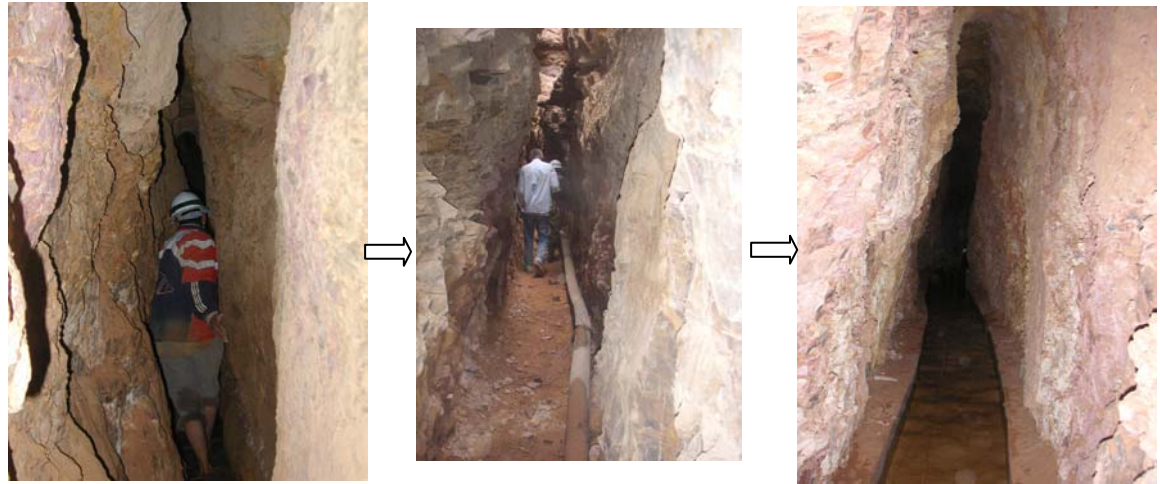
Khettara Diba  
Before rehabilitation. Gallery wall is composed of firm rock. 0.4m gallery width prevents smooth movement for maintenance works.

After enlargement of gallery section, concrete canal was placed. 0.6m wide canal (inside) make workers easy to carry out maintenance works.

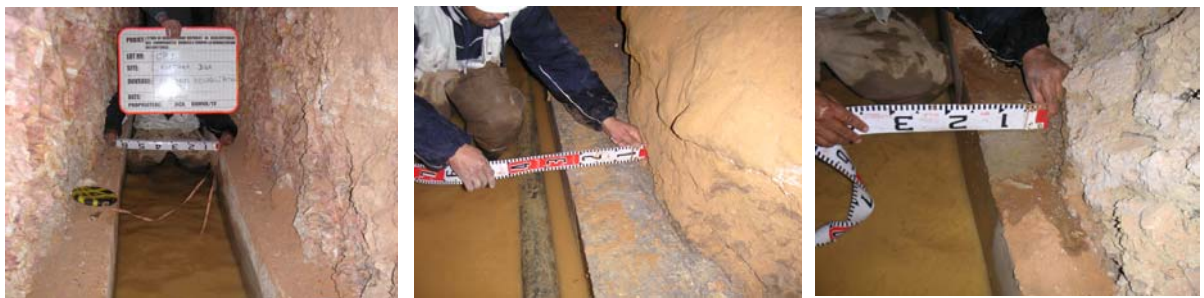
Space between side wall and rock is filled with concrete.

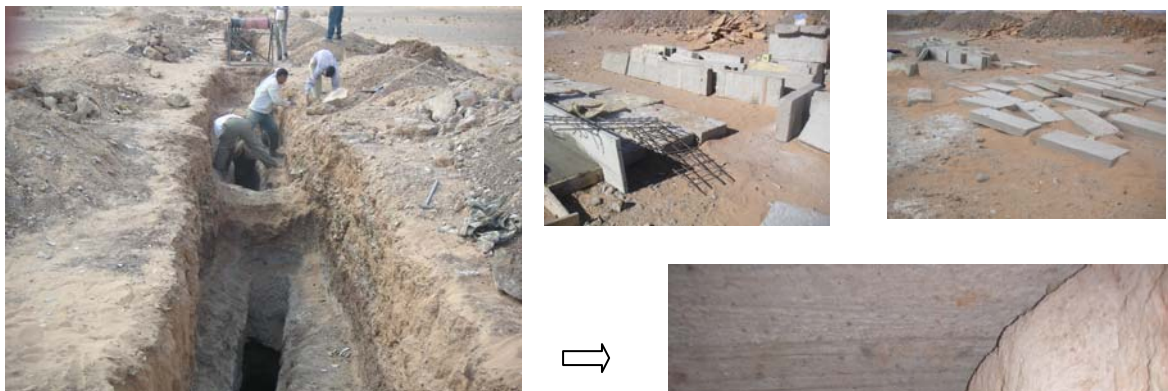
Existing gallery was excavated from the ground, and covered with plane stone. Gallery is about 10 m below from the ground. Photo shows after removal of stone cover to secure the safety inside of the gallery.

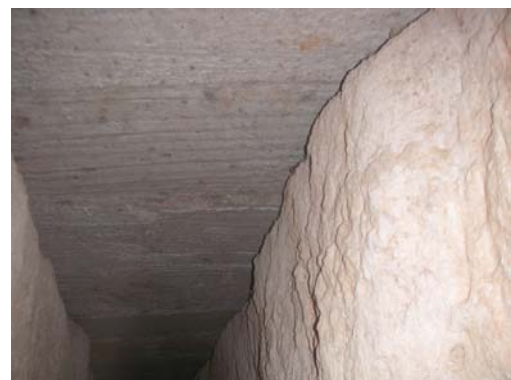
Replacement of gallery cover by concrete slab. (see from inside of the gallery)

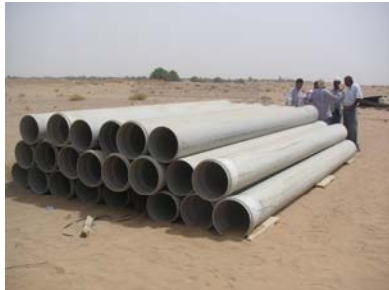
PVC pipe (diameter 400mm) mitigates leakage loss through gravel layer.

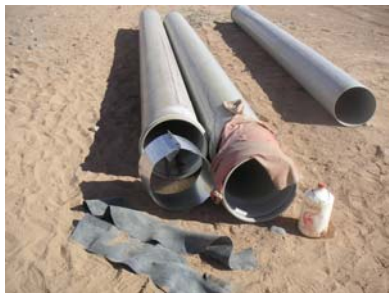
Excavation works for PVC pipe installation. Gallery is located at 18 m below ground surface.

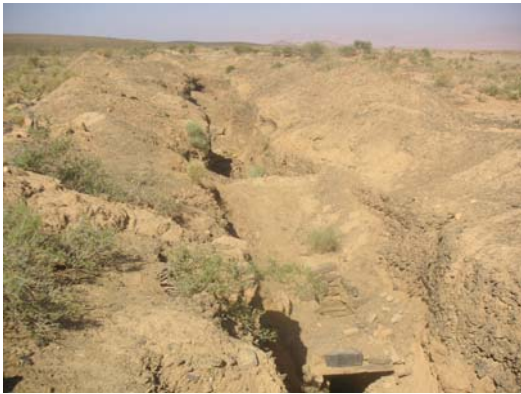
Khettara Azag

Before rehabilitation works. Masonry wall of gallery was damaged by flood.

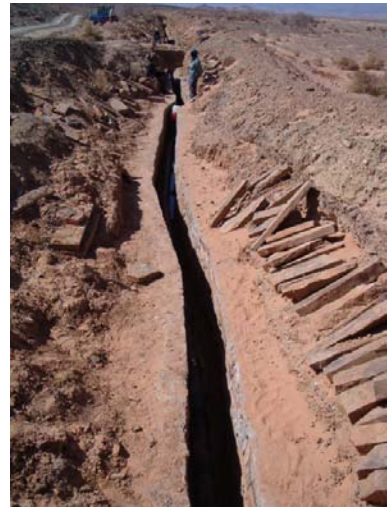
After rehabilitation works by masonry. (same location as photograph at left)

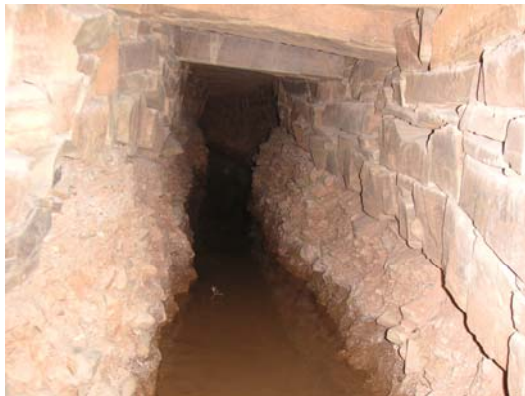
Galley section before rehabilitation works. Riverbed deposits caused leakage before construction.

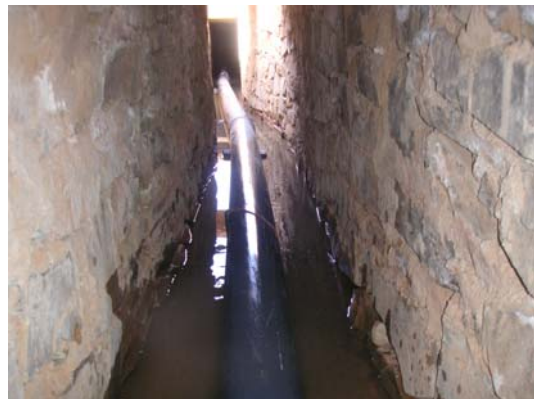
PVC pipe installed in the gallery (diameter 200mm)

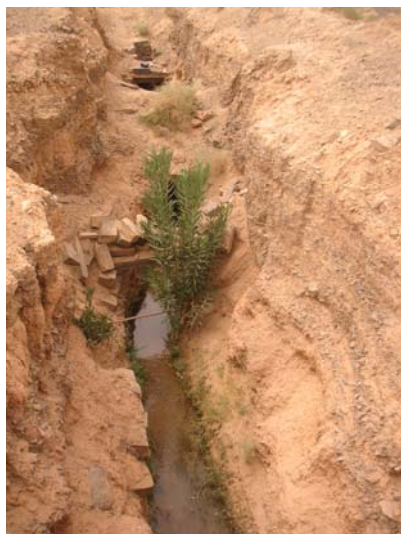
27m length was completely damaged by floods.

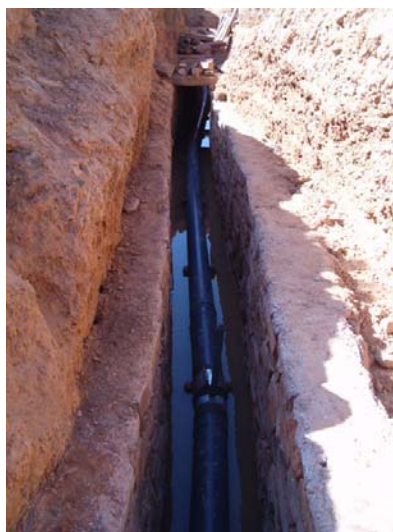
After rehabilitation works by masonry wall. PVC pipe was installed to prevent leakage.

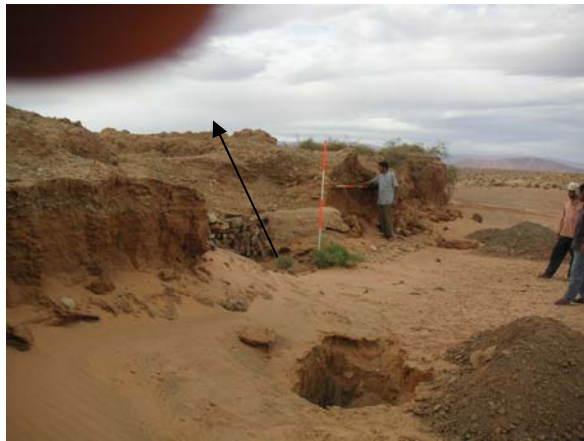
Bank erosion was developed to gallery. Water level was about 1.2 m from the river bed (Horizontal pole shows water level in the photograph)

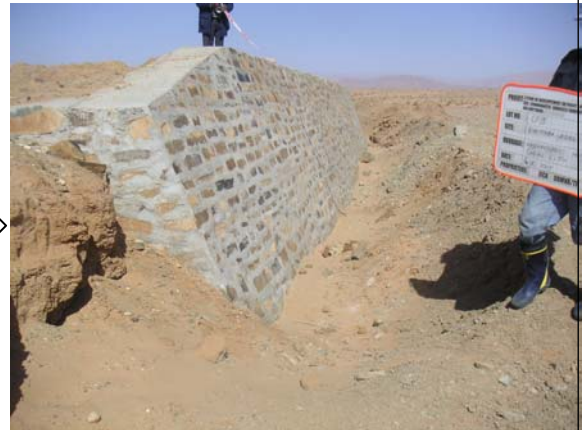
Completion of flood protection wall (masonry)  
Masonry wall has 3.5 m high from foundation or 2.75m from riverbed.

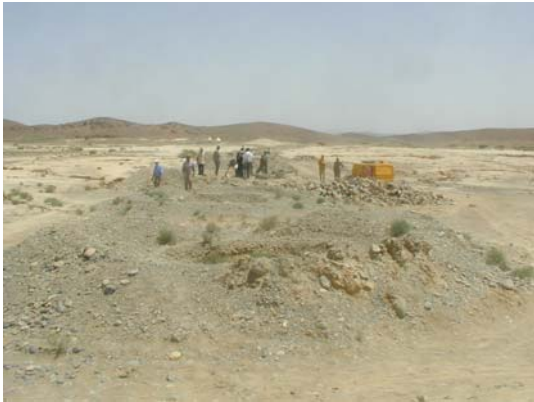
Khattara Agoumad

View of ground surface  
Khattara is located along the river (wadi), so floods have damaged khettaras.

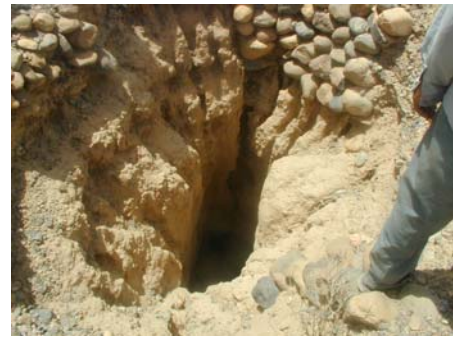
↓  
Vertical shaft damaged by floods

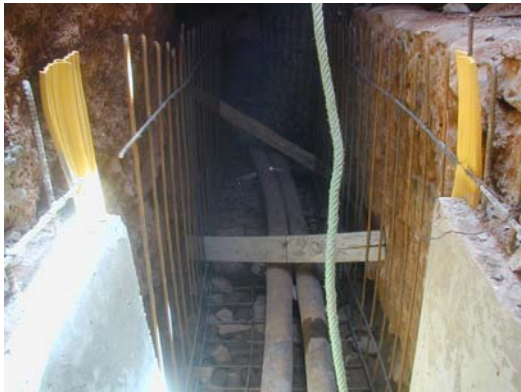
Downstream of the khettara is located in the residential area, so that waste water has caused contamination of the water for potable use.

Concrete is used to mitigate waste water inflow instead of existing masonry.

In addition, water stop along the joint of culvert is important for the same reason above.
