2.2.6 QIP for Support for Radio Station (Building)

Figure 2.2.19 RRI Damage Condition

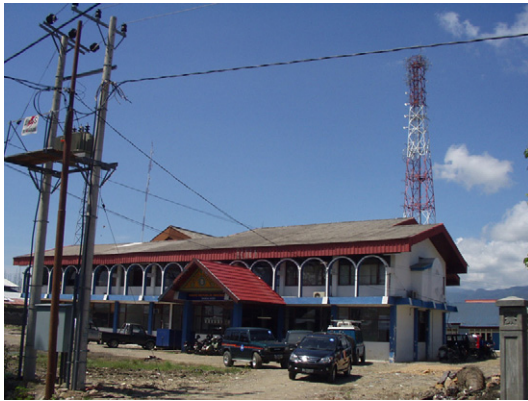
RRI Radio Station - Studio

- ◆ Facility road maintenance: The area in question is in a low-lying area, and consequently has considerable flood damage. The tsunami caused catastrophic damage to broadcasting equipment on the first floor of the studio. To prevent such damage from occurring again, drainage for the facility grounds and land improvements are required. As part of this, the repair plan for facility roads calls for the use of interlocking block material, which offers good drainage.
- ◆ Grounds construction: Non-paved, open areas within the facility will be covered in sod.
- ◆ Gutters: Some of the facility gutters were damaged, and will be repaired.
- ◆ Fences, walls, and gates: To be built anew, as washed away by the tsunami.
- ◆ Gatehouse: To be built anew, as washed away by the tsunami.
- ◆ Parking lot roof: To be built anew, as washed away by the tsunami.

- ◆ For studio buildings, since broadcasting equipment will be installed mainly on the second floor, reconstruction of the room will be undertaken

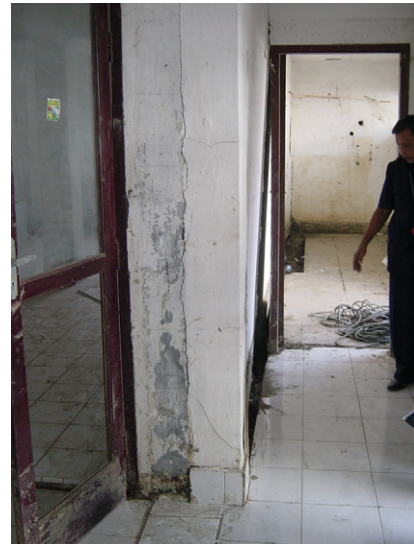
Damage of column

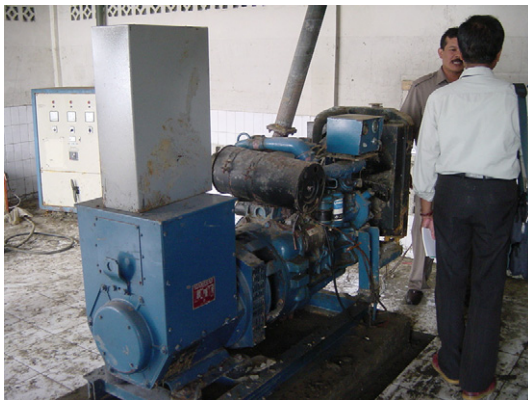
Damage of Generator

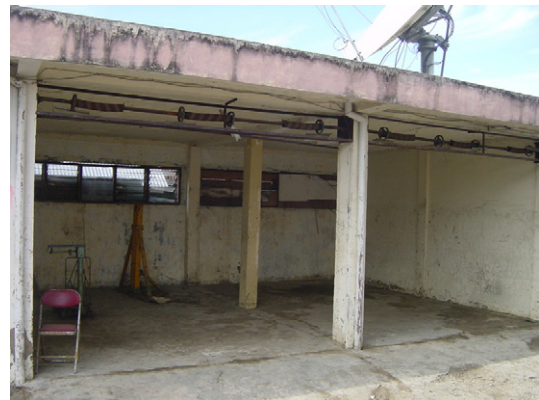
Damage of Garage
