REHABILITATION OF ORPHANAGES

(JROH NAGUNA & NIRMALA)

UNDER JAPAN'S NON-PROJECT TYPE GRANT AID

**APPENDIX-5 REHABILITATION OF ORPHANAGES  
(JROH NAGUNA & NIRMALA)  
UNDER JAPAN’S NON-PROJECT TYPE GRANT AID**

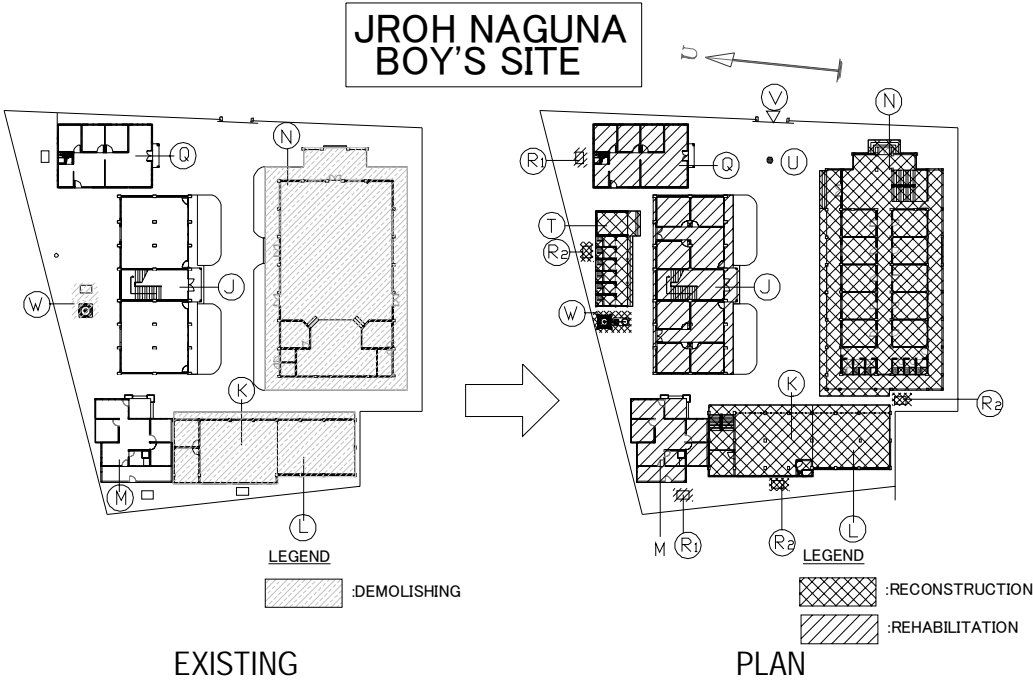
Figure 1.1.3 Site Plan and Rehabilitation Plan for Jroh Naguna Orphanage

Symbol	Facility name		Repair classification (○: Usable X: Unusable ▲: Overall repairs □: Partial repairs)									
			Structure	Exterior walls	Interior walls	Indoor flooring	Halls Stairs	Ceilings	Roofs	Fixtures	Light fixtures	Plumbing fixtures
A/C	Office and Hostel (Boy)1	2 <sup>nd</sup> fl	○	▲	▲	△	△	▲	△	△	△	△
		1 <sup>st</sup> fl		▲	▲	▲	▲	▲		△	△	△
B	Auditorium	2 <sup>nd</sup> fl	○	▲	▲	△	▲	▲	△	△	▲	○
		1 <sup>st</sup> fl		▲	▲	△	N/A	▲		△	▲	○
D	Mosque		○	▲	▲	▲	N/A	▲	▲	△	○	N/A
E-I	Hostel (Girl)1	2 <sup>nd</sup> fl	○	▲	▲	△	△	▲	○	△	△	△
		1 <sup>st</sup> fl		▲	▲	△	△	▲		△	△	○
E-II	Hostel(Girl)2	2 <sup>nd</sup> fl	○	▲	▲	△	○	▲	▲	△	○	○
		1 <sup>st</sup> fl		▲	▲	△	○	▲		△	○	○
F	Office House		○	▲	▲	▲	N/A	△	○	△	○	△
G/I	Kitchen and Mess Room1	2 <sup>nd</sup> fl	○	▲	▲	○	△	▲	△	△	△	○
		1 <sup>st</sup> fl		▲	▲	△	△	▲		△	△	○
H	Hostel(Boy)2	2 <sup>nd</sup> fl	○	▲	▲	△	○	△	△	△	△	○
		1 <sup>st</sup> fl		▲	▲	△	○	△		△	△	○
J	Education Room	2 <sup>nd</sup> fl	○	▲	▲	○	△	▲	△	△	▲	○

1 <sup>st</sup> fl		▲	▲	▲	△	▲		△	▲	○
K/L	Workshop and Boarding House		X	New construction, due to major damage to structure frame.								
M	Polyclinic		○	▲	▲	▲	N/A	▲	▲	△	○	○
N	Auditorium		X	New construction, due to major damage to structure frame.								
Q	Kitchen and Mess Room2		○	▲	▲	▲	N/A	▲	○	△	○	△
T	Toilet		X	New construction, due to tsunami damage.

In addition to the repairs listed in Table 1.1.2, other repair work performed will include the following described repairs to the roads inside the premises, restoration of walls and gates, and repairs to water supply facilities.

- ◆ Roads inside premises: Since the corridor connecting the boys' hostel was severely damaged, repairs will be made using interlocking block material.
- ◆ Grounds work: The roads in vacant land other than the roads inside the premises of the boys' hostel will be repaired with gravel.

- ◆ Walls and gates: Walls on the perimeter of the facilities collapsed due to the tsunami, and will therefore be rebuilt.
- ◆ Water supply facilities: Saltwater damage due to the tsunami rendered the existing well unusable. Therefore, new water supply facilities will be installed.

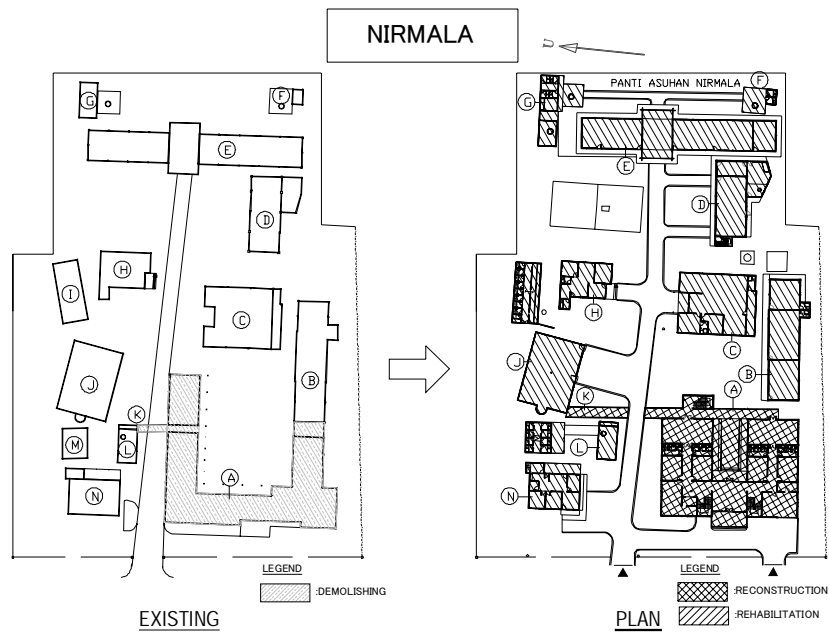
Figure 1.1.5 Site Plan and Rehabilitation Plan for Nirmala Orphanage

Symbol	Facility name		Repair classification (○: Usable X: Unusable ▲: Overall repairs □: Partial repairs)									
			Structure	Exterior walls	Interior walls	Indoor flooring	Halls Stairs	Ceiling material	Roofing material	Fixtures	Light fixtures	Plumbing fixtures
A	Office and Education Room	2 <sup>nd</sup> fl	X	New construction, due to major damage to structure frame. Plan is for replacing the content of the existing facility and adding a third floor along with a multipurpose room which will also function as an evacuation area.								
		1 <sup>st</sup> fl										
B	Hostel (Girl)		○	▲	▲	△	N/A	△	▲	○	▲	▲
C	Hostel (Boy)1		○	▲	▲	▲	N/A	▲	▲	▲	▲	▲
D	Mess Room	2 <sup>nd</sup> fl	○	▲	▲	▲	△	▲	▲	▲	▲	○
		1 <sup>st</sup> fl		▲	▲	▲	△	▲		▲	▲	○
E	Hostel (Boy)2		○	▲	▲	▲	△	▲	▲	▲	▲	N/A
F	Toilet 4		○	▲	▲	▲	N/A	▲	▲	▲	▲	▲
G	Toilet 3		○	▲	▲	▲	N/A	▲	▲	▲	▲	▲
H	Guest House		○	▲	▲	○	N/A	▲	○	△	▲	○
I	Toilet 2		○	▲	▲	▲	N/A	▲	▲	▲	▲	▲

J	Mosque		○	▲	▲	○	N/A	▲	▲	▲	▲	N/A
K	Corridor		X	New construction, due to tsunami damage								
L	Well Facility		○	▲	▲	▲	N/A	N/A	N/A	N/A	N/A	N/A
M	Toilet 1		○	▲	▲	▲	N/A	▲	▲	▲	▲	▲
N	Office		○	▲	▲	○	▲	▲	▲	○	○	▲

In addition to the repairs listed in Table 1.1.3, other repair work performed will include the following described repairs to the roads inside the premises, restoration of walls and gates, and repairs to the water supply facilities.

- ◆ Roads inside premises: Since the corridor connecting the facilities was severely damaged, repairs will be made using interlocking block material.
- ◆ Grounds work: Repair work in vacant land other than the roads inside the premises will be made using sod.
- ◆ Walls and gates: Walls on the perimeter of the facilities collapsed due to the tsunami, and will therefore be rebuilt. To make the gates more convenient, two additional gates will be built along the road on the western side of the facility.
- ◆ Water supply facilities: Salt damage due to the tsunami rendered the existing well unusable. Therefore, new water supply facilities will be installed.
- ◆ Other: The volleyball court will be repaired.

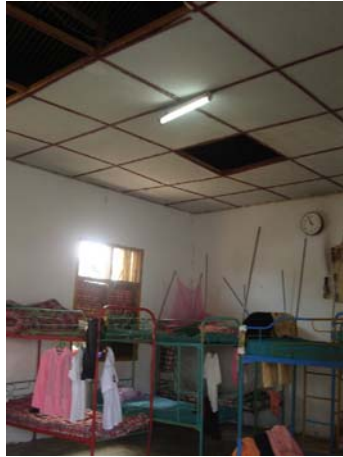
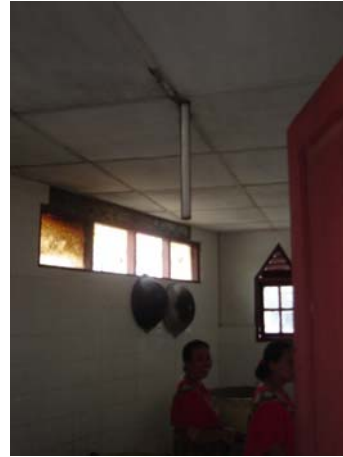
Figure 1.1.8 Condition of Lighting Fixture in Nirmala Orphanage

As is the case with the Jroh Naguna orphanage, lighting fixtures here have also been damaged to the extent that most of them in the facility need to be replaced. In particular, the damage on the first floor is extensive, and most of the light fixtures are unusable as a result of deterioration of parts because of rust, both from age and from the tsunami. The spread of rust will lead to damage such as electrical leaks and earth fault accidents, and therefore necessitates immediate replacement of these parts. In addition, some light fixtures have fallen from the ceilings as a result of vibration from the earthquakes. When the light fixtures fell from the ceilings it exerted an excessive amount of strain on the cables and contact points resulting in damage to the insulating coating on cables and fixtures.

As a result, these parts also require immediate replacement (see photos below).

Lighting fixtures in sleeping rooms and kitchen  
(the screws holding the fixtures in place have dropped out and the fixtures are hanging by their cables)

- ◆ For lighting fixtures, lighting fixtures and hooks that show extensive damage will be replaced, and repairs will be made to any broken indoor wiring. However, since the outlets and switches are usable, the existing ones will be kept and used.

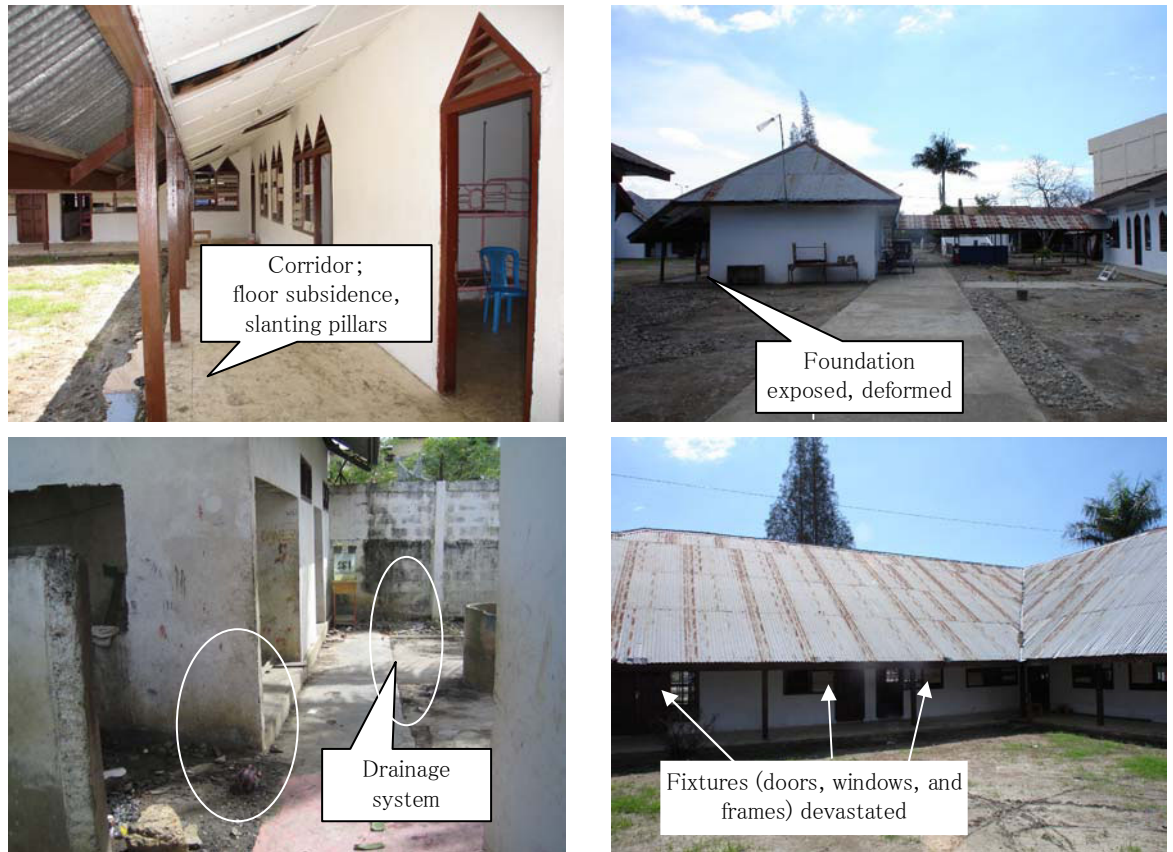
Figure 1.1.9 Damage Condition of Nirjala Orphanage

One of the buildings with the most significant aging was the administration building, comprising an office, a store, an education room, and a boarding house. The images below show the severe structural damage suffered by the front of the building, where the force of the tsunami was greatest as shown Figure 1.1.9.

- ◆ This facility is an aged building several decades old and already had problems in terms of structural strength due to aging.
- ◆ Large cracks (10 mm wide by 30 cm long) appeared at the junction of the two pillars and the beam at the front entrance, and the reinforcing steel is deformed.
- ◆ The pillars and walls on which the roof rests have numerous cracks.
- ◆ The foundation on the back patio side has subsided causing visible structural distortion.
- ◆ Distortion has caused windows and fixtures to break and/or change shape, and these parts are irreparable.
- ◆ There is damage throughout the building, including the foundation, and the safety of this building most likely cannot be ensured by performing repair work alone.

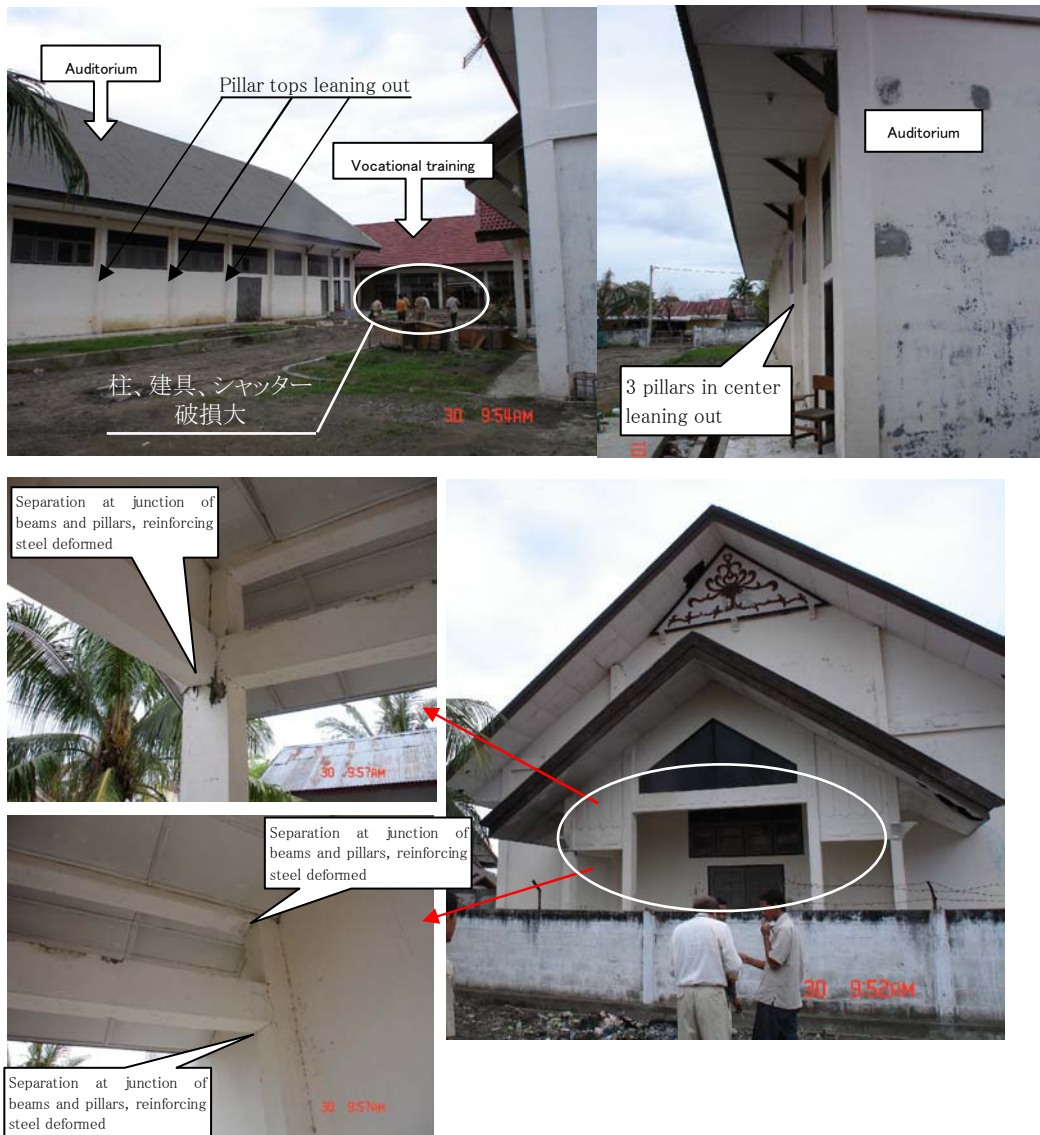
Figure 1.1.10 Damage Condition of Jroh Naguna Orphanage Auditorium

The doors and windows of the centrally-located boys' hostel are severely damaged. This building is one of the oldest (60 years old) and the floor is not of a sufficient height since it is the same as the ground outside. It floods regularly during heavy rainfalls.

- ◆ The pillars, which are main structural supports, exhibit both deformation and damage. The 18 main pillars in the center (north side), running the length of the building, are approximately 5 meters high. Six of those are separated from the beam above them by 8 cm and 12 cm, creating a structurally dangerous condition.

- ◆ The junctions between the roof beam and pillars near the front entrance have cracks in 4 parts. Among them, at 2 points, the coated concrete has come off and fallen, revealing the deformed reinforcing steel.

- ◆ The roof trusses are deformed as a result of strain on the building and the roofing material has come off and fallen significantly.
- ◆ The walls have countless diagonal cracks.

- ◆ Strain on the building has resulted in damage to and deformation of the windows and other fixtures, making these parts irreparable.
- ◆ There is damage throughout the building, including the foundation, and the safety of this

building most likely cannot be ensured by performing repair work alone as shown Figure 1.1.10.

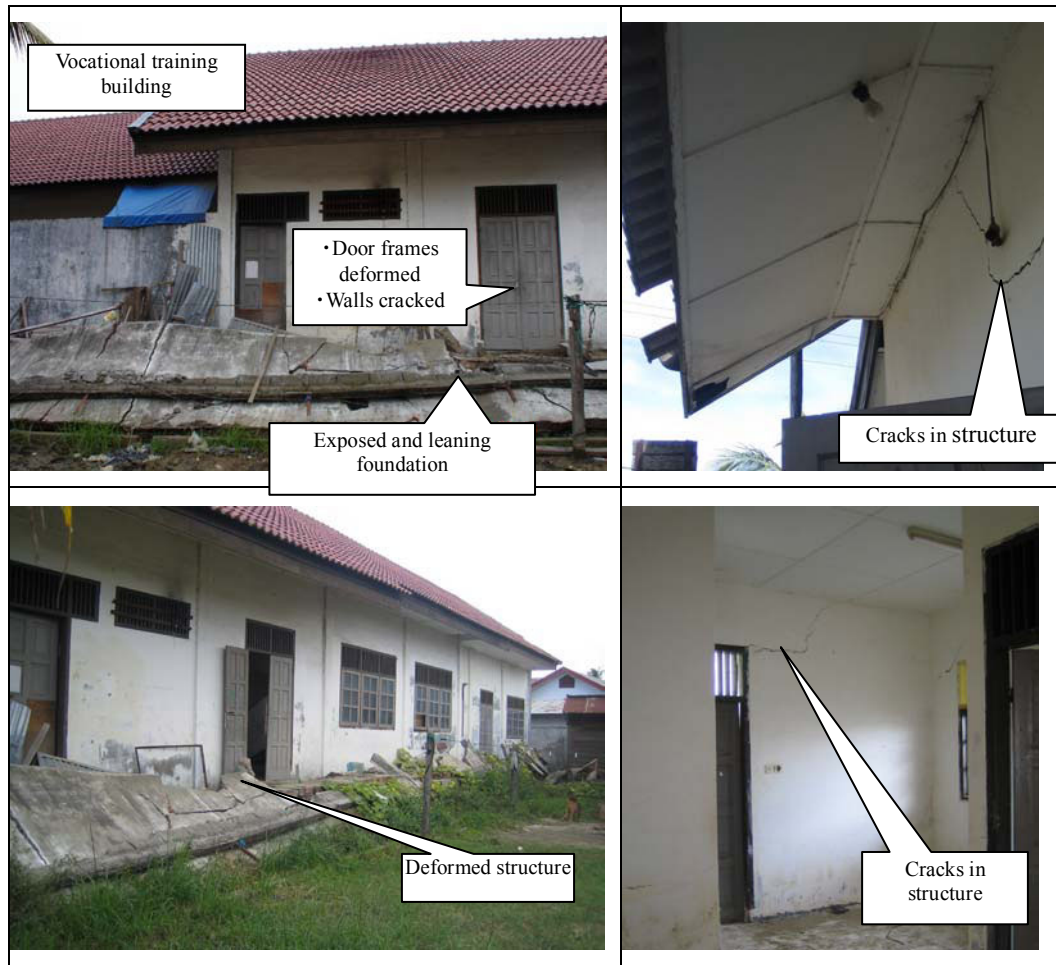
Figure 1.1.11 Damage Condition of Jroh Naguna Orphanage Vocational Training Building

- ◆ Subsidence of the foundation has triggered structural deformation.
- ◆ The beam, a major structural component, has numerous diagonal cracks significantly impairing its strength.
- ◆ The walls have countless diagonal cracks.
- ◆ The ceilings are sagging severely.
- ◆ Strain on the building has resulted in damage to and deformation of the windows and other fixtures, making these parts irreparable.
- ◆ There is damage throughout the building, including the foundation, and the safety of this building most likely cannot be ensured by performing repair work alone as shown Figure 1.1.11.
