REPORT ON SOIL ENRICHMENT FOR SOIL EROSION CONTROL

**SARAKATA HYDROPOWER ENVIRONMENTAL MONITORING AND
REHABILITATION**

REPORT ON SLOPE STABILIZATION FOR LAND SLIDES AND LAND CRACKS CONTROL

SLOPE STABILIZATION WORKS FOR SARAKATA HYDRO

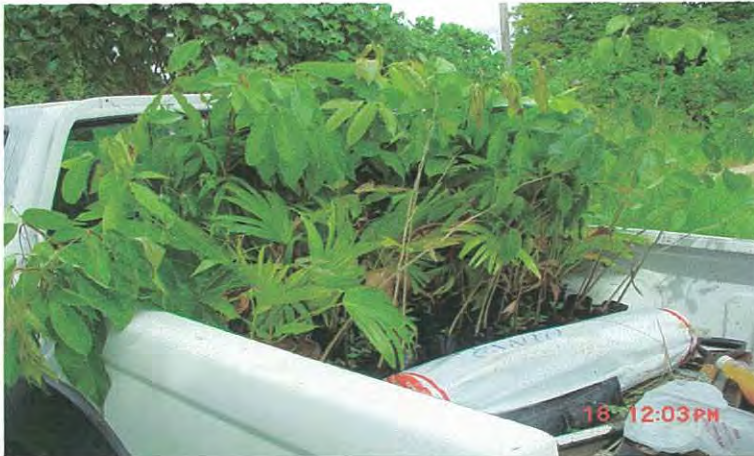
Transporting seedlings to site

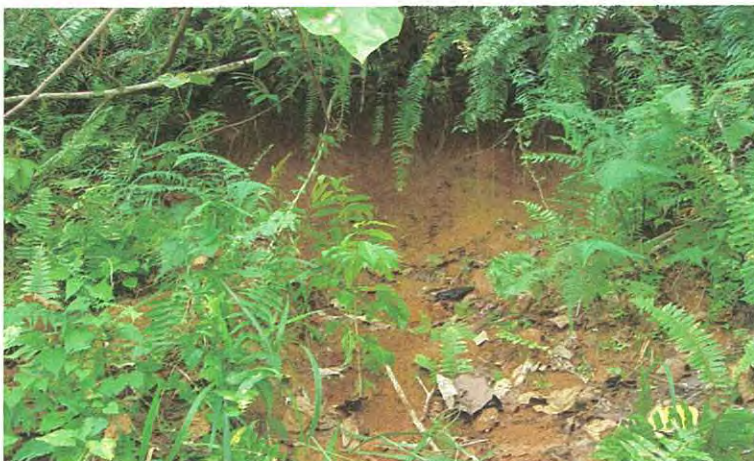
Mahogany and Natora planted at the landslide site

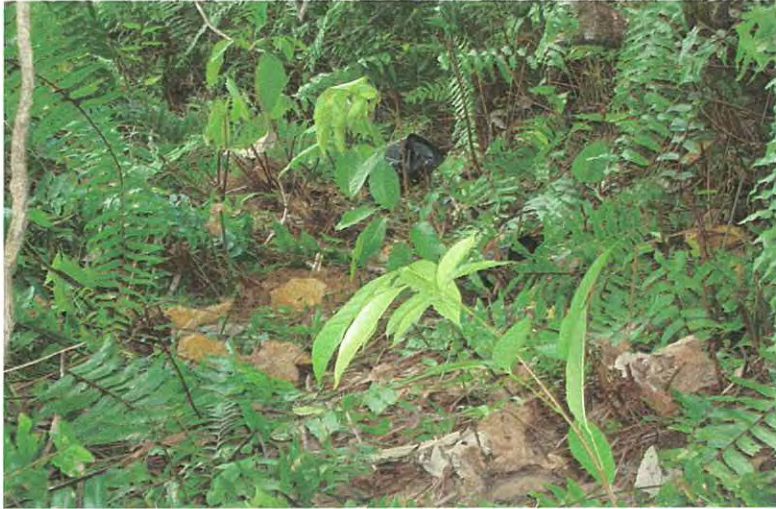
Mahogany seedlings

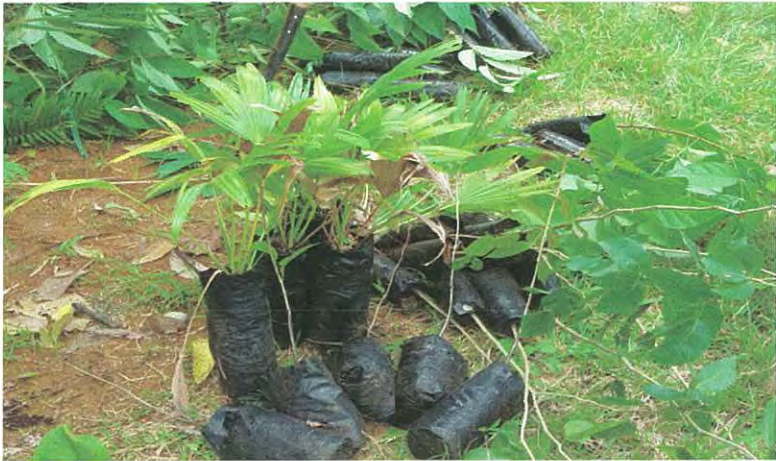
Palm seedlings planted at the base of the man-made cliff

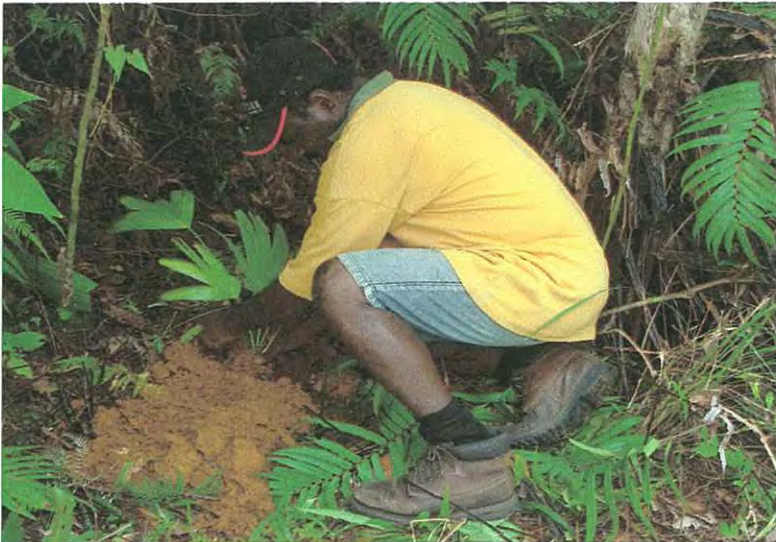
Construction of soil entrapment

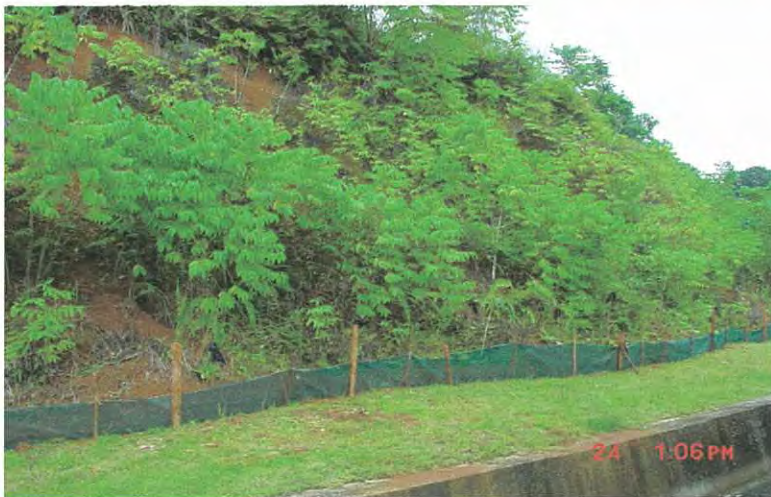
Exposed areas still to be planted with Vetiva grass (Vetiva not found around Luganville)

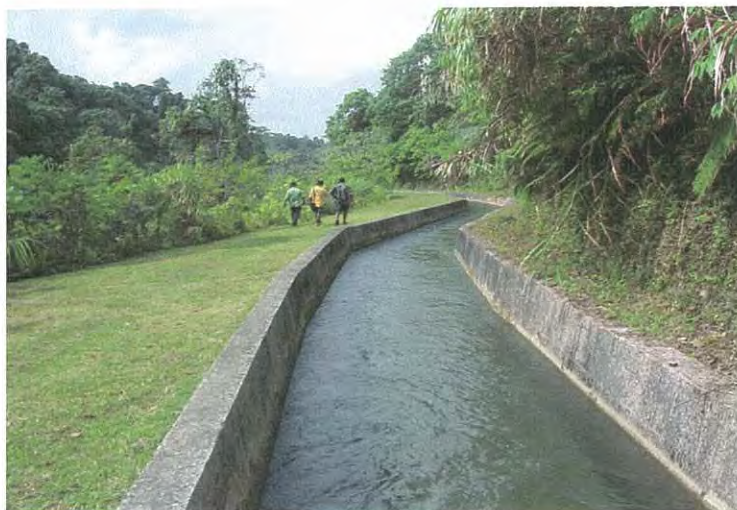
The channel is 2.5 meters wide and 1.6 meters deep and 800 meters long. The structure is constructed along a cut embankment.

The structure itself has no defects and still maintains its original position with the intake of water for the last 10 years.

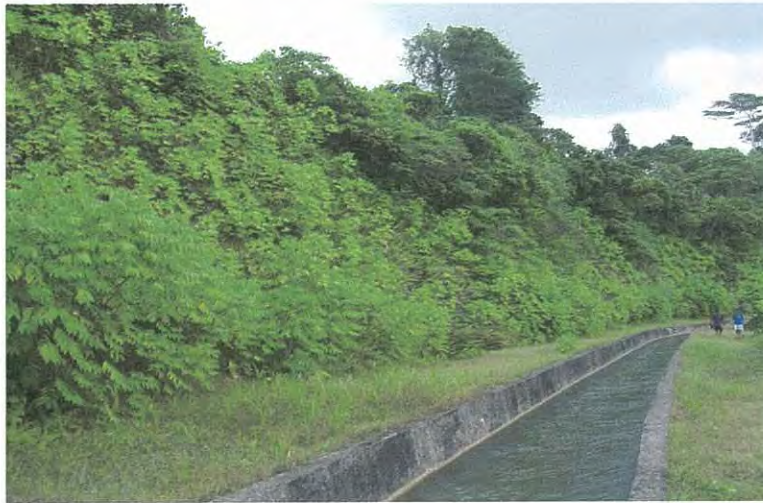
From the intake dam to the head tank the slope has had natural vegetation overgrown on its surface. This has therefore made the cut slope rigid and by visual inspection the slope has no defects or signs of land slides.

The landward embankment should also be observed monthly to indicate the possibility of land slides or defects.

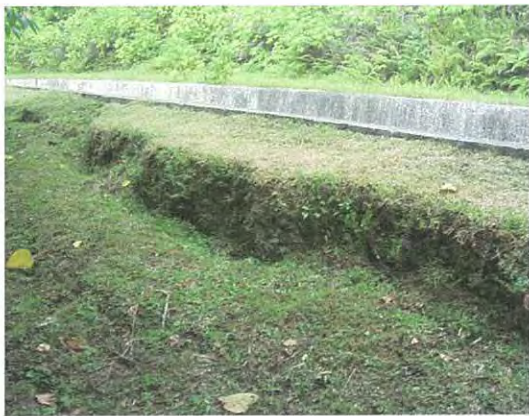
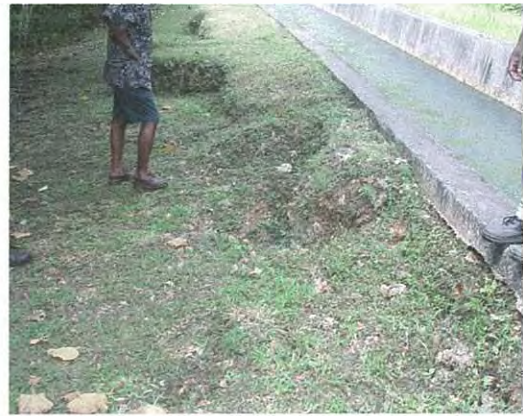
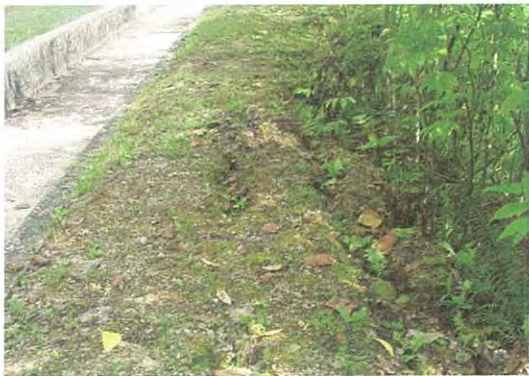
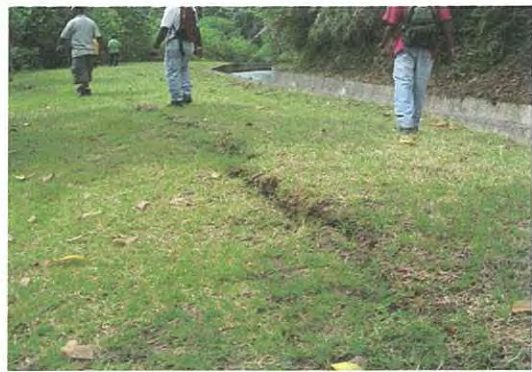
This is where defects or landslides is visible. The following was observed:

- 1 Longitudinal cracks.
- 2 Landslides occurring on various sections along the cut slope. The length of the deteriorated section is about 400 meters.

- 1 During construction the slope was not stabilized. The weight of the growing vegetation might have caused the land to slide down hill.

- 2 Run-off from rain causes surface erosion and contributes to the land de-stabilization causing it to slide downwards.
- 3 There might be cracks on the river Channel therefore water escaping from the channel and contributing to the landslides.

The damages indicate that this area has become unstable and may lead to the collapse of the structure. The situation may worsen if water is allowed to seep in the cracks.

Clean up the area and fill cracks and depressions with soil. Cover the whole longitudinal area with a damp proof course [black plastic].

- 1 Clear the whole river side slope. Construct retaining reinforced wall or gabion basket massive structure which take the form of a wall stepped on the external face along the river edge and top off or filled with top soil. Reno mattresses to face the upper part of the embankment.
- 2 Drive sheet piles along the entire length and 1 meter away from the edge of the canal. Sheet piles should take a maximum depth of between 40 to 50 meters.

For the time being recommendation of the immediate actions should be carried out. Excavations on land slide areas or where cracks are visible should be done so that the channel wall can be surveyed to indicate crack visibility. Once identified sealing of these cracks must be done to stop outflow of the water.
