**SOLOMON ISLANDS WATER AUTHORITY**

**THE STUDY FOR  
REHABILITATION AND IMPROVEMENT  
OF  
SOLOMON ISLANDS WATER AUTHORITY'S  
WATER SUPPLY AND SEWERAGE SYSTEMS**

**FINAL REPORT  
SUMMARY**

**JUNE 2006**

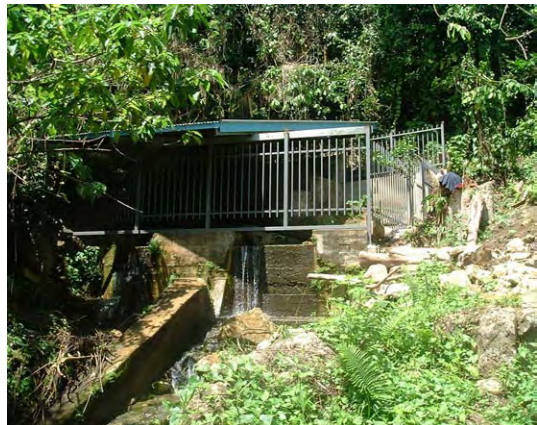
<p>Situation of Konglai Spring in Dec. 2007. Discharge rate from the spring has been reduced since Nov. 2006 as half as the normal condition. Almost all the water is being taken by SIWA results in little over-flow.</p>	<p>Situation of hills in south of Honiara Honiara Reef-limestone is in the front and Honiara beds is in the back. Mbonehi limestone is distributed in the mountains behind hills.</p>

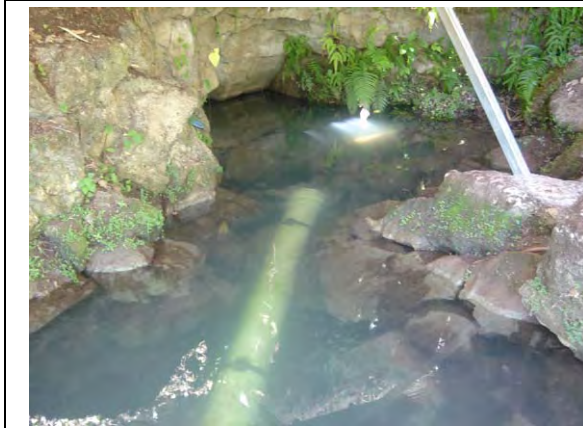
Water intake point of Konglai Spring. This spring is the main water source for Honiara covering 50% of distribution volume. However, the distribution volume is reduced to less than 40% due to the blockage occurred in October 2005.

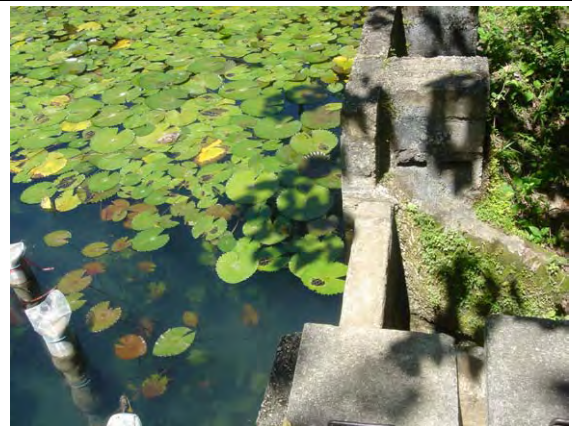
Condition of water intake point and weir of Rove Spring. Water weed can be seen and water quality is acceptable.

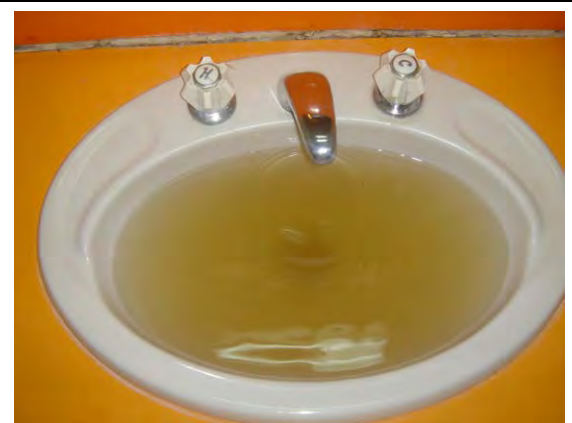
Tap water shows high turbidity for a few days after heavy rain, which affects the daily life of the residents.

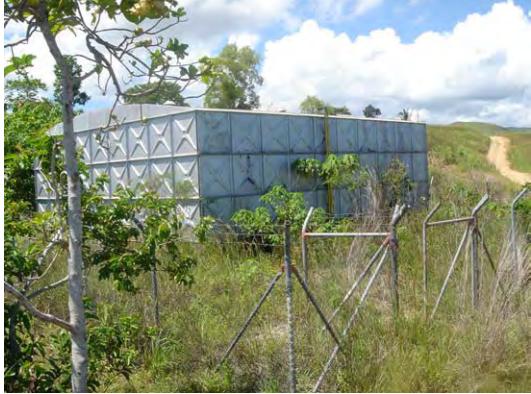
<p>Tasahe Reservoir. Water is transferred from Konglai Spring to this reservoir by pumping.</p>	<p>Titinge Reservoir. Water transferred by pumping from Konglai Spring to Tasahe Reservoir is further transferred to this reservoir. This reservoir is not in use at present due to large leakage.</p>

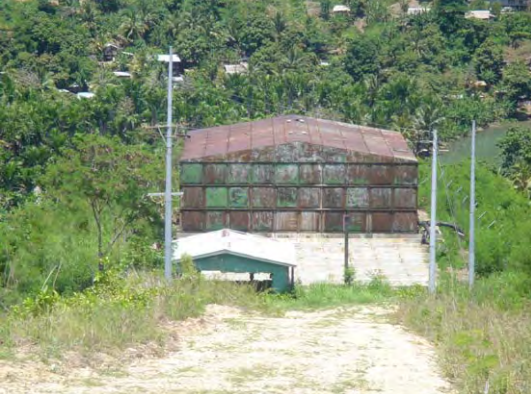
<p>Skyline Reservoir. Water is transferred from Konglai Spring and Mataniko Borefield to this reservoir. The reservoir at the right hand side was constructed in 1998 by the Japan's grant aid.</p>	<p>Low West Kolaa Reservoir. This reservoir is not in use due to deterioration by usage over service life. One of the two reservoirs was demolished for replacement.</p>

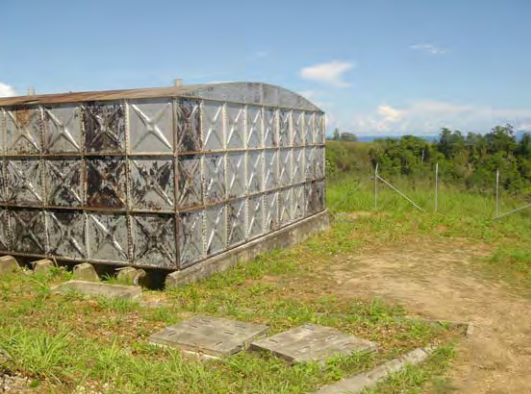
<p>Panatina Reservoir. Water source of this reservoir is Panatina Borefield which was constructed under the Japan's grant aid project in 1998.</p>	<p>White River Reservoir. Old reservoir is not in use at present due to deterioration by usage over service life. New reservoir was constructed under the Japan's grant aid project.</p>

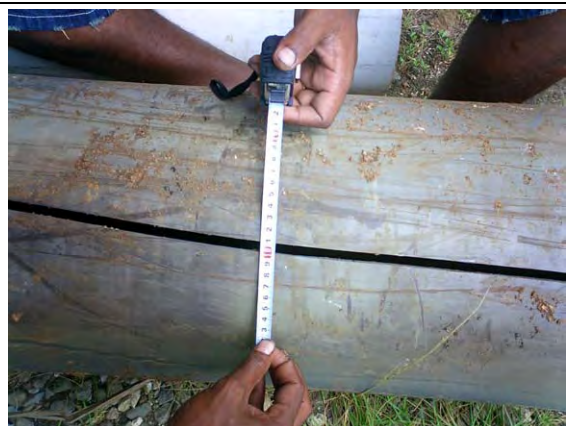
On the water distribution main (diameter of 300mm, PVC pipe), large leakage may occur through large crack on the pipe.
