**SOLOMON ISLANDS WATER AUTHORITY**

**THE STUDY FOR  
REHABILITATION AND IMPROVEMENT  
OF  
SOLOMON ISLANDS WATER AUTHORITY'S  
WATER SUPPLY AND SEWERAGE SYSTEMS**

**FINAL REPORT  
MAIN REPORT**

**JUNE 2006**

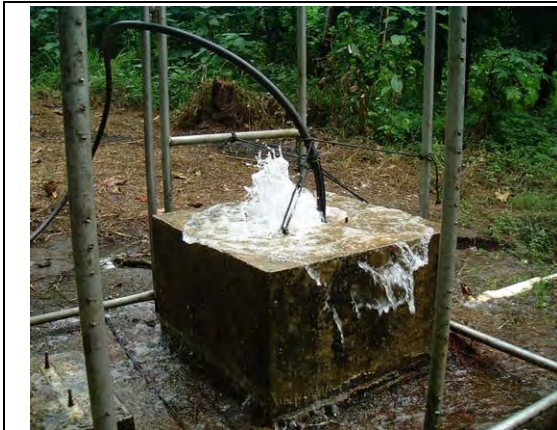
Situation of borehole washing in White river area. Several boreholes were washed to recover production capacity in the Study.

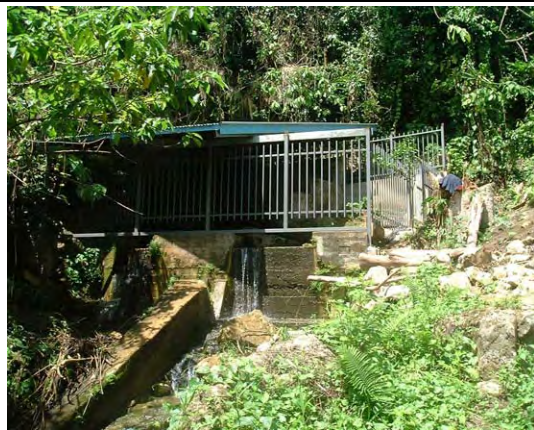
Situation of Konglai Spring in Dec. 2007. Discharge rate from the spring has been reduced since Nov. 2006 as half as the normal condition. Almost all the water is being taken by SIWA results in little over-flow.

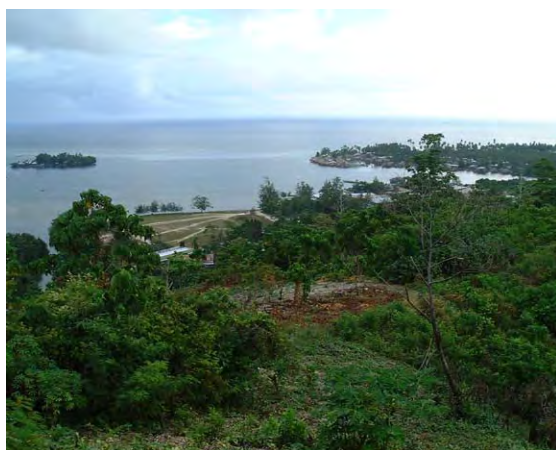
Hill behind Auki town-area. Excellent aquifer by limestone is distributed in this area. Two new boreholes should be developed to meet water demand in 2010.

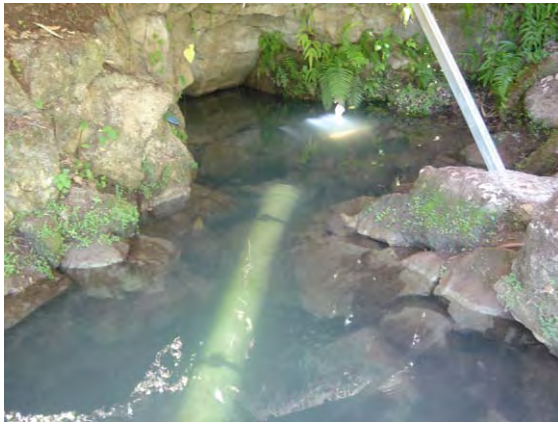
Water intake point of Konglai Spring. This spring is the main water source for Honiara covering 50% of distribution volume. However, the distribution volume is reduced to less than 40% due to the blockage occurred in October 2005.

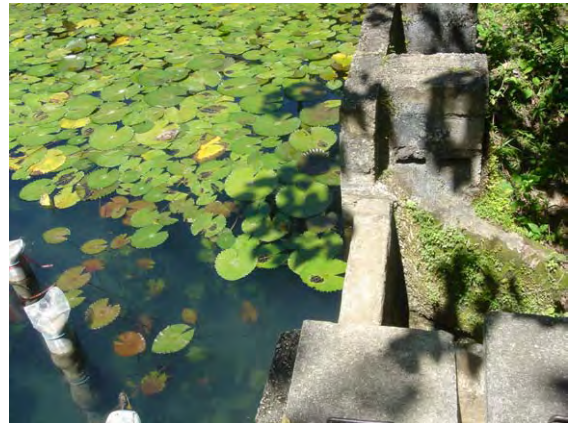
Condition of water intake point and weir of Rove Spring. Water weed can be seen and water quality is acceptable.

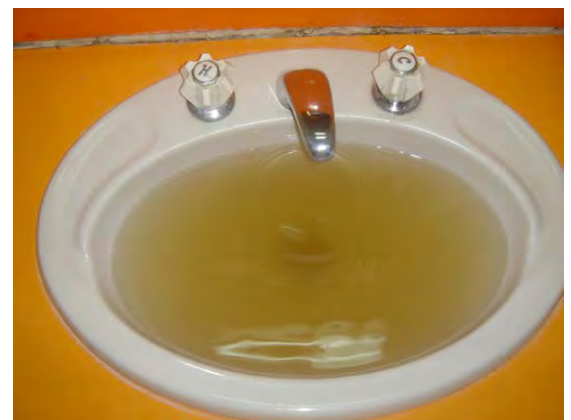
Tap water shows high turbidity for a few days after heavy rain, which affects the daily life of the residents.

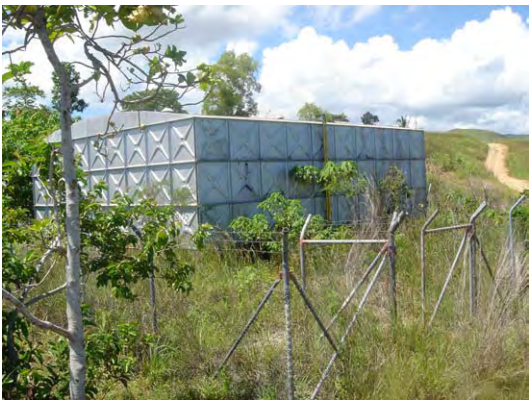
<p>Tasahe Reservoir. Water is transferred from Konglai Spring to this reservoir by pumping.</p>	<p>Titinge Reservoir. Water transferred by pumping from Konglai Spring to Tasahe Reservoir is further transferred to this reservoir. This reservoir is not in use at present due to large leakage.</p>

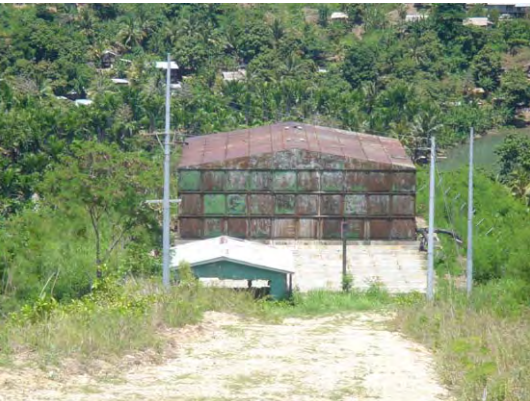
<p>Skyline Reservoir. Water is transferred from Konglai Spring and Mataniko Borefield to this reservoir. The reservoir at the right hand side was constructed in 1998 by the Japan's grant aid.</p>	<p>Low West Kolaa Reservoir. This reservoir is not in use due to deterioration by usage over service life. One of the two reservoirs was demolished for replacement.</p>

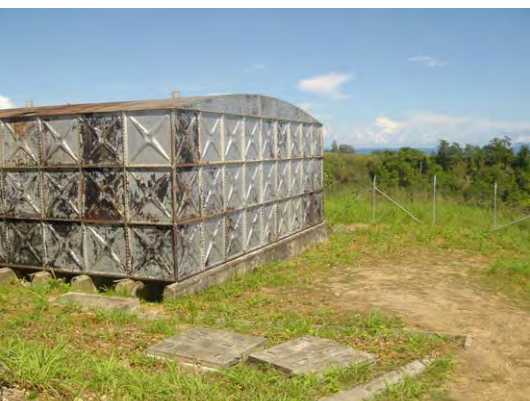
<p>Panatina Reservoir. Water source of this reservoir is Panatina Borefield which was constructed under the Japan's grant aid project in 1998.</p>	<p>White River Reservoir. Old reservoir is not in use at present due to deterioration by usage over service life. New reservoir was constructed under the Japan's grant aid project.</p>

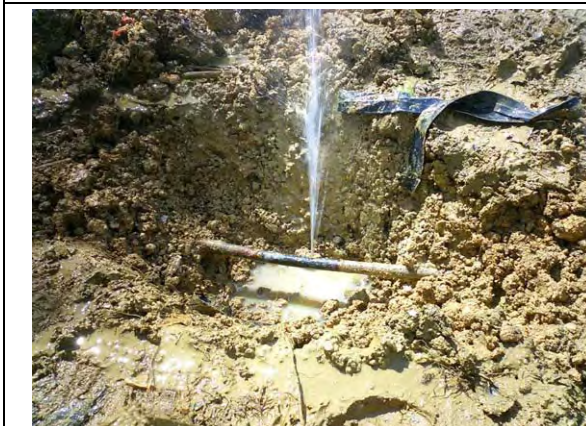
Leakage from water distribution branch pipeline (diameter of 50mm, galvanized iron pipe). Water is being spouted from the pipe.
