S-3-1-6 Observation of Leakage Conditions

Outline of Leakage Situations

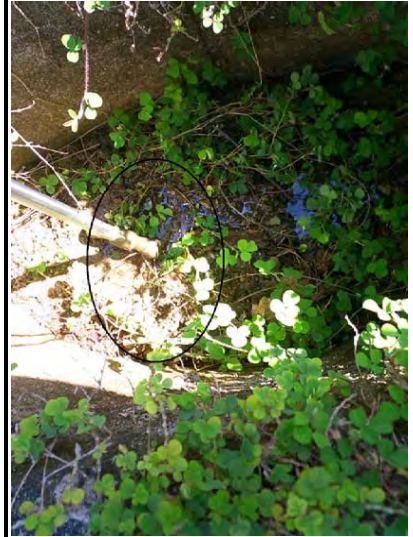
Date of Survey:	21-Jun-05	
Survey No.:	1 Stop Cock	
System name:	W.R.P, W.R.P, Rove, Mataniko-P, JICA-B, Kombito, Kombito-G, Panatina, Others	
Address:	Orion company NGOSSI	
Main Line	CIP, GP, PVC, POL, Others()	Position Condition Pipe, Connection, Valve, Others Hole, Crack, Brake, Pack kin, Loose, Others
Diameter	"or mm	Cause Corrosion, Water-pressure, Wrong Construction, Traffic load, Others
Service Line	CIP, GP, PVC, POL, Others()	Position Condition Pipe, Connection, Valve, Others Hole, Crack, Brake, Pack kin, Loose, Others
Diameter	1/2 "or 13 mm	Cause Corrosion, Water-pressure, Deterioration, Wrong Construction, Traffic load, Others
Depth	15 cm	Ground Asphalt, Concrete, Gravel, Grass, Others
Leakage Size	Large, Medium, Small	Leakage Quantity (Estimation) 0.5L/min or 0.03 m ³ /h

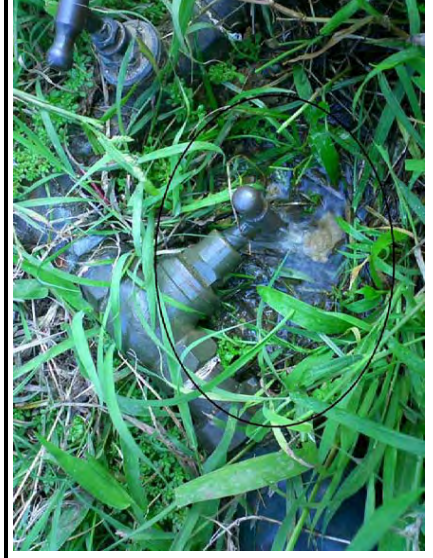
Date of Survey:	21-Jun-05	
Survey No.:	2 Stop Cock	
System name:	W.R.P, W.R.P, Rove, Mataniko-P, JICA-B, Kombito, Kombito-G, Panatina, Others	
Address:	Mr. David Quan H/No. 41 NGOSSI	
Main Line	CIP, GP, PVC, POL, Others()	Position Condition Pipe, Connection, Valve, Others Hole, Crack, Brake, Pack kin, Loose, Others
Diameter	"or mm	Cause Corrosion, Water-pressure, Wrong Construction, Traffic load, Others
Service Line	CIP, GP, PVC, POL, Others()	Position Condition Pipe, Connection, Valve, Others Hole, Crack, Brake, Pack kin, Loose, Others
Diameter	1/2 "or 13 mm	Cause Corrosion, Water-pressure, Deterioration, Wrong Construction, Traffic load, Others
Depth	10 cm	Ground Asphalt, Concrete, Gravel, Grass, Others
Leakage Size	Large, Medium, Small	Leakage Quantity (Measured) 5L/min or 0.3 m ³ /h

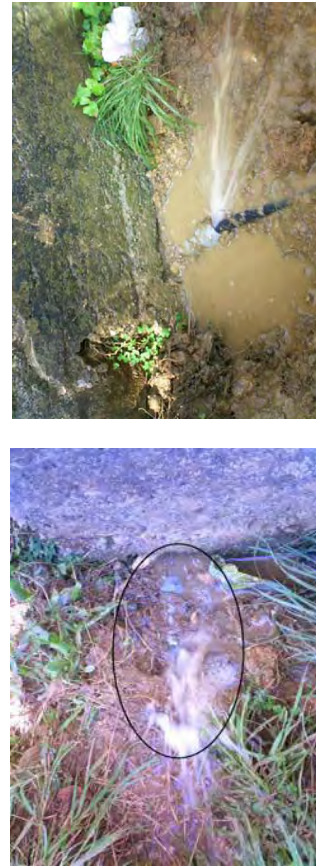
Date of Survey:	21-Jun-05	
Survey No.:	3 Service Pipe	
System name:	W.R.P., W.R.P., Rove, Mataniko-P, JICA-B, Kombito, Kombito-G, Panatina, Others	
Address:	Mr. Luke Eta H/No.25 NGOSSI	
Main Line	CIP, GP, PVC, POL, Others()	Position Pipe, Connection, Valve, Others
Diameter	" or mm	Condition Hole, Crack, Brake, Pack kin, Loose, Others
Service Line	CIP, GP, PVC, POL, Others()	Cause Corrosion, Water-pressure, Wrong Construction, Traffic load, Others
Diameter	1/2 " or 13 mm	Position Pipe, Connection, Valve, Others
Depth	30 cm	Condition Hole, Crack, Brake, Pack kin, Loose, Others
Leakage Size	Large, Medium, Small	Cause Corrosion, Water-pressure, Deterioration Wrong Construction, Traffic load, Others
		Ground Asphalt, Concrete, Gravel, Grass, Others
		Leakage Quantity (Measured)
		20L/min or 1.2 m ³ /h

Connection

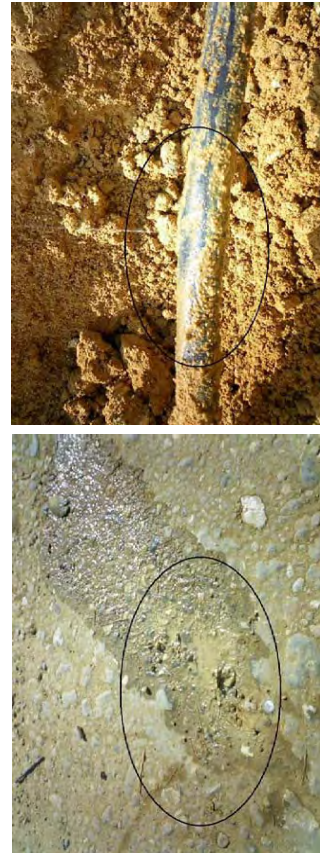
Date of Survey:	21-Jun-05	
Survey No.:	4 Service Pipe	
System name:	W.R.P., W.R.P., Rove, Mataniko-P, JICA-B, Kombito, Kombito-G, Panatina, Others	
Address:	Opposite Welstar Shop NGOSSI	
Main Line	CIP, GP, PVC, POL, Others()	Position Pipe, Connection, Valve, Others
Diameter	" or mm	Condition Hole, Crack, Brake, Pack kin, Loose, Others
Service Line	CIP, GP, PVC, POL, Others()	Cause Corrosion, Water-pressure, Wrong Construction, Traffic load, Others
Diameter	1/2 " or 13 mm	Position Pipe, Connection, Valve, Others
Depth	20 cm	Condition Hole, Crack, Brake, Pack kin, Loose, Others
Leakage Size	Large, Medium, Small	Cause Corrosion, Water-pressure, Deterioration Wrong Construction, Traffic load, Others
		Ground Asphalt, Concrete, Gravel, Grass, Others
		Leakage Quantity (Measured)
		1L/min or 0.06 m ³ /h

Crack by stone

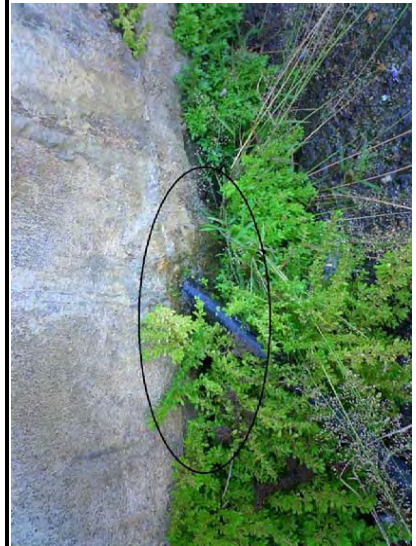
Date of Survey:	21-Jun-05	
Survey No.:	5	
System name:	W.R.P, W.R.P, Rove, Mataniko-P, JICA-B, Kombito, Kombito-G, Panatina, Others	
Address:	Mr. Antony Makabo NGOSSI	
Main Line	CIP, GP, PVC, POL, Others()	Position Condition Pipe, Connection, Valve, Others Hole, Crack, Brake, Pack kin, Loose, Others
Diameter	"or mm	Cause Corrosion, Water-pressure, Wrong Construction, Traffic load, Others
Service Line	CIP, GP, PVC, POL, Others()	Position Condition Pipe, Connection, Valve, Others Hole, Crack, Brake, Pack kin, Loose, Others
Diameter	1/2 "or 13 mm	Cause Corrosion, Water-pressure, Deterioration Wrong Construction, Traffic load, Others
Depth	20 cm	Ground Asphalt, Concrete, Gravel, Grass, Others
Leakage Size	Large, Middelium, Small	Leakage Ququinty (Estimation) 10L/min or 0.6 m ³ /h

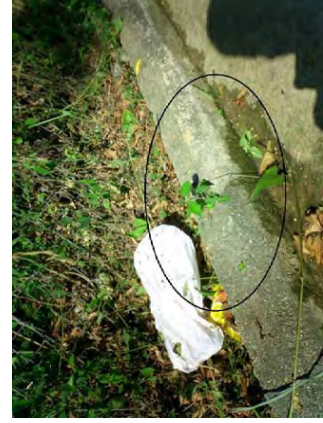
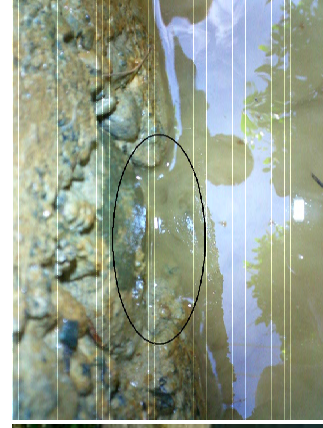
Date of Survey:	21-Jun-05	
Survey No.:	6	
System name:	W.R.P, W.R.P, Rove, Mataniko-P, JICA-B, Kombito, Kombito-G, Panatina, Others	
Address:	Mr. Y. Sato NGOSSI	
Main Line	CIP, GP, PVC, POL, Others()	Position Condition Pipe, Connection, Valve, Others Hole, Crack, Brake, Pack kin, Loose, Others
Diameter	"or mm	Cause Corrosion, Water-pressure, Wrong Construction, Traffic load, Others
Service Line	CIP, GP, PVC, POL, Others()	Position Condition Pipe, Connection, Valve, Others Hole, Crack, Brake, Pack kin, Loose, Others
Diameter	1/2 "or 13 mm	Cause Corrosion, Water-pressure, Deterioration Wrong Construction, Traffic load, Others
Depth	30 cm	Ground Asphalt, Concrete, Gravel, Grass, Others
Leakage Size	Large, Middelium, Small	Leakage Ququinty (Estimation) 10L/min or 0.6 m ³ /h

Under the concrete

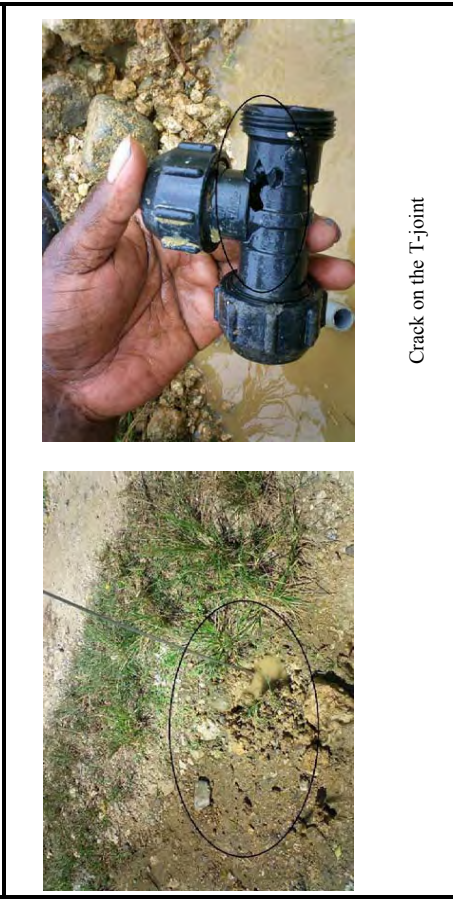
Date of Survey:	21-Jun-05	
Survey No.:	7	
System name:	Service Pipe	
Address:	W.R.P, W.R.P, Rove, Matamiko-P, JICA-B, Kombito, Kombito-G, Panatina, Others	
Main Line	Position Condition	Pipe, Connection, Valve, Others
Diameter	Cause	Hole, Crack, Brake, Pack kin, Loose, Others
Service Line	Position Condition	Corrosion, Water-pressure, Wrong Construction, Traffic load, Others
Diameter	Cause	Pipes, Connection, Valve, Others
Depth	Position Condition	Hole, Crack, Brake, Pack kin, Loose, Others
Leakage Size	Cause	Corrosion, Water-pressure, Deterioration
	Ground	Wrong Construction, Traffic load, Others
	Leakage Quantity (Measured)	20L/min or 1.2 m ³ /h

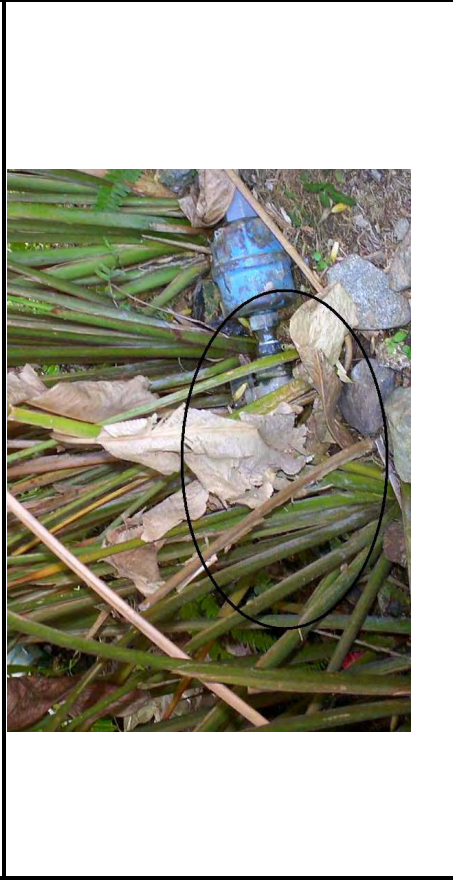
Date of Survey:	21-Jun-05	
Survey No.:	8	
System name:	Joint	
Address:	W.R.P, W.R.P, Rove, Matamiko-P, JICA-B, Kombito, Kombito-G, Panatina, Others	
Main Line	Position Condition	Mr. Akula Alosio Bishop Epale School Teacher's House NGOSSI
Diameter	Cause	Pipe, Connection, Valve, Others
Service Line	Position Condition	Hole, Crack, Brake, Pack kin, Loose, Others
Diameter	Cause	Corrosion, Water-pressure, Wrong Construction, Traffic load, Others
Depth	Position Condition	Pipes, Connection, Valve, Others
Leakage Size	Cause	Hole, Crack, Brake, Pack kin, Loose, Others
	Ground	Corrosion, Water-pressure, Deterioration
	Leakage Quantity (Measured)	Wrong Construction, Traffic load, Others
		Asphalt, Concrete, Gravel, Grass, Others
		0.5L/min or 0.03 m ³ /h

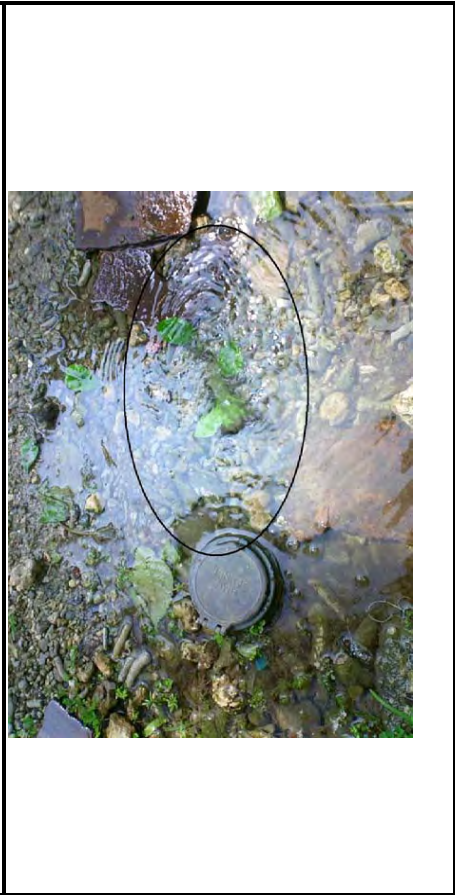
Date of Survey:	22-Jun-05	Stop Cock
Survey No.:	9	
System name:	W.R.G, W.R.P, Rove, Mataniko-P, JICA-B, Kombito, Kombito-G, Panatina, Others	
Address:	Mr. Colin Pitakesa Police m/Qt's H/No, 15 NGOSSI	
Main Line	CIP, GP, PVC, POL, Others()	Position Pipe, Connection, Valve, Others
Diameter	"or mm	Condition Hole, Crack, Brake, Paek kin, Loose, Others
Service Line	CIP, GP, PVC, POL, Others()	Cause Corrosion, Water-pressure, Wrong Construction, Traffic load, Others
Diameter	1/2 "or 13 mm	Position Pipe, Connection, Valve, Others
Depth	15 cm	Condition Hole, Crack, Brake, Paek kin, Loose, Others
Leakage Size	Large, Middium, Small	Cause Corrosion, Water-pressure, Deterioration, Wrong Construction, Traffic load, Others
		Ground Asphalt, Concrete, Gravel, Grass, Others
		Leakage Quantity (Measured) 10L/min or 0.6 m ³ /h

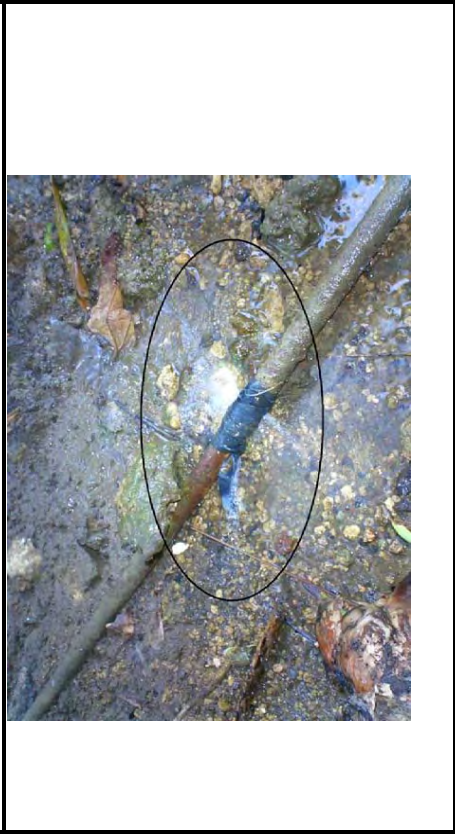
Date of Survey:	22-Jun-05	Service Pipe
Survey No.:	10	
System name:	W.R.G, W.R.P, Rove, Mataniko-P, JICA-B, Kombito, Kombito-G, Panatina, Others	
Address:	Mr. Anderson Marafice M/Qt's H/No, 15 NGOSSI	
Main Line	CIP, GP, PVC, POL, Others()	Position Pipe, Connection, Valve, Others
Diameter	"or mm	Condition Hole, Crack, Brake, Paek kin, Loose, Others
Service Line	CIP, GP, PVC, POL, Others()	Cause Corrosion, Water-pressure, Wrong Construction, Traffic load, Others
Diameter	1/2" or 13 mm	Position Pipe, Connection, Valve, Others
Depth	cm	Condition Hole, Crack, Brake, Paek kin, Loose, Others
Leakage Size	Large, Middium, Small	Cause Corrosion, Water-pressure, Deterioration, Wrong Construction, Traffic load, Others
		Ground Asphalt, Concrete, Gravel, Grass, Others
		Leakage Quantity (Measured) 16L/min or 1.0 m ³ /h

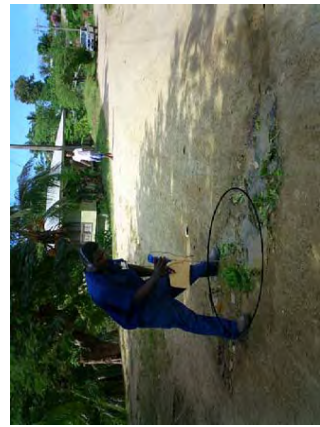
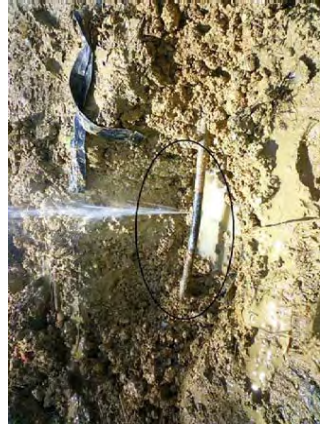
Date of Survey:	21-Jun-05	Service Pipe
Survey No.:	11	
System name:	W.R.D, W.R.P, Rove, Mataniko-P, JICA-B, Kombito, Kombito-G, Panatina, Others	
Address:	Mr. Joseph Puara H/No, PC15 TAVIO	
Main Line	CIP, GP, PVC, POL, Others()	Position Pipe, Connection, Valve, Others
Diameter	"or mm	Condition Hole, Crack, Brake, Pack kin, Looses, Others
Service Line	CIP, GP, PVC, POL, Others()	Cause Corrosion, Water-pressure, Wrong Construction, Traffic load, Others
Diameter	1/2 "or 13 mm	Position Pipe, Connection, Valve, Others
Depth	30 cm	Condition Hole, Crack, Brake, Pack kin, Looses, Others
Leakage Size	Large, <u>Middium</u> , Small	Cause Corrosion, Water-pressure, Deterioration, Wrong Construction, Traffic load, Others
	Leakage Quantity (Measured)	Ground Asphalt, Concrete, Gravel, Grass, Others
		Leakage Quantity (Estimation) 16L/min or 1.0 m ³ /h

After excavation

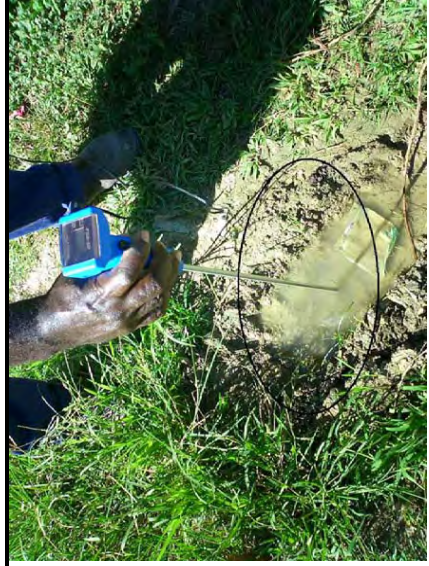
Date of Survey:	21-Jun-05	Joint
Survey No.:	12	
System name:	W.R.D, W.R.P, Rove, Mataniko-P, JICA-B, Kombito, Kombito-G, Panatina, Others	
Address:	Mr. Robert Sisilo H/No, Q993 TINGE	
Main Line	CIP, GP, PVC, POL, Others()	Position Pipe, Connection, Valve, Others
Diameter	"or mm	Condition Hole, Crack, Brake, Pack kin, Looses, Others
Service Line	CIP, GP, PVC, POL, Others()	Cause Corrosion, Water-pressure, Wrong Construction, Traffic load, Others
Diameter	1/2 "or 13 mm	Position Pipe, Connection, Valve, Others
Depth	20 cm	Condition Hole, Crack, Brake, Pack kin, Looses, Others
Leakage Size	Large, <u>Middium</u> , Small	Cause Corrosion, Water-pressure, Deterioration, Wrong Construction, Traffic load, Others
	Leakage Quantity (Estimation)	Ground Asphalt, Concrete, Gravel, Grass, Others
		Leakage Quantity (Estimation) 10L/min or 0.6 m ³ /h

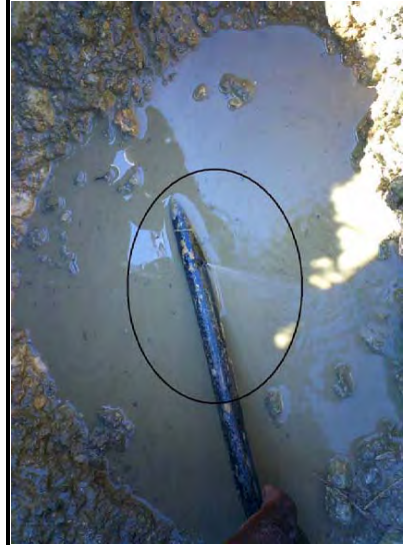
Date of Survey:	21-Jun-05	
Survey No.:	13	
System name:	Service Pipe	
Address:	W.R.P., W.R.P., Rove, Matamiko-P, JICA-B, Kombito, Kombito-G, Panatina, Others Mr. Allen Rahari Police Rove H/Qtr's TINGE	
Main Line	CIP, GP, PVC, POL, Others()	Pipe, Connection, Valve, Others
Diameter	"or mm	Hole, Crack, Brake, Pack kin, Looses, Others
Service Line	CIP, GP, PVC, POL, Others()	Corrosion, Water-pressure, Wrong Construction, Traffic load, Others
Diameter	1/2 "or 13 mm	Pipe, Connection, Valve, Others
Depth	30 cm	Hole, Crack, Brake, Pack kin, Looses, Others
Leakage Size	Large, Middles, Small	Corrosion, Water-pressure, Deterioration Wrong Construction, Traffic load, Others
	Leakage Quantity (Measured)	10L/min or 0.6m ³ /h

Crack by stone

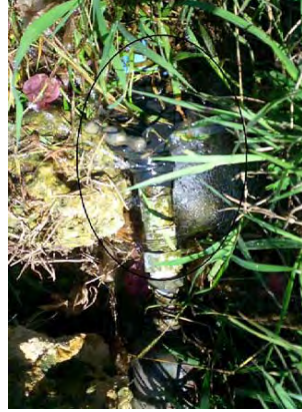
Date of Survey:	21-Jun-05	
Survey No.:	14	
System name:	Stop Cock	
Address:	W.R.P., W.R.P., Rove, Matamiko-P, JICA-B, Kombito, Kombito-G, Panatina, Others Mr. Allen Rahari Police Rove H/Qtr's TINGE	
Main Line	CIP, GP, PVC, POL, Others()	Pipe, Connection, Valve, Others
Diameter	"or mm	Hole, Crack, Brake, Pack kin, Looses, Others
Service Line	CIP, GP, PVC, POL, Others()	Corrosion, Water-pressure, Wrong Construction, Traffic load, Others
Diameter	1/2 "or 13 mm	Pipe, Connection, Valve, Others
Depth	20 cm	Hole, Crack, Brake, Pack kin, Looses, Others
Leakage Size	Large, Middles, Small	Corrosion, Water-pressure, Deterioration Wrong Construction, Traffic load, Others
	Leakage Quantity (Measured)	25L/min or 1.5m ³ /h

Crack

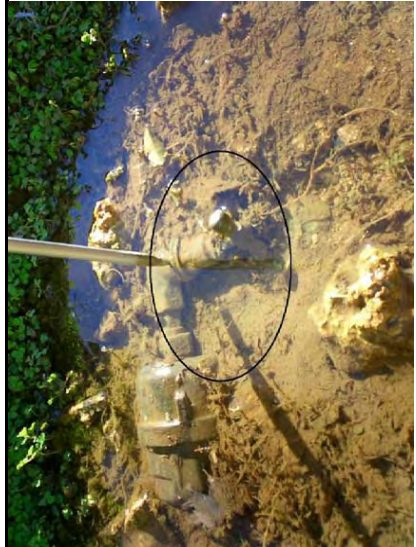
Date of Survey:	21-Jun-05	
Survey No.:	15	
System name:	Stop Cock	
Address:	W.R.P, W.R.P, Rove, Mataniko-P, JICA-B, Kombito, Kombito-G, Panatina, Others	
Main Line	CIP, GP, PVC, POL, Others()	Mr, Tony Misions police Rove TINGE
Diameter	" or mm	Pipe, Connection, Valve, Others
Service Line	CIP, GP, PVC, POL, Others()	Hole, Crack, Brake, Pack kin, Looes, Others
Diameter	1/2 " or 13 mm	Corrosion, Water-pressure, WrongConstruction, Traffic load, Others
Depth	20 cm	Pipe, Connection, Valve, Others
Leakage Size	Large, Medium, Small	Hole, Crack, Brake, Pack kin, Looes, Others
		Corrosion, Water-pressure, WrongConstruction, Traffic load, Others
		Pipe, Connection, Valve, Others
		Hole, Crack, Brake, Pack kin, Looes, Others
		Corrosion, Water-pressure, Deterioration
		WrongConstruction, Traffic load, Others
		Asphalt, Concrete, Gravel, Grass, Others
		Leakage Quantity (Estimation)

1.6L/min or 0.1 m ³ /h

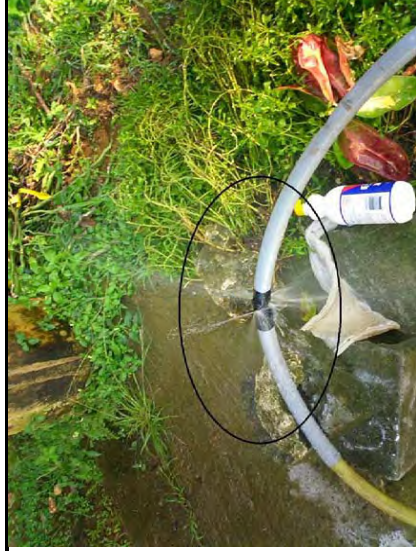
Date of Survey:	21-Jun-05	
Survey No.:	16	
System name:	Service Pipe	
Address:	W.R.P, W.R.P, Rove, Mataniko-P, JICA-B, Kombito, Kombito-G, Panatina, Others	
Main Line	CIP, GP, PVC, POL, Others()	Mr, Johnson Siapy Police Rove TINGE
Diameter	" or mm	Pipe, Connection, Valve, Others
Service Line	CIP, GP, PVC, POL, Others()	Hole, Crack, Brake, Pack kin, Looes, Others
Diameter	1/2 " or 13 mm	Corrosion, Water-pressure, WrongConstruction, Traffic load, Others
Depth	cm	Pipe, Connection, Valve, Others
Leakage Size	Large, Medium, Small	Hole, Crack, Brake, Pack kin, Looes, Others
		Corrosion, Water-pressure, WrongConstruction, Traffic load, Others
		Pipe, Connection, Valve, Others
		Hole, Crack, Brake, Pack kin, Looes, Others
		Corrosion, Water-pressure, Deterioration
		WrongConstruction, Traffic load, Others
		Asphalt, Concrete, Gravel, Grass, Others
		Leakage Quantity (Measured)
		10L/min or 0.6 m ³ /h

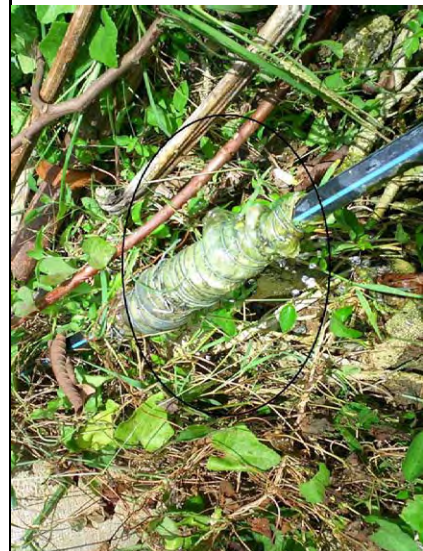
Date of Survey:	21-Jun-05	
Survey No.:	17	
System name:	W.R.C, W.R.P, Rove, Matamiko-P, JICA-B, Kombito, Kombito-G, Panatina, Others	
Address:	Mr, Beneth Roau Police Rove, TINGE	
Main Line	CIP, GP, PVC, POL, Others()	Position Condition Pipe, Connection, Valve, Others Hole, Crack, Brake, Pack kin, Looes, Others
Diameter	"or mm	Cause Corrosion, Water-pressure, Wrong Constructuon, Traffic load, Others
Service Line	CIP, GP, PVC, POL, Others()	Position Condition Pipe, Connection, Valve, Others Hole, Crack, Brake, Pack kin, Looes, Others
Diameter	1" or 25 mm	Cause Corrosion, Water-pressure, Deterioration Wrong Constructuon, Traffic load, Others
Depth	cm	Ground Asphalt, Concrete, Gravel, Grass, Others
Leakage Size	Large, Medium, Small	Leakage QuANTITY (Measured) 3L/min or 0.2 m ³ /h

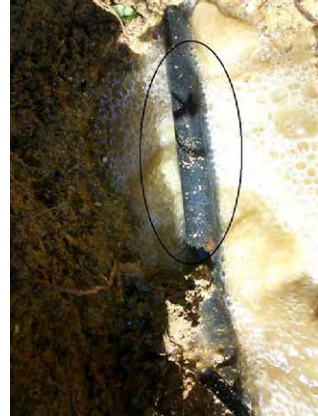
Date of Survey:	21-Jun-05	
Survey No.:	18	
System name:	W.R.C, W.R.P, Rove, Matamiko-P, JICA-B, Kombito, Kombito-G, Panatina, Others	
Address:	Mr, Laiza Rodi G, province GC7 TINGE	
Main Line	CIP, GP, PVC, POL, Others()	Position Condition Pipe, Connection, Valve, Others Hole, Crack, Brake, Pack kin, Looes, Others
Diameter	"or mm	Cause Corrosion, Water-pressure, Wrong Constructuon, Traffic load, Others
Service Line	CIP, GP, PVC, POL, Others()	Position Condition Pipe, Connection, Valve, Others Hole, Crack, Brake, Pack kin, Looes, Others
Diameter	3/4" or 20 mm	Cause Corrosion, Water-pressure, Deterioration Wrong Constructuon, Traffic load, Others
Depth	30 cm	Ground Asphalt, Concrete, Gravel, Grass, Others
Leakage Size	Large, Medium, Small	Leakage QuANTITY (Measured) 33L/min or 2.0m ³ /h

crack on the pipe

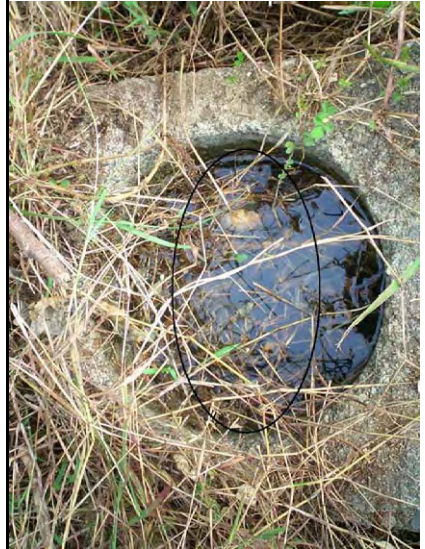
Date of Survey:	22-Jun-05	
Survey No.:	19 Valve	
System name:	W.R.P, W.R.P, Rove, Mataniko-P, JICA-B, Kombito, Kombito-G, Panatina, Others	
Address:	Redio Technich Neer High Tank TAVIO	
Main Line	CIP, GP, PVC, POL, Others()	Position Condition
Diameter	" or mm	Pipe, Connection, Valve, Others Hole, Crack, Brake, Pack kin, Looses, Others
Service Line	CIP, GP, PVC, POL, Others()	Cause Position Condition
Diameter	1/2 " or 13 mm	Corrosion, Water-pressure, Deterioration Wrong Construction, Traffic load, Others
Depth	50 cm	Ground
Leakage Size	Large, Middium, Small	Leakage Quantity (Estimation) 10L/min or 0.6 m ³ /h

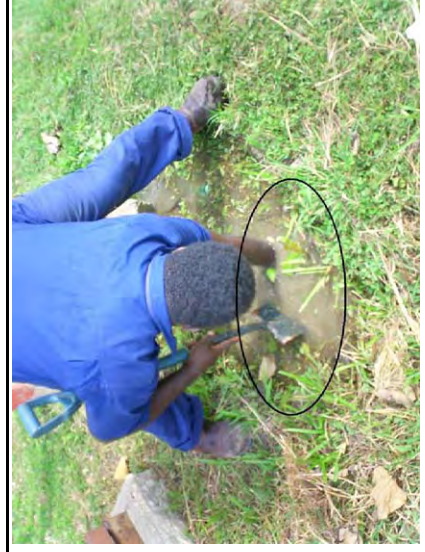
Date of Survey:	22-Jun-05	
Survey No.:	20 Valve	
System name:	W.R.P, W.R.P, Rove, Mataniko-P, JICA-B, Kombito, Kombito-G, Panatina, Others	
Address:	Redio Technich Neer High Tank TAVIO	
Main Line	CIP, GP, PVC, POL, Others()	Position Condition
Diameter	" or mm	Pipe, Connection, Valve, Others Hole, Crack, Brake, Pack kin, Looses, Others
Service Line	CIP, GP, PVC, POL, Others()	Cause Position Condition
Diameter	1/2 " or 13 mm	Corrosion, Water-pressure, Deterioration Wrong Construction, Traffic load, Others
Depth	50 cm	Ground
Leakage Size	Large, Middium, Small	Leakage Quantity (Measured) 16L/min or 1.0 m ³ /h
