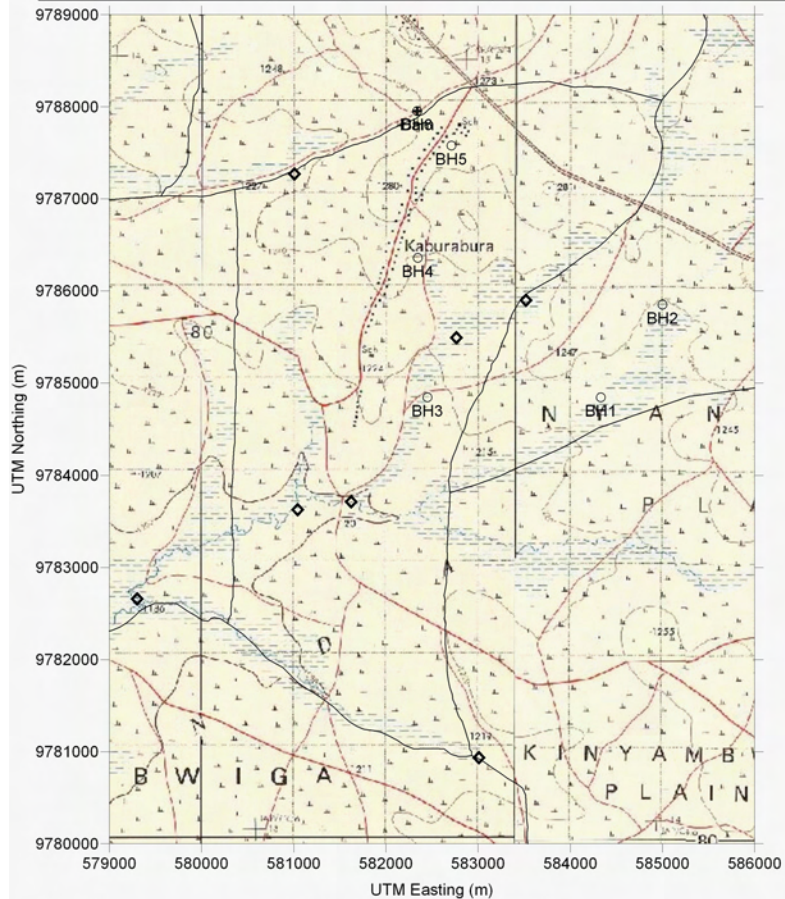
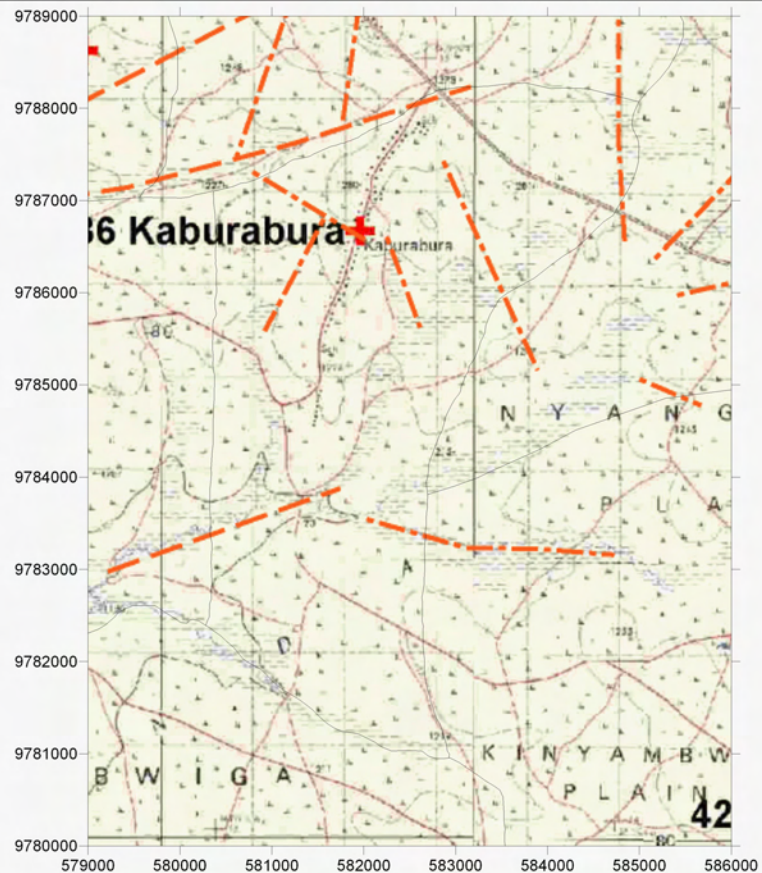
BH2	585000	9785850	Same valley with BH1. Upper portion. Mbuga clay and quartz rich	C	Req. RS	
														BH3	582450	9784844	At the center of wide valley with trace lineament.	C	Road construction required. Req. RS	
														BH4	582347	9786358	Upper side of the same valley of BH3.	B	Road construction required. Req. RS	
														BH5	582709	9787580	At the hilltop. Close of the village center. Flatland.	C	Req. RS	
														BH6	582339	9787954	Flatland. Surrounded by small hills. No depression. Side of the dam.	C	Req. RS

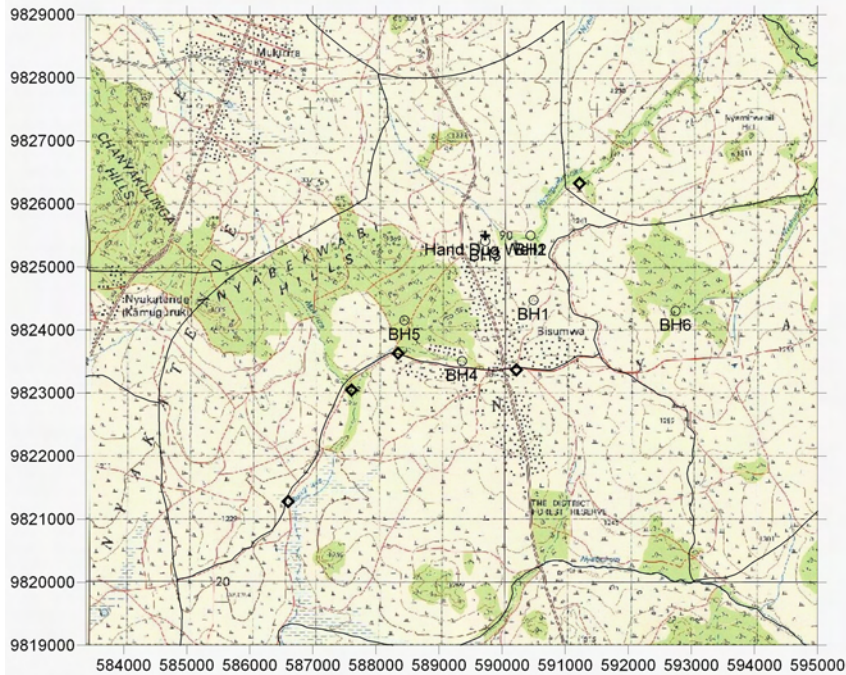
Groundwater Development Plan

BH3	589732	9825408	At the valley. Granite outcrops (medium grained) distribute at the side of inserberg.		A	
																BH4	589363	9823506	Upper portion of wide valley. On the minor lineament. Weathered granite at the hillside.		B	Road rehabilitation required.
																BH5	588448	9824152	On the clear lineament. Between two granite inserberg.		A	
																BH6	592750	9824300	Wide valley. On the trace lineament.		B	Road construction required.

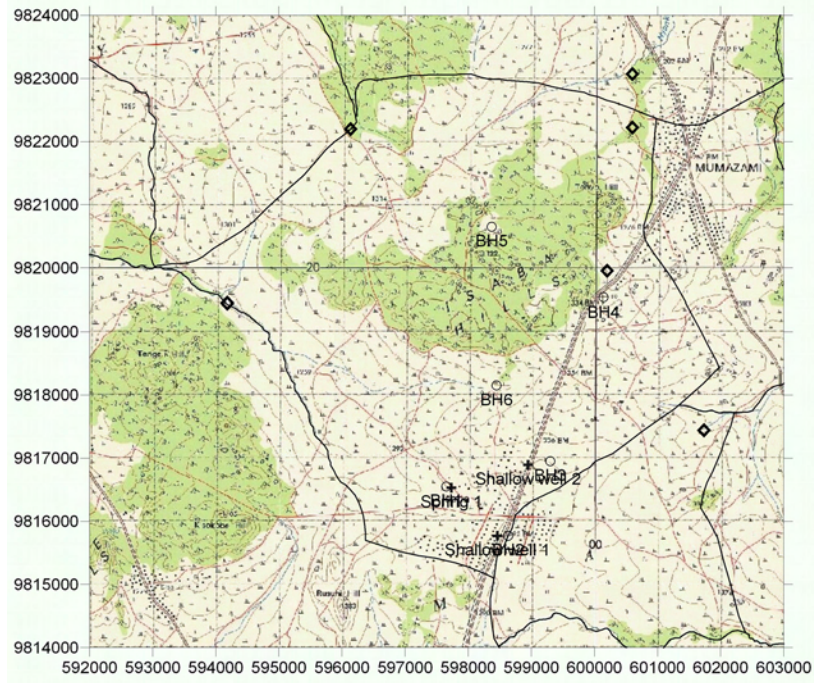
Groundwater Development Plan

Shallow well 1	598464	9815770	yes	no	HESAWA well. Sittely salty. Discharge is small in dry season.	BH2	598632	9815770	At the center of a valley. Some water pond exist. Laterite outcrops at the side of the hill.	B	Road rehabilitation required. Req. RS	
								Shallow well 2	598949	9816892	yes	yes	HESAWA well. No water in the dry season.	BH3	599300	9816950	At the upper portion of a valley. Under a spring consist of granitic	B	Road rehabilitation required. Req. RS	
														BH4	600146	9819536	Surrounded by granite inseberg. The valley with small depression.	A		
														BH5	598371	9820650	Surrounded by granite inseberg. The valley with small depression.	A	Road construction required.	
														BH6	598450	9818150	At a valley center on the clear lineament. Granite inseberg distributes along the valley side.	A	Road construction required.
