Groundwater Development Plan

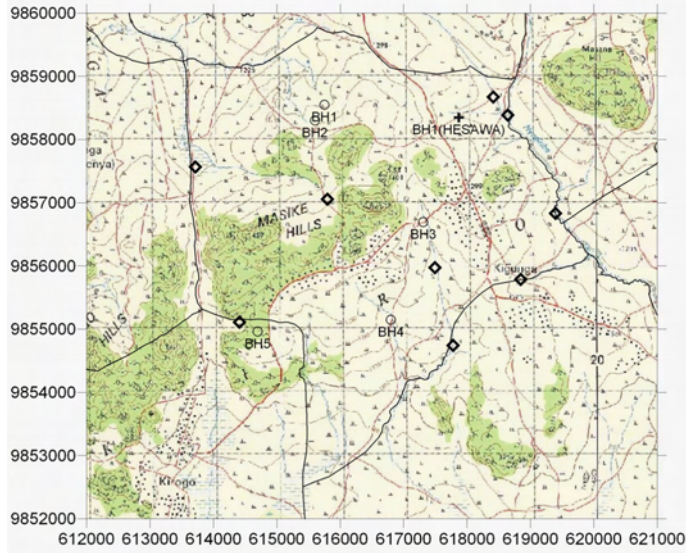
BH 2			no	yes	The shallow well was made by RIDEP. But pump has been broken followed by open up the concrete cap and its functioning as open shallow well.	BH2	615600	9858300	Between two granite inserberg. At the center of the valley.	B	Road rehabilitation will be required.	
								BH3	617309	9856692	On the clear lineament. Between two large inserberg. Grey sand soil distributes at the valley.	A								
								BH4	616800	9855150	Intersection of two major lineament.	A	Road rehabilitation will be required.							
								BH5	614697	9854960	Between two granite inserberg. At the center of the valley.	A	Road rehabilitation will be required.							
								BH6			not located as the BH by HESAWA has water.	A

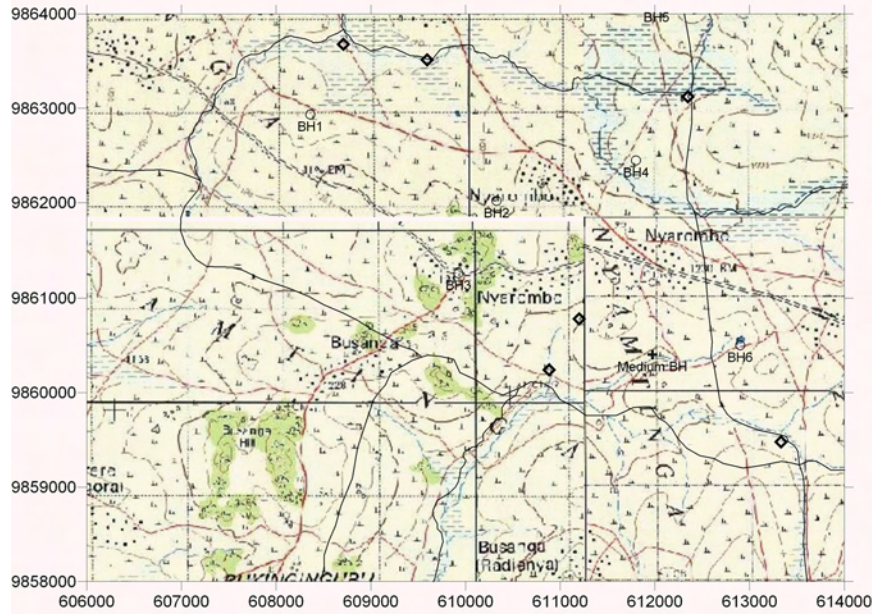
Groundwater Development Plan

Survey Date	District	ID	Village	Population	Access	Topographic, Geological Overview	Condition of Water Source	Existing Water Source					Alternative Bore Hole Location						
								Type of Source	Coordination	Function	Seasonal	Remarks	BH Number	Coordination	Description of Selected point (Geology, Topography, Structure)	Score (probability of yielding well)	Remarks	Attended Villager	
2006/3/22	Tarime	137	Nyarombo	2,049	1h 10 min through well maintained rough road.	Low lying valley at north. Granite hills and ridges occupy southern portion. Outcrops of granite (coarse - medium grained) is common at the hill side and top hill.	1 SW and 1BH, about 6 hand dug wells at the stream. In dry season, villagers depend on the water source from Lake Victoria.	Medium BH	611975	9860402	no	no	A bishop in the village privately drilled. Even the water is existing in the hole, it is not open to the public and the hole is not yet completed.	BH1	608360	9862936	At the center of wide valley. Laterites and granitic sand at the slope.	A	Because of the government program for drought area, VC and VEO was mentioned that they are busy. Therefore, two members of water committee attended. VVC: Johannes Kanyongo, Lucas Orudo (no photo has taken as the camera was broken)

BH2	610328	9862020	At the center of wide valley. Laterites and granitic sand at the slope.	A							
								BH3	609924	9861264	Between two granite insberg. At the small depression.	A							
								BH4	611800	9862450	At the center of wide valley.	A	Road rehabilitation will be required.						
								BH5	612016	9864090	At the intersection of two wide valley. Close to the existing BH.	A							
								BH6	612900	9860500	At the two wide valley. Upper portion of the BH.	A	Road rehabilitation will be required.

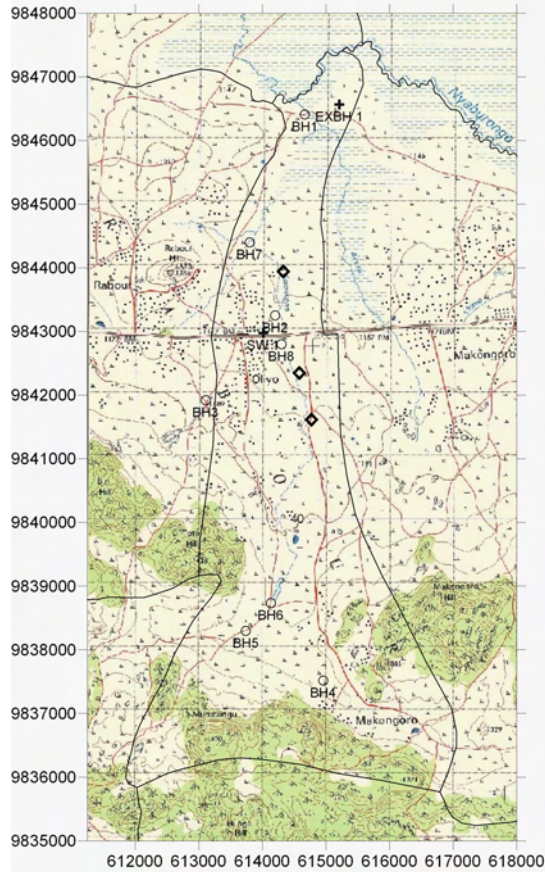
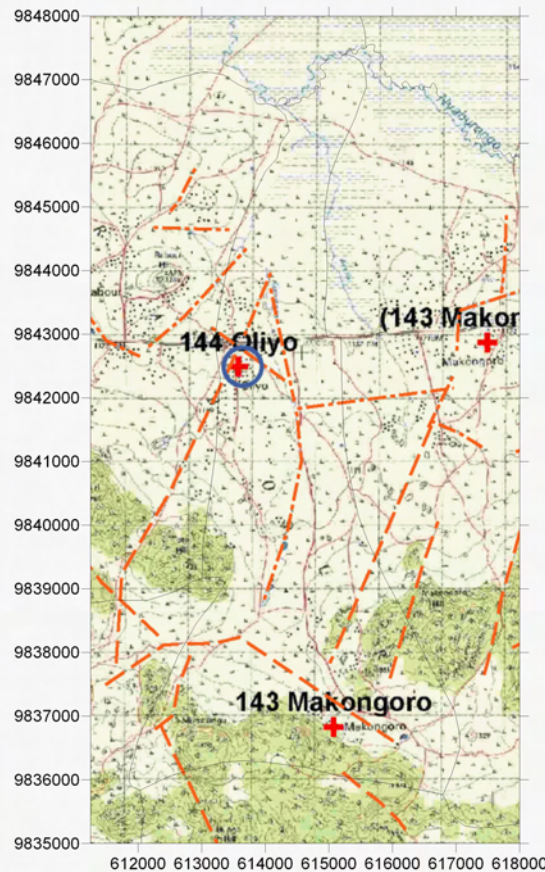
Survey Date	District	ID	Village	Population	Access	Topographic, Geological Overview	Condition of Water Source	Existing Water Source					Alternative Bore Hole Location					Attended Villager
								Type of Source	Coordination	Function	Seasonal	Remarks	BH Number	Coordination	Description of Selected point (Geology, Topography, Structure)	Score (probability of yielding water)	Remarks	
2006/020	Tarime	144	Oliyo	3,494	1 h to the junction of Nyaburongo River at the north and granite inserbergs at south. Lineament is generally trace at north, and clear at south.	3 Shallow Well (2 is not functioning), 1BH, Stream. 2 wells are available at dry season.	EXBH 1	615212 9846566	yes	no	Drilled by Geo China funded by IFAD. Salty taste.	BH1	614670 9846410	At the flatland with small depression, swamp. Grey sand soil and	B	Req. RS	VEO: John Odouo, Ward executive officer; Ismal Noiege Otak.	
							SW 1	614015 9842976	no	-	Pump is functioning but no water in the well.	BH2	614201 9843252	At the lineament center. The valley consist of weathered granite.	A

BH3	613110 9841920	Gentle slope on the lineament. Granitic sandy soil.	B	Req. RS		
												BH4	614958 9837516	Depression of wide valley. Fan deposit shall be distribute.	A			
												BH5	613742 9838296	Close to the intersection of two lineament. Consist of loose granitic sand.	A			
												BH6	614135 9838736	On the lineament. Small creek and depression. Consist of loose granitic sand.	B	Req. RS		
												BH7	613800 9844400	Intersection of two small creek or gully.	B	Req. RS		
												BH8	614300 9842800	On the lineament. Close to the bridge at village center.	A
