## THE STUDY ON URGENT REHABILITATION PROGRAM OF PORTS IN THE REPUBLIC OF ANGOLA

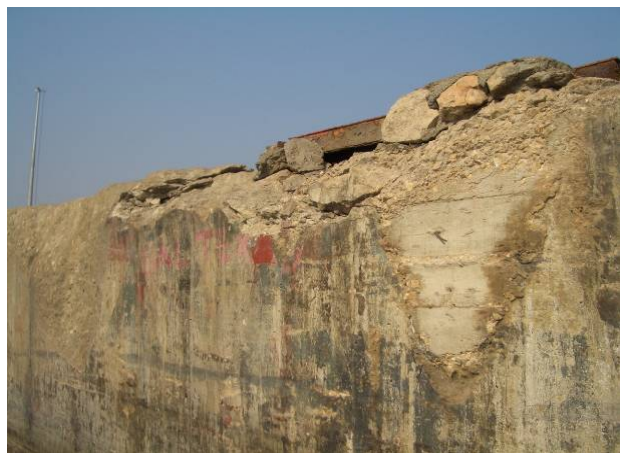
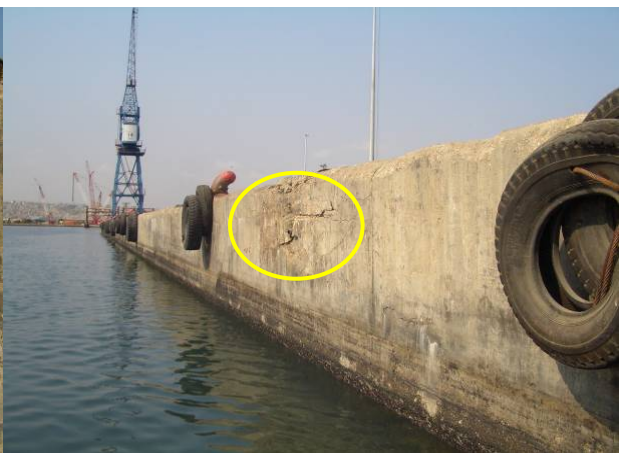
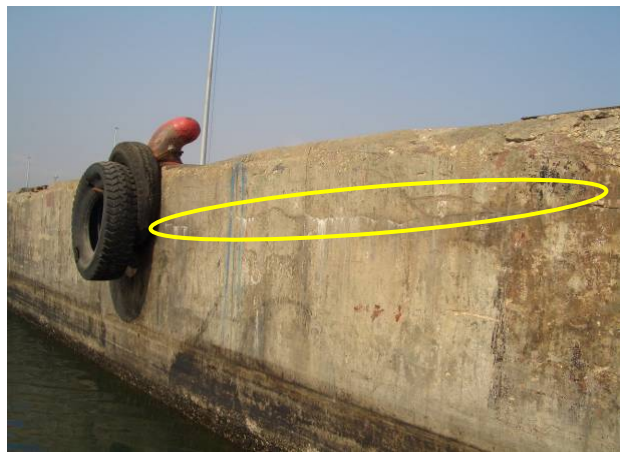
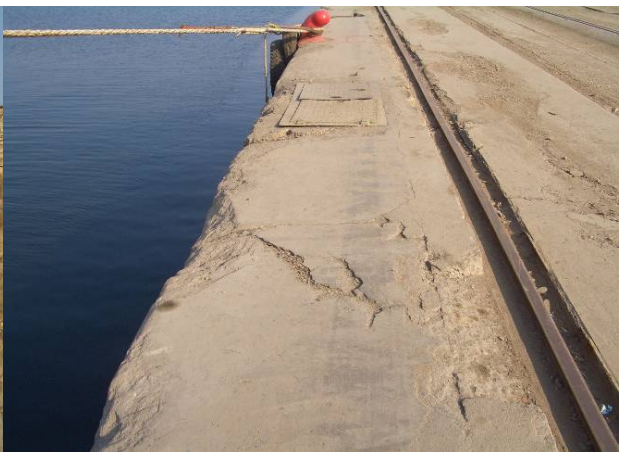
Facility ID	Lo -02 -035	Survey Date	2005/06/01, 09/27
Port Name	Lobito	Category	Coping Concrete
Year Constructed	1975		
Maintenance Record	unknown		
Facility Description	Berth No.8 From Bollard No.33 to No.34 A crane socket is found.		
Existing Condition	The edges of the coping concrete are chipped off throughout the length of interval. There can be seen some cracks and floating of concrete along the sides (encircled part in the photo hereunder).		
Structural Condition Assessment	<div>Grade 2</div> <p>The facility is in structurally bad condition. It will become the object of rehabilitation plan.</p>		
Location	<div>

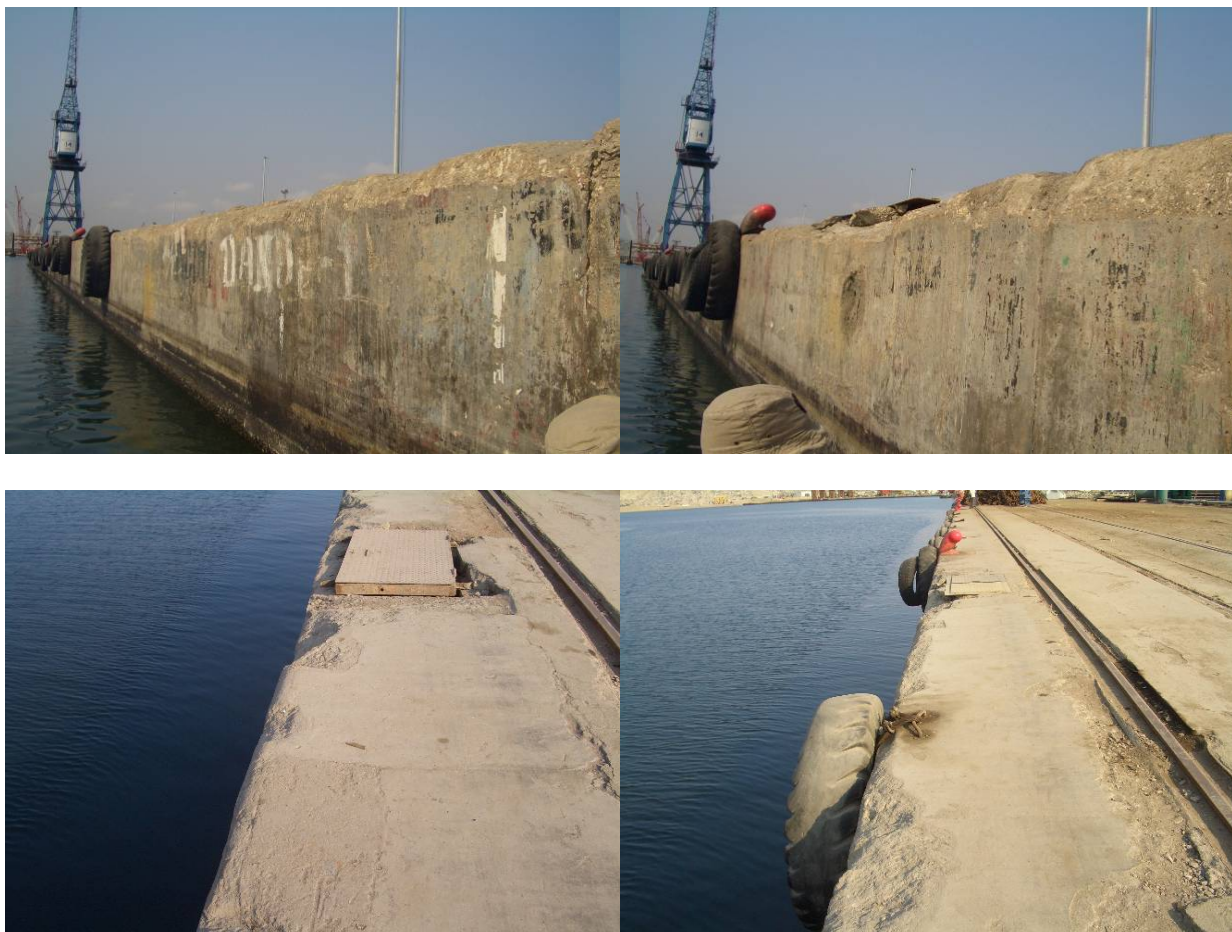
Facility ID	Lo -02 -036	Survey Date	2005/06/01, 09/27
Port Name	Lobito	Category	Coping Concrete
Year Constructed	1975		
Maintenance Record	unknown		
Facility Description	Berth No.8 From Bollard No.34 to No.35 An water supply bulb and a crane socket are found.		
Existing Condition	The edges of the coping concrete are heavily chipped off throughout the length of interval.		
Structural Condition Assessment	<div>Grade 2</div> <p>The facility is in structurally bad condition. It will become the object of rehabilitation plan.</p>		
Location	<div>

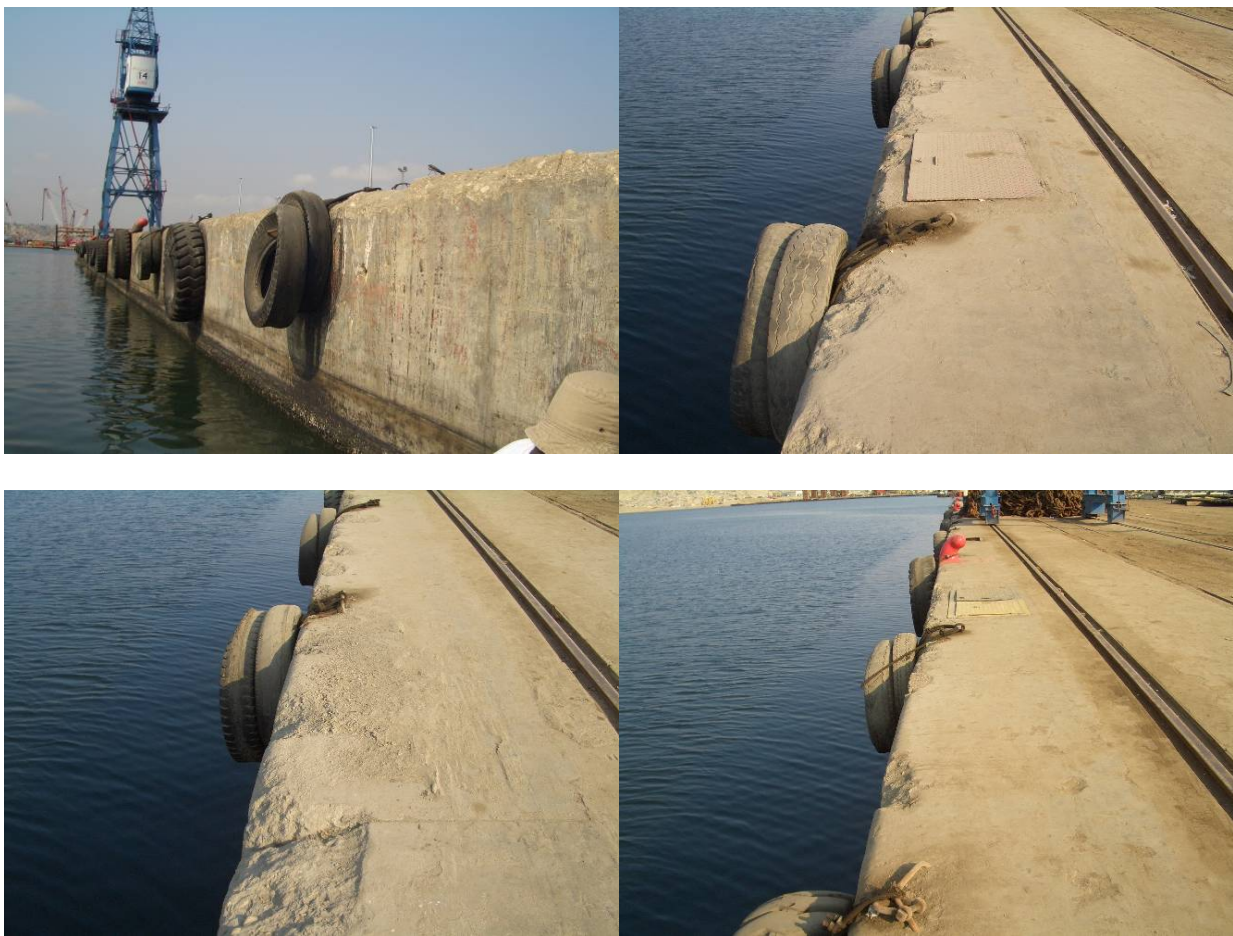
Facility ID	Lo -02 -037	Survey Date	2005/06/01, 09/27
Port Name	Lobito	Category	Coping Concrete
Year Constructed	1975		
Maintenance Record	unknown		
Facility Description	Berth No.8 From Bollard No.35 to No.36 An water supply bulb and a crane socket are found.		
Existing Condition	The edges of the coping concrete are heavily chipped off throughout the length of interval.		
Structural Condition Assessment	<div>Grade 2</div> <p>The facility is in structurally bad condition. It will become the object of rehabilitation plan.</p>		
Location	<div>

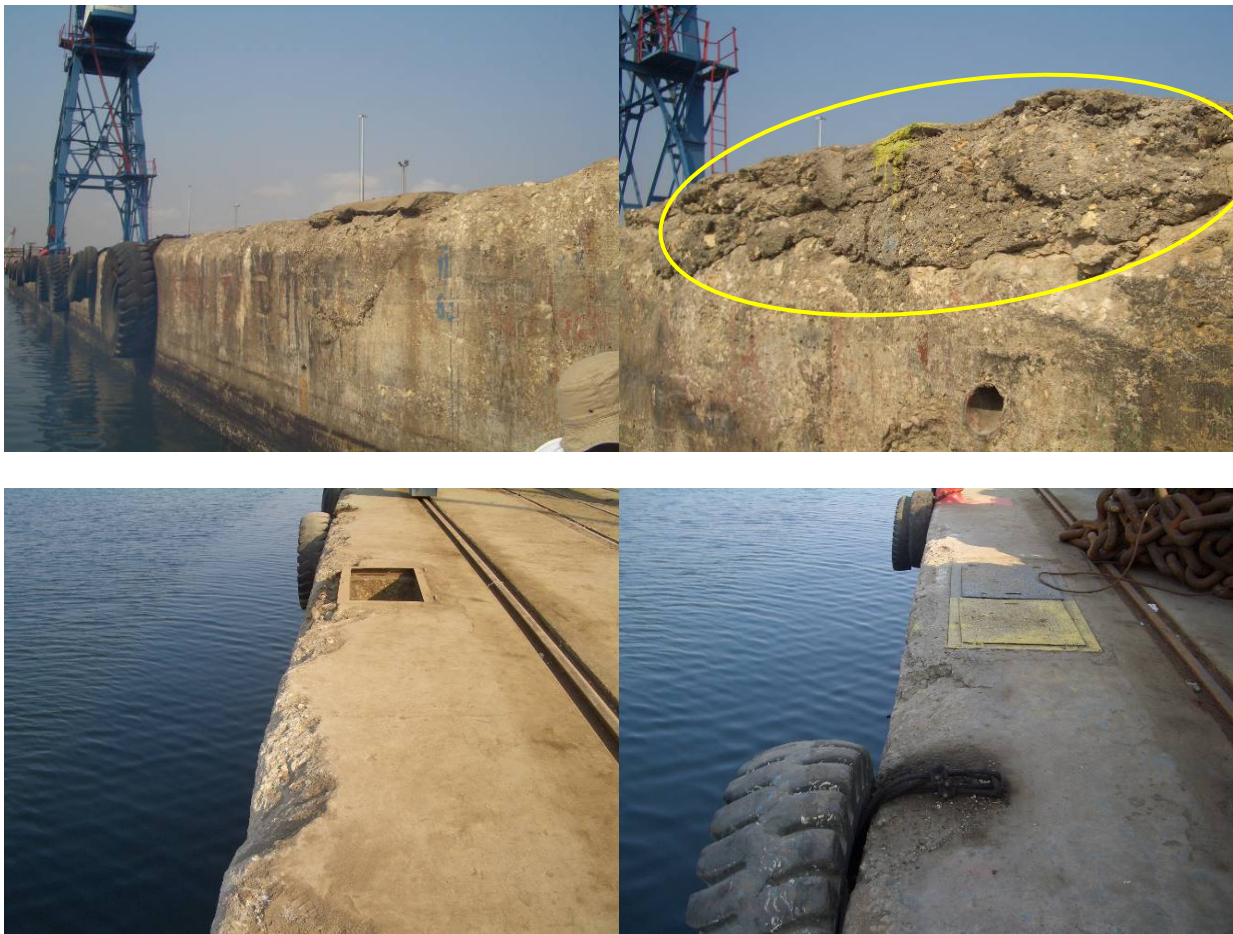
Facility ID	Lo -02 -038	Survey Date	2005/06/01, 09/27
Port Name	Lobito	Category	Coping Concrete
Year Constructed	1975		
Maintenance Record	unknown		
Facility Description	Berth No.8 From Bollard No.36 to No.37 An water supply bulb and a crane socket are found.		
Existing Condition	The edges of the coping concrete are chipped off throughout the length of interval. Partially repaired (encircled part in the photo hereunder)		
Structural Condition Assessment	<div>Grade 2</div> The facility is in structurally bad condition. It will become the object of rehabilitation plan.		
Location

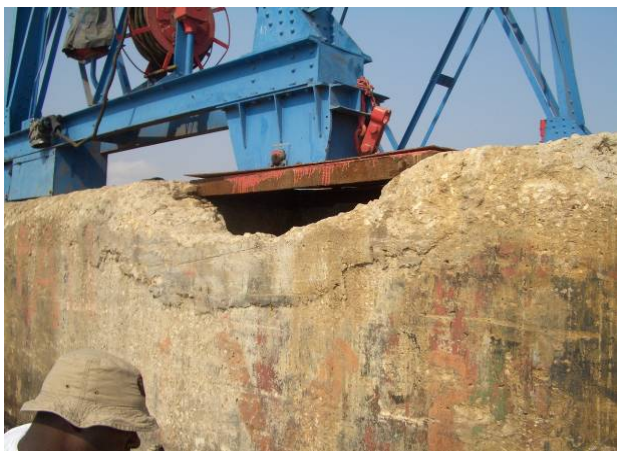
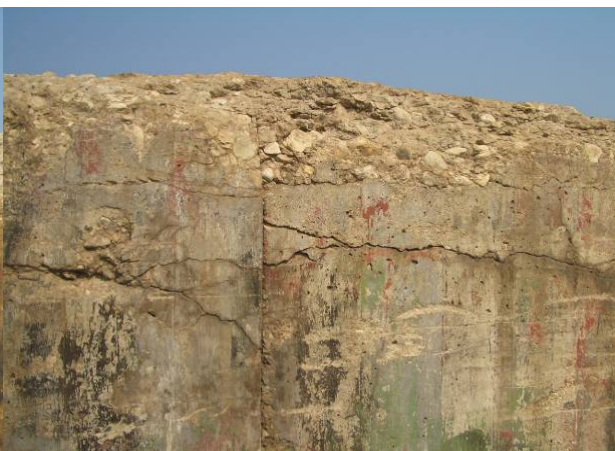
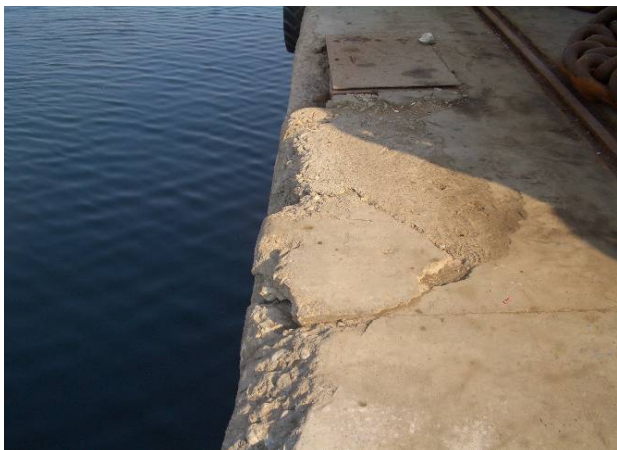
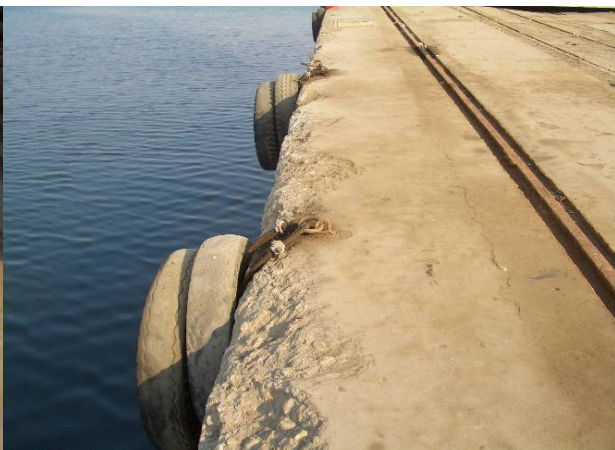
Facility ID	Lo -02 -039	Survey Date	2005/06/01, 09/27
Port Name	Lobito	Category	Coping Concrete
Year Constructed	1975		
Maintenance Record	unknown		
Facility Description	Berth No.8 From Bollard No.37 to No.38 An water supply bulb and a crane socket are found.		
Existing Condition	The edges of the coping concrete are heavily chipped off throughout the length of interval.		
Structural Condition Assessment	<div>Grade 2</div> <div>The facility is in structurally bad condition. It will become the object of rehabilitation plan.</div>		
Location	<div>

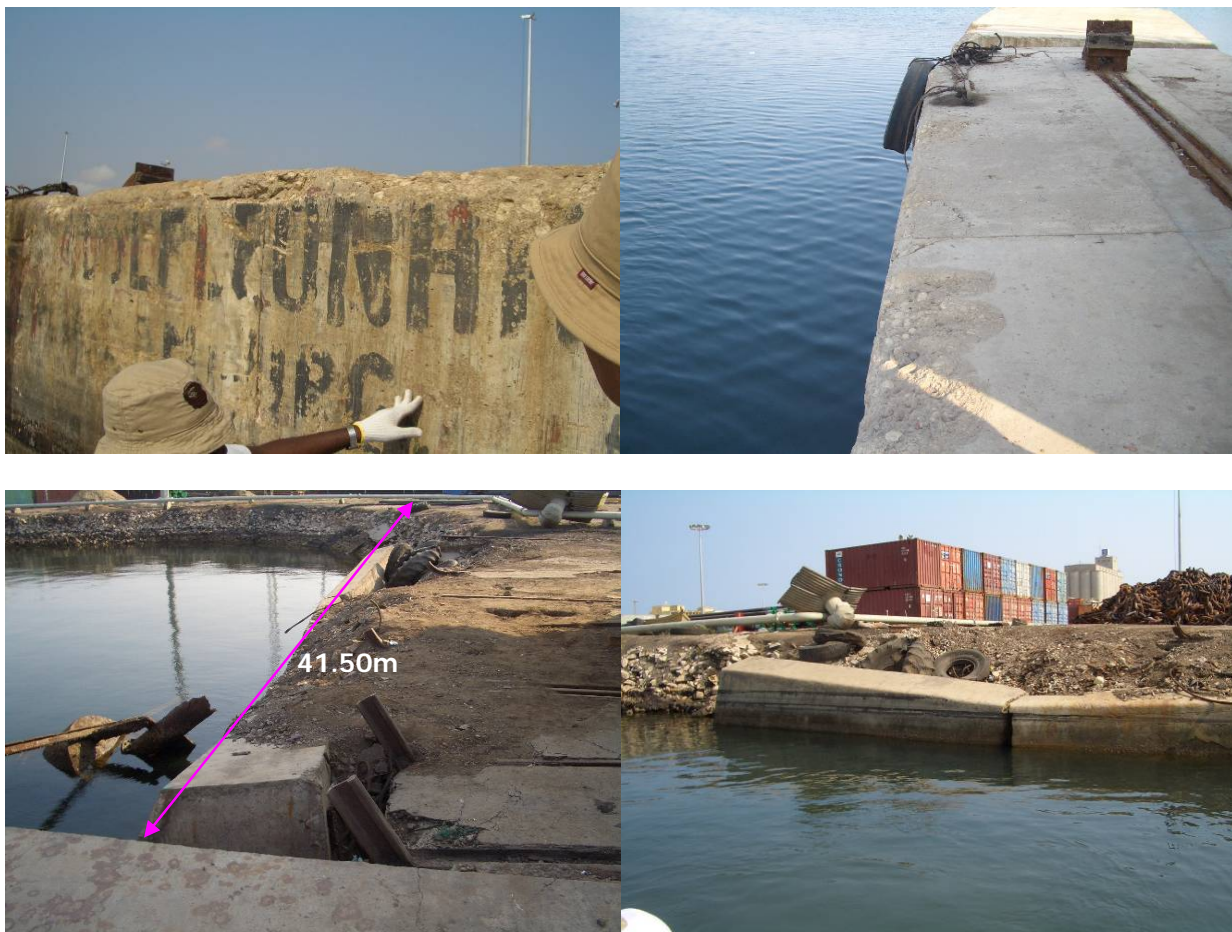
Facility ID	Lo -02 -040	Survey Date	2005/06/01, 09/27
Port Name	Lobito	Category	Coping Concrete
Year Constructed	1975		
Maintenance Record	unknown		
Facility Description	Berth No.8 From Bollard No.38 to Eastend		
Existing Condition	The edges of the coping concrete are chipped off throughout the length of interval. The retaining wall is collapsed.		
Structural Condition Assessment	<div>Grade 2</div> <p>The facility is in structurally bad condition. It will become the object of rehabilitation plan.</p>		
Location

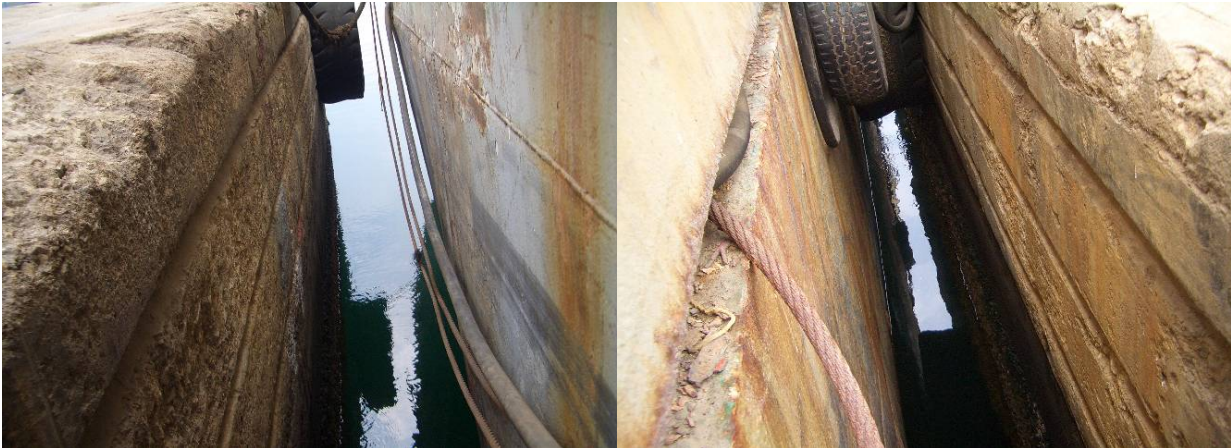
<b>Facility ID</b>	Lo -03 -001	<b>Survey Date</b>	2005/10/04			
<b>Port Name</b>	Lobito	<b>Category</b>	Quaywall			
<b>Year Constructed</b>	1934					
<b>Maintenance Record</b>	unknown					
<b>Facility Description</b>	Berth No.1 From Northend to Bollard No.1					
<b>Existing Condition</b>	Small defects were found on the surface of the quaywall, but general condition is sound.					
<b>Structural Condition Assessment</b>	<p style="text-align: center;"><b>Grade 0</b></p> <p>The facility is in sound condition. Detailed survey is not required.</p>					
<b>Location</b>

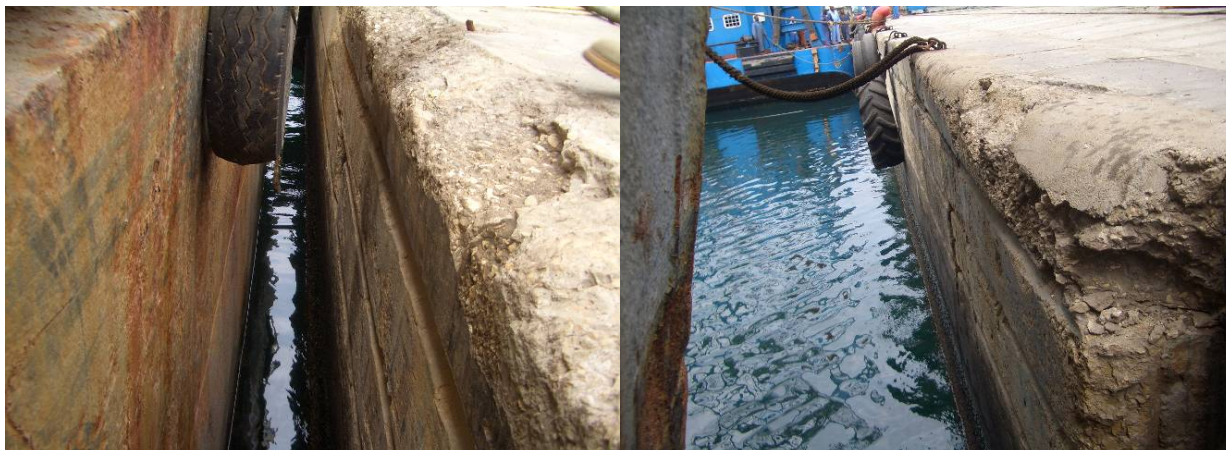
<b>Facility ID</b>	Lo -03 -002	<b>Survey Date</b>	2005/10/04
<b>Port Name</b>	Lobito	<b>Category</b>	Quaywall
<b>Year Constructed</b>	1934		
<b>Maintenance Record</b>	unknown		
<b>Facility Description</b>	Berth No.1 From Bollard No.1 to No.2		
<b>Existing Condition</b>	Small defects were found on the surface of the quaywall, but general condition is sound.		
<b>Structural Condition Assessment</b>	<p style="text-align: center;"><b>Grade 0</b></p> <p>The facility is in sound condition. Detailed survey is not required.</p>		
<b>Location</b>

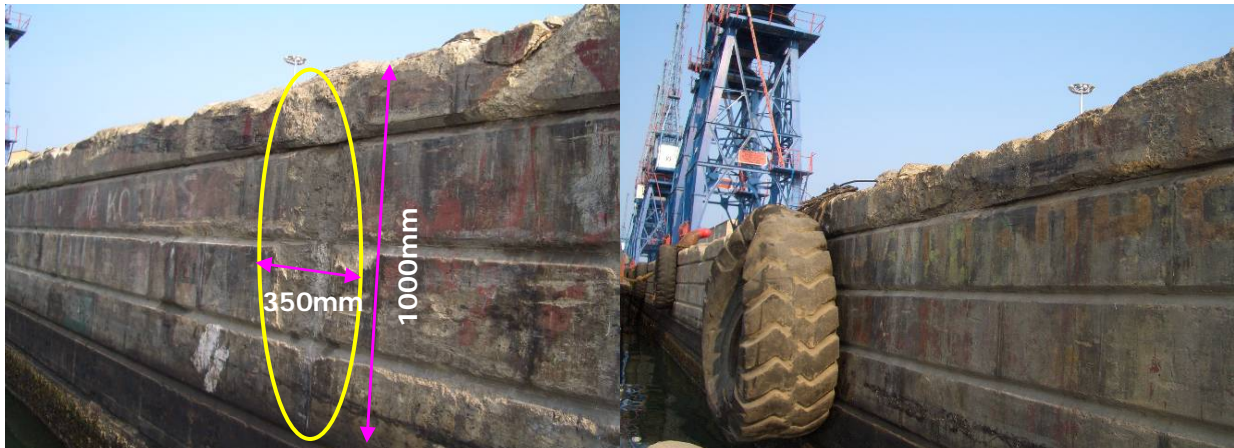
<b>Facility ID</b>	Lo -03 -009	<b>Survey Date</b>	2005/06/01, 10/04
<b>Port Name</b>	Lobito	<b>Category</b>	Quaywall
<b>Year Constructed</b>	1928		
<b>Maintenance Record</b>	unknown		
<b>Facility Description</b>	Berth No.2 From Bollard No.8 to No.9		
<b>Existing Condition</b>	Some part of wall is chipped off (encircled in the photo hereunder).		
<b>Structural Condition Assessment</b>	<div style="background-color: red; color: white; text-align: center; padding: 2px;"><b>Grade 2</b></div> <p>The facility is in structurally bad condition. It will become the object of rehabilitation plan.</p>		
<b>Location</b>

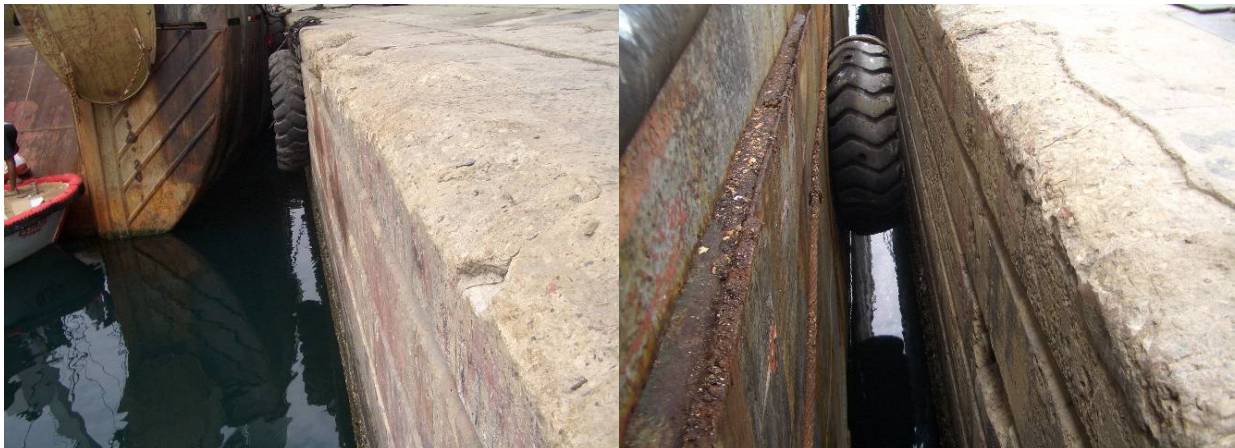
<b>Facility ID</b>	Lo -03 -012	<b>Survey Date</b>	2005/10/04
<b>Port Name</b>	Lobito	<b>Category</b>	Quaywall
<b>Year Constructed</b>	1934		
<b>Maintenance Record</b>	unknown		
<b>Facility Description</b>	Berth No.3 From Bollard No.11 to No.12		
<b>Existing Condition</b>	Small defects were found on the surface of the quaywall, but general condition is sound.		
<b>Structural Condition Assessment</b>	<p style="text-align: center;"><b>Grade 0</b></p> <p>The facility is in sound condition. Detailed survey is not required.</p>		
<b>Location</b>

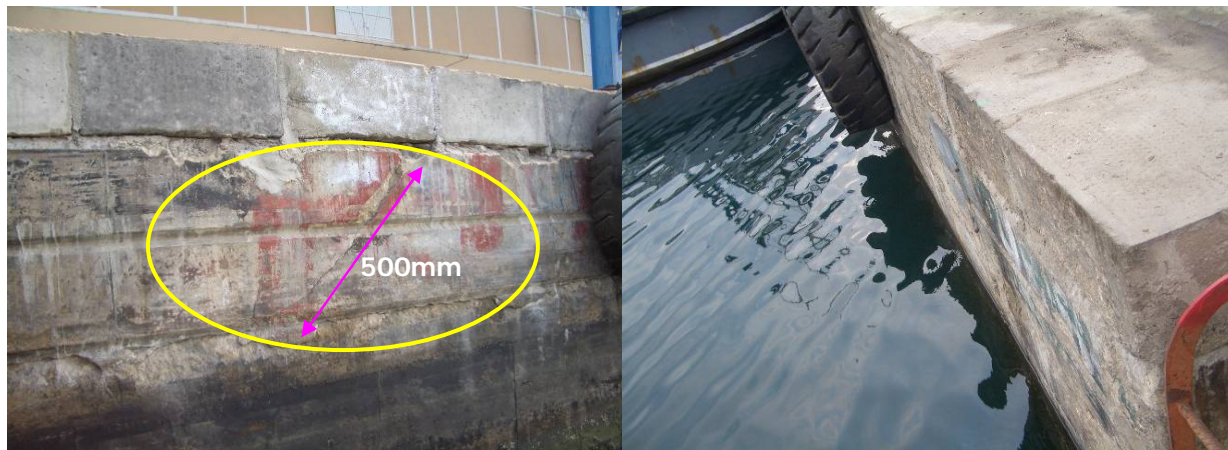
<b>Facility ID</b>	Lo -03 -014	<b>Survey Date</b>	2005/06/01, 10/04
<b>Port Name</b>	Lobito	<b>Category</b>	Quaywall
<b>Year Constructed</b>	1934		
<b>Maintenance Record</b>	unknown		
<b>Facility Description</b>	Berth No.3 From Bollard No.13 to No.14		
<b>Existing Condition</b>	There can be seen some cracks on the side (encircled in the photo hereunder).		
<b>Structural Condition Assessment</b>	<div style="background-color: red; color: white; text-align: center; padding: 2px;"><b>Grade 2</b></div> <p>The facility is in structurally bad condition. It will become the object of rehabilitation plan.</p>		
<b>Location</b>
