**THE STUDY ON URGENT REHABILITATION PROGRAM OF PORTS IN THE REPUBLIC OF ANGOLA**

<b>Facility ID</b>	Na -02 -012	<b>Survey Date</b>	2005/05/17, 10/12
<b>Port Name</b>	Namibe	<b>Category</b>	Coping Concrete
<b>Year Constructed</b>	1953-1957		
<b>Maintenance Record</b>	unknown		
<b>Facility Description</b>	Berth No.3 From Bollard No.11 to No.12 A crane socket is found.		
<b>Existing Condition</b>	The edges of the coping concrete are chipped off throughout the length of interval.		
<b>Structural Condition Assessment</b>	<b>Grade 2</b>		
	The facility is in structurally bad condition. It will become the object of rehabilitation plan.		
<b>Location</b>

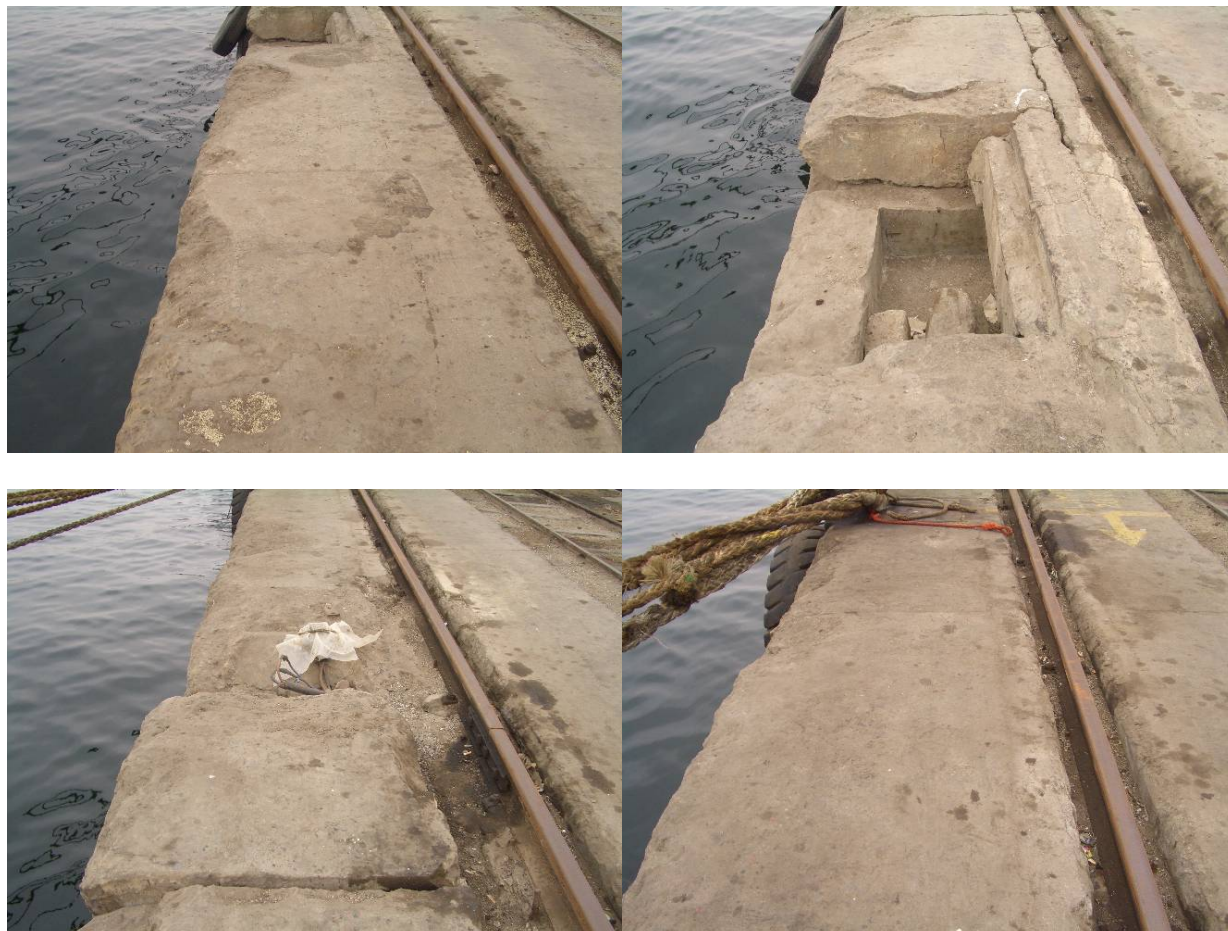
<b>Facility ID</b>	Na -02 -013	<b>Survey Date</b>	2005/05/17, 10/12
<b>Port Name</b>	Namibe	<b>Category</b>	Coping Concrete
<b>Year Constructed</b>	1953-1957		
<b>Maintenance Record</b>	unknown		
<b>Facility Description</b>	Berth No.3 From Bollard No.12 to No.13 A sewage discharge point is found.		
<b>Existing Condition</b>	The edges of the coping concrete are chipped off throughout the length of interval.		
<b>Structural Condition Assessment</b>	<b>Grade 2</b>		
	The facility is in structurally bad condition. It will become the object of rehabilitation plan.		
<b>Location</b>

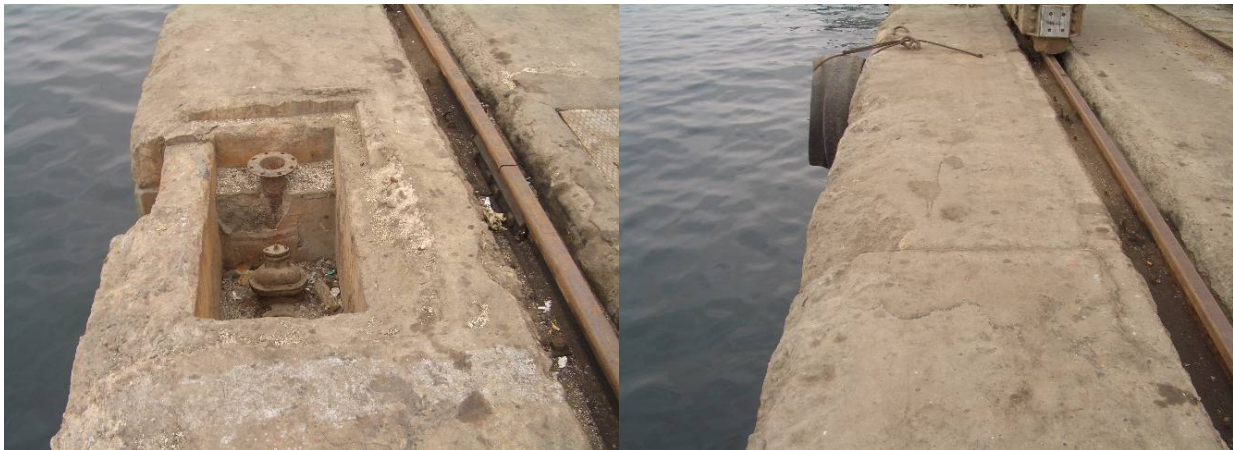
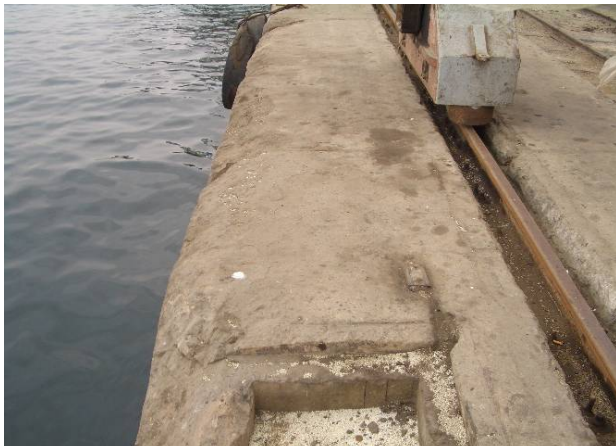
<b>Facility ID</b>	Na -02 -014	<b>Survey Date</b>	2005/05/17, 10/12
<b>Port Name</b>	Namibe	<b>Category</b>	Coping Concrete
<b>Year Constructed</b>	1953-1957		
<b>Maintenance Record</b>	unknown		
<b>Facility Description</b>	Berth No.3 From Bollard No.13 to No.14 An water supply bulb is found.		
<b>Existing Condition</b>	The edges of the coping concrete are chipped off throughout the length of interval.		
<b>Structural Condition Assessment</b>	<b>Grade 2</b>		
	The facility is in structurally bad condition. It will become the object of rehabilitation plan.		
<b>Location</b>

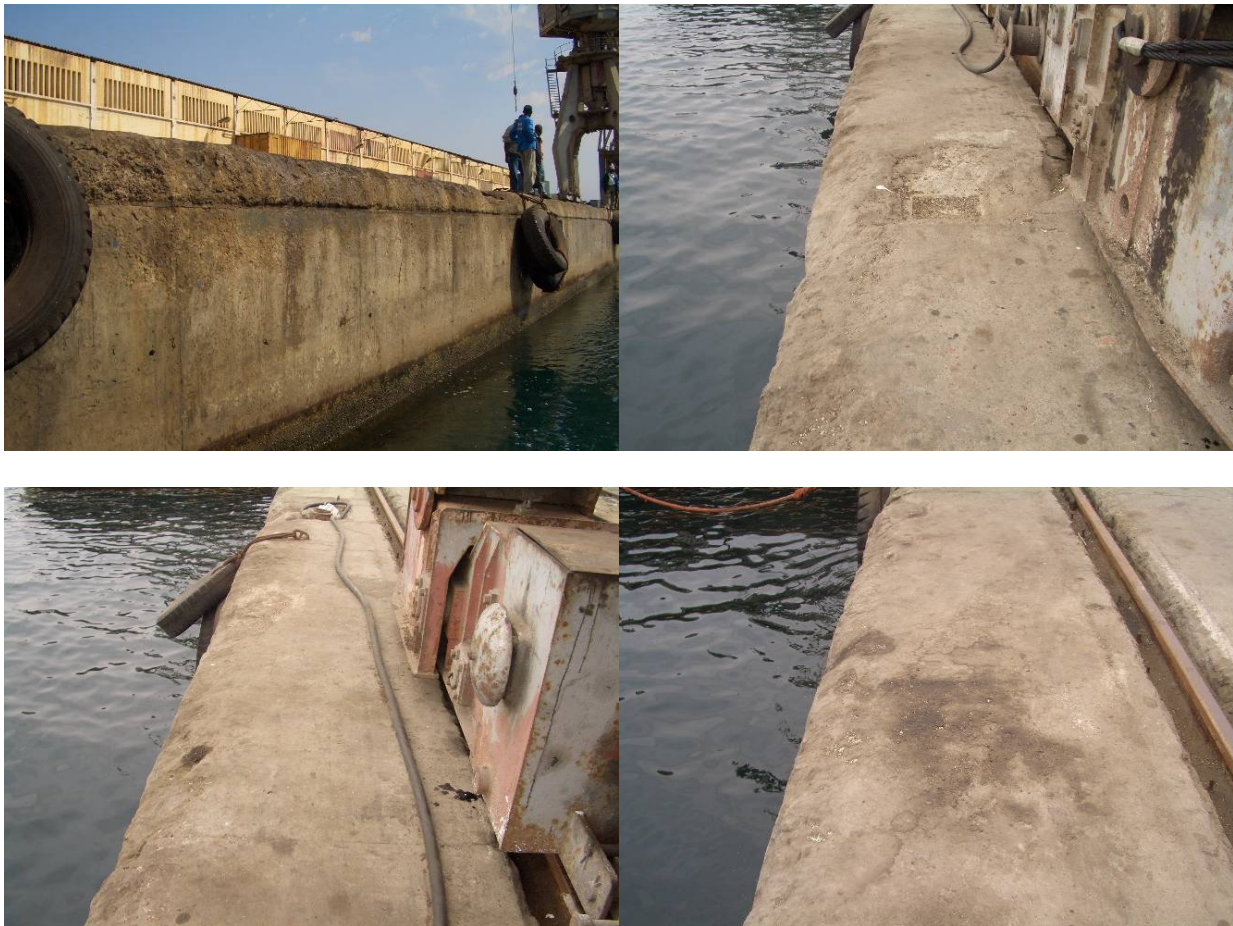
<b>Facility ID</b>	Na -02 -015	<b>Survey Date</b>	2005/05/17, 10/12
<b>Port Name</b>	Namibe	<b>Category</b>	Coping Concrete
<b>Year Constructed</b>	1953-1957		
<b>Maintenance Record</b>	unknown		
<b>Facility Description</b>	Berth No.3 From Bollard No.14 to No.15 A crane socket is found.		
<b>Existing Condition</b>	The edges of the coping concrete are chipped off throughout the length of interval.		
<b>Structural Condition Assessment</b>	<b>Grade 2</b>		
	The facility is in structurally bad condition. It will become the object of rehabilitation plan.		
<b>Location</b>

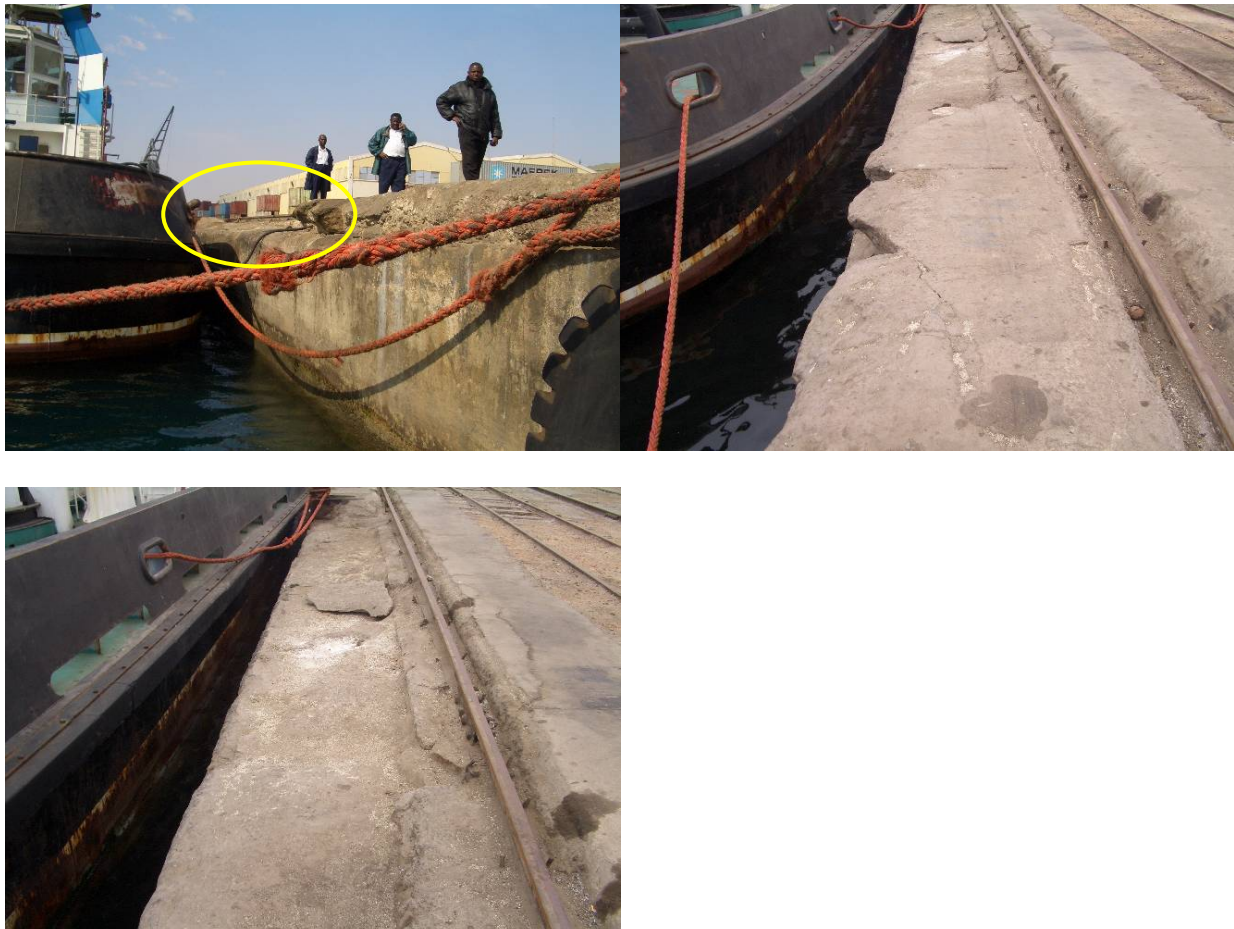
<b>Facility ID</b>	Na -02 -016	<b>Survey Date</b>	2005/05/17, 10/12
<b>Port Name</b>	Namibe	<b>Category</b>	Coping Concrete
<b>Year Constructed</b>	1953-1957		
<b>Maintenance Record</b>	unknown		
<b>Facility Description</b>	Berth No.3 From Bollard No.15 to No.16		
<b>Existing Condition</b>	The edges of the coping concrete are chipped off throughout the length of interval. There can be seen lack of the coping concrete (encircled part in the photo hereunder).		
<b>Structural Condition Assessment</b>	<b>Grade 2</b>		
	The facility is in structurally bad condition. It will become the object of rehabilitation plan.		
<b>Location</b>

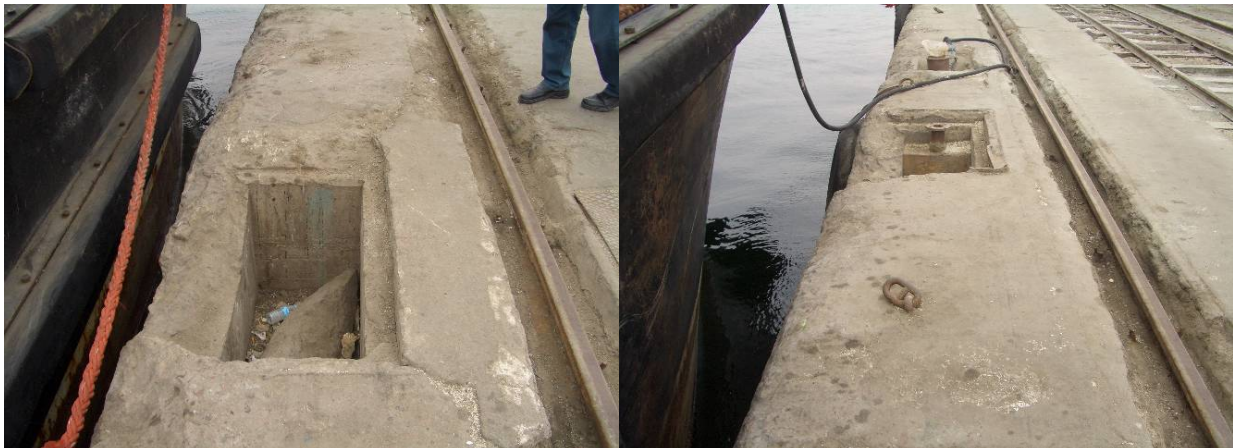
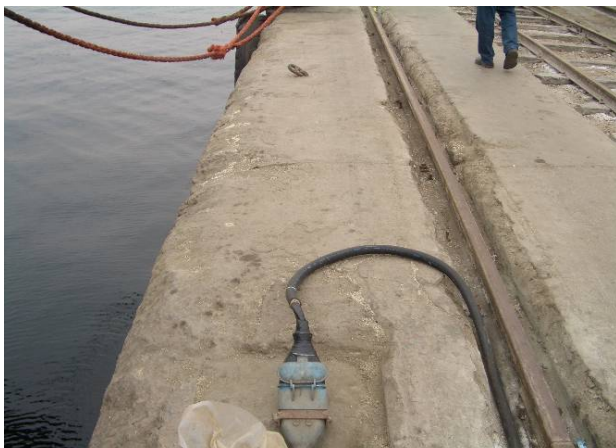
<b>Facility ID</b>	Na -02 -017	<b>Survey Date</b>	2005/05/17, 10/12
<b>Port Name</b>	Namibe	<b>Category</b>	Coping Concrete
<b>Year Constructed</b>	1953-1957		
<b>Maintenance Record</b>	unknown		
<b>Facility Description</b>	Berth No.3 From Bollard No.16 to No.17 A sewage discharge point, an water supply bulb and crane socket are found.		
<b>Existing Condition</b>	The edges of the coping concrete are chipped off throughout the length of interval.		
<b>Structural Condition Assessment</b>	<b>Grade 2</b>		
	The facility is in structurally bad condition. It will become the object of rehabilitation plan.		
<b>Location</b>

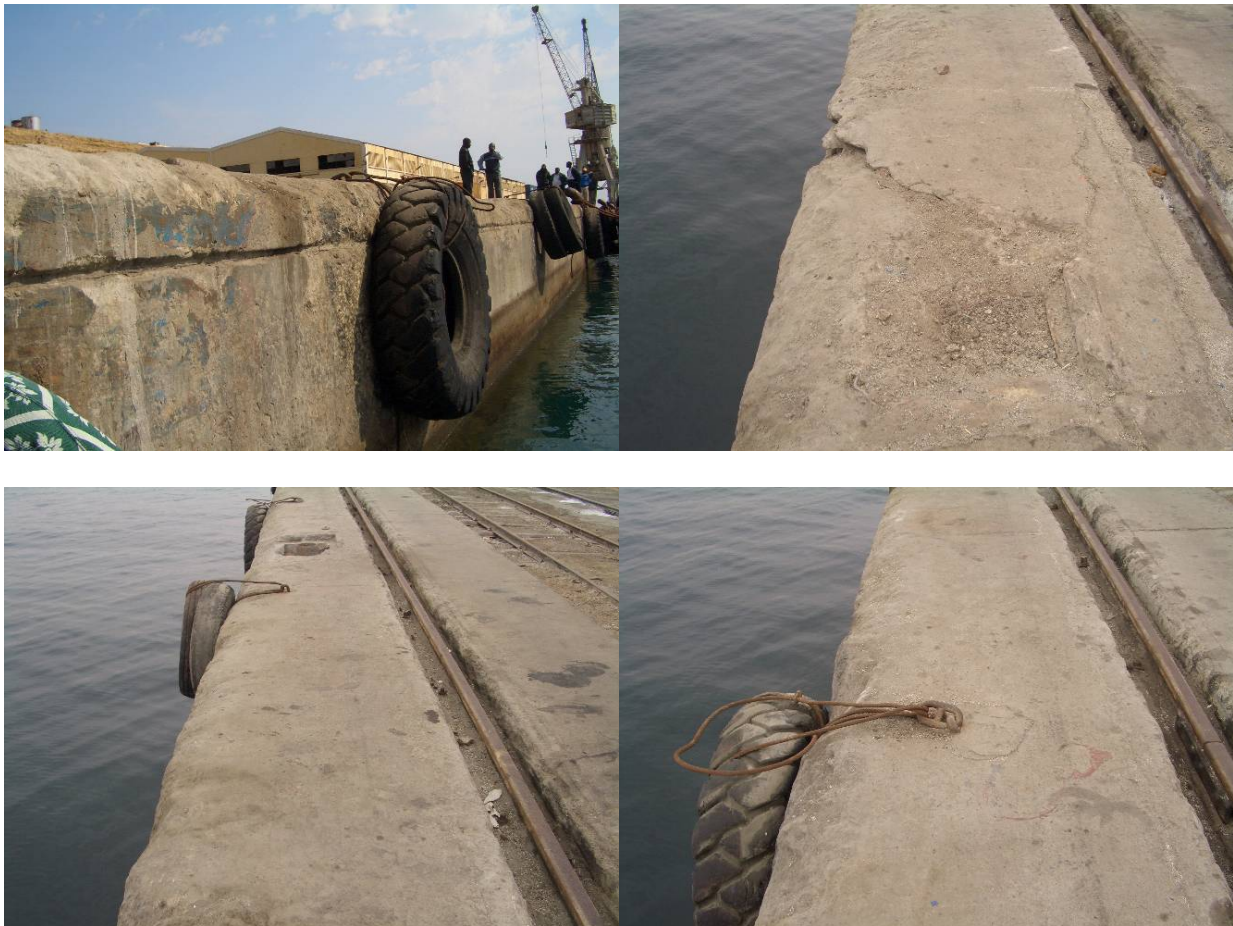
<b>Facility ID</b>	Na -02 -018	<b>Survey Date</b>	2005/05/17, 10/12
<b>Port Name</b>	Namibe	<b>Category</b>	Coping Concrete
<b>Year Constructed</b>	1953-1957		
<b>Maintenance Record</b>	unknown		
<b>Facility Description</b>	Berth No.3 From Bollard No.17 to No.18 A crane socket is found.		
<b>Existing Condition</b>	The edges of the coping concrete are chipped off throughout the length of interval.		
<b>Structural Condition Assessment</b>	<b>Grade 2</b>		
	The facility is in structurally bad condition. It will become the object of rehabilitation plan.		
<b>Location</b>

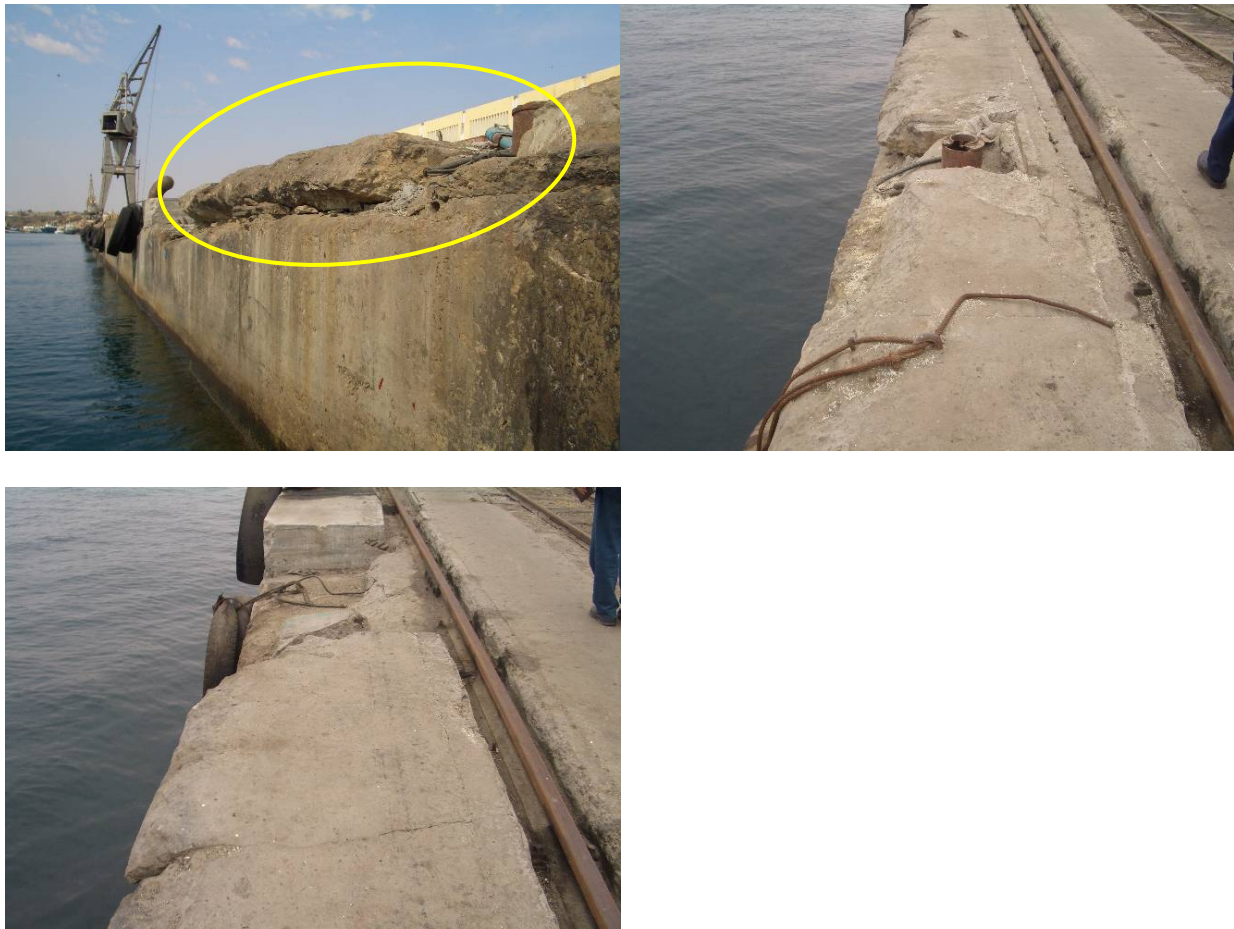
<b>Facility ID</b>	Na -02 -019	<b>Survey Date</b>	2005/05/17, 10/12
<b>Port Name</b>	Namibe	<b>Category</b>	Coping Concrete
<b>Year Constructed</b>	1953-1957		
<b>Maintenance Record</b>	unknown		
<b>Facility Description</b>	Berth No.3 From Bollard No.18 to No.19 A crane socket is found.		
<b>Existing Condition</b>	The edges of the coping concrete are chipped off throughout the length of interval. There can be seen some broken parts of the coping concrete (encircled part in the photo hereunder).		
<b>Structural Condition Assessment</b>	<b>Grade 2</b>		
	The facility is in structurally bad condition. It will become the object of rehabilitation plan.		
<b>Location</b>

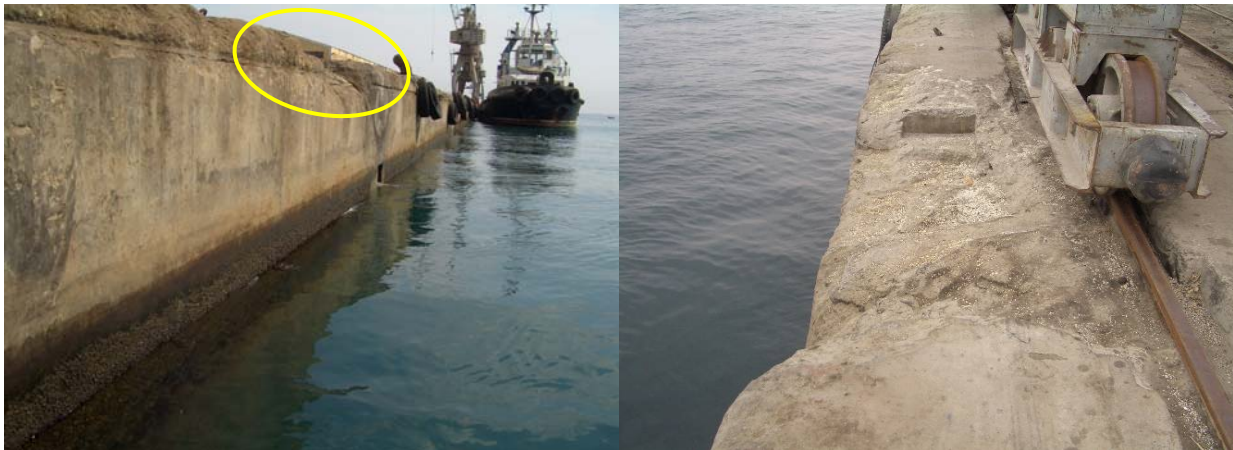
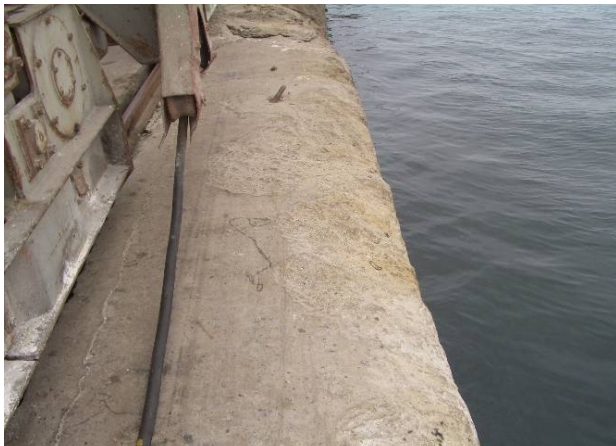
<b>Facility ID</b>	Na -02 -020	<b>Survey Date</b>	2005/05/17, 10/12
<b>Port Name</b>	Namibe	<b>Category</b>	Coping Concrete
<b>Year Constructed</b>	1953-1957		
<b>Maintenance Record</b>	unknown		
<b>Facility Description</b>	Berth No.3 From Bollard No.19 to No.20		
<b>Existing Condition</b>	The edges of the coping concrete are chipped off throughout the length of interval. There can be seen lack of the coping concrete (encircled part in the photo hereunder).		
<b>Structural Condition Assessment</b>	<b>Grade 2</b>		
	The facility is in structurally bad condition. It will become the object of rehabilitation plan.		
<b>Location</b>

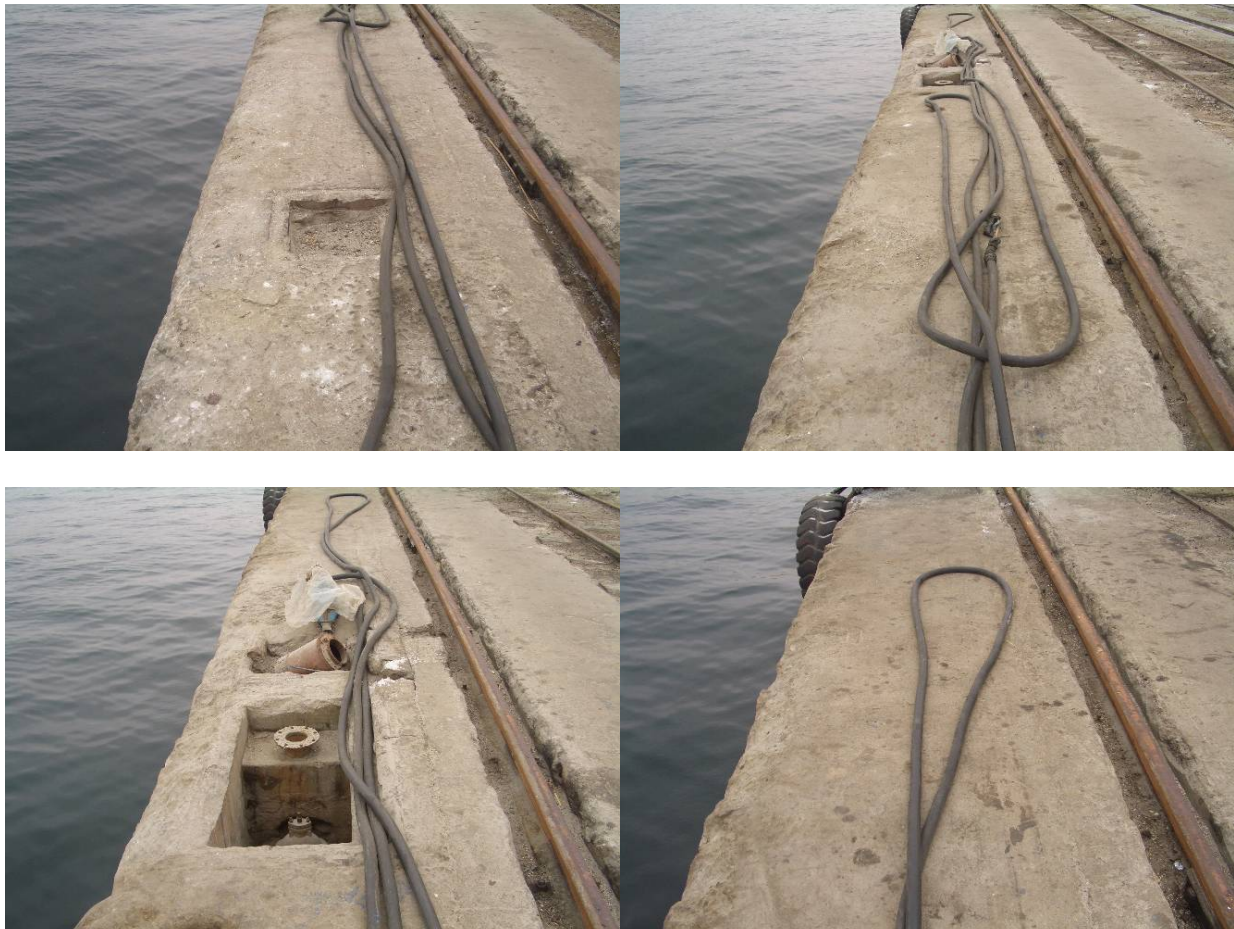
<b>Facility ID</b>	Na -02 -021	<b>Survey Date</b>	2005/05/17, 10/12
<b>Port Name</b>	Namibe	<b>Category</b>	Coping Concrete
<b>Year Constructed</b>	1953-1957		
<b>Maintenance Record</b>	unknown		
<b>Facility Description</b>	Berth No.3 From Bollard No.20 to No.21 An water supply bulb and a crane socket is found.		
<b>Existing Condition</b>	The edges of the coping concrete are chipped off throughout the length of interval.		
<b>Structural Condition Assessment</b>	<b>Grade 2</b>		
	The facility is in structurally bad condition. It will become the object of rehabilitation plan.		
<b>Location</b>

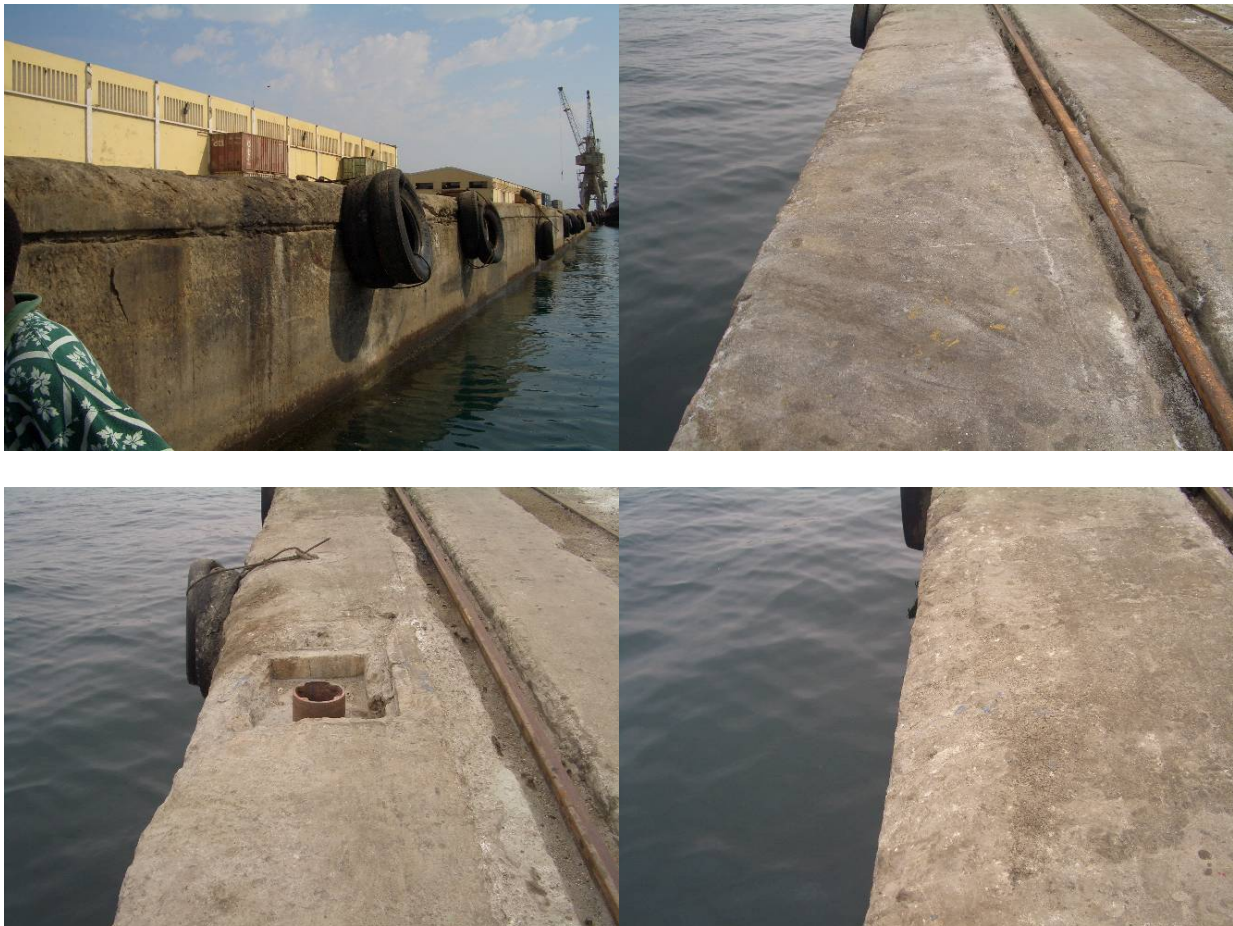
<b>Facility ID</b>	Na -02 -022	<b>Survey Date</b>	2005/05/17, 10/12
<b>Port Name</b>	Namibe	<b>Category</b>	Coping Concrete
<b>Year Constructed</b>	1953-1957		
<b>Maintenance Record</b>	unknown		
<b>Facility Description</b>	Berth No.3 From Bollard No.21 to No.22 A crane socket is found.		
<b>Existing Condition</b>	The edges of the coping concrete are chipped off throughout the length of interval.		
<b>Structural Condition Assessment</b>	<b>Grade 2</b>		
	The facility is in structurally bad condition. It will become the object of rehabilitation plan.		
<b>Location</b>

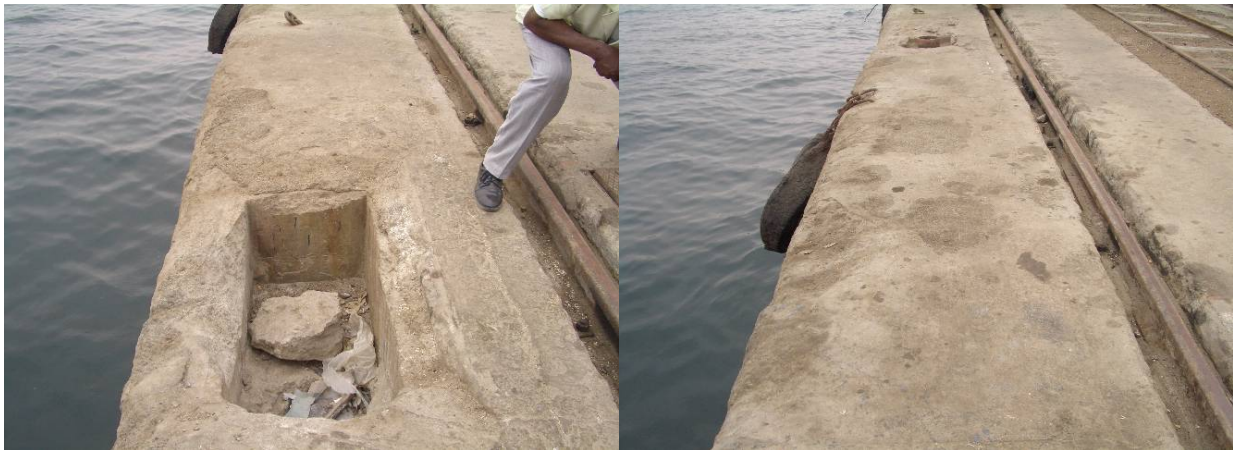
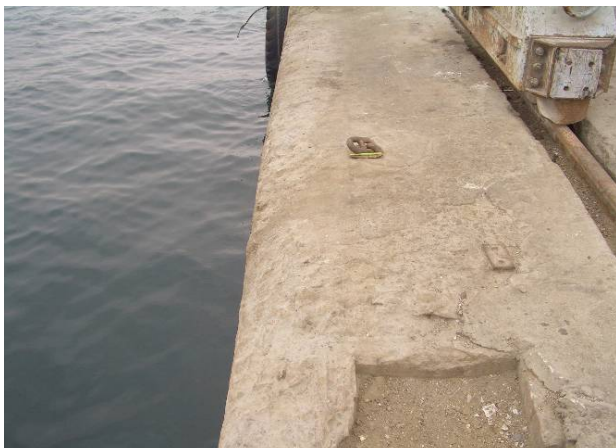
<b>Facility ID</b>	Na -02 -023	<b>Survey Date</b>	2005/05/17, 10/12
<b>Port Name</b>	Namibe	<b>Category</b>	Coping Concrete
<b>Year Constructed</b>	1953-1957		
<b>Maintenance Record</b>	unknown		
<b>Facility Description</b>	Berth No.3 From Bollard No.22 to No.23 A sewage discharge point and a crane socket are found.		
<b>Existing Condition</b>	The edges of the coping concrete are chipped off throughout the length of interval.		
<b>Structural Condition Assessment</b>	<b>Grade 2</b>		
	The facility is in structurally bad condition. It will become the object of rehabilitation plan.		
<b>Location</b>

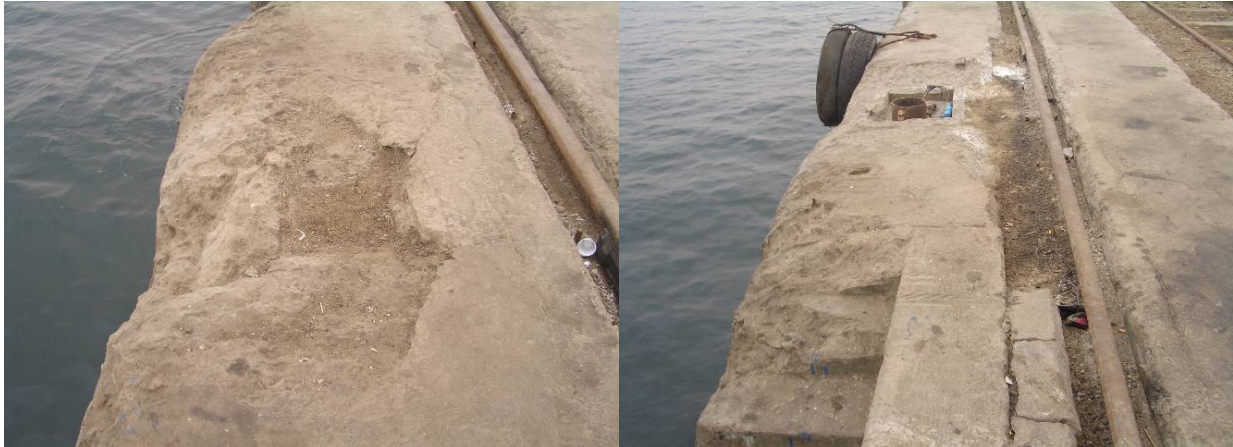
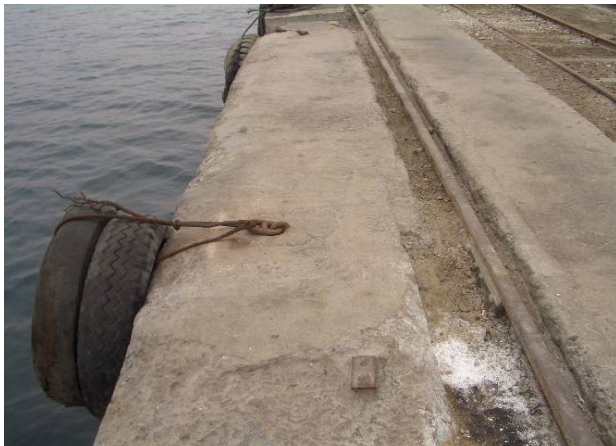
<b>Facility ID</b>	Na -02 -024	<b>Survey Date</b>	2005/05/17, 10/12
<b>Port Name</b>	Namibe	<b>Category</b>	Coping Concrete
<b>Year Constructed</b>	1953-1957		
<b>Maintenance Record</b>	unknown		
<b>Facility Description</b>	Berth No.3 From Bollard No.23 to No.24 A crane socket is found.		
<b>Existing Condition</b>	The edges of the coping concrete are chipped off throughout the length of interval.		
<b>Structural Condition Assessment</b>	<b>Grade 2</b>		
	The facility is in structurally bad condition. It will become the object of rehabilitation plan.		
<b>Location</b>

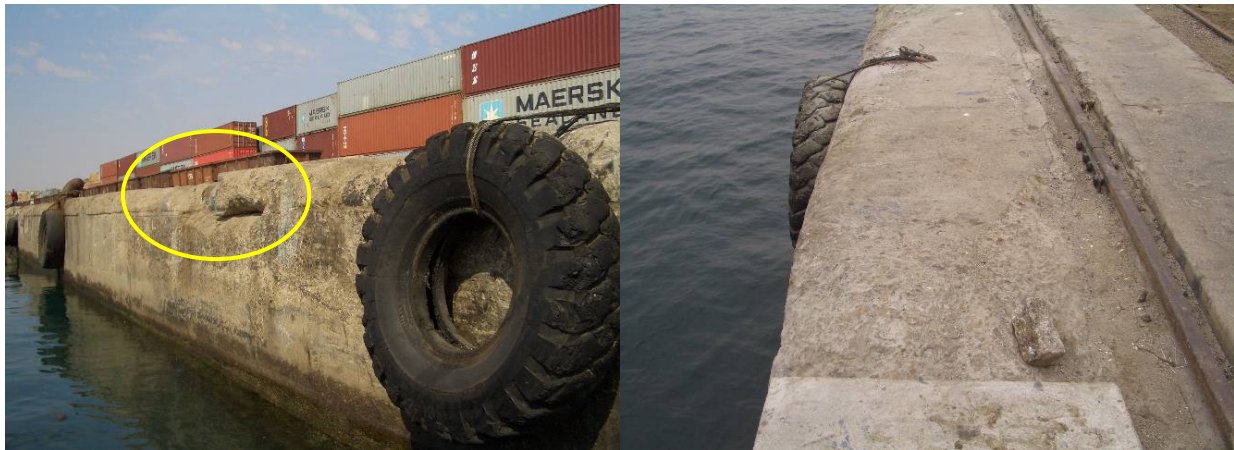
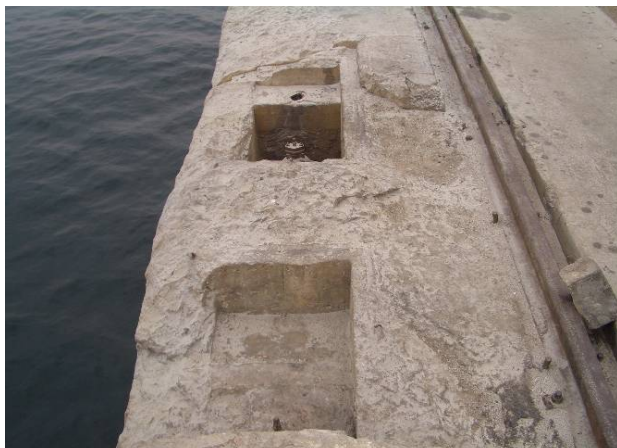
<b>Facility ID</b>	Na -02 -025	<b>Survey Date</b>	2005/05/17, 10/12
<b>Port Name</b>	Namibe	<b>Category</b>	Coping Concrete
<b>Year Constructed</b>	1953-1957		
<b>Maintenance Record</b>	unknown		
<b>Facility Description</b>	Berth No.2 From Bollard No.24 to No.25 A sewage discharge point and an water supply bulb are found.		
<b>Existing Condition</b>	The edges of the coping concrete are chipped off throughout the length of interval. There can be seen some broken parts of the coping concrete (encircled part in the photo hereunder).		
<b>Structural Condition Assessment</b>	<b>Grade 2</b>		
	The facility is in structurally bad condition. It will become the object of rehabilitation plan.		
<b>Location</b>
