# **EXISTING CONDITION OF THE WATER SUPPLY AND SANITATION / SEWERAGE SYSTEMS**

### 3.1      Water Supply System

### 3.1.2 Salaulim Water Supply Scheme

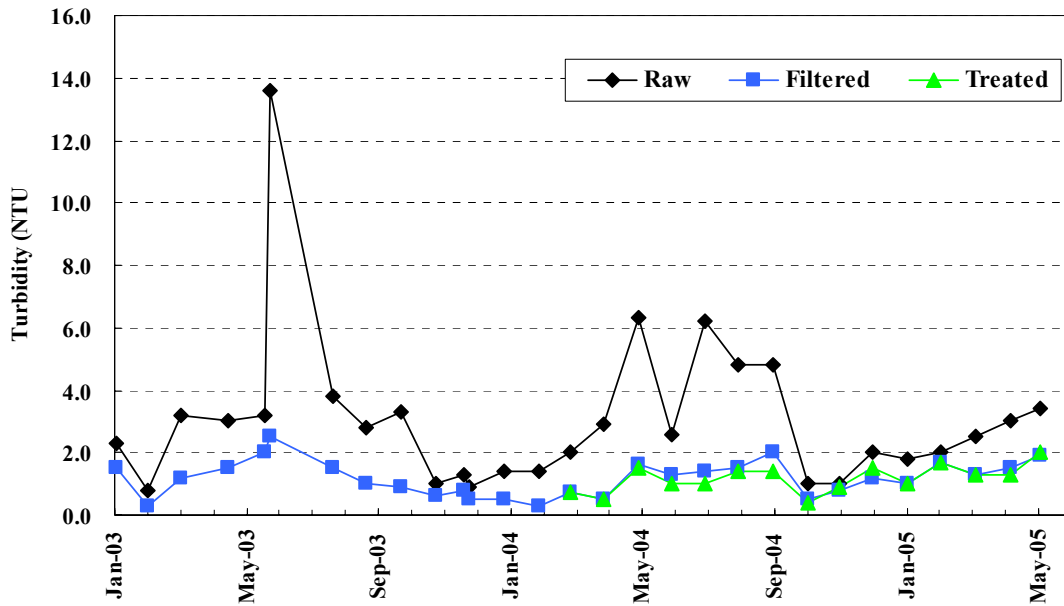
**Figure 31.6 Turbidity of Raw Water from Salaulim Dam**

The results show that the raw water turbidity at Salaulim Dam is relatively low and that there are no significant fluctuations resulting from rainfall runoff during the wet season.

The Manual on Water Supply and Treatment (Ministry of Urban Development, CPHEEO, May 1991) recommends that turbidity of water that is delivered to consumers should not exceed 1 NTU. Generally the turbidity of the treated water at the Salaulim WTP exceeds 1 NTU. This high turbidity may result of the poorly functioning treatment process.

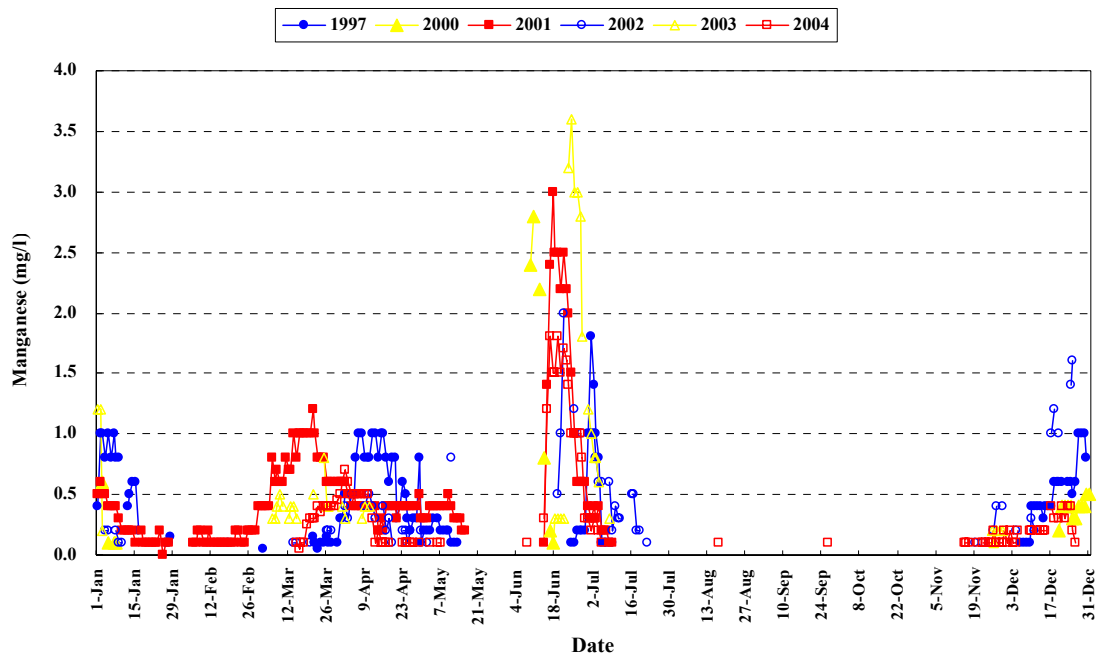
**Figure 31.7 Manganese Concentration in Raw Water at Salaulim WTP**

Figure 31.7 shows that the concentration of manganese in the raw water in 1997 and from 2000 to 2004 was relatively high. Therefore, it might be necessary for upgrades to the WTP to consider manganese treatment.

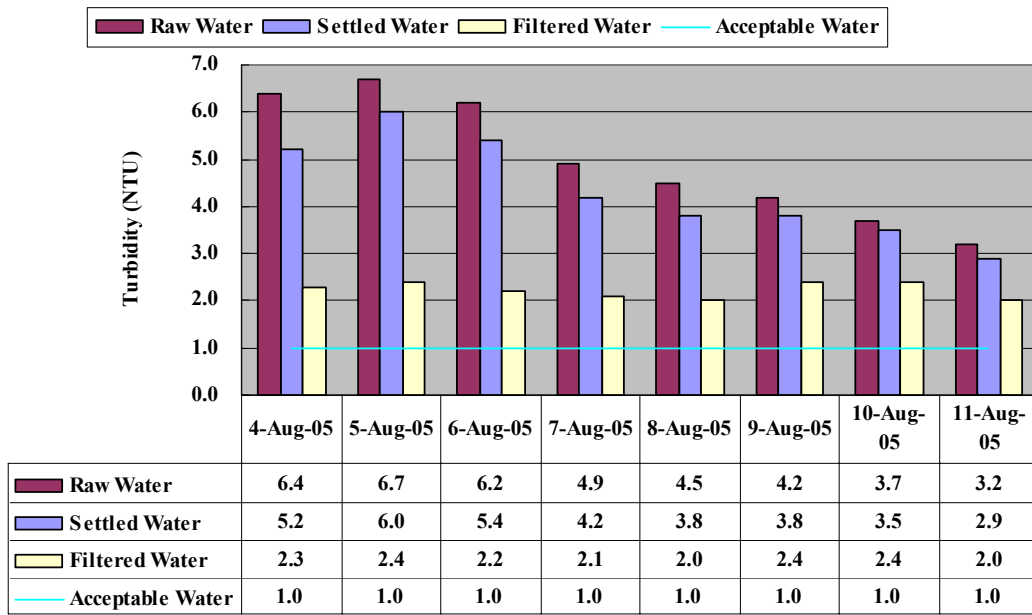
**Figure 31.8 Reduction of Turbidity as a Result of the Treatment Process at the Salaulim WTP**

The sedimentation basins are not effectively managed because the inflow turbidity and pH are not adequately understood. An understanding of these parameters is required to determine the correct chemical dosing rates. Figure 31.8 shows that turbidity is not effectively reduced.

Figure 31.8 shows that the majority of turbidity is removed at the filtration basin. When turbidity levels are high and therefore the sediment load at the filtration basin is large, more frequent backwashing of the filters is required.

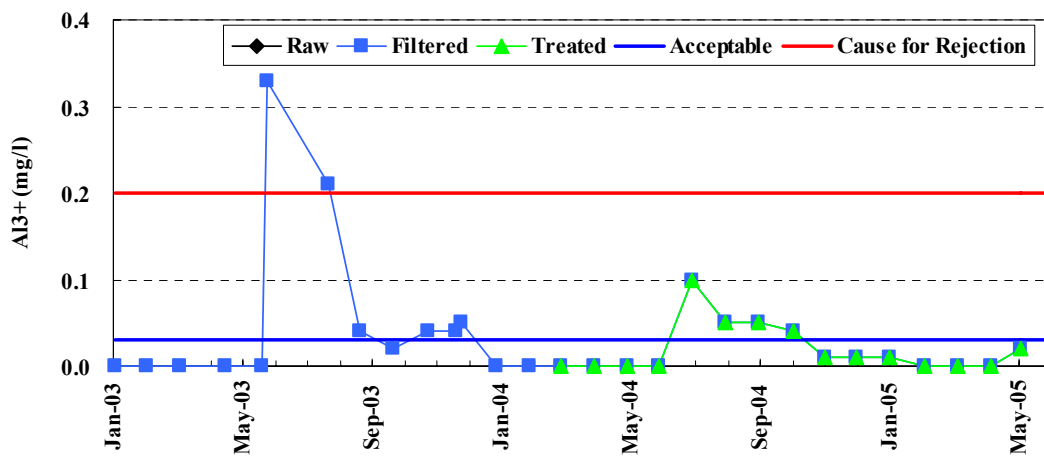
**Figure 31.9 Concentration of Aluminium in Treated Water**

The aluminium concentration in the treated water is shown in Figure 31.9. The presence of aluminium in the treated water indicates that the chemical dosing rates are not well controlled or that the mixing is not sufficient.

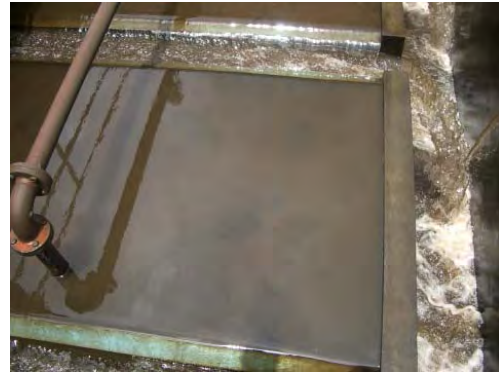
**Photo 31.1 Backwashing at Salaulim WTP**

The field investigation found that turbid water is discharged from the filter even immediately after the filter is backwashed (see Photo 31.1). This may be because the backwashing procedure (which uses air scouring) is not sufficient, for example the duration of backwashing is not sufficient, and/or there is a structural problem of the filter basin.

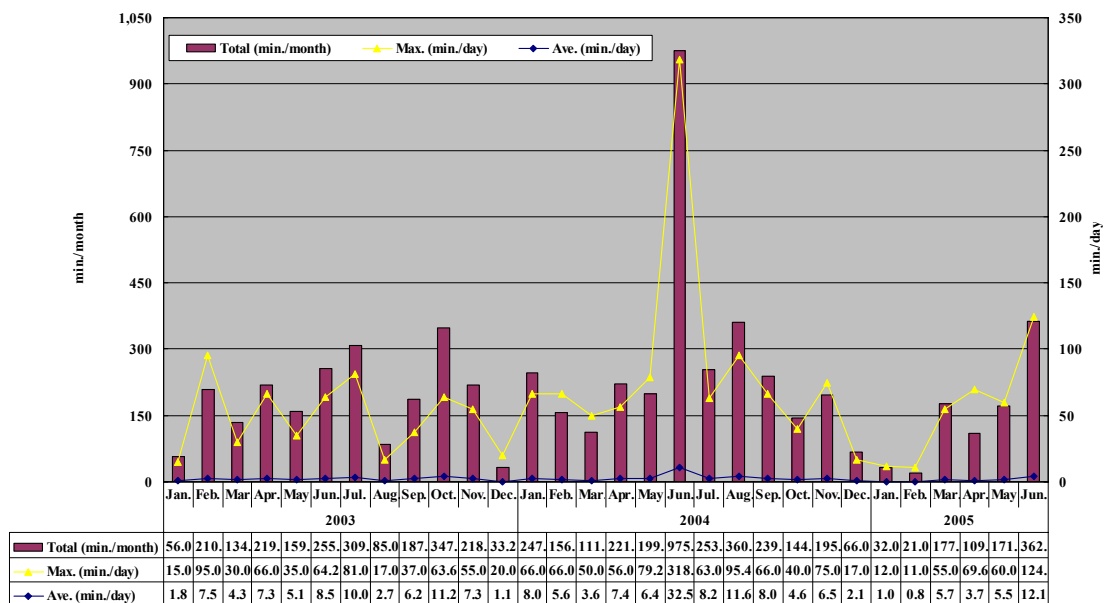
**Figure 31.10 Power Outages in 2004**

During 2004, the operation of the Salaulim WTP was interrupted for approximately 3,170 minutes (8.7 minutes/day, on average) as shown in Figure 31.10.

To prevent intermittent water supplies and damage to facilities resulting from water hammer effects, the following measures to protect against power outages should be considered:

- provide surge control to address water hammer problems;
- provide a standby electrical power generator; and
- provide sufficient reservoir capacity to store water.

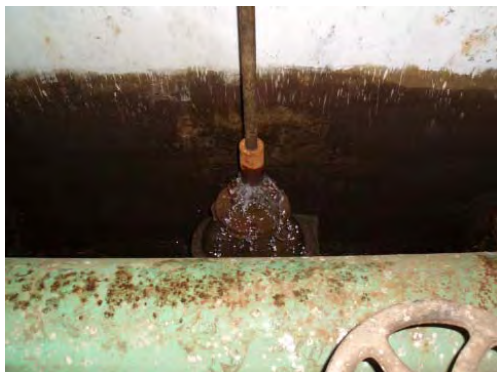
There are many visible leaks at the WTP and at almost all the air valves along the transmission mains (see Photos 31.2 and 31.3). As the first step towards reducing leakages, reactive measures to fix visible leaks should be implemented.

**Photo 31.2 Leakage from Valve at Salaulim WTP**

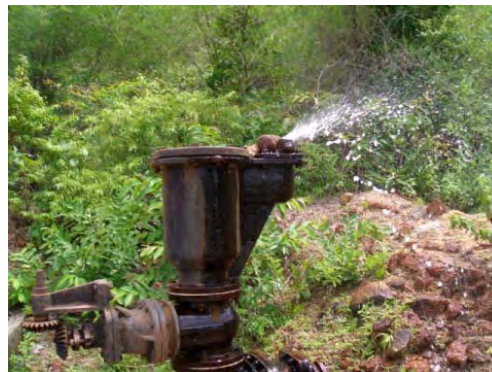
**Photo 31.3 Leakage from Air Valve along the Transmission Main**

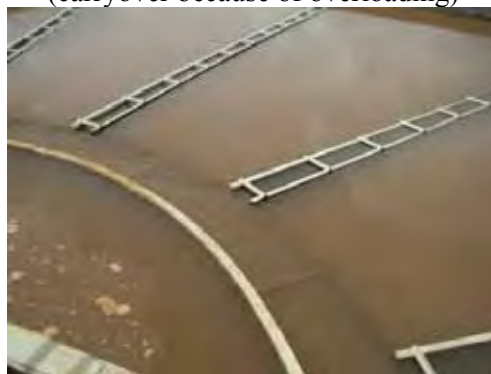
Figures 31.17 and 31.18 indicate that the turbidity of the raw water and the settled water are similar. This means turbidity is not reduced by the sedimentation basins (see Photo 31.5). The sedimentation basins are inefficient because the chemical dosing rate cannot be accurately determined due to the lack of information regarding turbidity and pH of the water being treated.

**Photo 31.4 Sedimentation Basin at Plant IV**  
(carryover because of overloading)

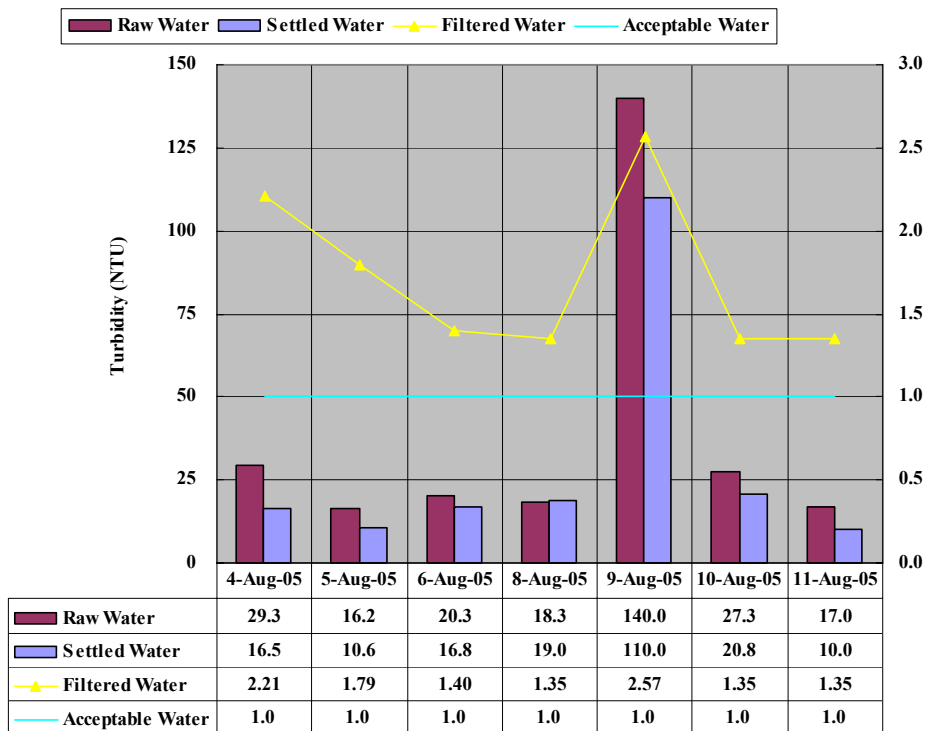
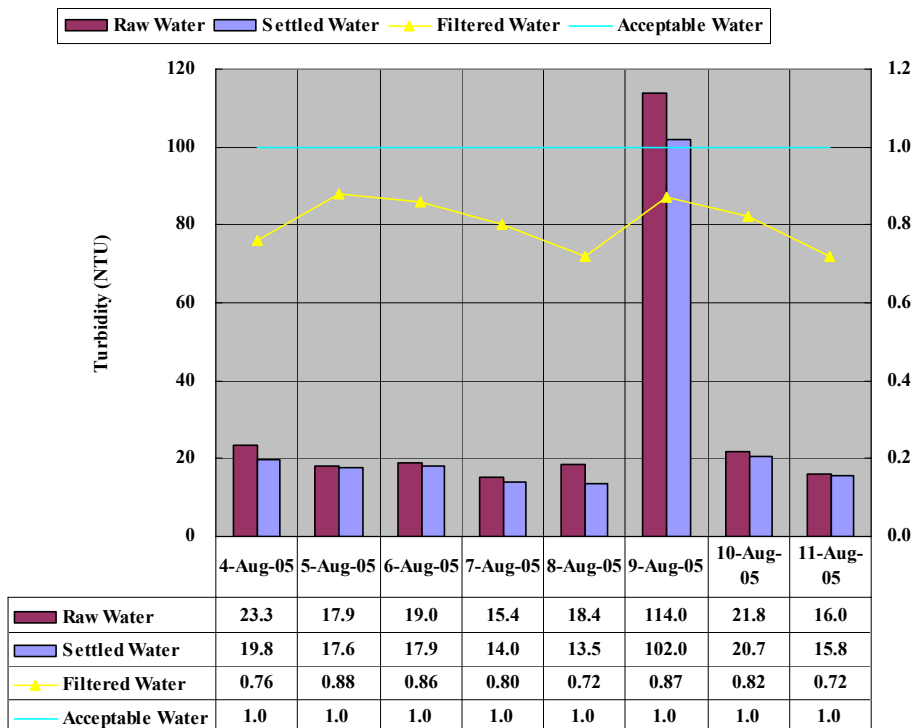
These figures show that the filtration basin removes most of the turbidity. As turbidity increases more frequent backwashing of the filters is required. The filtration rate of Plant IV (40 MLD) is 10.2 m/hr on average. A standard filtration rate is 4.8 to 6.0 m/hr. This rate may result in high turbidity levels in the treated water.

(Ministry of Urban Development, CPHEED, May 1991) recommends that the turbidity of water delivered to the consumers should be less than 1 NTU. The treated water turbidity at Plant III (52 MLD) exceeds 1 NTU. This may be because the treatment process does not function well.

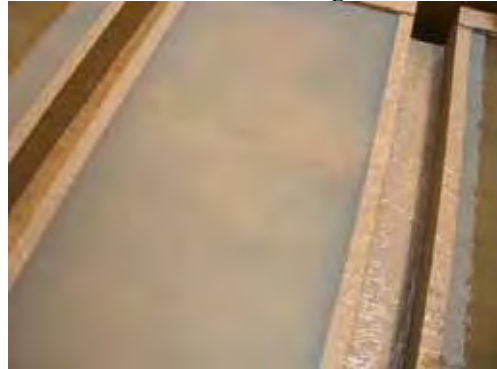
**Photo 31.5 Backwashing at Plant IV**

The field investigation indicated that the water coming out of the filter is turbid (see Photo 31.6). This means that backwashing (using air scouring) may not be sufficient because the duration of backwashing is not sufficient and the sequence is not appropriate and that there may be a structural problem of the filter basin.

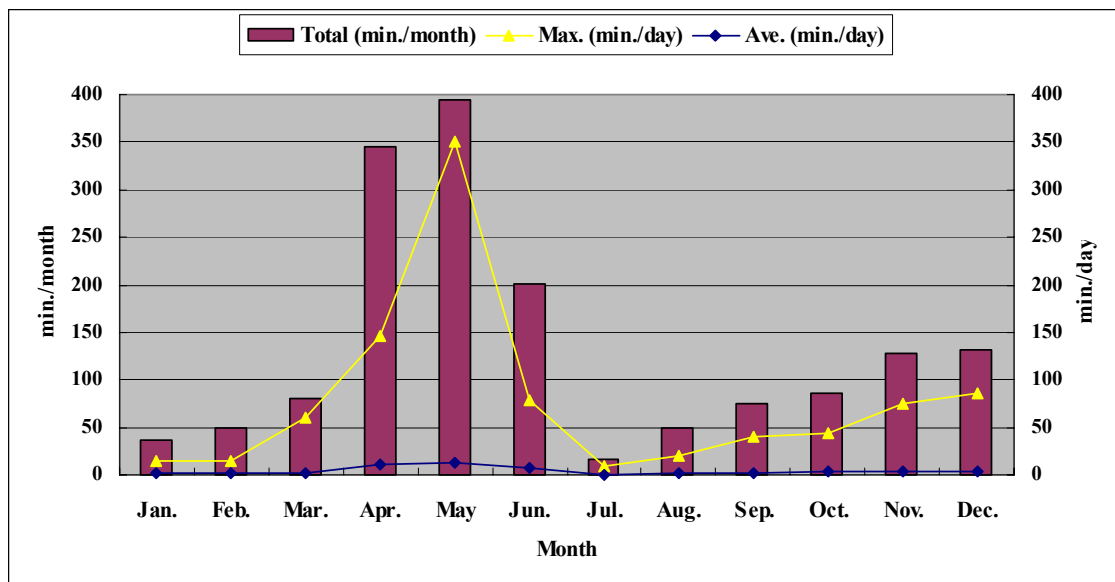
**Figure 31.19 Power Outages During 2004**

There were 36 days during 2004 when the Opa WTP experienced power outages. In total, there was no power for 1,594 minutes, as shown in Figure 31.19.

Power outages result in intermittent water supplies and facilities are damaged from water hammer. The following protective measures should be considered:

- surge control to address the water hammer problems;
- install a standby generator; and
- ensure the reservoirs have sufficient capacity to store water.

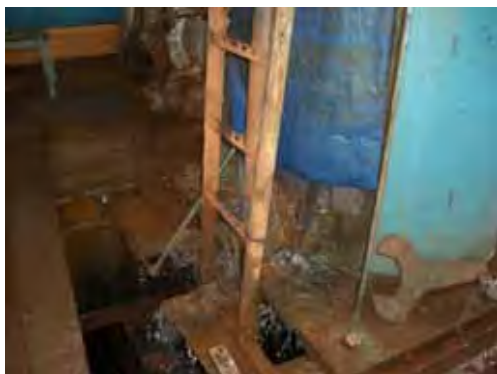
There are many visible leaks at the WTP and along the transmission mains (see Photos 31.7 and 31.8), however there are fewer leaks than at the Salaulim WSS. The first step to reduce leakage should be a reactive approach of fixing visible leaks.

**Photo 31.6 Leakage from Intake Pump at the Curti Plant**

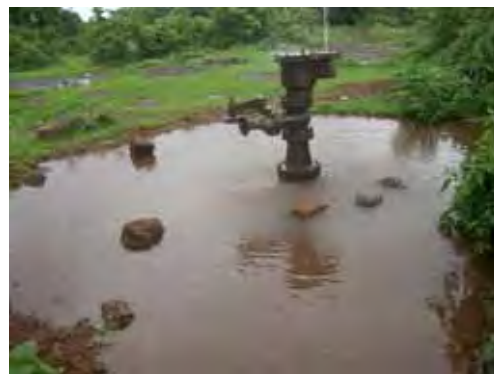
**Photo 31.7 Leakage from Air Valve along the Transmission Main**
