3.1.4 Chandel Water Supply Scheme

3.1.5 Assonora Water Supply Scheme

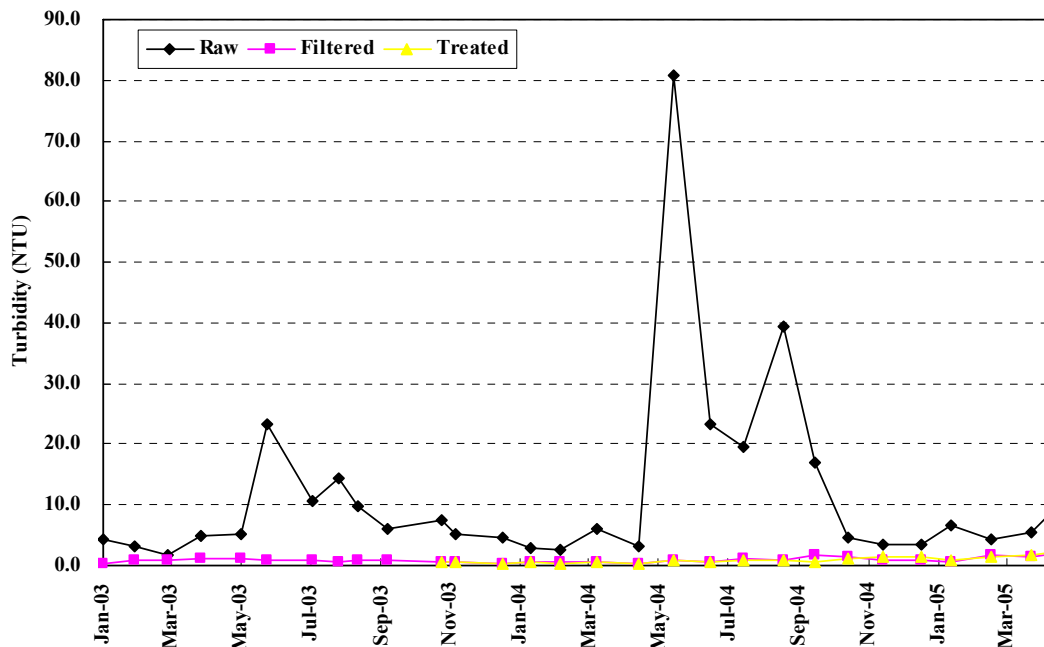
Figure 31.22 Turbidity of Raw Water taken from Kalana River

The results show that the turbidity levels of the raw water taken from Kalana River fluctuate. This is particularly evident during the wet season (May to October) when turbidity increases as a result of rainfall runoff.

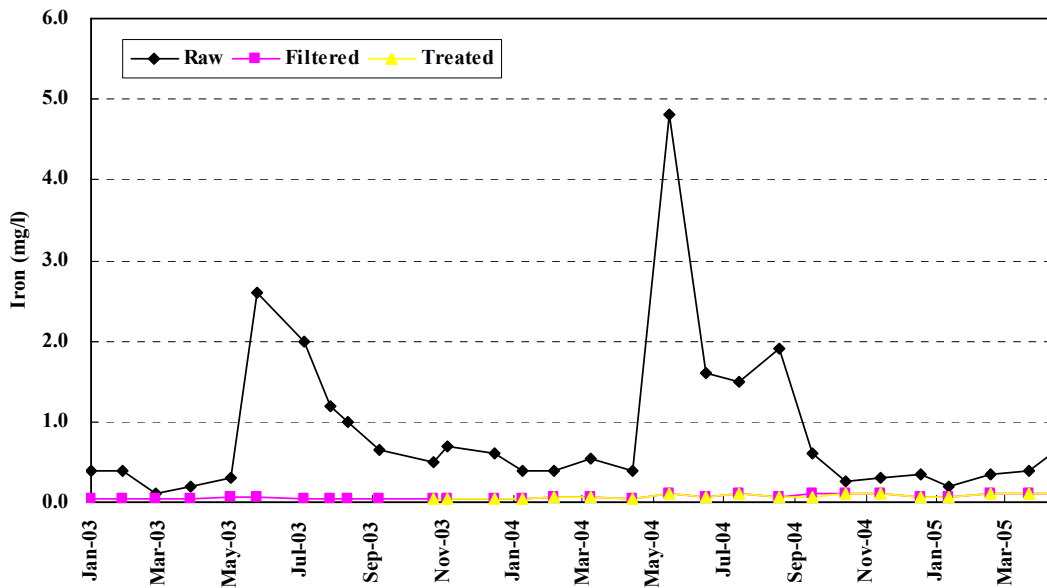
Figure 31.23 Iron Concentration in the Raw Water delivered to the Chandel WTP

Figure 31.23 shows the concentration of iron (Fe) in the raw water from 2003 to the present. This figure shows that the concentration of iron occasionally increases.

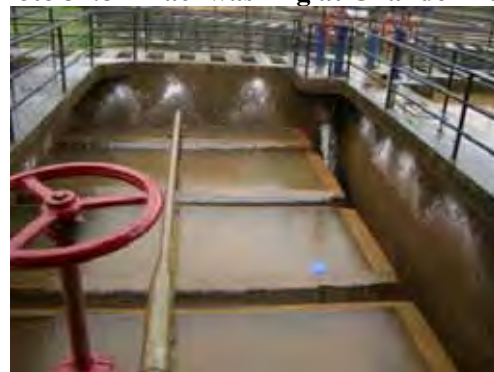
Photo 31.8 Backwashing at Chandel Plant

The field investigation found that turbid water is discharged from the filter even immediately after the filter is backwashed (see Photo 31.9). This may be because the backwashing procedure is not sufficient, for example the duration of backwashing is not sufficient, and/or there is a structural problem of the filter basin..

(There are many leaks from the concrete wall)

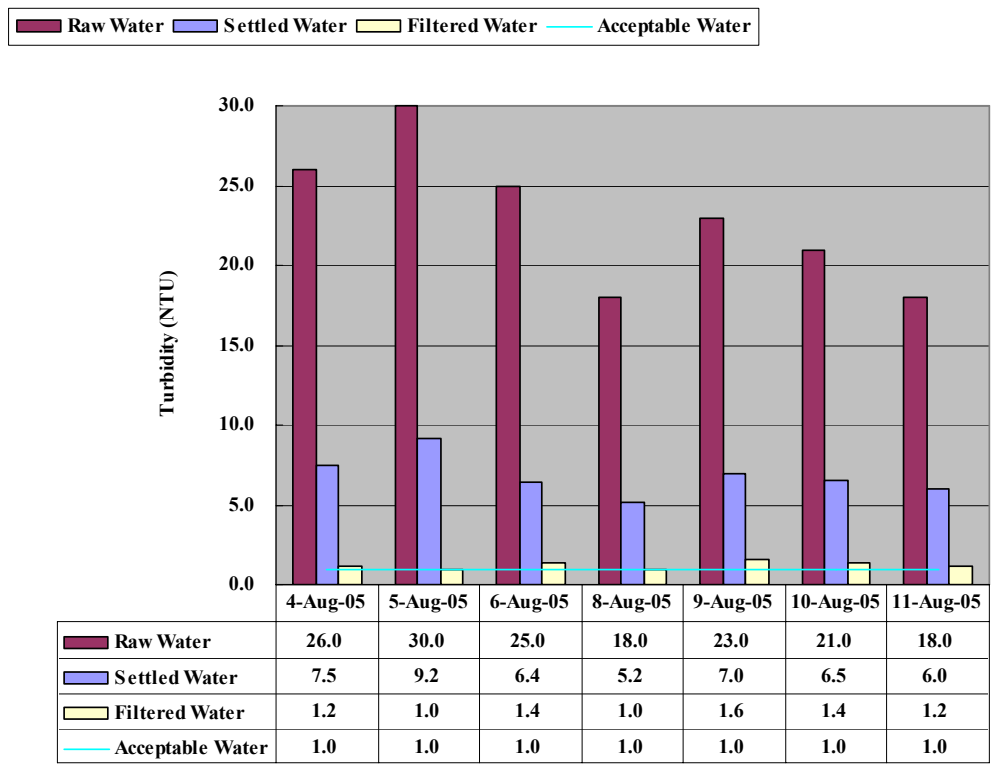
Figure 31.30 Turbidity Reduction at the Assonora WTP (12 MLD)

Figures 31.30 and 31.31 show the turbidity of the raw water, the settled water and the filtered water for the 12 MLD and 30 MLD plants. Comparing these results to the results from the other schemes, it seems that the sedimentation and filtration processes are functioning effectively. However, the turbidity of the filtered water exceeds one NTU.

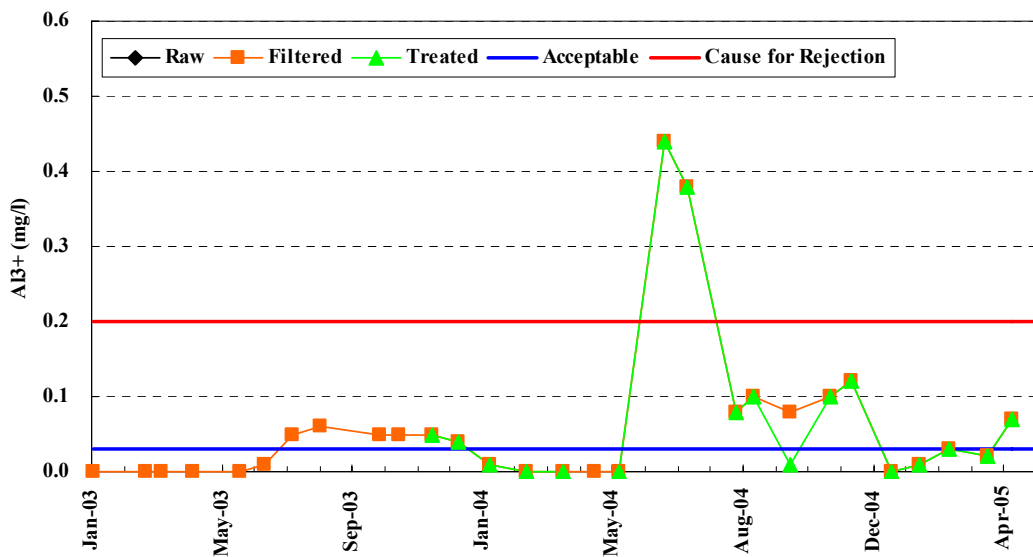
Figure 31.32 Concentration of Aluminium in the Treated Water

The aluminium concentration in the treated water is shown in Figure 31.32. The presence of aluminium in the treated water indicates that the chemical dosing rate is not adequately controlled or that the mixing is not sufficient.

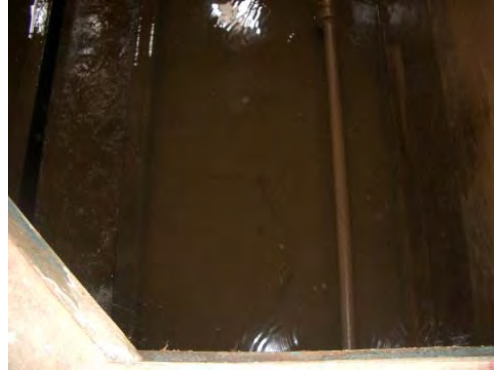
Photo 31.9 Backwashing at Assonora Plant

The water discharged from the filter, just after it had been backwashed, was turbid (see Photo 31.10) indicating that the backwashing process may be inadequate and there may be a structural problem of the filter basin.
