### 3.1.6 Sanquelim Water Supply Scheme

**(6) Problems Identified**

The following problems were identified with the Sanquelim WSS during the Reconnaissance Survey, as part of Phase I of this project:

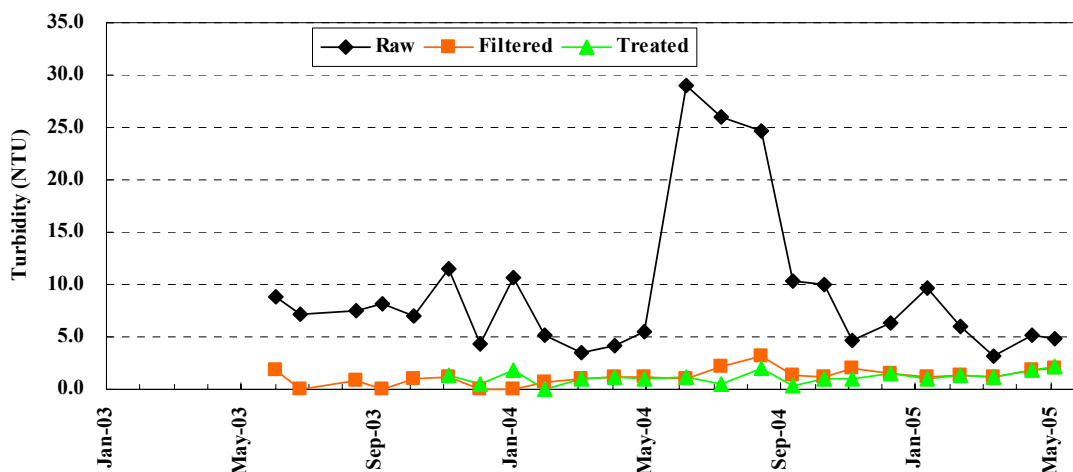
**Figure 31.35 Turbidity of Raw Water at the Podocem WTP (40 MLD)**

The test results show that the turbidity of the raw water from the Valvant River fluctuates, particularly during the wet season (May to October) when turbidity levels increase as a result of rainfall runoff. The turbidity levels of the raw water at the Podocem WTP were found to be very similar to those at the Sanquelim WTP (12 MLD). This would be because the water for these two plants is sourced from the same river.

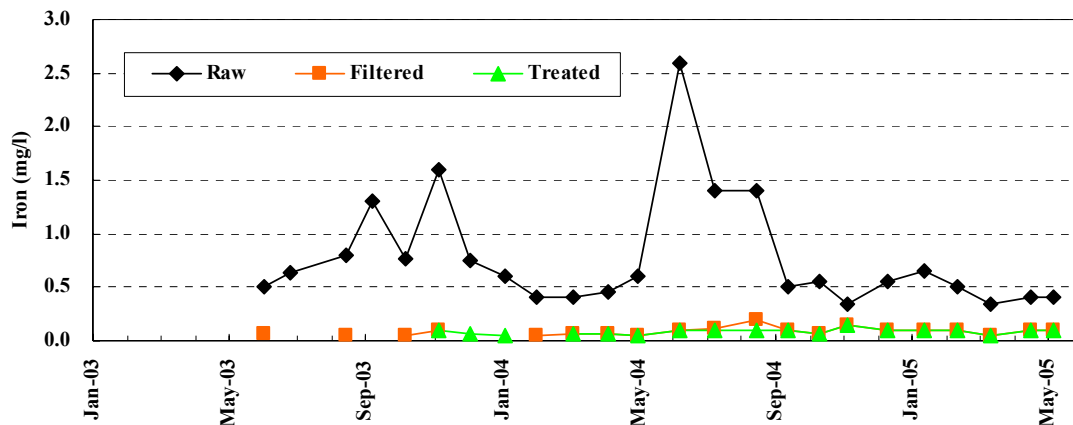
**Figure 31.36 Iron Concentration in the Raw Water at the Podocem WTP**

Figure 31.36 shows the concentration of iron (Fe) in the raw water at the Podocem WTP from 2003 to present. The results indicate that the concentration of iron occasionally increases.

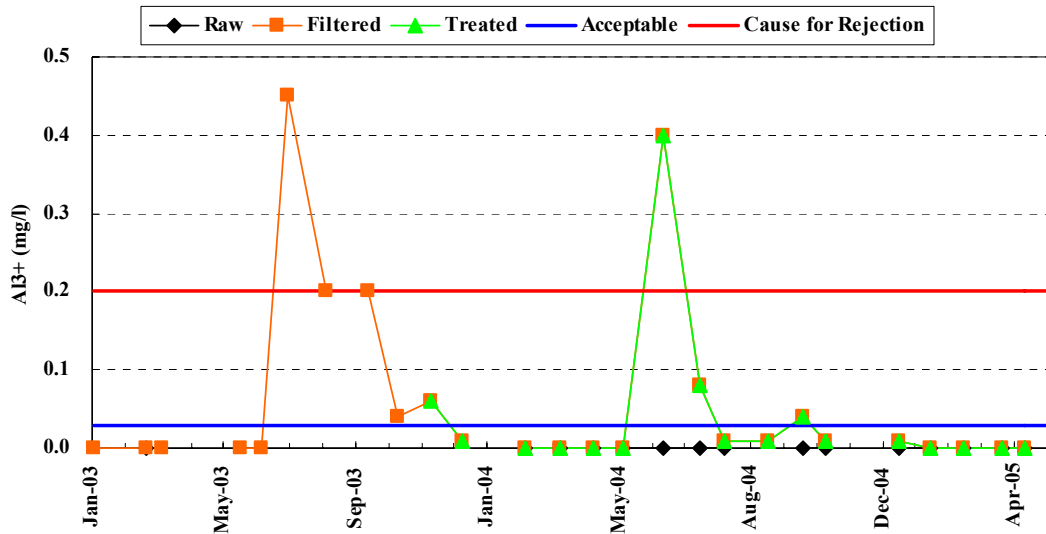
**Figure 31.37 Aluminium Concentration in Treated Water at the Sanquelim WTP (12 MLD)**

Figure 31.37 presents the aluminium concentration in the treated water. The presence of aluminium in the treated water indicates that chemical dosing is not managed properly or that the mixing is not sufficient.

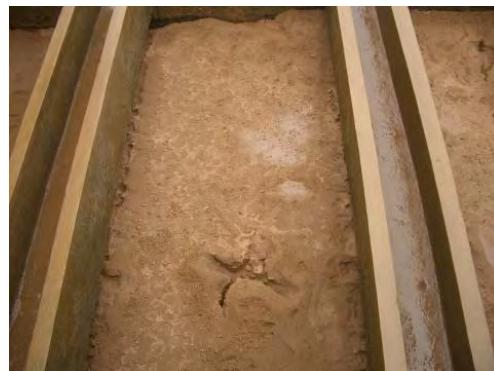
**Photo 31.10 Filter Media of Podocem Plant**

The field investigation found the filter sands contain a lot of mud, the filter media layers are not uniform (see Photo 31.11) and water discharged from the filter, just after it has been backwashed, is turbid. This means that backwashing may not be sufficient because the duration of backwashing is not sufficient and that there may be a structural problem of the filter basin.

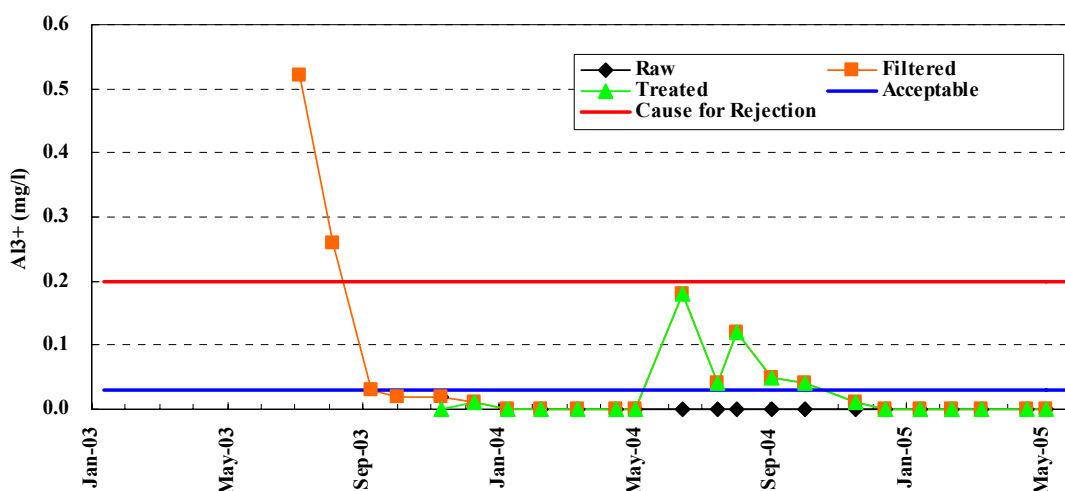
**Figure 31.42 Aluminium Concentration in Treated Water at Dabose WTP**

The aluminium concentration in the filtered and treated water is shown in Figure 31.42. The presence of aluminium in the treated water indicates that chemical dosing is not managed properly or that the mixing is not sufficient.

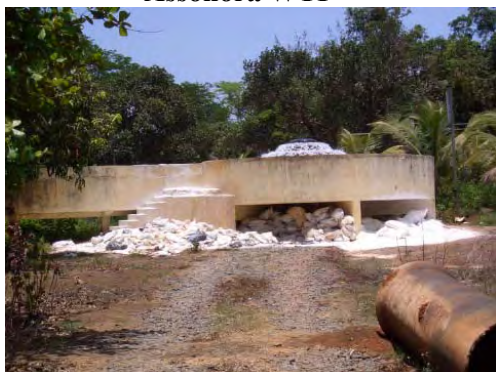
**Photo 31.11 Chemical Storage at the Assonora WTP**

Photos 31.12 and 31.13 show the inadequate chemical storage conditions at the Assonora WTP and the Dabose WTP, respectively. The other WTPs have similar poor storage conditions.
