Flood and Debris Flow Study

**THE STUDY ON FLOOD AND DEBRIS FLOW
IN THE CASPIAN COASTAL AREA
FOCUSING ON THE FLOOD-HIT REGION
IN GOLESTAN PROVINCE**

PAPER IX FLOOD AND DEBRIS FLOW STUDY

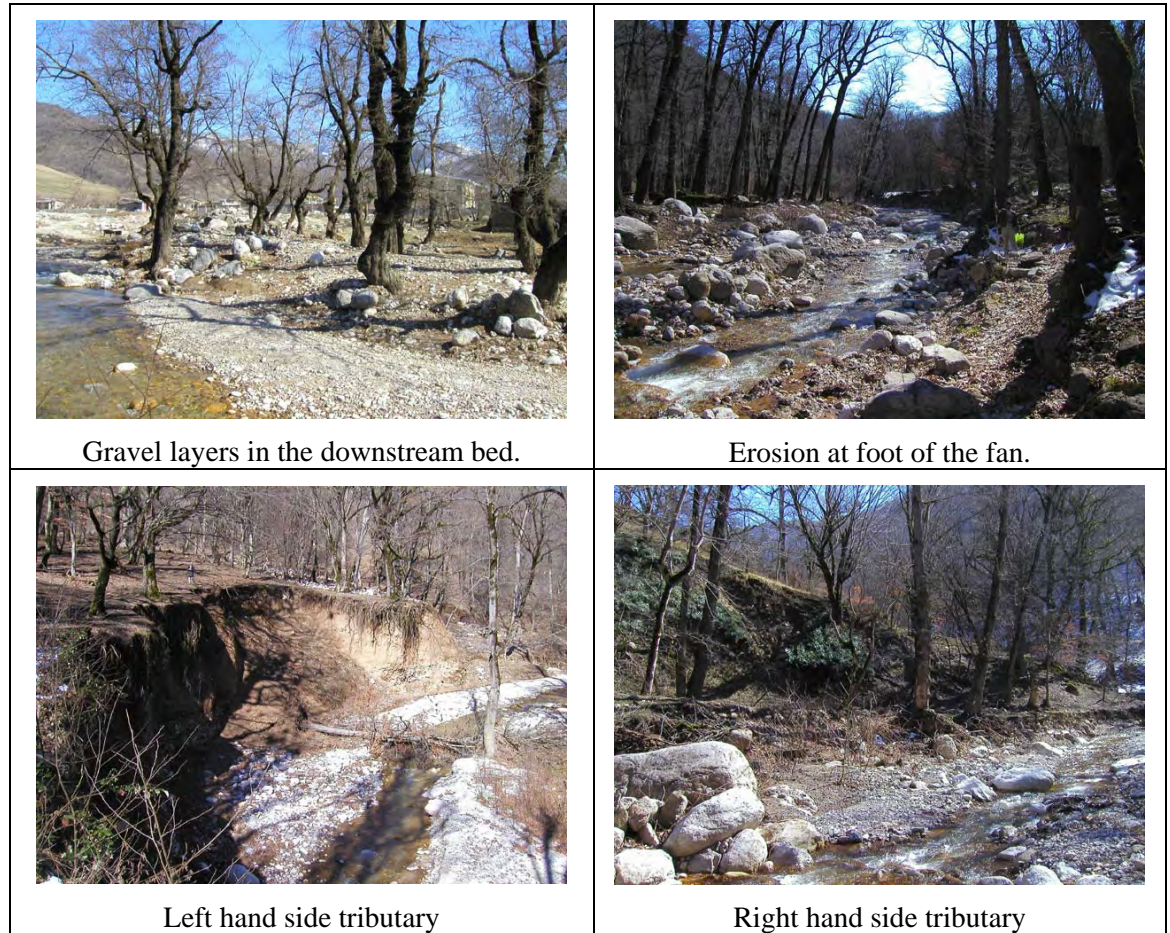
Figure 4.3 Debris Condition of T1 Valley

Considering the long and gentle slope of the streambed in the downstream and the wide catchment area and rainfall records in Tangrah, there were not much potential on debris flow but much potential on flash flood bringing serious damages to the areas along the valley.

Flood control facility was required to protect residence and public facility against flash flood while protection works against debris flow was not required.

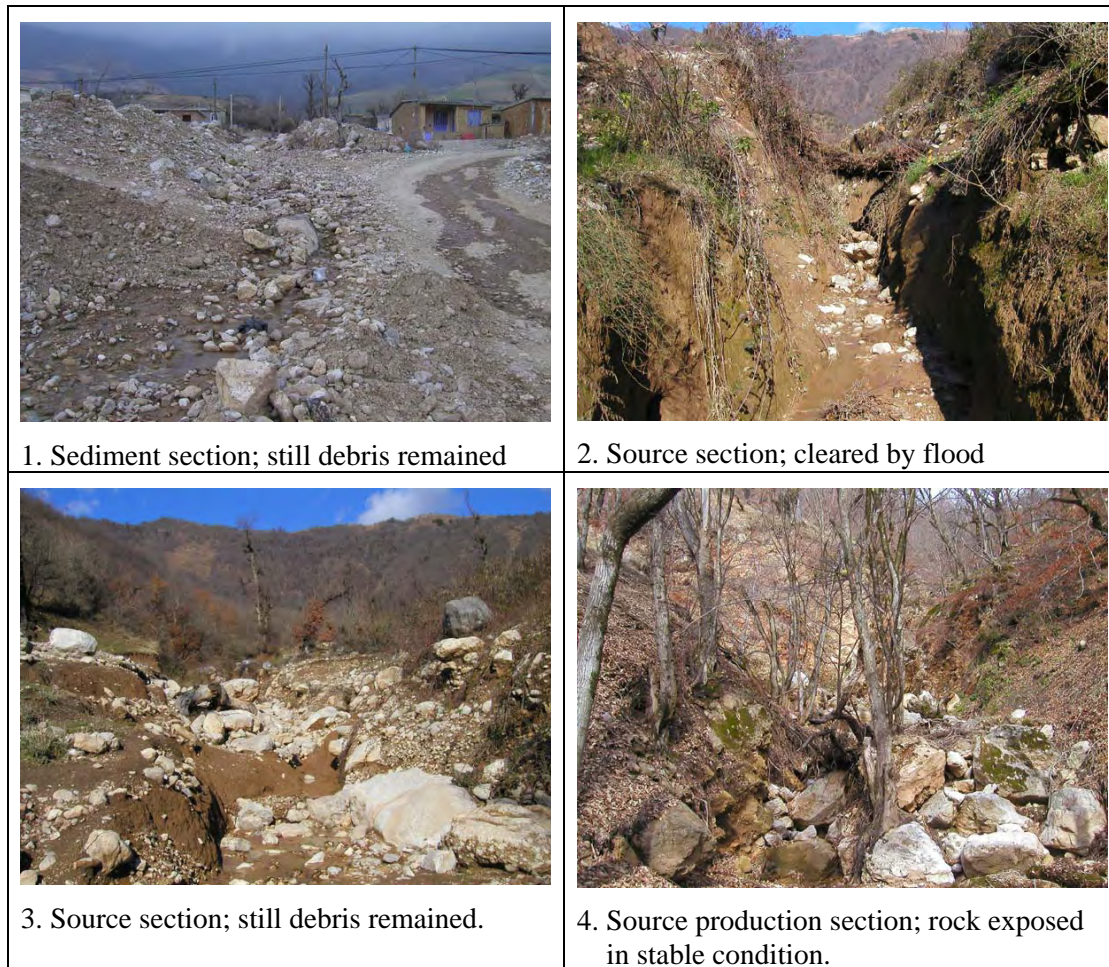
Figure 4.6 Debris Condition in T4 Valley

Trace of the ditch suggested that debris flashed out to the village was originated from the ditch section while debris from further upstream area was not much appeared.

Debris rested in the right upstream of the road still had potential hazard that flash flood was diverted to residential area by blockage of debris deposition or caused debris flow splash up to the road.

1. Clear the remaining of debris deposit from the Terjenly Village property.
2. Consolidate the mass of debris deposit at the upper end of the ditch to prevent recurrence of debris flow in this valley.
3. Provide the waterway crossing the road to drain floodwater directly to the Madarsoo.
4. The Team had been still studying design discharge for hydraulic structure taking account into the rainfall records after 2001-flood while MOJA Golestan had adopted 30 cu.m/sec for the Tangrah Basin, which was based on the records before the 2001-flood
5. Warning with forecasting debris flow occurrence was useful for the residents to evacuate from the hazard at the right time.

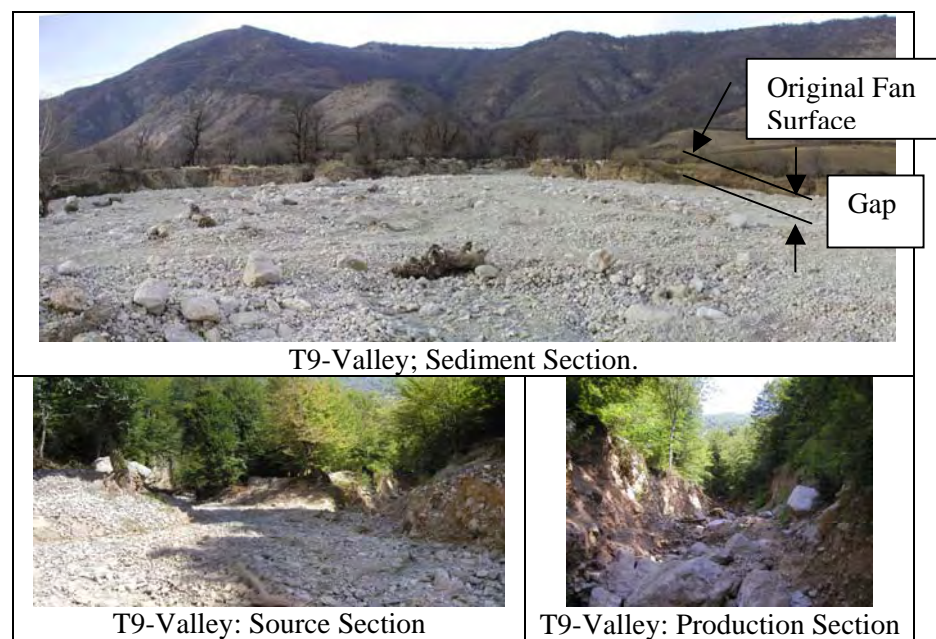
Figure 4.9 Debris Condition of T9 Valley

T9-Valley had had debris flow, which was spilled out to the road, in 2001-flood. Source section still had debris accumulation, even though some parts of it were washed out in 2001-flood.

1. Maintain clearing the sediment section to provide a pocket for the future debris flashed out.
2. Monitor the debris condition. In case in future debris would spill out of the dams and reservoirs, additional dams and excavation should be required.
3. Provide waterway through the pocket area crossing the road with a bridge to drain floodwater to the Madarsoo.

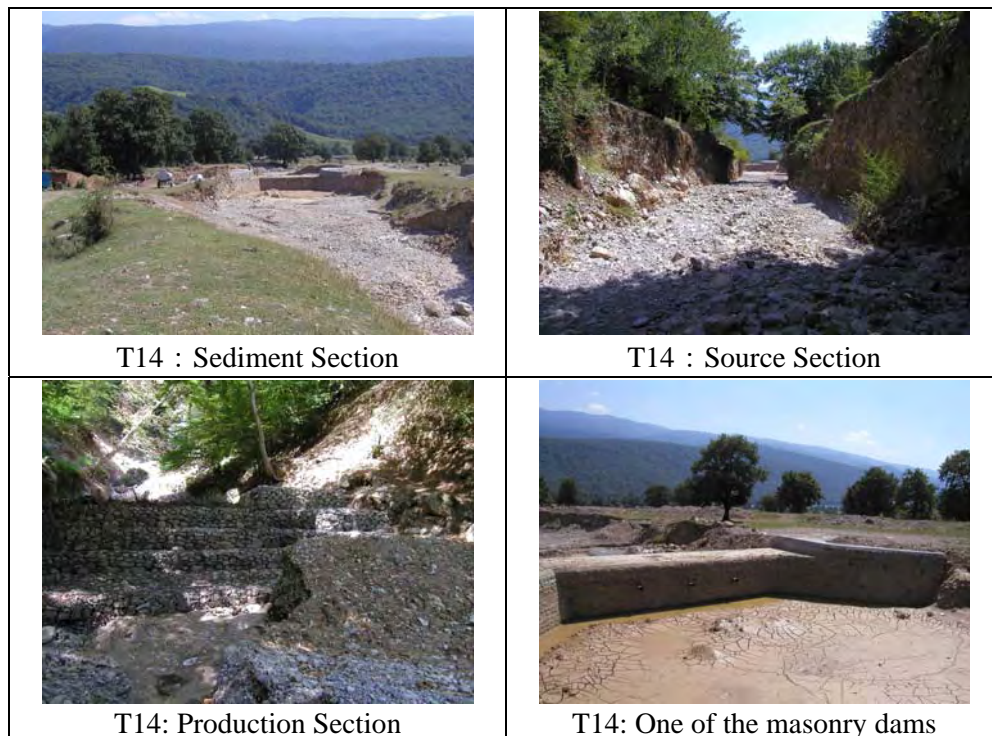
Figure 4.12 Debris Condition of T14 Valley

It was found through site observation on that SV-3 had considerably high productivity of the debris unlike SV-2 and 3 among several sub-valleys in the source production section. Six gabion-dams founded right downstream of SV-3 should function to receive the debris in their capacities.

1. Monitor bank erosion in the source section 1, and sedimentation in the dam reservoirs after the flash floods occurred.
2. Empty the debris accumulated in the dam reservoirs of the masonry dams after flash flood occurred in future.

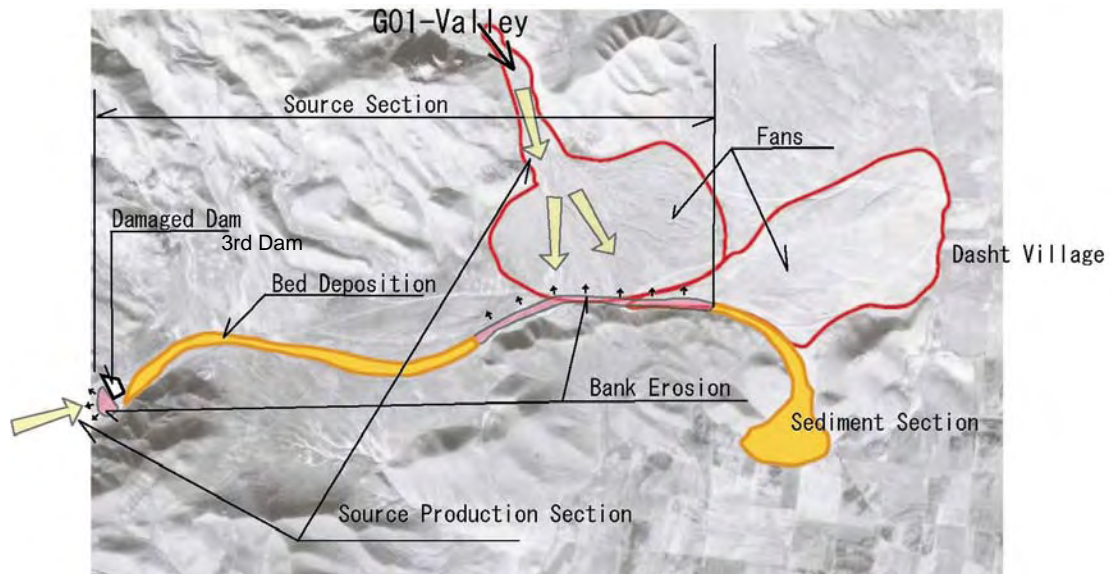
Figure 4.14 Schematic Concept of Debris Movement in Ghyz Galeh

Therefore, source of the debris spread over the Dasht farmland was considered to originate from the area between the broken dam reservoir and eroded portion of the fans.

After 2001-flood, MOE North Khoransan Province excavated debris to secure the waterway and embanked surrounding the village to protect from flooding.

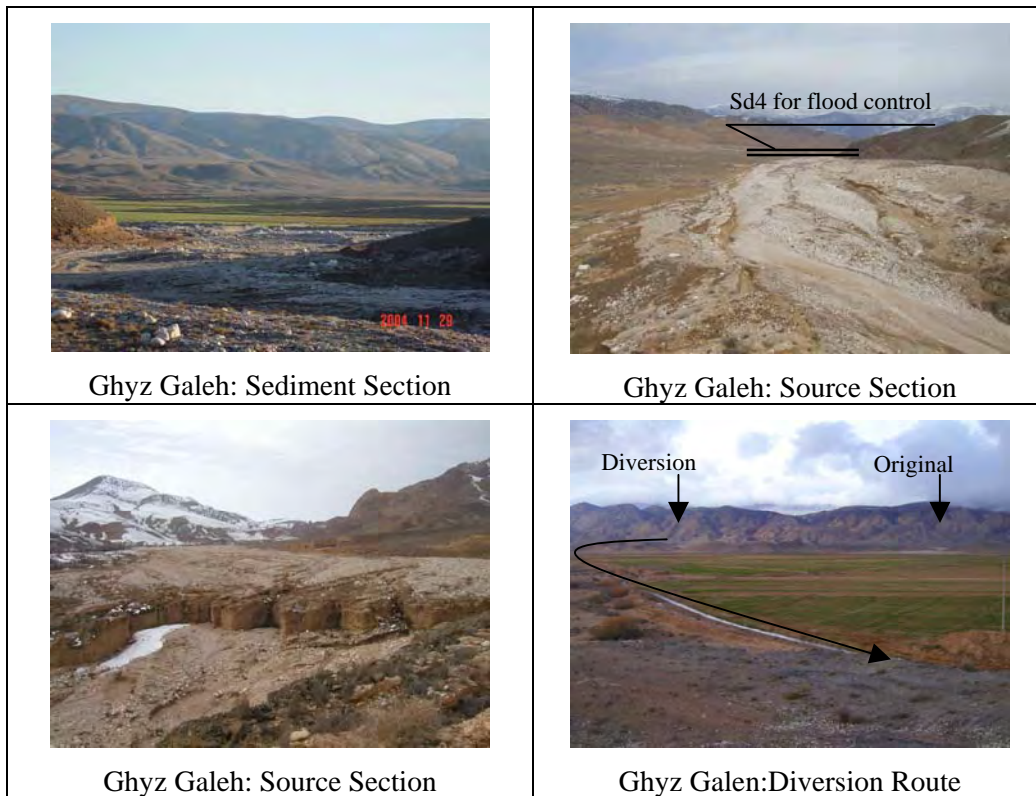
Figure 4.15 Debris Condition in the Ghyz Galeh

Another active source was the sediment lay between the dam and the fan, which was the direct source supplying debris to the Dasht farmland in 2001-flood and still remained with debris, which had been supplied directly from the reservoir erosion of the third dam.

Therefore, countermeasures should be prepared taking into account such sediment and erosion. Considering geographical condition, diverting the waterway to dodge from the fan erosion portion could be applicable for the countermeasure.
