4.2 Damage Estimation for Facilities and Equipment

4.2.1 Preliminary Seismic Diagnosis

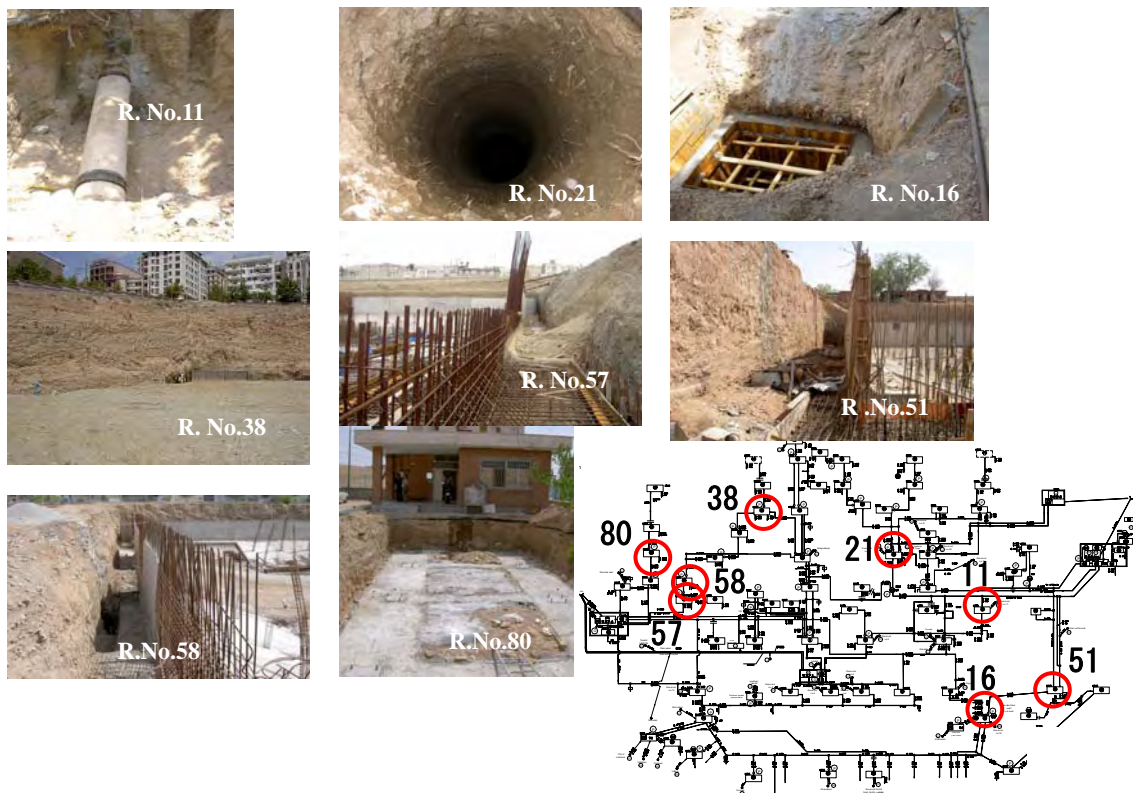
Picture 4.2.1 Ground Condition on Reservoir Sites

- Reservoir No.11 in northeast: Exposure of inlet pipe
- Reservoir No.21 in north: Underground-pipe works and construction of chamber and sewage pit
- Reservoir No.16 in southeast: Construction site of manhole
- Reservoir No.38 in northwest: Ground wall
- Reservoir No.51 in west: Extension field of Reservoir
- Reservoir No.57 in northwest: Extension field of Reservoir
- Reservoir No.58 in northwest: Extension field of Reservoir
- Reservoir No.80 in northwest: Foundation works of telemetry house

Moreover, it is observed that soil is cohesive and that there is no ground water from the construction situations of reservoir No.16 in southern alluvial fan. RC manhole was made without formwork, concreting using excavated ground face, only by inside formwork. Probability of liquefaction is low.

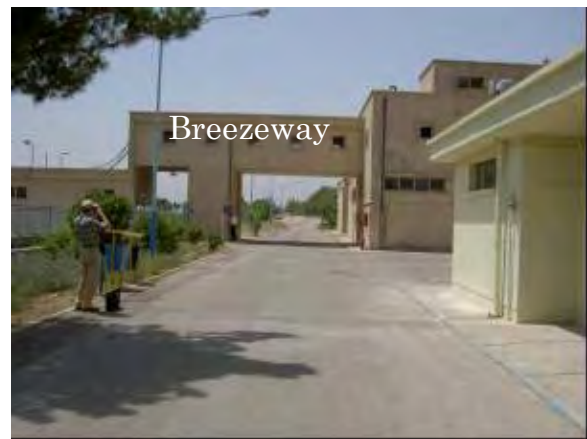
Picture 4-2-2 chemical House

- The conditions of principal structure of water tanks and buildings look good because of good foundation, so they have high earthquake resistance.
- Although it is not directly related to the dependability of structure, water has leaked at Filter and it is necessary to repair expansion joint.
- Breezeway exists from Chemical House to Dosing Point. End support of Breezeway is a structure, which might be damaged at the time of earthquake due to twisting moment. Detailed study is required.

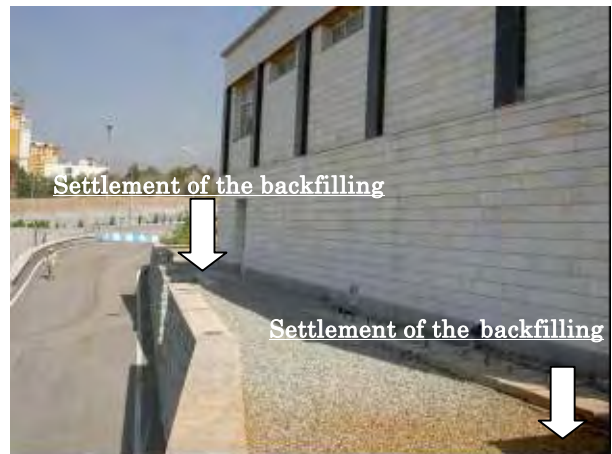
Picture 4-2-3 Chemical House

- Earthquake design was applied to this WTP; therefore the principal structure has high earthquake resistance. But what the structures is located on the fault, had to be considered.
- Settlement of the backfilling around Chemical House was observed (Picture 4-1-3). The influence was indicated by the existence of crack at external staircase or retaining wall, the cave-in of the ground, etc. But the settlement has not affected beams or columns. It is thought that there is no problem in a frame because the deformation was small or negligible. Since the backfilling ground is not stable yet, there is high possibility of affecting the surrounding retaining wall. Therefore,

- This WTP has used new construction material which is not used in other WTP(s). This might cause new issues for earthquake-resistant design. There is the possibility of curtain wall falling or detaching marble veneer used for the wall outer finishing or columns of the building. The probability is high that these non-structural members including windowpane might get broken in case of earthquake, or might get separated, and fall off and may harm the human being present nearby.

a certain countermeasure is possibly required in the future.

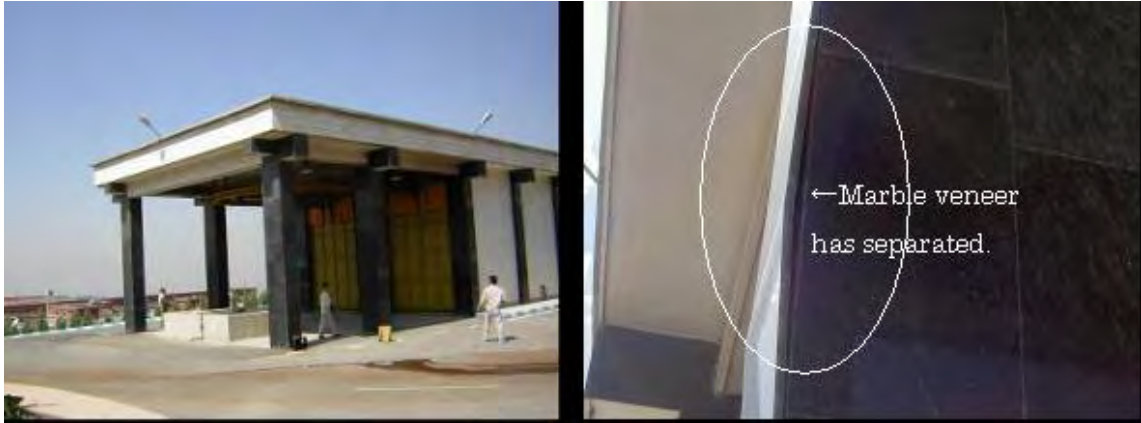
Picture 4.2.6 Chlorine House

Installation of large marble veneer to columns is not stable in chlorine house. Since marble veneer has already fallen down, and installation position is high, it is dangerous in case of earthquake. It is recommended to strip off all of them and re-install or fix them by anchor bolts. In the case of stone-finish, metal strap anchor is used for the slates to fix them to the wall. Being attached only with mortar without metal strap anchor as observed in Tehran, slate panels may easily detach in case of an earthquake.

Since a slate is heavy and easy to fall from concrete in case of occurrence of earthquake, there is a fear of accident that might cause injury or death as a result of falling down as it is attached at relative heights. Needless to say even though the height of buildings is low, there is the necessity for reinforcement of this building.

Fixation of marble veneer finish of chlorine house at WTP No.5 is proposed.

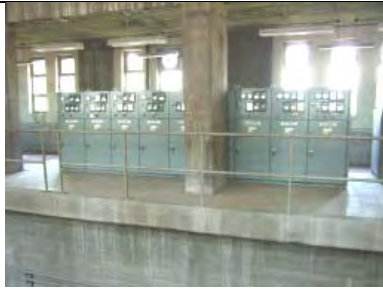
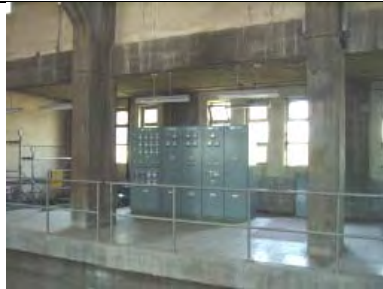
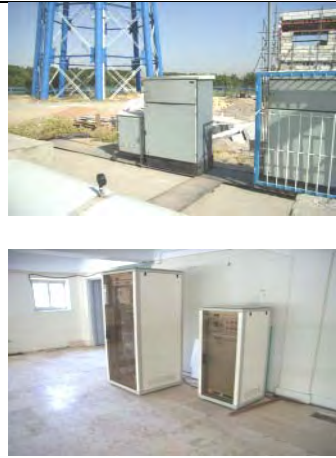
Table 4.2.4 Self-standing Panel

Fixed with foundation bolt	Fixed with foundation bolt	Fixed with welding, or not fixed at all

To confirm whether those panels are earthquake resistant or not, strength calculations of the foundation bolt were carried out. The result of calculations of Type A and Type B turned out to be “earthquake resistant”. (See Appendix-) As to Type C, it is difficult to consider them as earthquake resistant, because they are not fixed with foundation bolt.

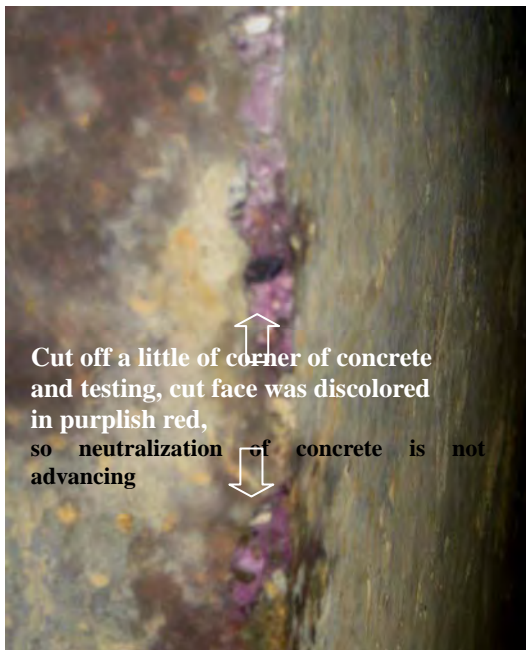
Picture 4.2.7 Phenol-Phthalein Test on the wall of utility conduit of Pulsator at WTP No.2

Therefore, under this alkaline environment in concrete, a protection barrier is formed around a reinforcing bar and this is protecting iron from corrosion. The calcium hydroxide changes to carbonic acid calcium with passage of time through the action of the carbon dioxide in the air, which is called neutralization. Although Carbonic acid calcium formed on concrete is rigid but fragile, it has no strength. Therefore if neutralization is advancing, the non-destructive test by a Schmidt rebound hammer couldn't be applied.

If neutralization advances, a protection barrier for iron would no longer be formed around a reinforcing bar and iron corrosion will start.
