5-5 Estimation of Slope Stability

5-5-1 Expected Slope Hazards

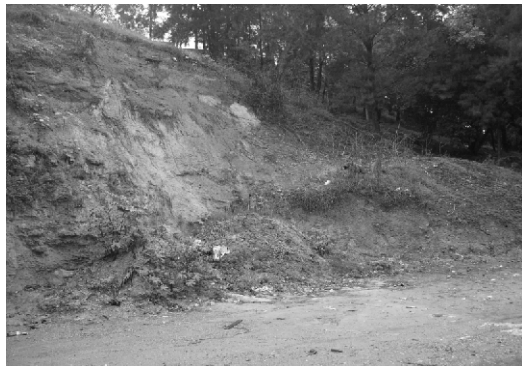
In the Study Area, perpendicular cutting slopes are found composed of Calcareous sandstones or schists. These rocks are strong enough for perpendicular cutting at normal times but during heavy rain or earthquake shock the vertical cutting slope in some areas will collapse (Photo 5-1). In the Study Area, high vertical cutting slopes exist and in some cases, houses are built at the edge (Photo 5-2). Therefore, even shallow landslides can result in the possibility of fatalities.

Photo 5-1 Shallow Landslide

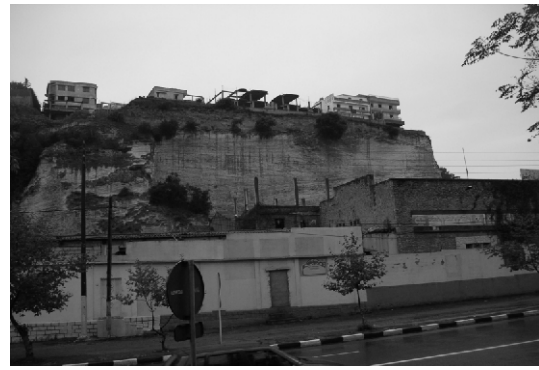
Photo 5-2 Houses at the Edge of Cutting

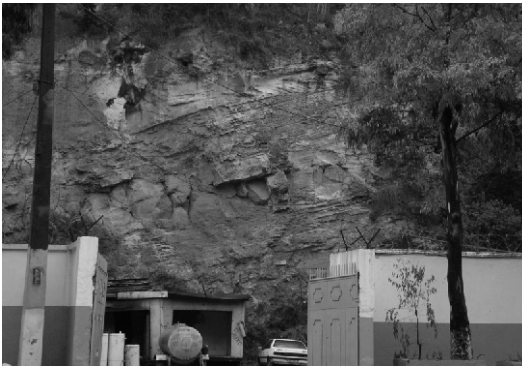
In addition, some of the cliffs include large rocks (Photo 5-3, Photo 5-4) resulting in rock fall hazards. In Photo 5-4, a dip slope structure is found, which implies the rock crack and slope inclination run in the same direction.

Photo 5-3 Slope Including Rock in the Wall

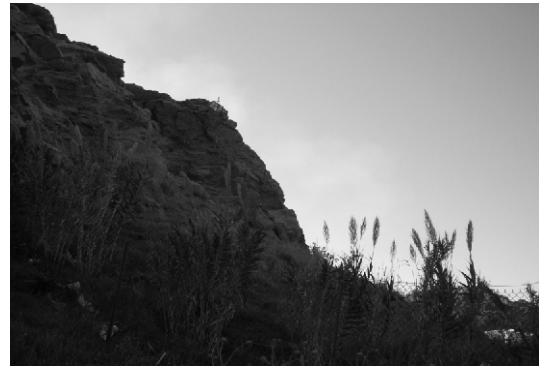
Photo 5-4 Dip Slope Structure

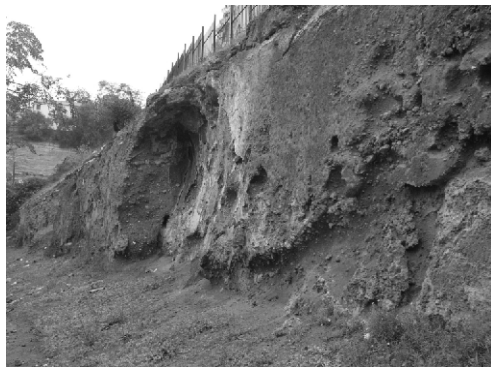
The unstable layer is difficult to estimate although Photo 5-5 and Photo 5-6 indicate its depth is less than 2 m, suggesting it has a possibility of collapsing.

Photo 5-5 Weak Layer within 2 m

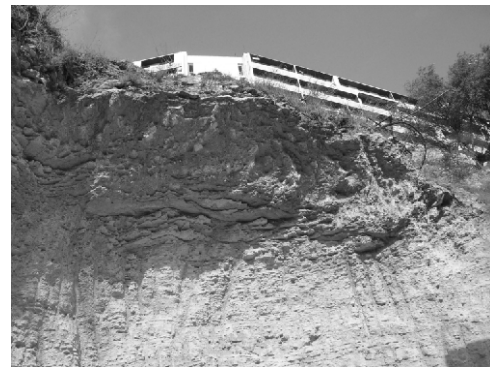
Photo 5-6 Weak Layer within 2 m

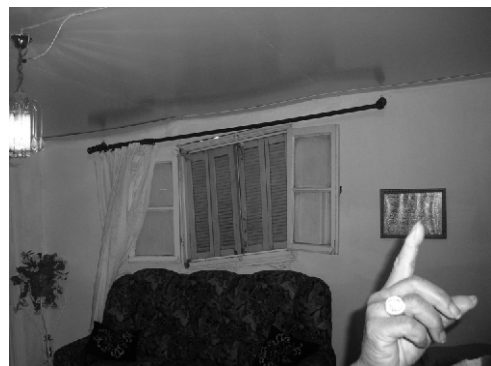
At No.18 drilling point, a landslide was found with Photo 5-7, Photo 5-8 and Photo 5-9 showing the damage due to its occurrence. An earthquake has a possibility of pushing the landslide out. Also, if earthquake motion is sufficiently strong there is a possibility that a new landslide will be produced.

Photo 5-7 Window Broken by Landslide

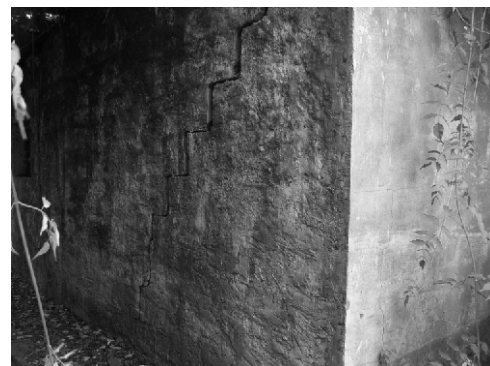
Photo 5-8 Wall Broken by Landslide

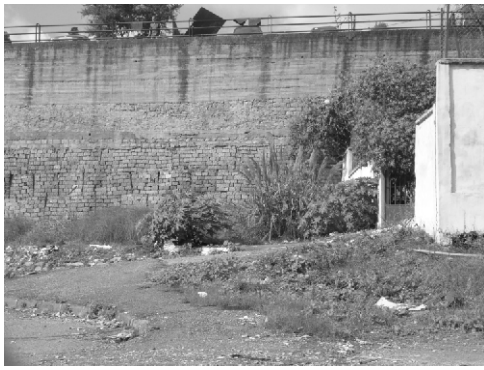
Photo 5-9 Wall Broken by Landslide

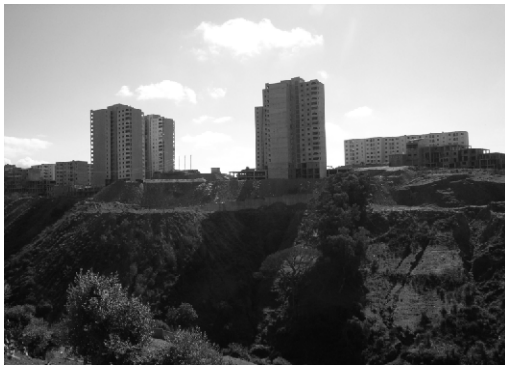
If rain occurs after an earthquake, there is a high potential for debris flow to occur. In several slope areas, the rock strength can also become weak after an earthquake. Therefore, lower intensity rainfall will produce the debris flows than under normal rainfall conditions. The debris flow material is readily found along the river (Photo 5-13). Photo 5-14 shows debris flow in 2001.

Photo 5-13 Unstable Soils along the River

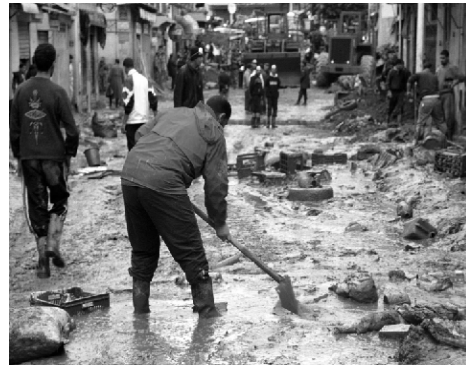
Photo 5-14 Debris Flow 2001(provided by Assia)

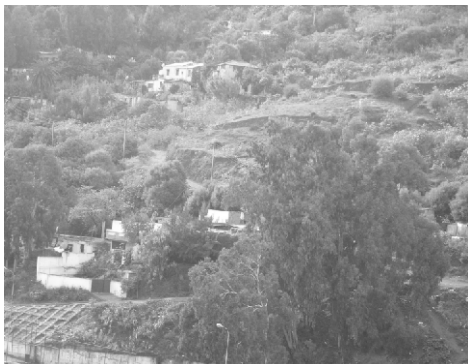
Uncrushed rocks are also found at the slope along the highway (Photo 5-15, Photo 5-16), reflecting a flow similar to an avalanche phenomenon. The onset of this type of flow is immediate and will extend some distance. Overall, possible locations of such flows in the near future are difficult to predict.

Photo 5-15 Slope along the Highway

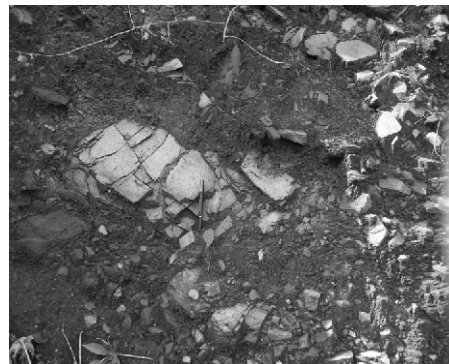
Photo 5-16 Trace of Flow without Rock Crushing
