6) Section F

7. Test Pit and its Test Result

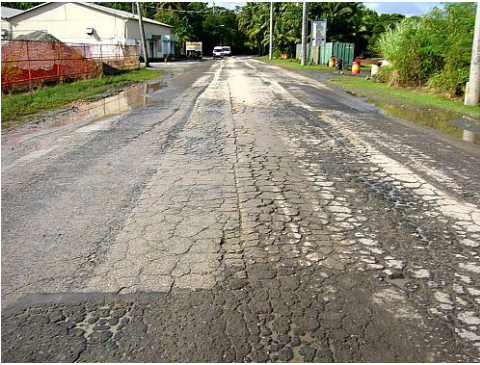
Section F-1 STA. 9+800 Flood Section, Alligator Cracks and Ravelling

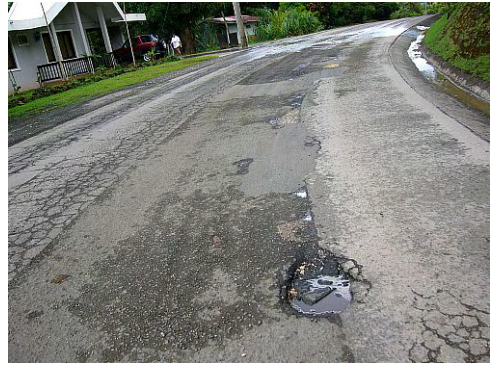
Section F-1 STA. 10+350 Alligator Cracks and Ravelling

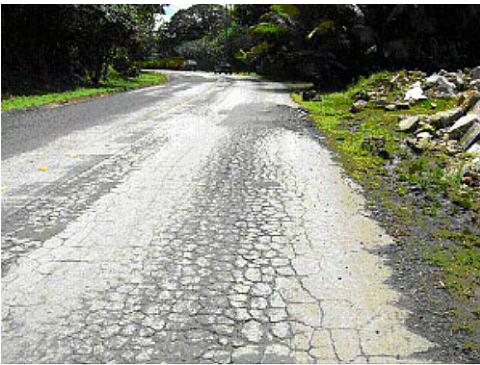
Section F-1 STA. 12+400 Alligator Cracks and Ravelling

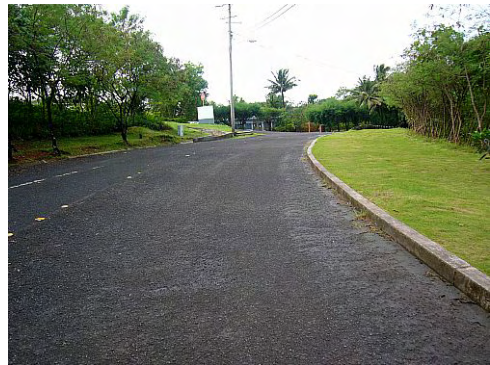
Section F-3 STA. 12+960 Ravelling

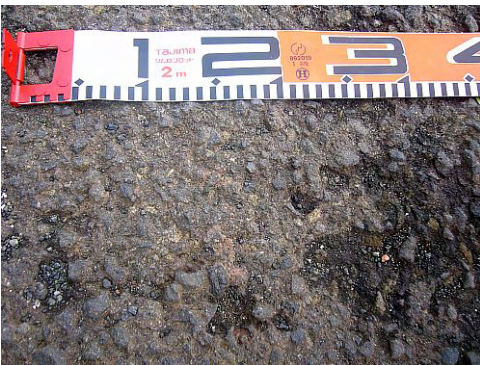
Section F-3 STA. 13+300 Ravelling nearby Airport

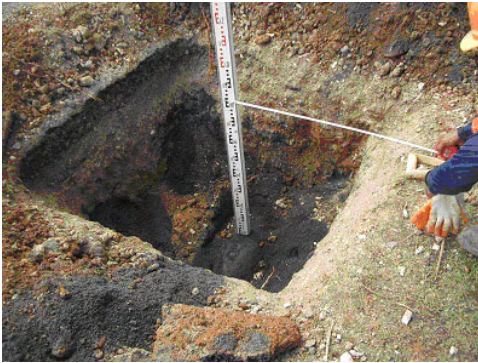
0.8 m deep steel steel pipe surrounded by 5 cm thick gravel

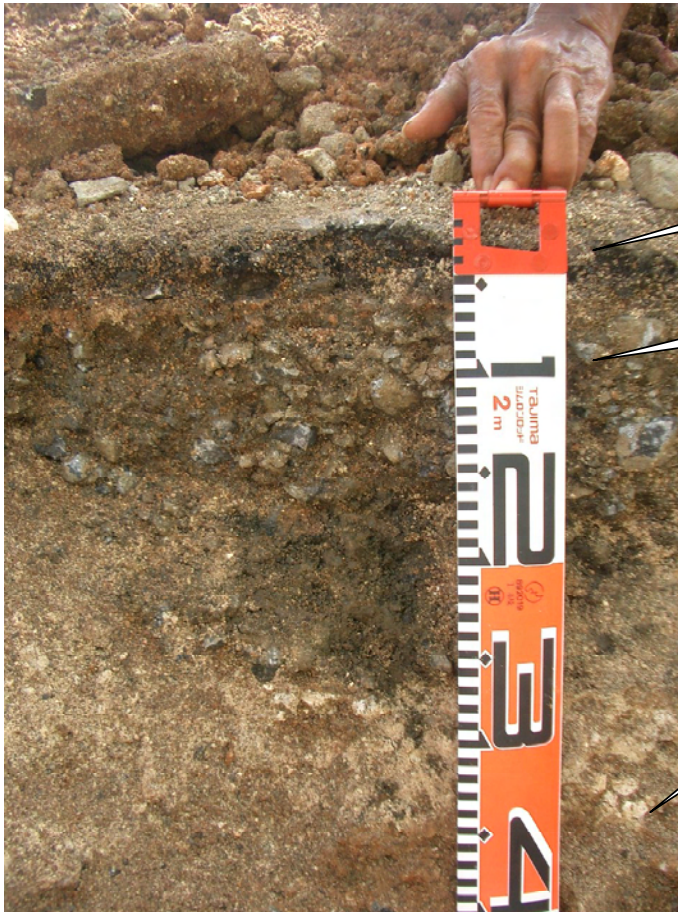
2) TP-2

Asphalt surface 5 cm thick

Base course: crushed stone 25 cm thick CBR 132%

Sub-base course: Coral sand 25 cm thick CBR 27%

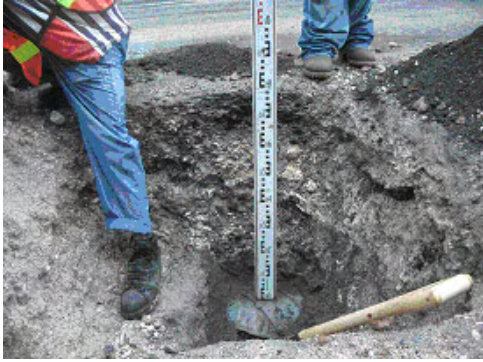
0.7 m deep steel pipe surrounded by 5 cm thick gravel

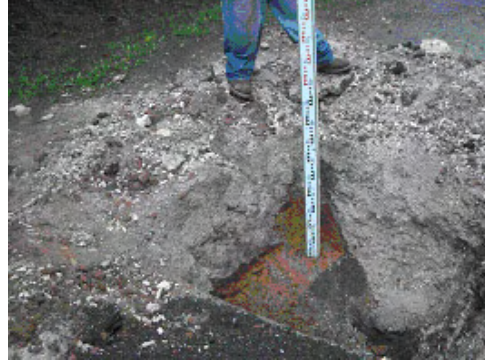
Roadbed soil exposed at opposite side

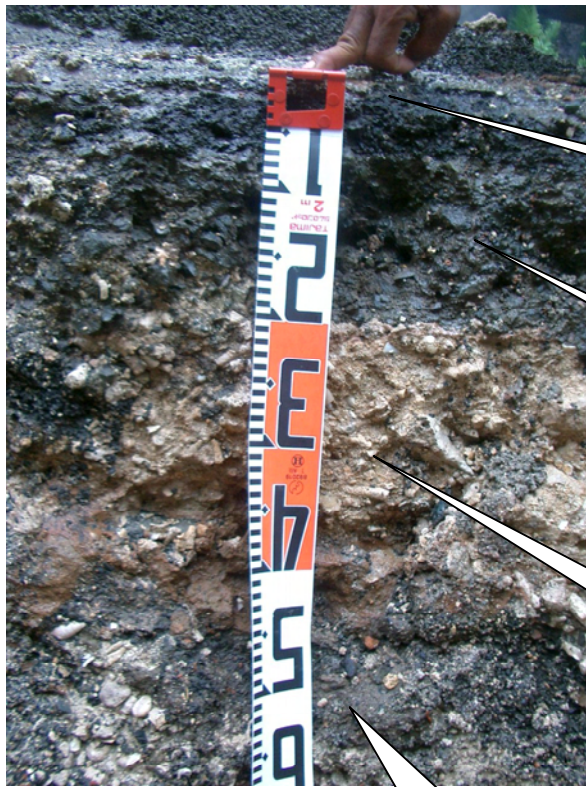
3) TP-3

Asphalt surface 5 cm thick

Base course: crushed stone 15 cm thick CBR 108%

Sub-base course: Coral sand 25 cm thick CBR 27%
