Chapter. 8 Existing Condition and Site Inspection of the Study Bridges

8.1 Existing Condition of the 29 Bridges

8.3 Results of the Inspections

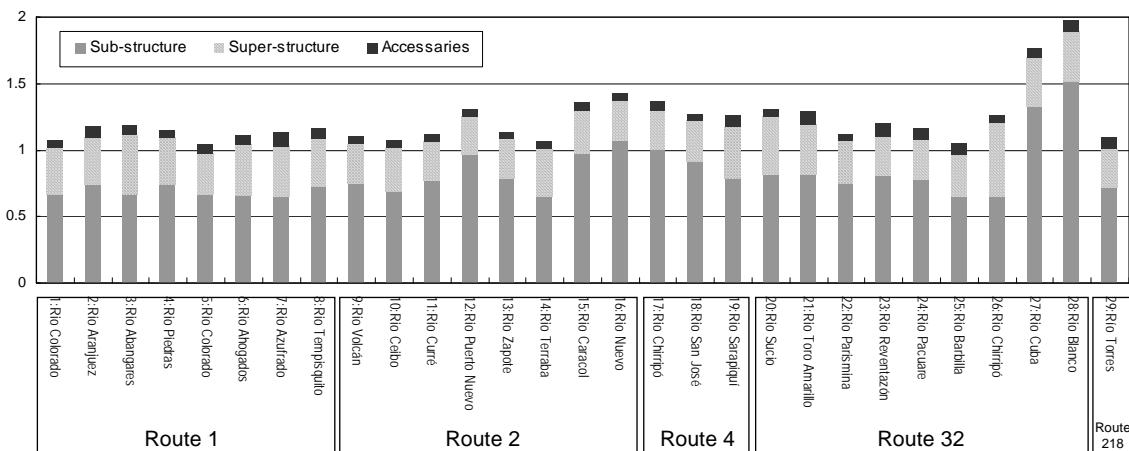
Figure.9.1. Results of the Evaluation of the Bridge Deficiency

Under collaboration between MOPT bridge engineers and the Study team, the weight determined by the structural importance and the weight determined by the potential negative impact were calculated through a procedure based on pair wise comparisons with the AHP, and the evaluation method of the bridge deficiency is formulated. Results of the calculation of deficiency for the 29 bridges are summarized in Figure S.9.1.

Note) Vertical axis: Bridge deficiency index, Larger Value = Severer Deficiency (5.0 in Max.)

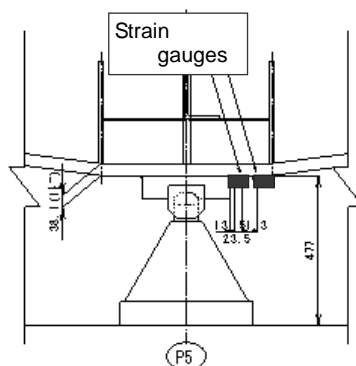
Figure.10.1. Bearing Connection Strain gauge setting

In general, fatigue failure tends to occur at structural members and/or parts where stress concentration and amplitude are largely appeared. In the Study, 4 positions such as connecting part with bearings (see Figure S.10.1), diagonal members and lateral members are selected to set the gauges. Stress frequency was monitored and recorded during 24 consecutive hours. Table.10.2 shows traffic volume per hour on the testing day. White painted of bars indicates a volume of the heavy traffic (5 axles), which causes large amplitude of stress. Traffic volume during 24 hours results 6,230 vehicles/day and 5 axles trucks were counted on 1,996 vehicles/day.

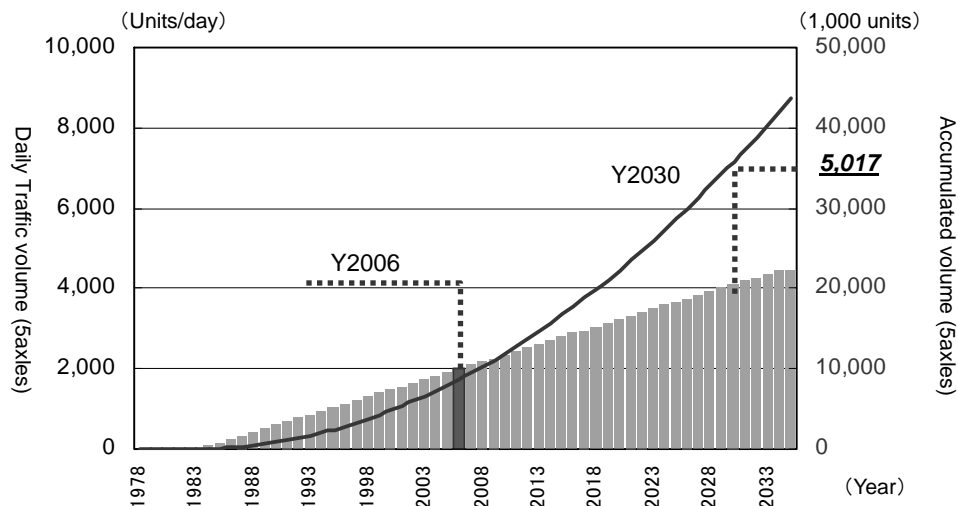
Figure.10.3. Interrelation between Occurrence of the Fatigue Failure and the Accumulated Traffic Volume

28 years have passed after Chirripo bridge (No.20), which stress frequency was measured, was constructed. On the simulation that the traffic volume keeps increasing with the current rate of growth, the residual life upon the fatigue limit of measured members is trial-calculated based on the accumulated traffic volume and the stress frequency. Figure S.10.3 shows the interrelation between the estimated time for the occurrence of the fatigue failure (residual life) and the accumulated traffic volume. In addition, estimated times per measured members are summarized in Table.10.8.

Results show that fatigue cracks will most likely appear at the connection with the bearing, which is the most critical part, by year 2030. The connections with the diagonal members still possess considerable tolerance. However, it will be essential to keep them monitored throughout the periodical inspections, since accidental errors in measuring and/or assumptions for structural modeling might cause certain variations to the test results.
