## CHAPTER 9 SELECTION OF 10 BRIDGES FOR REHABILITATION, REINFORCEMENT

### 10.1 Identification of Deterioration in 10 Bridges

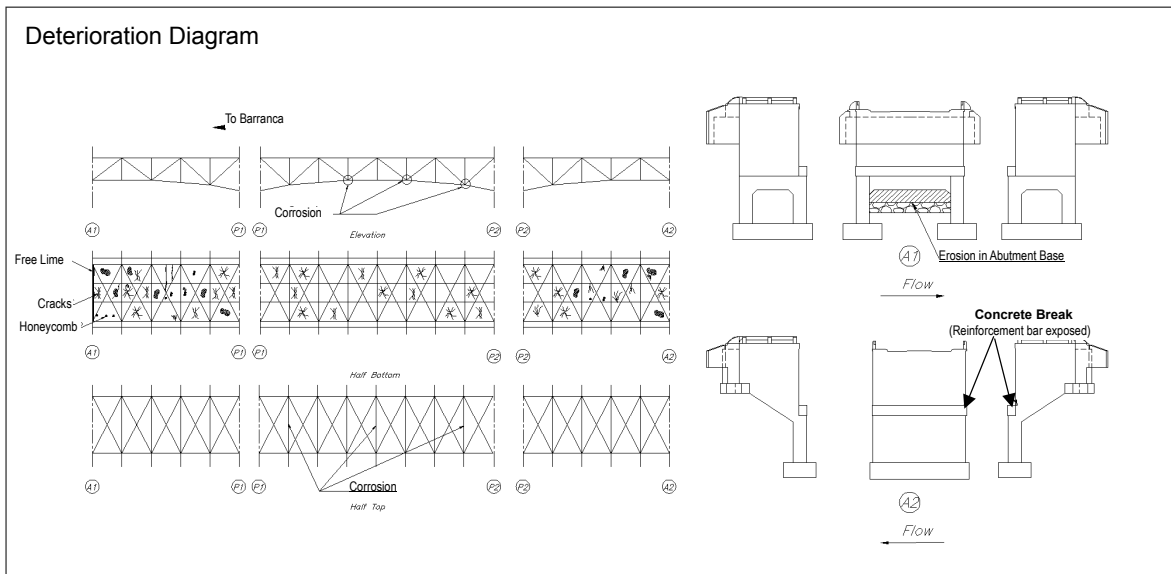
**Table 10.1.7. Results of Visual Inspection for Rio Aranjuez Bridge  
 (Route No.1 Bridge No.2)**

Accessory	<ul style="list-style-type: none"> <li>- No pavement on the slab deck. Vehicles are running on slab directly.</li> <li>- Many cracks and holes were observed in surface of slab.</li> <li>- Expansion joint has been damaged.</li> </ul>
Superstructure	<ul style="list-style-type: none"> <li>- Discoloration, rusting and peeling of painting were observed in all members.</li> <li>- Many cracks and free lime were observed in slab concrete.</li> <li>- Cracks occurred two (2) directions (longitudinal and transversal direction)</li> <li>- Discoloration and rusting were observed in the body of Bearing.</li> <li>- it is very dirty condition around bearing.</li> </ul>
Substructure	<ul style="list-style-type: none"> <li>- Surface of pier is worn away by the river flow.</li> <li>- Cold joint was observed in Pier No 2.</li> <li>- Fissility and exposure of reinforcement were observed in the body of Abutment A2.</li> </ul>

Foundation	<ul style="list-style-type: none"> <li>- Small scouring was observed.</li> </ul>

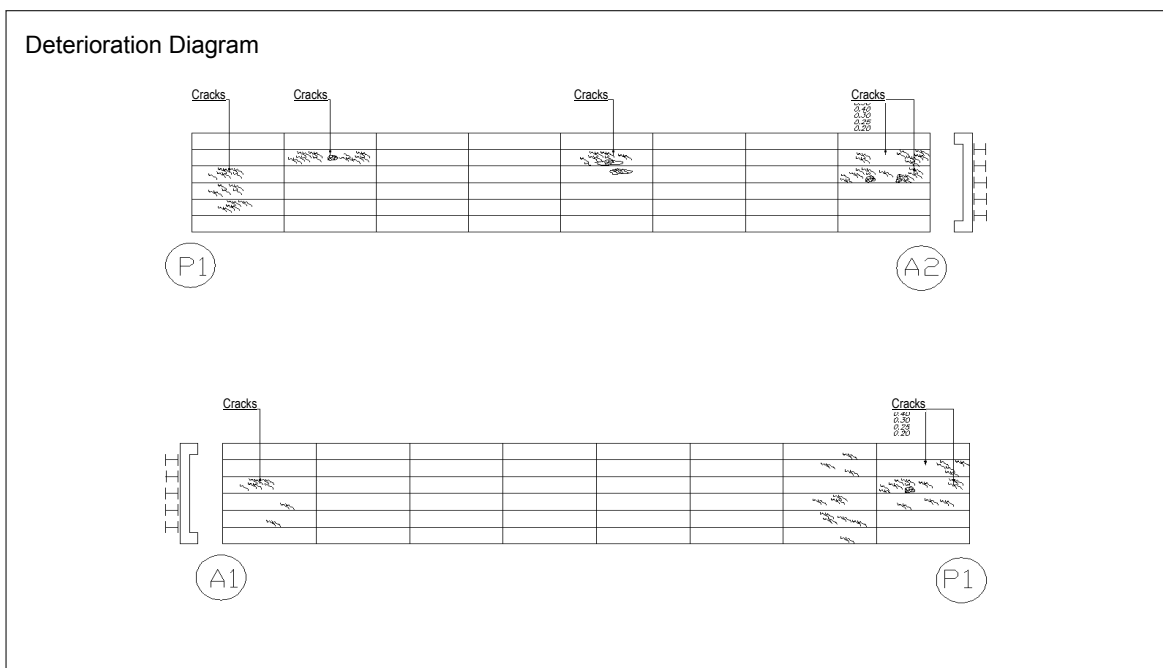
**Table 10.1.8. Results of Visual Inspection for Rio Abangares Bridge  
 (Route No.1, Bridge No.3)**

Accessory	<ul style="list-style-type: none"> <li>- Overlay (5 cm thickness) was carried out direct on previous pavement (dead load of pavement is increased)</li> <li>- Many cracks and holes were observed in surface of pavement.</li> <li>- Water leak was observed at expansion joint and dust or soil have fill in the space of expansion joint.</li> </ul>
Superstructure	<ul style="list-style-type: none"> <li>- Discoloration, rusting and peeling of painting were observed in all members and the corrosion was observed in some parts.</li> <li>- Upper sway braces were damaged by hitting of big vehicles. In the section from abutment A1 to pier they have repaired.</li> <li>- Near abutment A1, big hole ( 3.5m(L) x 2.0m(W)) have occurred and many cracks and free lime were observed in the deck slab concrete.</li> <li>- Cracks occurred two (2) directions (longitudinal and transversal directions) and the width range of them is from 0.3 to 0.4 mm</li> <li>- Rivets in joint between crossbeam and stringer have been lost or repaired and some joint plates cracked.</li> <li>- Discoloration and rusting were observed in the body of bearing.</li> <li>- It is very dirty condition around bearings.</li> </ul>

Substructure	<ul style="list-style-type: none"> <li>- Any special damage has not been observed</li> </ul>
Foundation	<ul style="list-style-type: none"> <li>- Any special damage has not been observed</li> </ul>

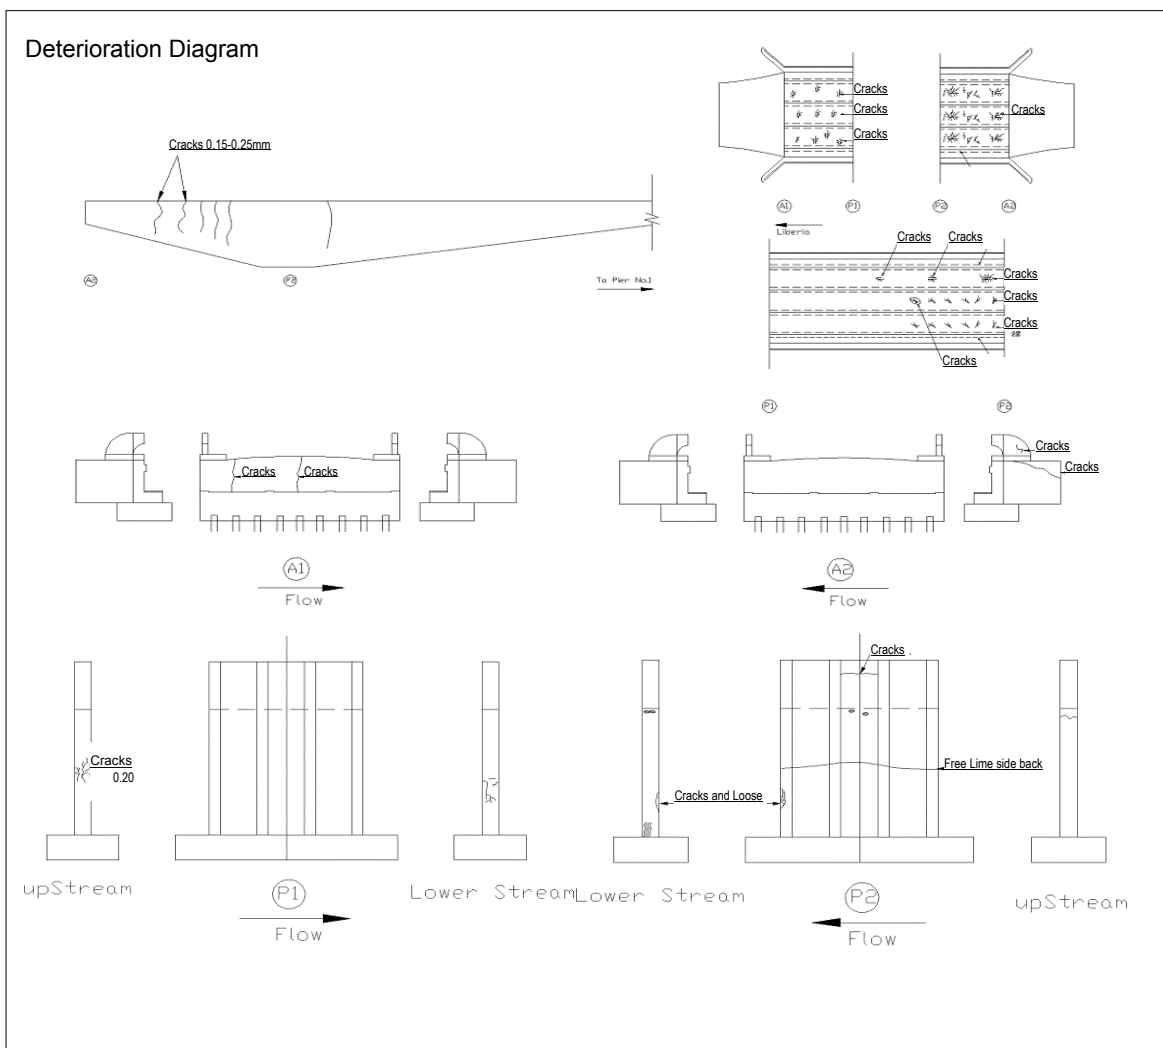
**Table 10.1.9. Results of Visual Inspection for Rio Azufrado Bridge  
 (Route No.1, Bridge No.7)**

Accessory	- Railing has been damaged by traffic accidents.
Superstructure	<ul style="list-style-type: none"> <li>- Many cracks and free lime were observed in slab concrete.</li> <li>- Cracks occurred two (2) directions (longitudinal and transversal directions) and the width range of them is from 0.2 to 0.3 mm</li> <li>- Exposure of reinforcement caused by re-bar corrosion was observed in overhanging slabs.</li> <li>- In the side of girder, many cracks were observed at upper portion of girder. These cracks run horizontal direction at 50cm interval and the width range of them is from 0.2 to 0.3 mm.</li> </ul>
Substructure	<ul style="list-style-type: none"> <li>- Some cracks were observed in Pier No.2.</li> <li>- There is no abutment. There is only cross beam at end of bridge, which protected soil. So girders of side span are cantilever beam.</li> </ul>
Foundation	- Any special damages were not observed

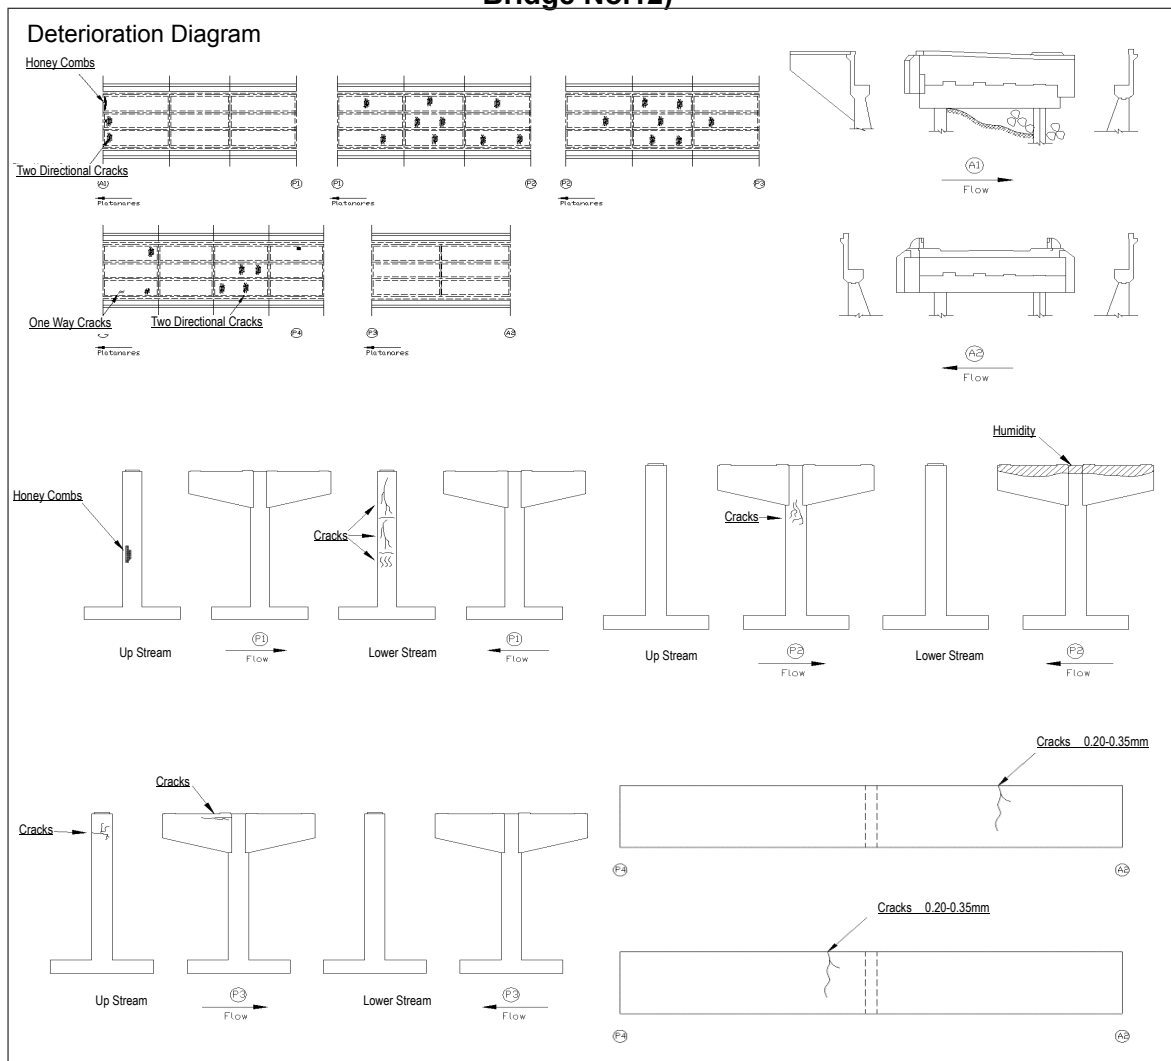
**Table 10.1.10. Results of Visual Inspection for Rio Puerto Nuevo Bridge (Route No.2 Bridge No.12)**

Accessory	<ul style="list-style-type: none"> <li>- Expansion joints at both abutments A1 and A2 were covered by overlay (5 cm thickness) asphalt concrete.</li> <li>- There are not expansion joints at the Pier No.2 and 4. There are spaces (20 mm) for expansion.</li> <li>- No Pavement on the slab deck. Vehicles run directly on slab</li> <li>- Water leak was observed at expansion joint.</li> </ul>
Superstructure (Concrete girder bridge)	<ul style="list-style-type: none"> <li>- There is a crack which width is 0.3 mm in internal girder near abutment A2. In external girder any crack was not observed.</li> <li>- In the slab, cracks occurred diagonal direction and its width is 0.2 to 0.3 mm.</li> </ul>
Superstructure (Steel girder bridge)	<ul style="list-style-type: none"> <li>- In the slab, cracks occurred two (2) directions (longitudinal and transversal directions) with around 50 cm interval each and their widths are 0.2 to 0.3 mm</li> <li>- Peelings of painting were observed in some parts of girder and cross beam.</li> </ul>

Substructure (Pier)	<ul style="list-style-type: none"> <li>- Vertical direction cracks were observed in all piers, and in beam of Pier No.3, some horizontal cracks were observed.</li> <li>- Upper portion of beam of Pier No.2 was wet condition by water, which has leaked from the joint of superstructure.</li> </ul>
Substructure (Abutment)	<ul style="list-style-type: none"> <li>- Slope around abutment was collapsed</li> <li>- Soil has accumulated on the bearing base and some bearings were overwhelmed by an accumulation of soil.</li> </ul>
Foundation	<ul style="list-style-type: none"> <li>- Any special damages were not observed</li> </ul>

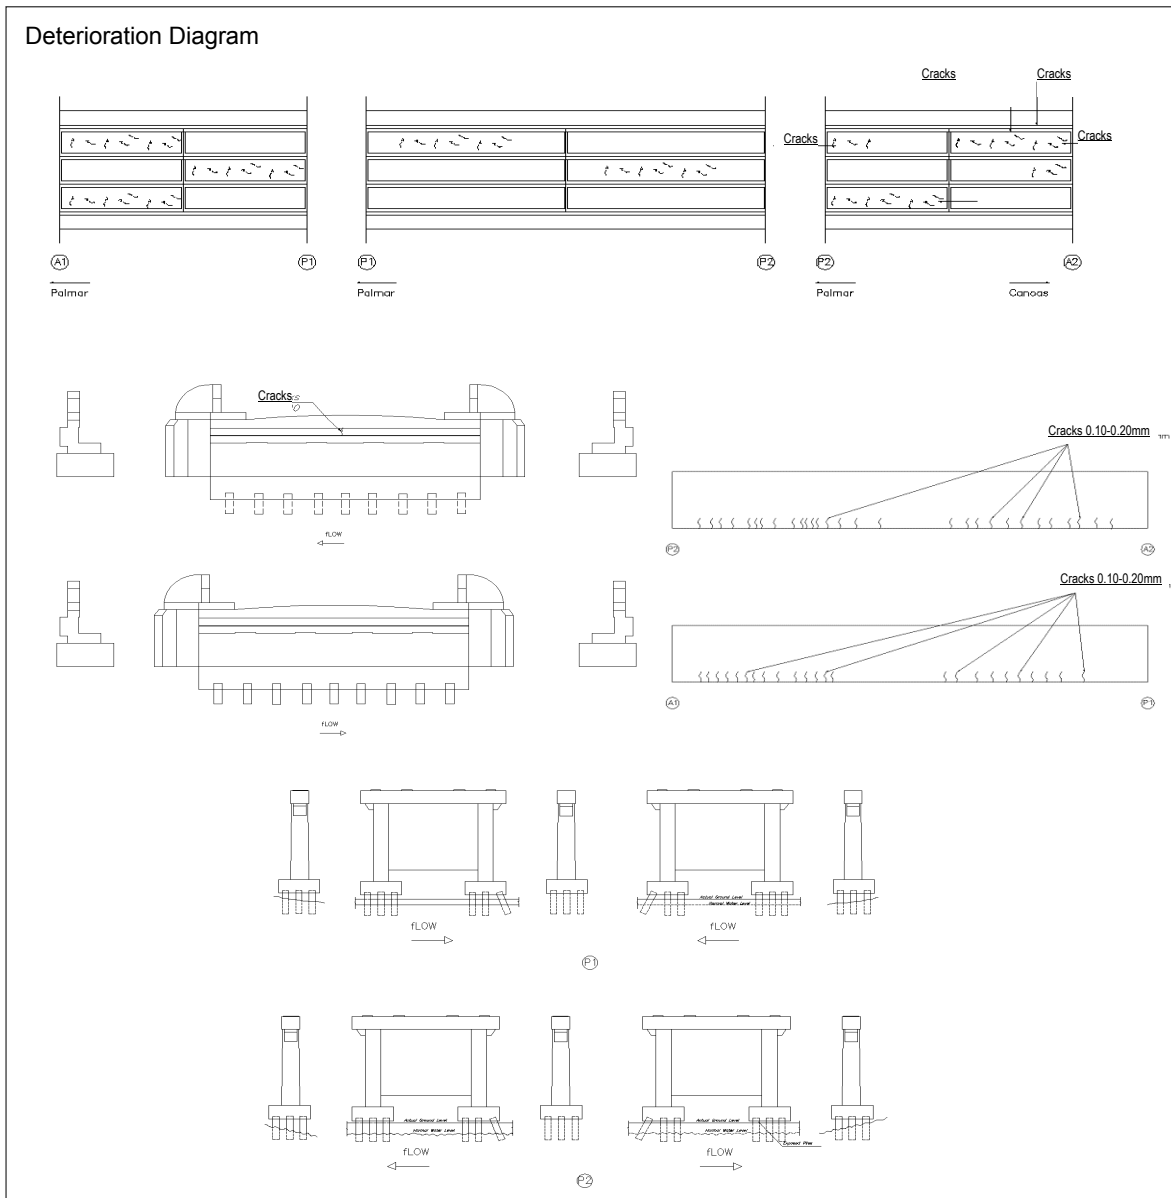
**Table 10.1.11. Results of Visual Inspection for Rio Nuevo Bridge  
 (Route No.2, Bridge No.16)**

Accessory	<ul style="list-style-type: none"> <li>- Overlay (5 cm thickness) was carried out direct on previous pavement ( Dead load of pavement was increased)</li> <li>- Water leak was observed at expansion joint.</li> </ul>
Superstructure	<ul style="list-style-type: none"> <li>- Cracks were observed in slab concrete with width range is from 0.15 to 0.25 mm.</li> <li>- In the lower part of girder, many cracks were observed. Its width range is from 0.1 to 0.2mm. These cracks occurred horizontal direction and some of them run 50cm interval and its width rang is from 0.2 to 0.3 mm.</li> <li>- Rusting and corrosion were observed in the body of bearing.</li> <li>- It is very dirty condition around bearing</li> </ul>
Substructure	<ul style="list-style-type: none"> <li>- Any special damage has not been observed</li> </ul>
Foundation	<ul style="list-style-type: none"> <li>- River bed is scoured and gone down more than 3 m, so piles at pier No.1 and No.2 protrude from riverbed more than 2m.</li> </ul>

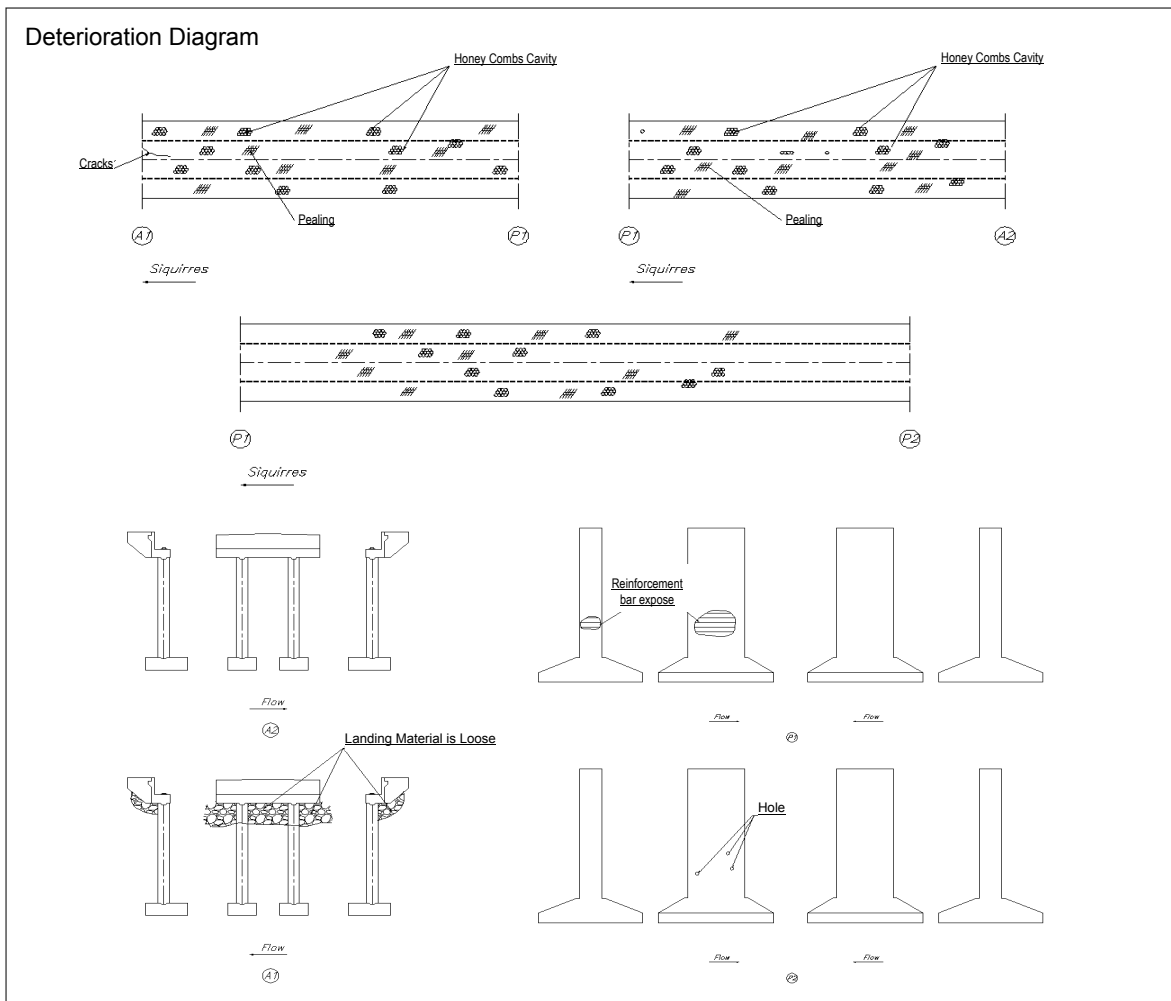
Table 10.1.12. Results of visual inspection for Rio Chirripo Bridge(Route No.4, Bridge No.17)

Accessory	<ul style="list-style-type: none"> <li>- Expansion joint has been broken and covered by Overlay asphalt concrete.</li> <li>- Pavement has removed and slab surface has appeared in some place.</li> <li>- Soil has deposited both side of surface and plants were grown around drain</li> </ul>
Superstructure	<ul style="list-style-type: none"> <li>- In middle span (P1 to P2) deformation was observed</li> <li>- Crack was observed in bottom slab near abutment No2</li> <li>- Free lime was observed at construction joint in bottom slab near pier No1</li> <li>- Concrete fissility was observed around hole in bottom slab for drain water inside box.</li> <li>- A hole that seem to correct core in top slab was not repaired.</li> <li>- Some defects in construction (honeycomb, not remove form etc) were observed.</li> <li>- Grout hose protrudes from surface of web, it must be cut inside concrete of web and covered by mortal or concrete.</li> </ul>

Substructure	<ul style="list-style-type: none"> <li>- Water leak was observed at the place of expansion joint and it is wet condition around bearing.</li> <li>- Surface of pier was damaged by stone attacking and re-bar has been appeared in pier No2.</li> <li>- Some holes that seem to correct core in pier No.1 were not repaired.</li> </ul>
Foundation	<ul style="list-style-type: none"> <li>- Small scouring was observed.</li> </ul>

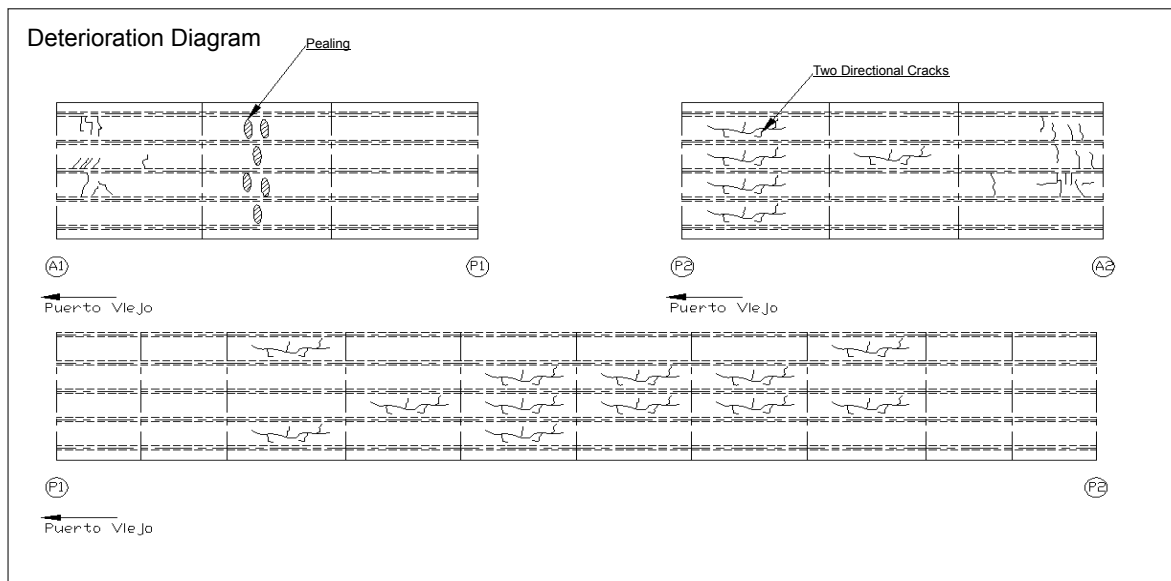
**Table 10.1.13. Results of Visual Inspection for Rio Sarapiquí Bridge  
 (Route No.4, Bridge No.19)**

Accessory	<ul style="list-style-type: none"> <li>- Expansion joints in both abutment A1 and A2 were covered by Overlay (5 cm thickness) asphalt concrete and they do not work.</li> <li>- When heavy vehicle passed middle of bridge, bridge surface lifted at the edge of bridge.</li> <li>- Water leak was observed at expansion joint.</li> </ul>
Superstructure	<ul style="list-style-type: none"> <li>- In the slab, cracks occurred transversal direction with width of about 0.2mm.</li> <li>- Discoloration, rusting and peeling of painting were observed in all members. And in some part, the corrosion was observed.</li> <li>- Losses of cross section reduced by corrosion were observed in main girder.</li> <li>- Main girder deformation was observed.</li> <li>- Discoloration and rusting were observed in the body of bearing.</li> <li>- It is very dirty condition around bearing.</li> </ul>
Substructure	<ul style="list-style-type: none"> <li>- Any special damage has not been observed</li> </ul>

Foundation	<ul style="list-style-type: none"> <li>- Small scouring was observed.</li> </ul>

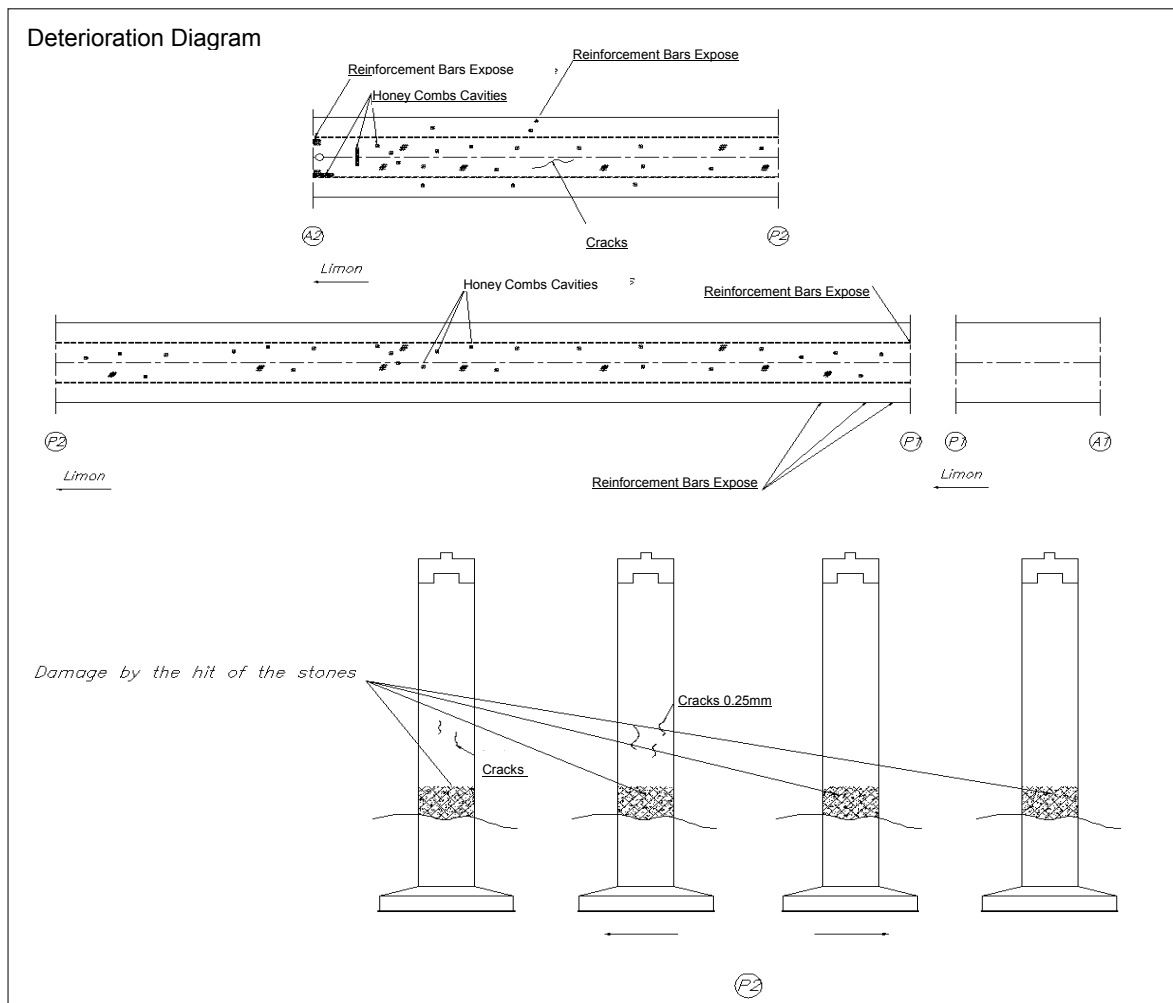
**Table 10.1.14. Results of Visual Inspection for Rio Sucio Bridge  
 (Route No.32, Bridge No.20)**

Accessory	<ul style="list-style-type: none"> <li>- Expansion joints were broken and covered by overlay asphalt concrete.</li> </ul>
Superstructure	<ul style="list-style-type: none"> <li>- Free lime and exposure of reinforcement were observed in bottom slab</li> <li>- Concrete fissility was observed around hole for drainage in bottom slab inside box girder.</li> <li>- Some defects in construction (honeycomb, not remove form etc) were observed.</li> <li>- Grout hose protrudes from surface of web, it must be cut inside concrete of web and covered by mortal or concrete.</li> </ul>
Substructure	<ul style="list-style-type: none"> <li>- Some cracks were observed in Pier No.2.</li> <li>- Water leak was observed at expansion joint in Abutment No.2 and it is wet condition around bearings.</li> <li>- Surface of pier was damaged by stone attacking. Maximum depth of concrete fissility is about 10 cm.</li> </ul>

Foundation	<ul style="list-style-type: none"> <li>- Small scouring was observed.</li> </ul>

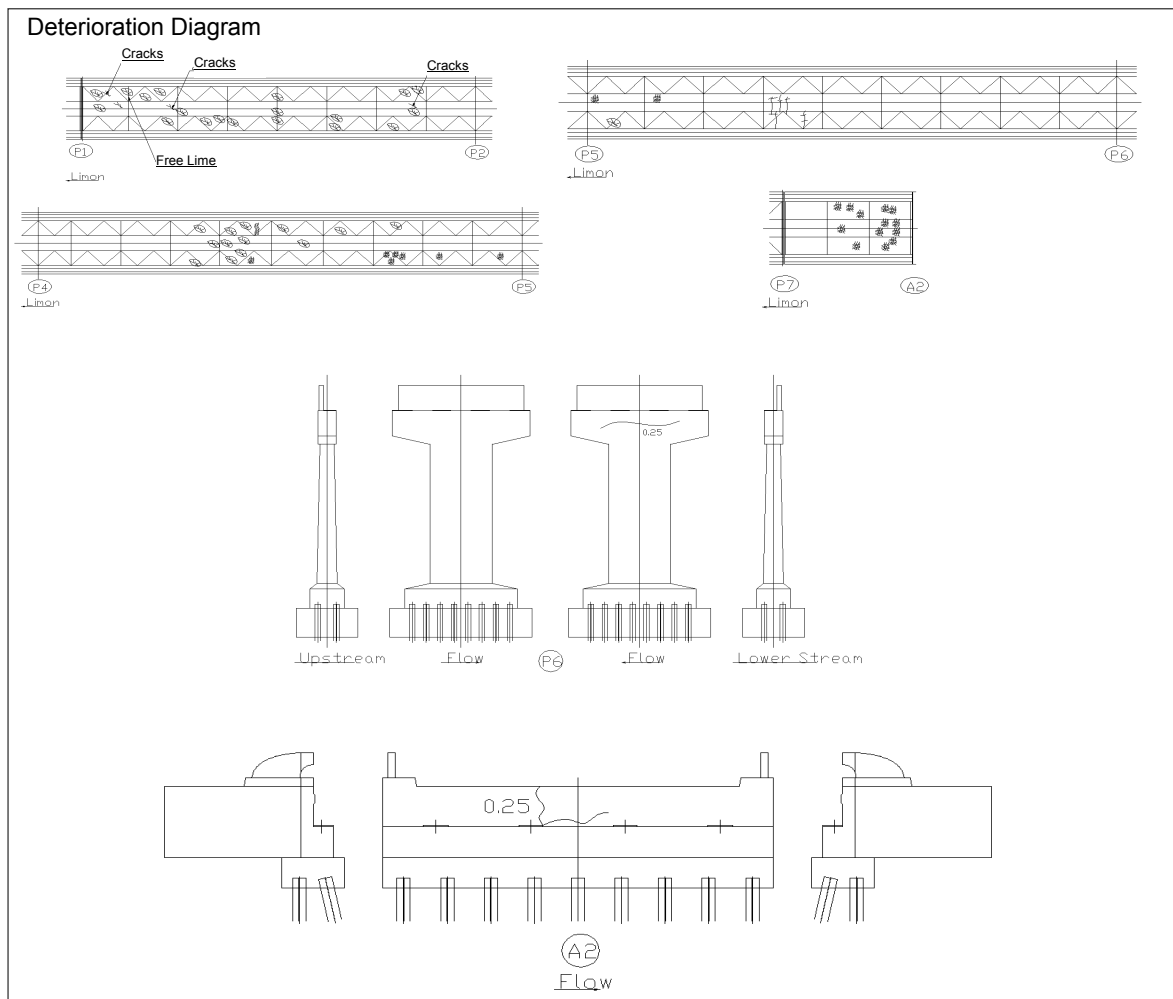
**Table 10.1.15. Results of Visual Inspection for Rio Chirripo Bridge  
 (Route No.32, Bridge No.26)**

Accessory	<ul style="list-style-type: none"> <li>- Expansion joints at both abutments A1 and A2 were covered by Overlay (5 cm thickness) asphalt concrete. And there have not worked.</li> </ul>
Superstructure	<ul style="list-style-type: none"> <li>- Continuance girder has been moved to Limon side and upstream side about 10 cm. End of continuance girder at Limon side has bumped into Pier No.1</li> <li>- Side span, which is simple span bridge, has supported temporarily by H-beam pier.</li> <li>- In the some parts of slab, two (2) directions (longitudinal and transversal directions) cracks were observed and their widths are from 0.2 to 0.3 mm.</li> <li>- Water leak was observed at joint of slab concrete.</li> <li>- All bearings have been broken.</li> </ul>
Substructure	<ul style="list-style-type: none"> <li>- Horizontal direction cracks were observed in some piers.</li> <li>- Soil has accumulated on the bearing base and bearings were overwhelmed by an accumulation of soil at abutment and some piers.</li> </ul>

Foundation	<ul style="list-style-type: none"> <li>- Small scouring was observed.</li> </ul>

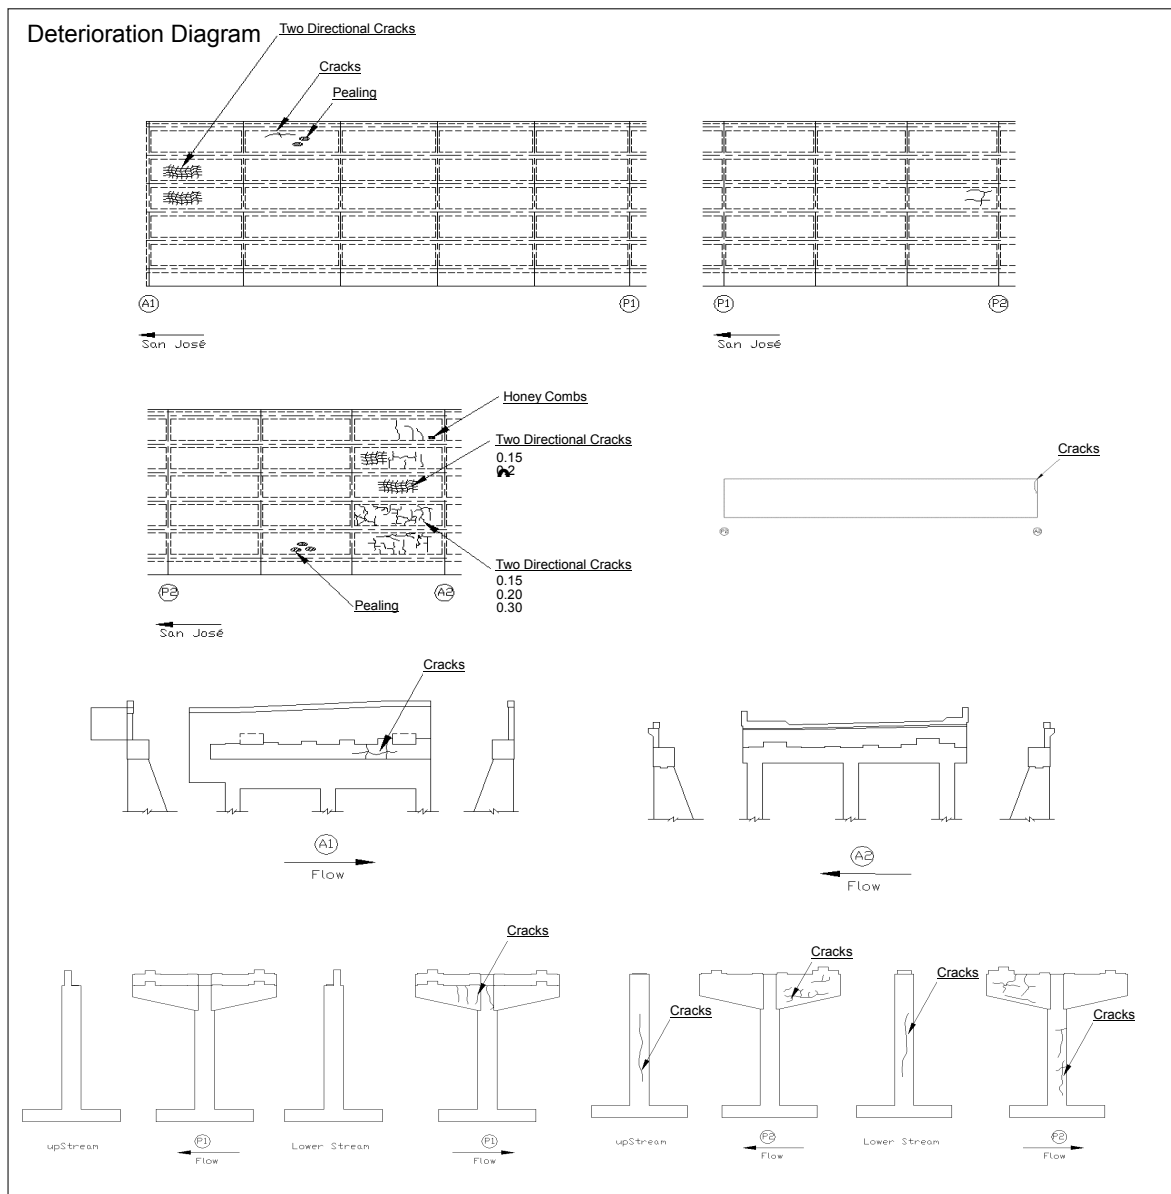
**Table 10.1.16. Results of Visual Inspection for Rio Torres Bridge  
 (Route No.218, Bridge No.29)**

Accessory	<ul style="list-style-type: none"> <li>- Top pipe of railing was lost.</li> <li>- Expansion joint has been broken and covered by overlay asphalt concrete.</li> </ul>
Superstructure	<ul style="list-style-type: none"> <li>- Two direction cracks were observed in slab concrete. The width range of them is from 0.15 to 0.3 mm.</li> </ul>
Substructure	<ul style="list-style-type: none"> <li>- Many cracks were observed at transversal beam in Pier No.1, column of Pier No.2 and Abutment No.2.</li> <li>- Width of bearing base is too small.</li> </ul>
Foundation	<ul style="list-style-type: none"> <li>- Scouring was observed at pier No.1</li> </ul>

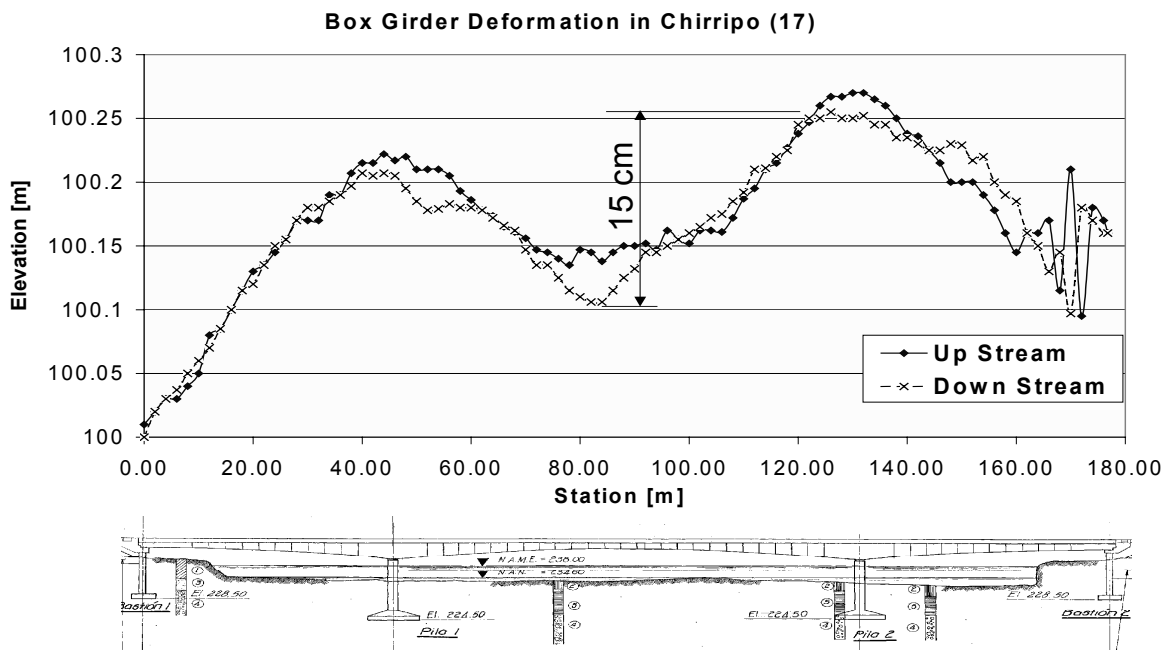
Figure 10.1.7. Deformation of Box Girder in Rio Chirripo Bridge (No.17)

Survey team in MOPT and Study team jointly measured deformation of girder in Rio Chirripo Bridge (No.17). Figure 10.1.7 shows the survey results. The deformation in Rio Chirripo Bridge presents about 10 to 15cm in the middle of the center span between P1 and P2, and the difference between pier and abutment is around 20 to 22cm. According to design drawings of this bridge, the difference in height between the levels positioned at pier and at abutment is 22cm. Therefore, the gradient of side span is almost same as the original drawing.
