13.2. Appendix-2: Road Damage Inventory Survey

Table 13.2.1 Road Damage Inventory Sheet: Kohala – Muzaffarabad City

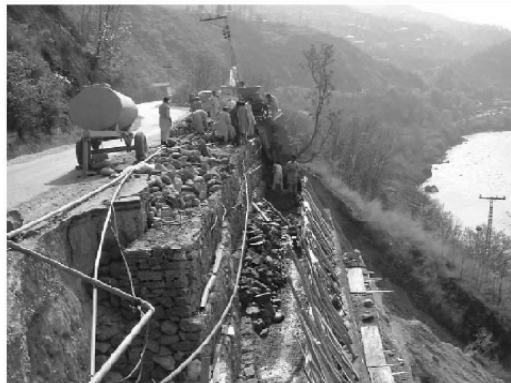
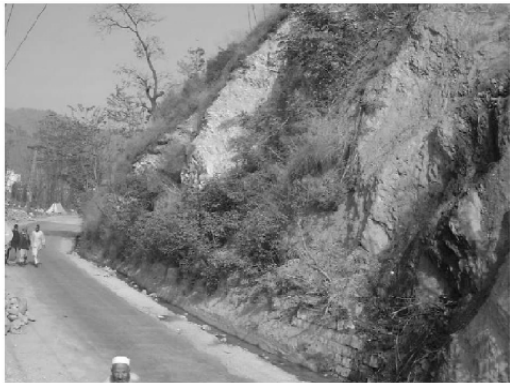
Road Damage Inventory Sheet for Internal Muzaffarabad City		
Inspection Date : 12/March/2006		Sheet No. 1 / 1
Road Name	Kohala - Muzaffarabad Road (S-2)	
Damage Section	Km 0 + 650 ~ Km 0 + 750	Length = 100 m
Description (Road Damage, Current State, etc.)		
<p>1) Part of Carriageway has fallen into the valley.</p> <p>2) Slope on hill side is unstable, comprising of erode able soil. Spring flowing over the slope has made condition worst.</p> <p>3) Slope protection work on valley side is in progress by PWD. Soil behind retaining wall is not properly compacted which may result in settlement of road.</p>		
Road Cross Section Sketch		
Site Photo		
Construction Work in Progress	Unstable Hill Side Slope
