付 属 資 料

付属資料-3 Bridge Damage Assessment

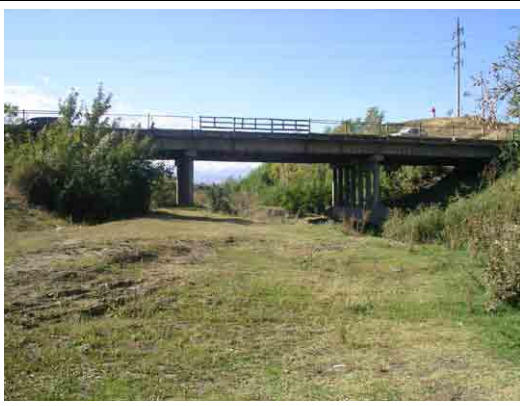
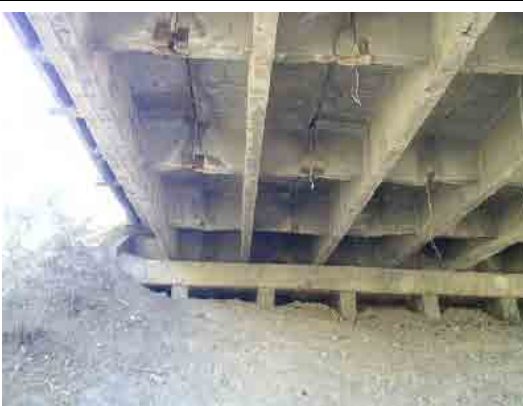
NO.1 Bridge

上部工はプレキャストRC桁であり、コンクリート強度はあるが、桁の回転により、版作用でなく梁作用となり非常に低い耐力となっている。特に中間横桁の損傷から主桁のひび割れが進行している。詳細ひび割れ調査が必要であるが非常に危険な橋である。下部工の基礎杭は約20°の傾斜があるが杭頭の損傷は見られず施工後の強制変位か施工ミスか不明である。洗掘による橋脚フーチングの露頭は不安定な構造になっている。一年以内に落橋する可能性があるかと判断した。

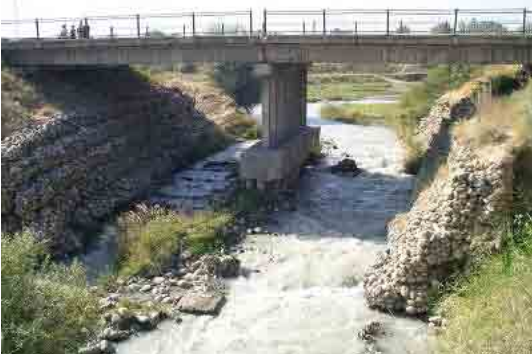
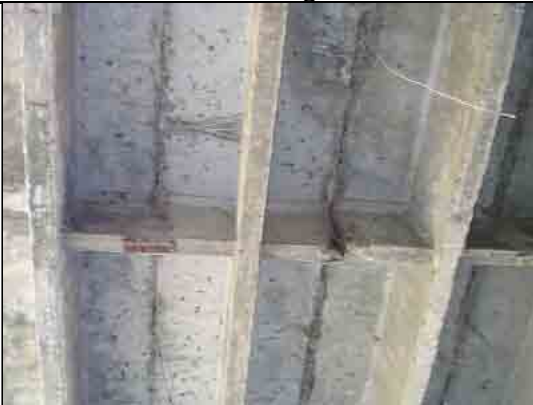
NO.2 Bridge

上部工はプレキャストRC桁であり、コンクリート強度はあるが、桁の沈下により、版作用でなく梁作用となり非常に低い耐荷力となっている。特に中間横桁の損傷から主桁のひび割れが進行している。詳細ひび割れ調査が必要であるが非常に危険な橋である。下部工の基礎杭の洗掘による橋脚フーチングの露頭は不安定な構造になっている。かなり早い局所流速による河床洗掘が発生しているので対策が必要である。一年以内に落橋する可能性があるかと判断した。

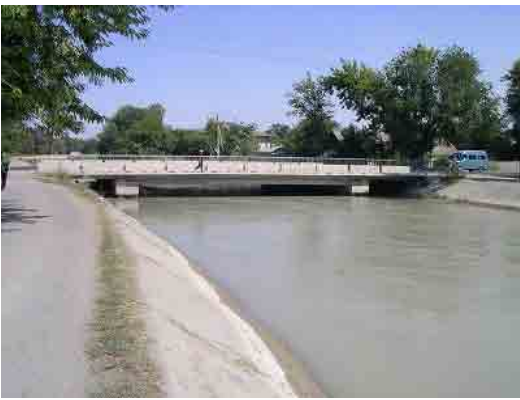
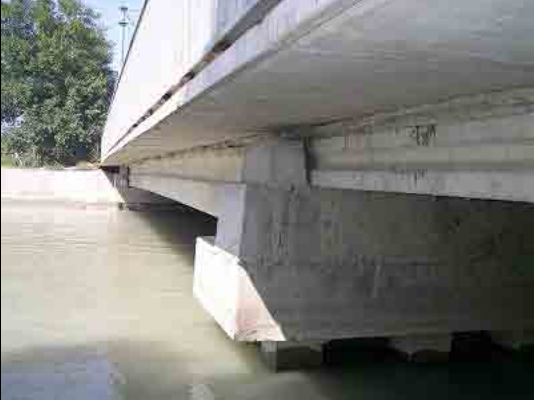
NO.8 Bridge

Honeycomb		レ					
	Others	レ						
Foundation	Settlement	レ						
	Deformation	レ						
	Scouring	レ						
	Others	レ						
Flood Protection (Gabion Works, Embankment, etc)	Settlement	レ						
	Deformation	レ						
	Destruction		レ					
	Scouring		レ					
	Erosion		レ					
Others	レ							
Description	<p>上部工形式は側径間はプレキャストPC床版橋、中央径間はプレキャストPC中空床版橋である。損傷はほとんどない。側径間は床版橋である。損傷はほとんどない。下部工はパイルベント橋台、パイルベント橋脚であるが、損傷はほとんどない。キルギス国の施工上の問題はないと考えられる。</p>

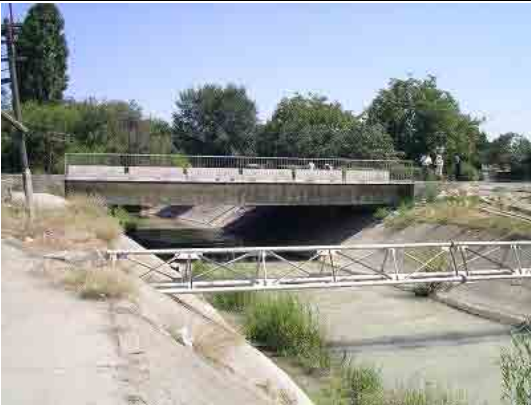
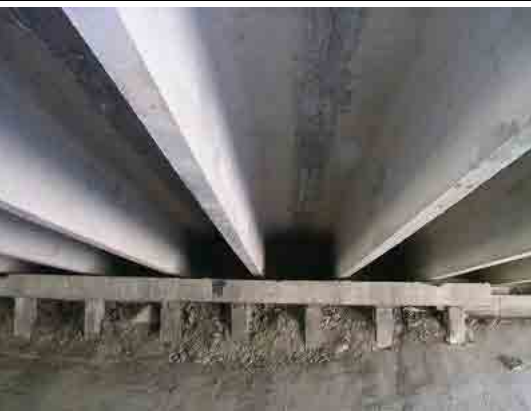
NO.9 Bridge

Honeycomb		レ					
	Others	レ						
Foundation	Settlement	レ						
	Deformation	レ						
	Scouring		レ					
	Others	レ						
Flood Protection (Gabion Works, Embankment, etc)	Settlement	レ						
	Deformation	レ						
	Destruction		レ					
	Scouring		レ					
	Erosion		レ					
Others	レ							
Description	<p>上部工形式はプレキャストRC桁(T型桁)である。1,2号橋のような中間横桁連結タイプでなく床版連結タイプである。損傷はほとんどない。下部工は護岸に隠れて構造は不明であるが、パイルベント橋台と想定する。特に問題はない。旧橋脚コンクリートが残されている。キルギス国の施工上の問題はないと考えられる。</p>

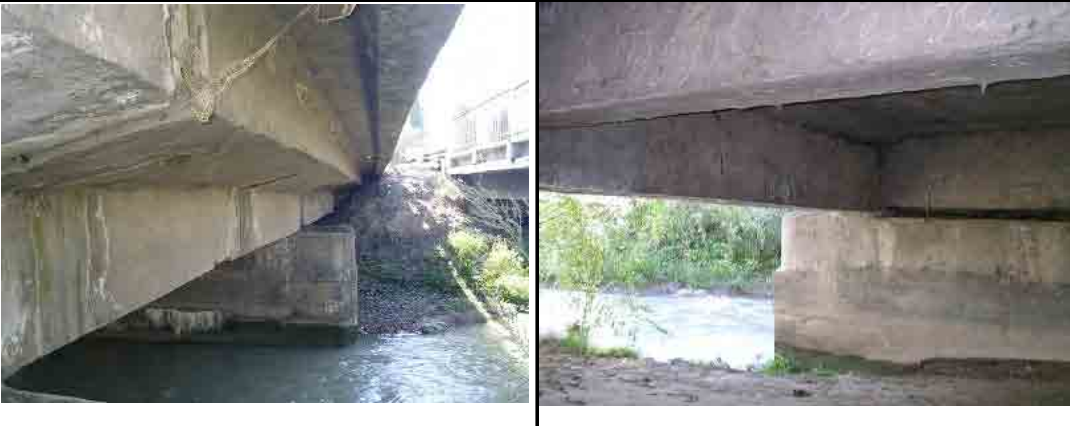
NO.14(1) Bridge

<p>図 RC2主桁 上部構造は2主桁のRC橋である。床版にはひび割れ等が見られる。上流側の桁の損傷は鉄筋露出、ひび割れ、露出付近のコンクリート強度低下が見られ、危険な橋である。下部工は重力式橋台、重力式橋脚である。上流側の洗掘は少し危険な状態である。三年以内に落橋する可能性があるかと判断した。</p>

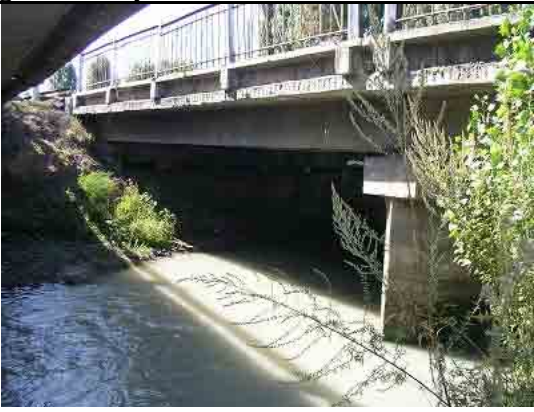
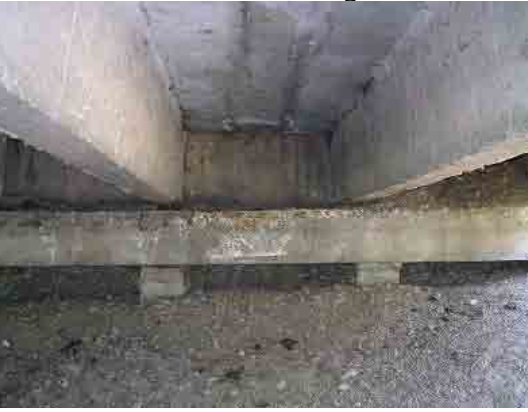
NO.14 (2) Bridge

Spalling				レ			
	Honeycomb			レ				
Others	レ							
Foundation	Settlement	レ						
	Deformation	レ						
	Scouring				レ			
	Others	レ						
Flood Protection (Gabion Works, Embankment, etc)	Settlement	レ						
	Deformation	レ						
	Destruction			レ				
	Scouring				レ			
	Erosion				レ			
Others	レ							
Description	<p>上部工形式はプレキャストRC桁である。1,2号橋のような中間横桁連結タイプでなく床版連結タイプである。ひび割れはあるが大きな損傷はない。下部工は重力式橋台、重力式橋脚である。上流側の洗掘は少し危険な状態である。橋脚のひび割れはコンクリート強度とひび割れ密度から、まだ問題ない。10年以内に落橋する可能性があるとは判断した。</p>

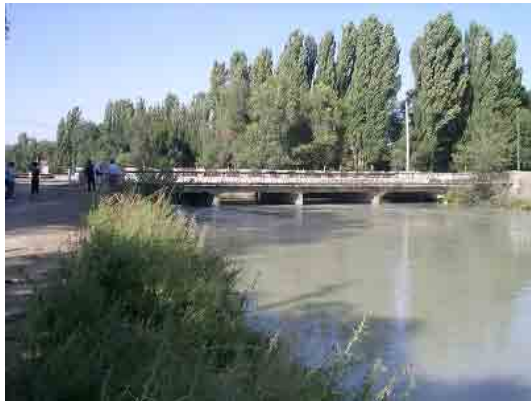
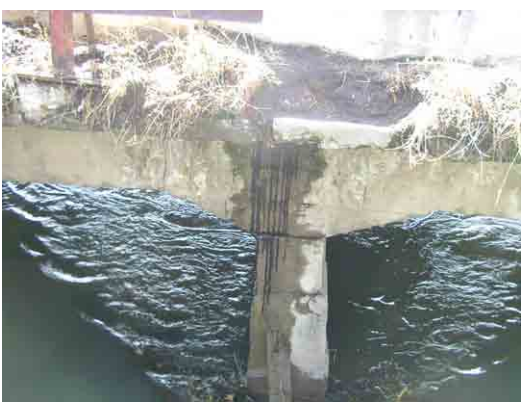
NO.15 (1)Bridge

Spalling				レ			
	Honeycomb			レ				
	Others	レ						
Foundation	Settlement	レ						
	Deformation	レ						
	Scouring				レ			
	Others	レ						
	Flood Protection (Gabion Works, Embankment, etc)	Settlement	レ					
Deformation		レ						
Destruction				レ				
Scouring					レ			
Erosion					レ			
Others		レ						
Description	ボックスカルバートのような床版と柱が剛結されたRC床版橋である。下流側主桁に多くのひび割れが見られるが上流側のひび割れが少なく版としては健全部があると判断し緊急性は少ない。橋台はひび割れが見られる。橋脚の洗掘は確認できないが、緊急性は少ないと考える。10年以内に落橋する可能性があるかと判断した。

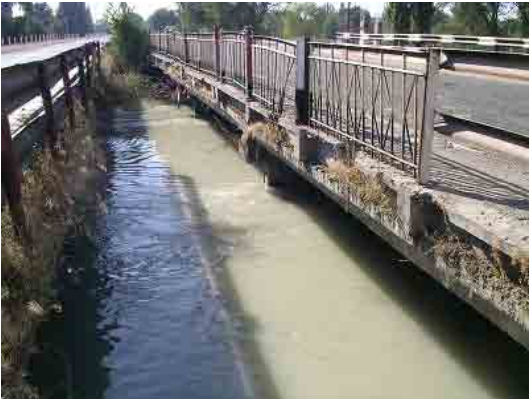
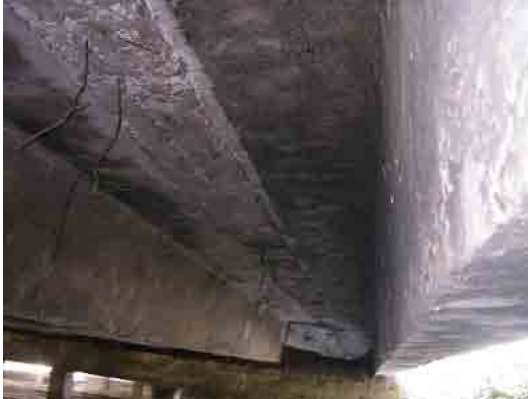
NO.15(2) Bridge

Spalling				レ			
	Honeycomb			レ				
Others	レ							
Foundation	Settlement	レ						
	Deformation	レ						
	Scouring				レ			
	Others	レ						
Flood Protection (Gabion Works, Embankment, etc)	Settlement	レ						
	Deformation	レ						
	Destruction			レ				
	Scouring				レ			
	Erosion				レ			
Others	レ							
Description	<p>上部工形式はプレキャストRC桁である。1,2号橋のような中間横桁連結タイプでなく床版連結タイプである。一部鉄筋露出が見られ、ひび割れの発生・進展が見られるが損傷は軽い。下部工はパイルベント橋台であり特に問題はない。5年以内に落橋する可能性があるかと判断した。</p>

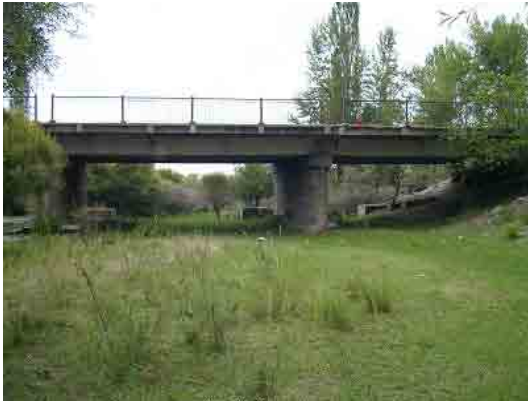
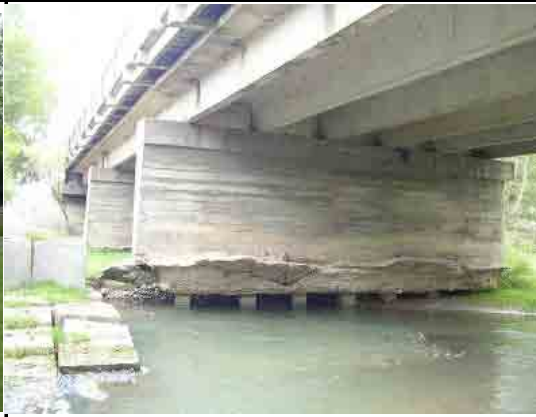
NO.19 Bridge

Spalling					レ		
	Honeycomb					レ		
Foundation	Others	レ						
	Settlement	レ						
	Deformation	レ						
	Scouring						レ	
Flood Protection (Gabion Works, Embankment, etc)	Others	レ						
	Settlement	レ						
	Deformation	レ						
	Destruction					レ		
	Scouring					レ		
Description	Erosion					レ		
	Others	レ						
Description		<p>上部工はプレキャストRC桁(横桁無し)であるが、支承が使用されていないのでせん断破壊しやすい構造になっている。せん断ひび割れや鉄筋露出が見られ、危険な橋である。下部工は洗掘されており危険である。3年以内に落橋する可能性があるかと判断した。</p>

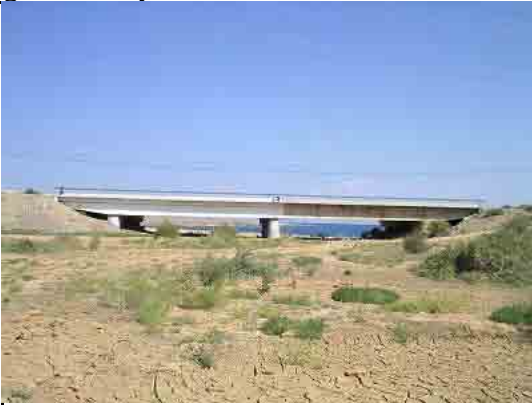
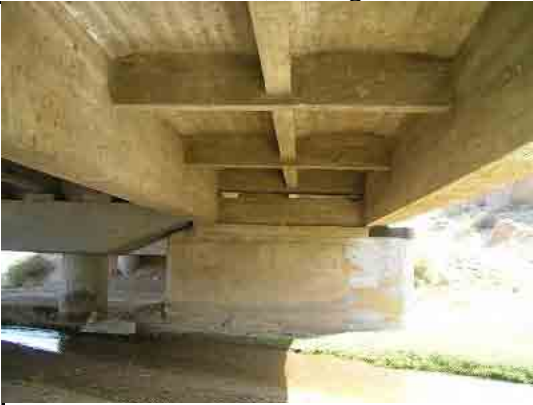
NO.22(1) Bridge

Spalling				レ			
	Honeycomb			レ				
	Others	レ						
Foundation	Settlement	レ						
	Deformation	レ						
	Scouring	レ						
	Others	レ						
Flood Protection (Gabion Works, Embankment, etc)	Settlement	レ						
	Deformation	レ						
	Destruction	レ						
	Scouring	レ						
	Erosion	レ						
	Others	レ						
Description	<p>上部工は、ひび割れが多く、曲げによるひび割れとせん断によるひび割れが見られる。特に側径間のせん断ひび割れと鉄筋露出は対荷力の低下を起している。左岸部分はひび割れ補修の塗装工事が行われていてひび割れが見にくいので内部検査が必要である。下部工はひび割れが多いが特に緊急性はない。左岸側はひび割れ補修工事が行われている。5年以内に落橋する可能性がある」と判断した。</p>

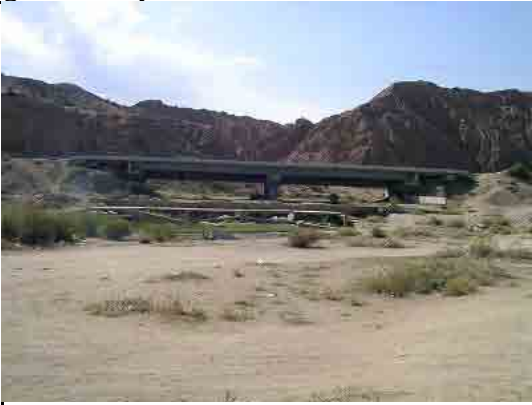
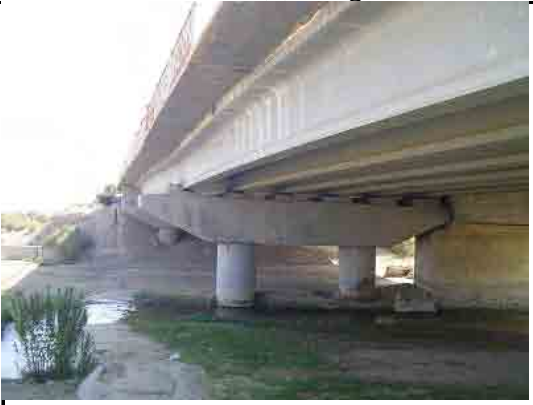
NO.22(2) Bridge

Spalling				レ			
	Honeycomb			レ				
Foundation	Others	レ						
	Settlement	レ						
	Deformation	レ						
	Scouring	レ						
Flood Protection (Gabion Works, Embankment, etc)	Others	レ						
	Settlement	レ						
	Deformation	レ						
	Destruction	レ						
	Scouring	レ						
Description	Erosion	レ						
	Others	レ						
Description		上部工は一部損傷があるが特に緊急性はない。下部工の橋脚は鋼板で被覆されているため内部コンクリートの状態が不明である。内部調査が必要である。10年以内に落橋する可能性があるかと判断した。

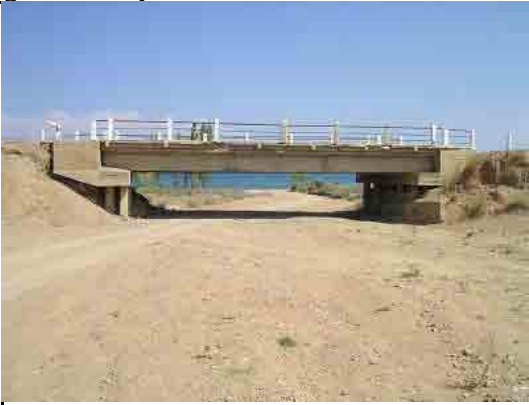
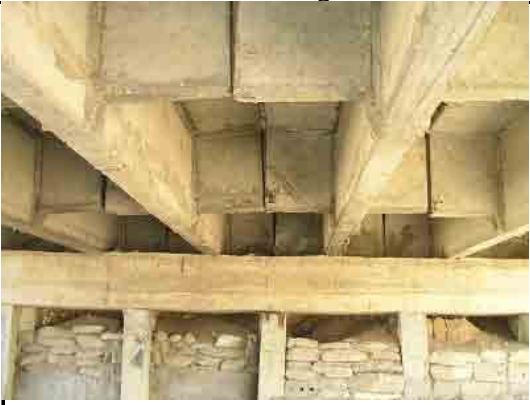
NO.23 Bridge

上部工の桁は健全であるが、横方向の連結がなく版作用でなく梁状態であり耐荷力が低い。桁の回転が見られる。下部工はパイルと受け梁の連結部分で部分的な圧縮破壊を起こしている。いつ壊れてもおかしくない状態である。3年以内に落橋する可能性があるかと判断した。

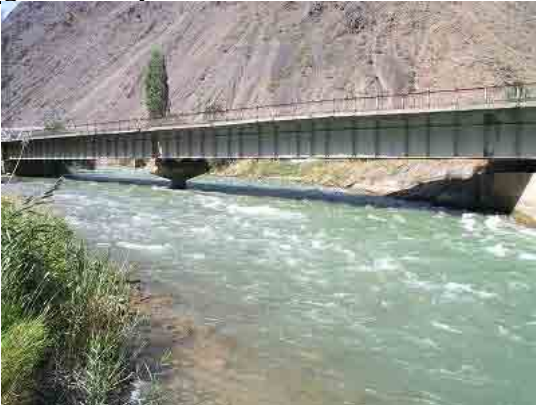
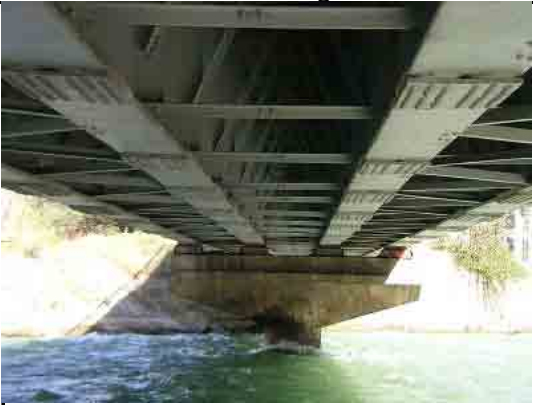
NO.25 Bridge

Honeycomb			レ				
	Others	レ						
Foundation	Settlement	レ						
	Deformation	レ						
	Scouring	レ						
	Others	レ						
Flood Protection (Gabion Works, Embankment, etc)	Settlement	レ						
	Deformation	レ						
	Destruction	レ						
	Scouring	レ						
	Erosion	レ						
Others	レ							
Description	<p>主桁は桁端部で垂直補剛材が座屈しているが健全であり、問題ない。鋼材腐食は軽微である。落橋の可能性はないが端部主桁の損傷は進行する。橋台のコンクリートは劣化している(コンクリート強度100kg/cm2程度)劣化原因は施工不良である。これが原因となって床版に縦方向と横断方向の貫通ひび割れがある。網状になっていないのでいま少しの耐力はあるが床版に穴があく可能性が高い。10年以内に落橋する可能性があるかと判断した。</p>
