SUMMARY OF PCG STATION					SITE	CGD ORMOC	
					CLASS		NO.
<b>1. LOCATION</b>							
Station	Address	Tel.	Fax	Longitude	Latitude		
CGS-Ormoc	Ebony St., Port Area, Ormoc City	053-5614213	None	° ' " E	° ' " N		
<b>2. GENERAL CONDITIONS</b>							
Moving from Manila		Site Access from Port	Road Traffic	Accommodation	Population		
By Plane	to Tacloban [Taking time: 1.0 hr.]	<input checked="" type="checkbox"/> Highway	<input type="checkbox"/> Heavy	<input checked="" type="checkbox"/> Hotel			
By Car	to Station [Taking time: 2.0 hrs.]	<input checked="" type="checkbox"/> Paved	<input checked="" type="checkbox"/> Medium	<input checked="" type="checkbox"/> Motel			
By	to [Taking time: hr.]	<input type="checkbox"/> Unpaved road	<input type="checkbox"/> Light	<input checked="" type="checkbox"/> Pension			
Airport Name : Tacloban Airport		Seaport Name: Ormoc Port		<input type="checkbox"/> None			
<b>3. CONDITIONS OF STATION</b>					Refer to attached drawing

Appendix 5-3 Circuit Design of VSAT and Microwave Communication System

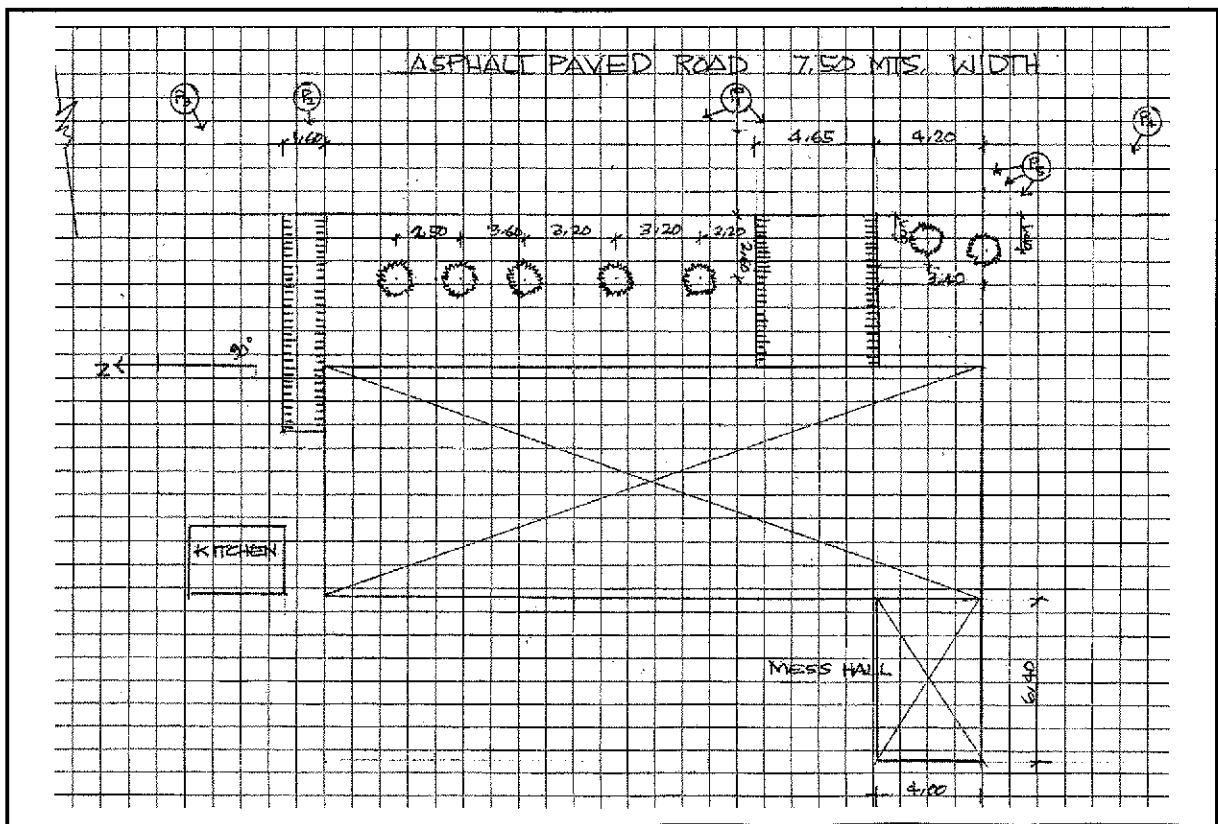
FIGURE 5-1-12 SITE LAYOUT FOR CGS TACLOBAN

It is to be noted that the location of the present coast guard station is inside a military compound in Brgy. San Jose of Tacloban City which is a stones throw away from the Tacloban Airport. It is about 10.0 kilometers away from the Port of Tacloban. The building occupied by CGS-Tacloban belongs to the Philippine Navy, the same being previously under its command prior to being transferred under the administrative jurisdiction of the DOTC. The CGS-Tacloban has an outpost at the Port of Tacloban being manned on a 24 hour basis for clearing of cargo vessels.

6. COMMENTS	
<b>Suggestion</b>	
<b>Remarks</b>	<p><u>Comments/Recommendations</u></p> <ol style="list-style-type: none"> <li>1. Replacement of outmoded HF and VHF equipment in order to attain direct station to Cebu district headquarter contact (HF equipment) as well as for direct contact from station to coast guard detachments and station to vessel contact under its area of responsibility (VHF equipment).</li> <li>2. Installation of appropriate antennae mounted on self – supporting type structure/ pole.</li> <li>3. Provide operation room with air-conditioning unit and computer for the typing of messages.</li> <li>4. Increase the number of skilled operator and provide training to personnel ( especially the non-rated personnel) for an efficient 24hrs communications equipment operation service.</li> <li>5. Provision of fast moving spare parts (fuses, diods, transistors, I.C.s, etc.).</li> <li>6. Creation of a communications maintenance repair group at the Cebu district headquarter with rated electronic technician.</li> <li>7. Provision of standby generator set to ensure uninterrupted power supply twenty four hours (24 hrs.) a day.</li> <li>8. Provide telefax machine as a fast and alternative means of transmitting communications.</li> <li>9. Repair of dilapidated portion of the ceiling to prevent leakages.</li> </ol>

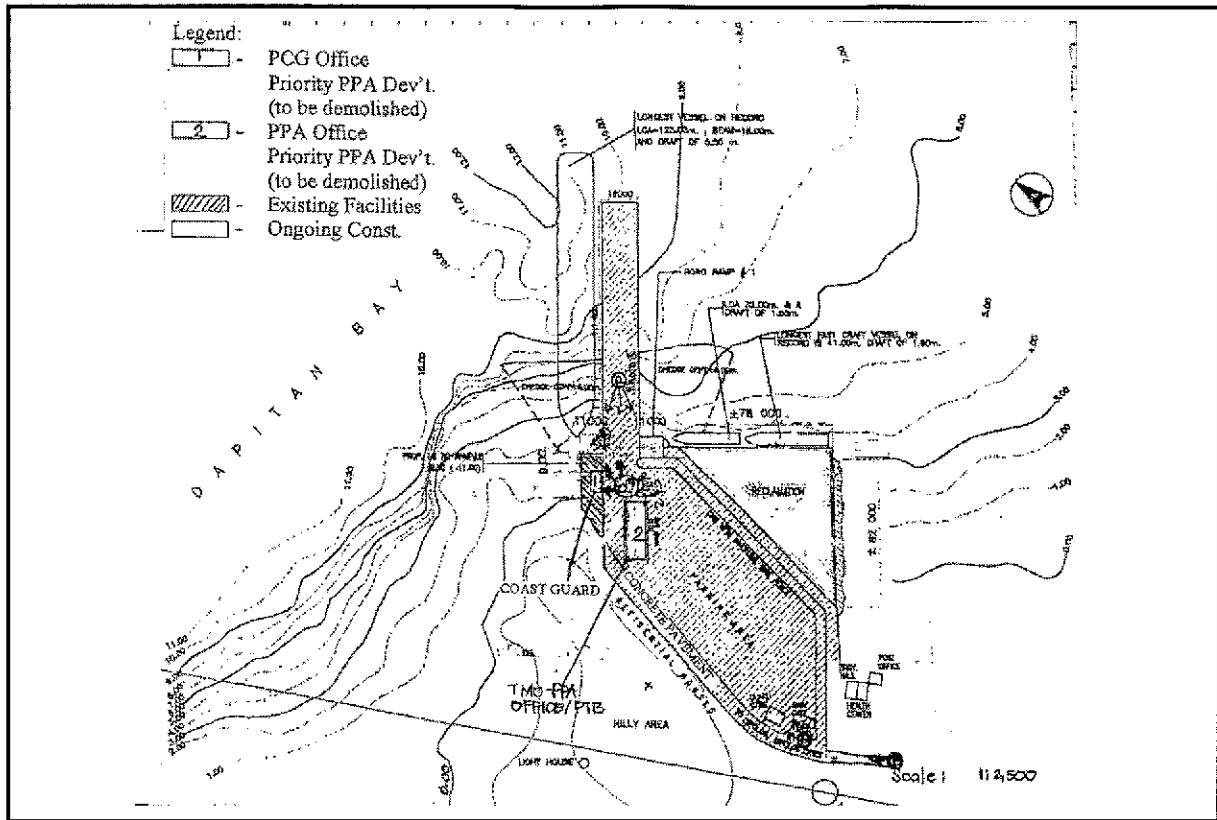
FIGURE 5-1-15 SITE LAYOUT FOR CGS DAPUTAN

3.	Building is not safe and secured because it is made of light wood materials (coco lumber, plywood and bamboo) which can easily be damaged. Building rests at sea which can be subject to damages during typhoons and low pressure weather conditions.

4.	A temporary antenna with bamboo pole is located at center top of building capable of transmitting and receiving only up to 1 km. distance only due to defective antenna; antenna needs to be upgraded.

6. COMMENTS	
Suggestions/Remarks	<ol style="list-style-type: none"> <li>1. Replacement of outmoded communication equipment with latest model and provision of Icom Radio including antenna. The replacement of existing outmoded HF and VHF with good quality equipment is recommended. In the case of HF equipment, to allow 24 hrs contact from station to headquarters as well as from Dapitan station to other coast guard stations. In the case of VHF equipment, to allow direct contact from Dapitan station to its various detachments and auxiliary volunteers within the area of responsibility as well as direct contact from the station (shore) to vessels (both foreign and local) transiting the area of responsibility.</li> <li>2. Provision of air conditioning and ventilation system.</li> <li>3. Provision of telephone line and facsimile machine.</li> <li>4. Expansion of operations room in order to accommodate all equipment including computer.</li> <li>5. Provision of fast moving spare parts (fuses, diods, transistors, I.C.s, etc.).</li> <li>6. Provision of standby generator set to ensure uninterrupted power supply twenty four hours (24 hrs.) a day.</li> <li>7. Provision of lightning arrester to prevent damage to the communications equipment.</li> <li>8. Provide telefax machine as a fast and alternative means of transmitting communications.</li> <li>9. Installation of appropriate antennae mounted on self-supporting type pole to increase present height of antennae which is mounted on a bamboo pole.</li> <li>10. Rehabilitation of dilapidated ceiling of the existing CGS-Dapitan Building to arrest water leakages.</li> <li>11. Training of personnel was given only once before they were enlisted except for the operations chief. Provide training to personnel (especially the non-rated enlisted personnel) for an efficient 24hrs communications equipment operation service.</li> </ol>

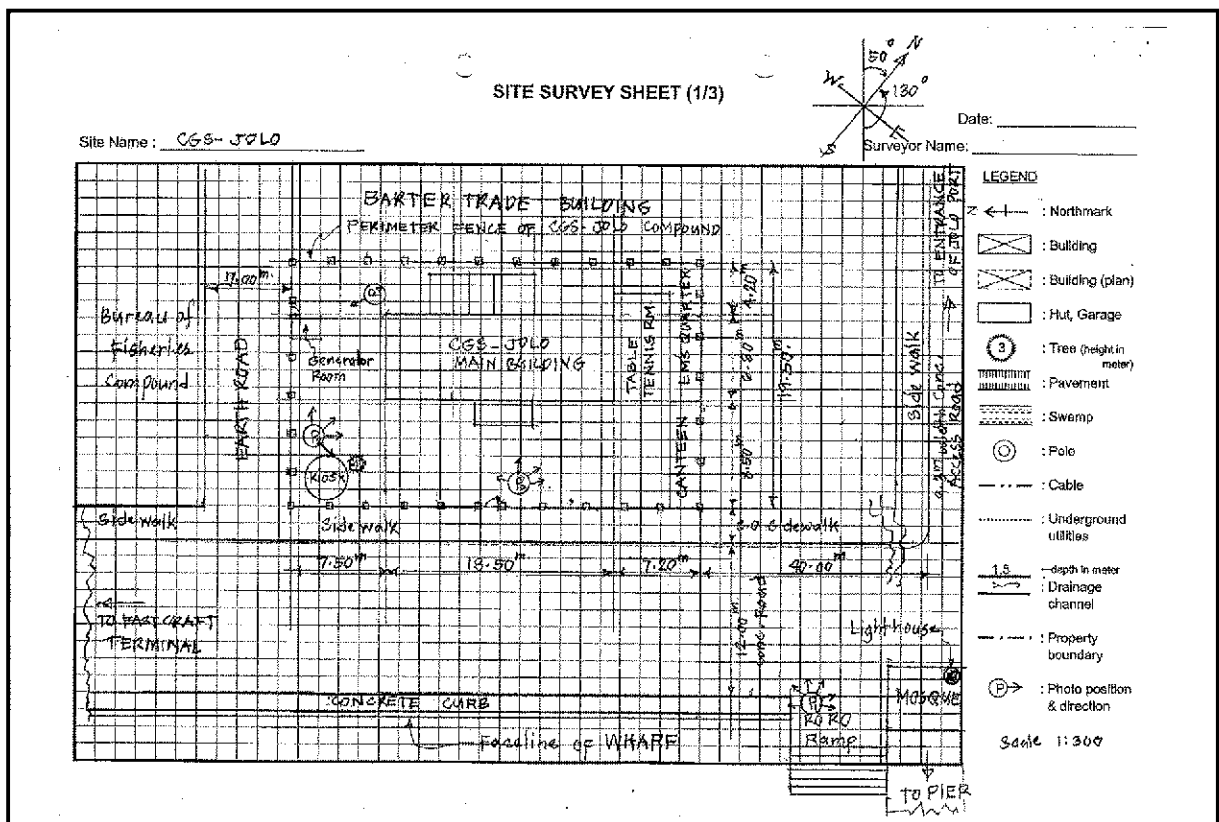
FIGURE 5-1-18 SITE LAYOUT FOR CGS JOLO

2.	The size of the operation/radio room (5.7 sq.m.) is inadequate and congested. It is located adjacent the administrative and receiving room. Presently, only the HF equipment is kept in this room. The VHF equipment is placed in one corner of the administrative/receiving room.

8.	The present condition of VHF equipment and height of VHF antennae could allow only three (3) nautical mile radius clear reception in all direction.

9.	The VHF equipment currently used by CGS-Jolo is not an organic property of the station. It is only borrowed from the spare of M/L Katrina vessel. This communication equipment can be pulled-out anytime when needed by the vessel.						
<b>4. OPERATION AND MAINTENANCE</b>		<b>5. PERSONNEL FORMATIONS</b>						
<b>Actions taken in equipment failure</b>								
Restoration flow	Seek assistance of private technician in the locality Otherwise equipment is send to Zamboanga headquarters for repair. HCGD Zbga would seek assistance from naval technician otherwise equipment is send to PCG Manila Headquarters.	Chief	1					
Examples of major failure	Equipment cannot transmit/ receive messages; No signal	Operator (skilled)	2	( )				
Sufficiency of spares	No spares	Technician (skilled)	None	( )				
<b>Records of damages</b>		Administrator	2 clerks					
<input type="checkbox"/> Heavy rainfall		Good	Bad					
<input type="checkbox"/> Storm		<input type="checkbox"/>	<input type="checkbox"/>	External noises

3.	Rehabilitation of dilapidated roof and ceiling of the existing CGS-Jolo Building to arrest water leakages (especially at the quarters and administrative/receiving area). Also, replacement of the electrical wiring system affected by the leak. Subsequently, the conversion of the existing 44.5 sq.m. quarters (located in the main building adjacent the admin room and presently not utilized due to leakages at the ceiling) to operations room; provision of an air-conditioning unit in said room and replacement of the 15 year old typewriter with computer for the typing of messages.

5.	Provision of fast moving spare parts (fuses, diodes, transistors, I.C.s, etc.).						
	6.	Creation of a maintenance repair group at Zamboanga Headquarter with rated electronic technician.

7.	Replacement of the existing twenty (20) years old and unreliable 15 KVA generator set to ensure uninterrupted power supply twenty four hours (24 hrs.) a day.

8.	Due to frequent and considerable voltage fluctuation, the provision of a step-up transformer and AVS has been requested.						
	9.	Provision of lightning arrester to prevent damage to the communications equipment.
