CHAPTER 3

LANDSLIDE DISASTER MANAGEMENT

3. Landslide Disaster Management

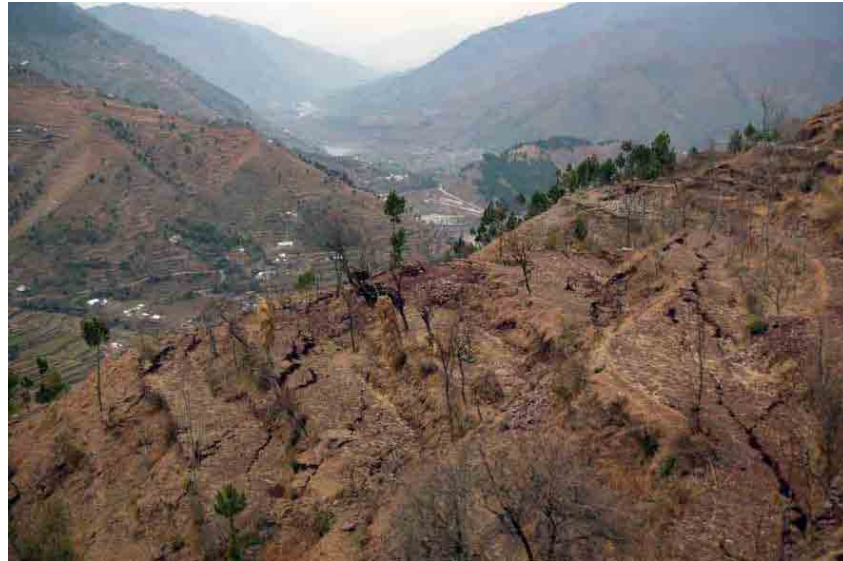
The Balakot-Garhi Fault is an earthquake fault that caused innumerable surface ruptures when the latest northern Pakistan earthquake in 2005 occurred (Photo 3.2.1). Surface rupture amounts to six meters occurred on alluvial terrace in case of the earthquake in 2005 (Kumahara & Nakata, 2005).

Photo 3.2.1 A series of tension cracks developed on a slope parallel to the active fault

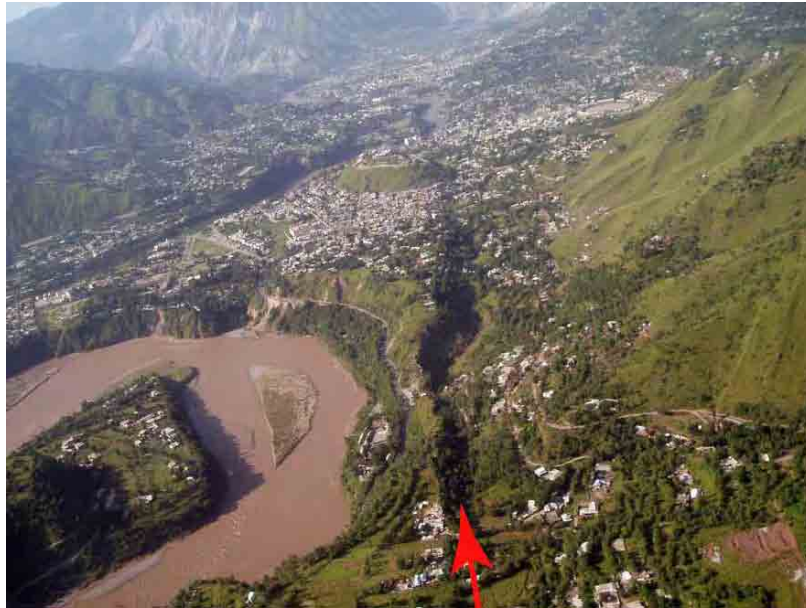
Photo 3.2.2 East facing active fault scarp of the Jhelum Fault south of Domei, Muzaffarabad

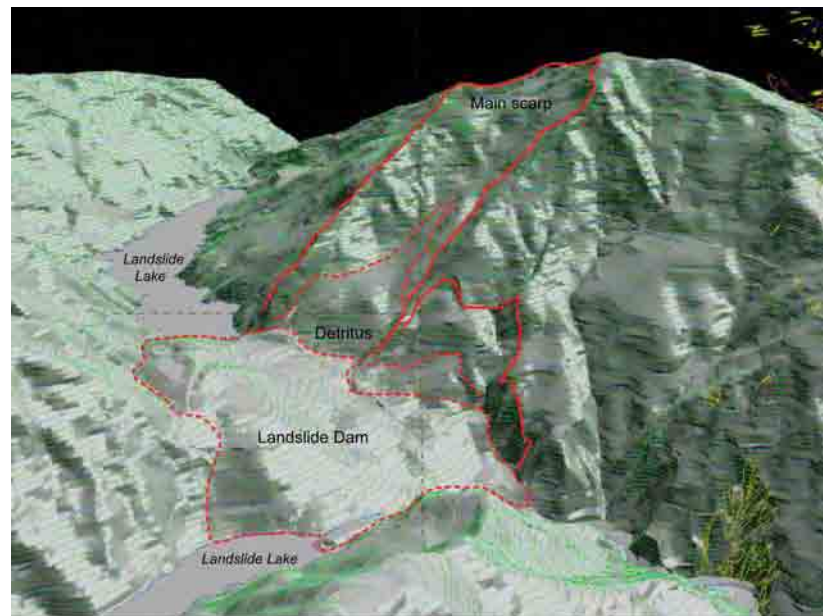
Bird's eye view of Dandbeh landslide and its vicinity from southeast

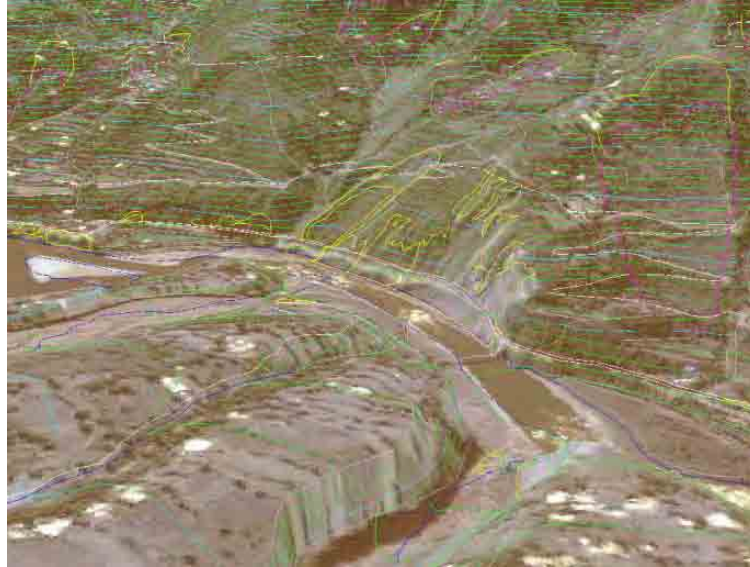
Figure 3.2.6 Slope failure marked by bare slope behind the barrage at Suguli where an under cut slope develops.

The Jhelum River flows from the left to the right in this picture. Deep landslide of activated one on the upper stream side of the slope failure also develops.

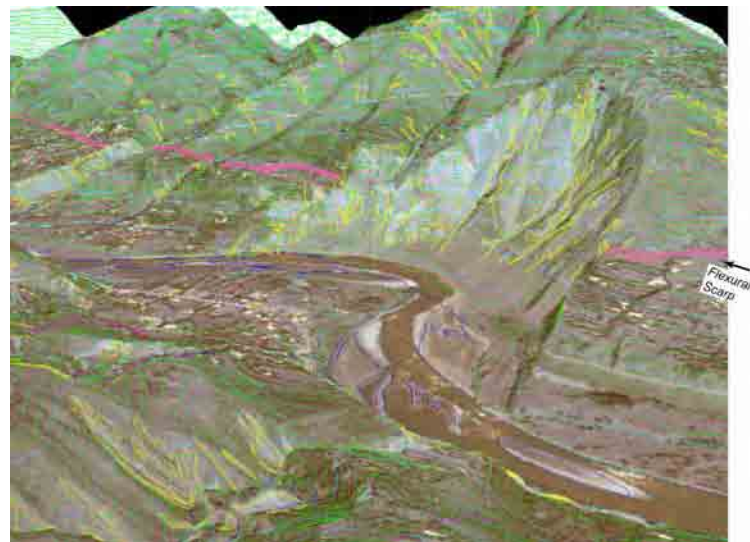
Figure 3.2.7 Slope failure of large scale at Bandi Tagian where an under cut slopes develops.

The Jhelum River flows from the right to left in this picture. Balakot- Garhi fault as an active fault is located along the right bank of the Jhelum River. It forms flexural slopes on river terraces and also runs across the under cut slope.

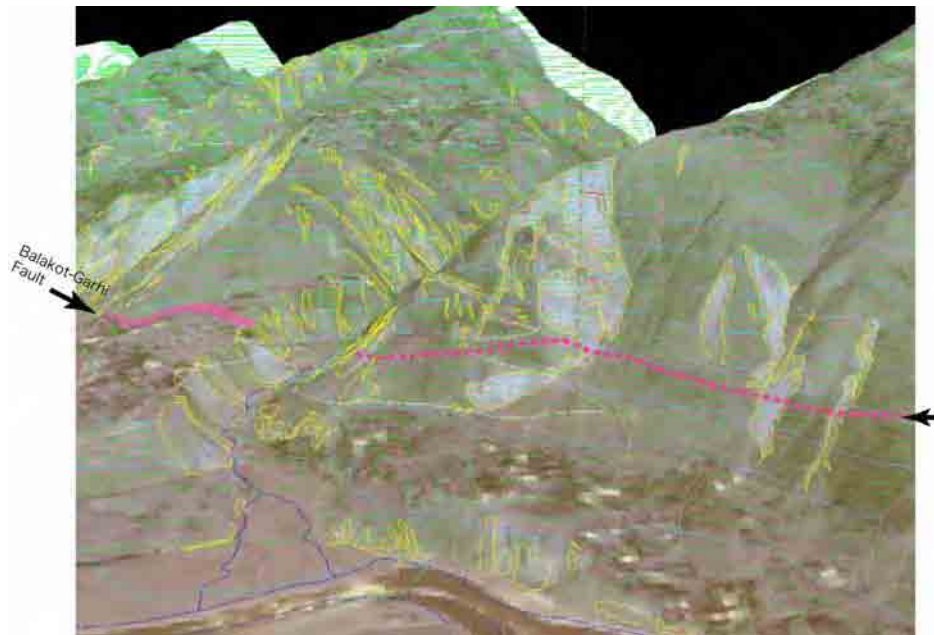
Figure 3.2.8 Slope failures of large scale at Kuloli where the active fault runs just along the foot slopes.

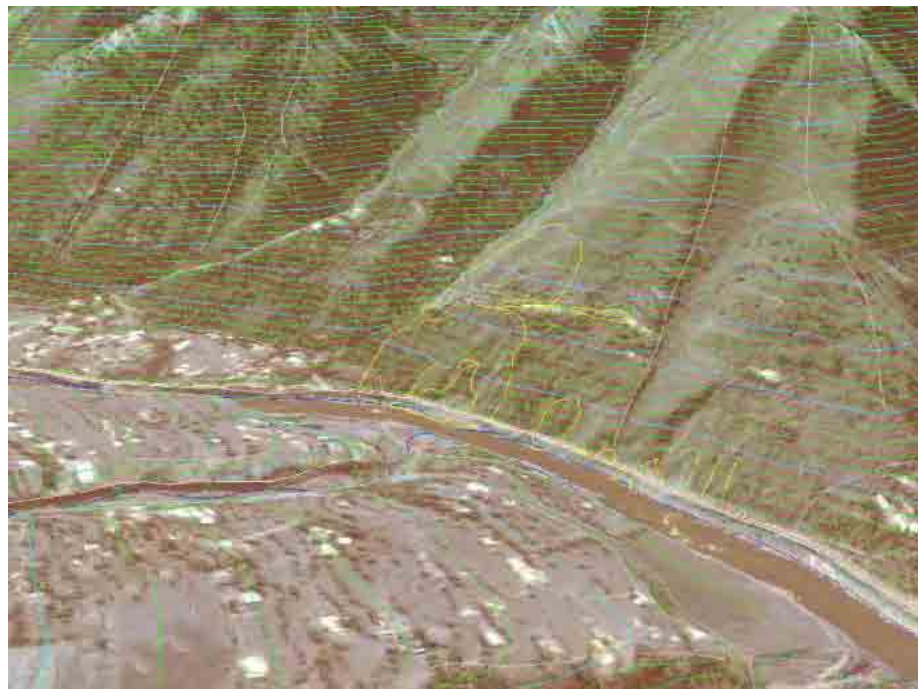
Figure 3.2.9 Deep active landslide of the initial stage at Badihara on an anti-dip slope in Muree Formation zone

The foot part of the landslide is undergoing severe toe erosion due to annual torrential stream of the Jhelum river. Besides the stream toe erosion, under cutting by civil road works against the toe part of the landslide facilitated to accelerate a rock landslide.

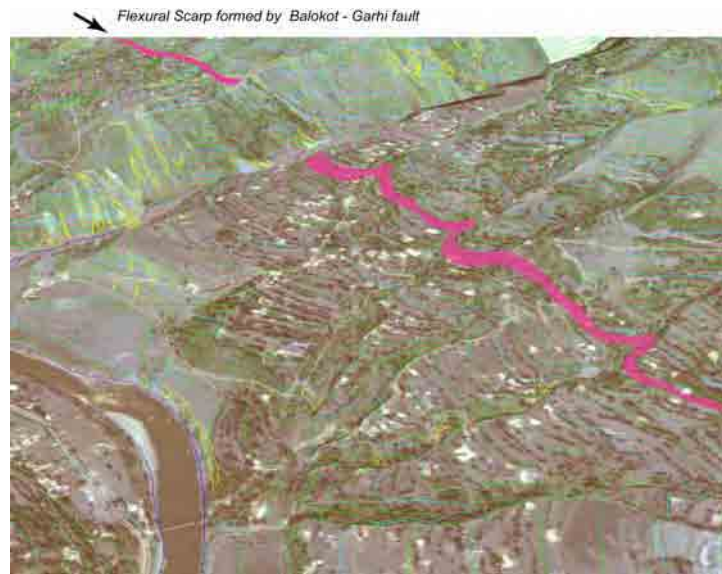
Figure 3.2.10 Flexural slope on the right bank of the Jhelum River around Totha downstream of Naushana

Numerable tension cracks parallel to the active fault are aligned on the flexural scarp. They are multi-genetic surface deformation combined with upheaval due to tectonic movement and subsequent gravitational movement. Some of them have expanded as slope failures.

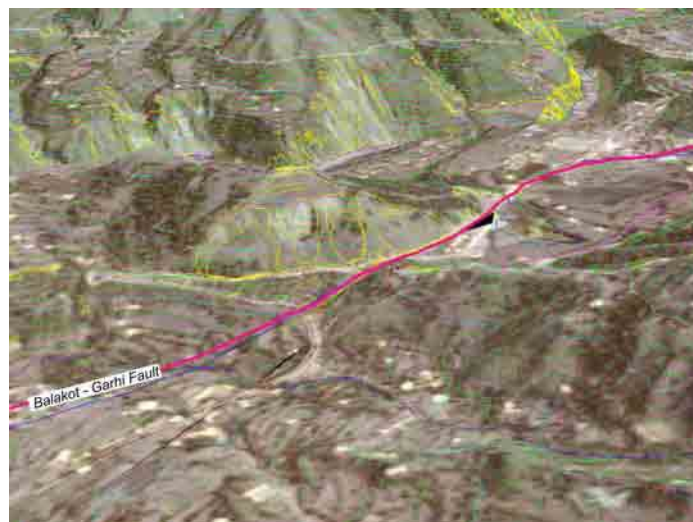
Figure 3.2.11 Active landslides along the Jhelum valley road at Dhallan where Balakot-Garhi fault runs across it

Gradual slide has continued after the earthquake, deforming Jhelum valley road at Dhallan on the left bank of the river. They are also reactivated landslides because aerial photographs taken in 1978 show pre-existed scarps of landslide origin.

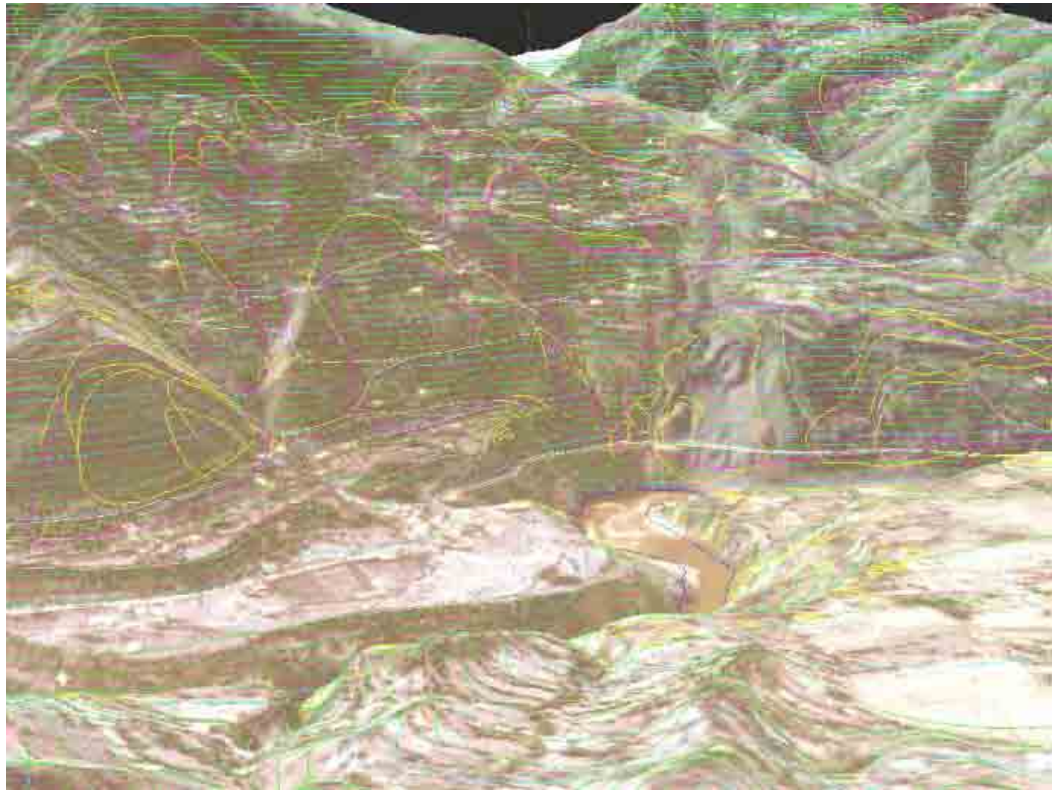
Figure 3.2.12 A series of deep and active landslides distributed at Naili along the gorge of the Jhelum River in the upper stream from Dhallan

This group of the Naili landslides is one of the most distinctive and problematic landslides in the valley. They are quite active, located on the under cut slope which has been undergoing severe toe erosion by the constant torrential stream of the river. Area of landslide covers a whole slope from the river bed to the ridge top for 700 - 1000 meters long.

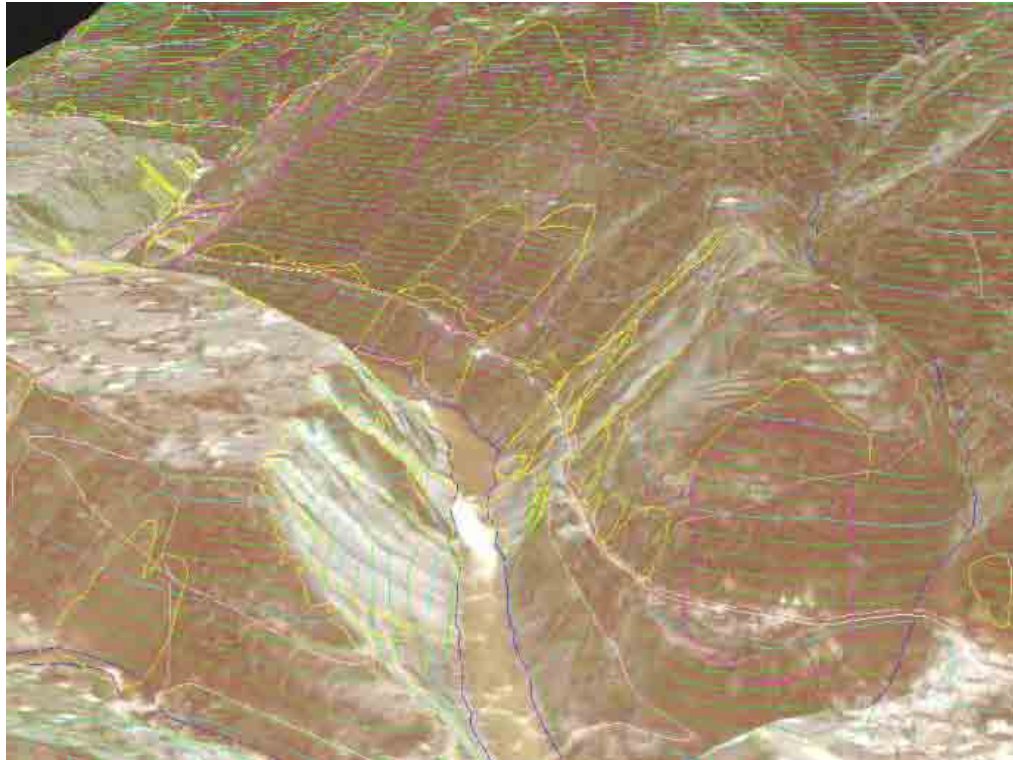
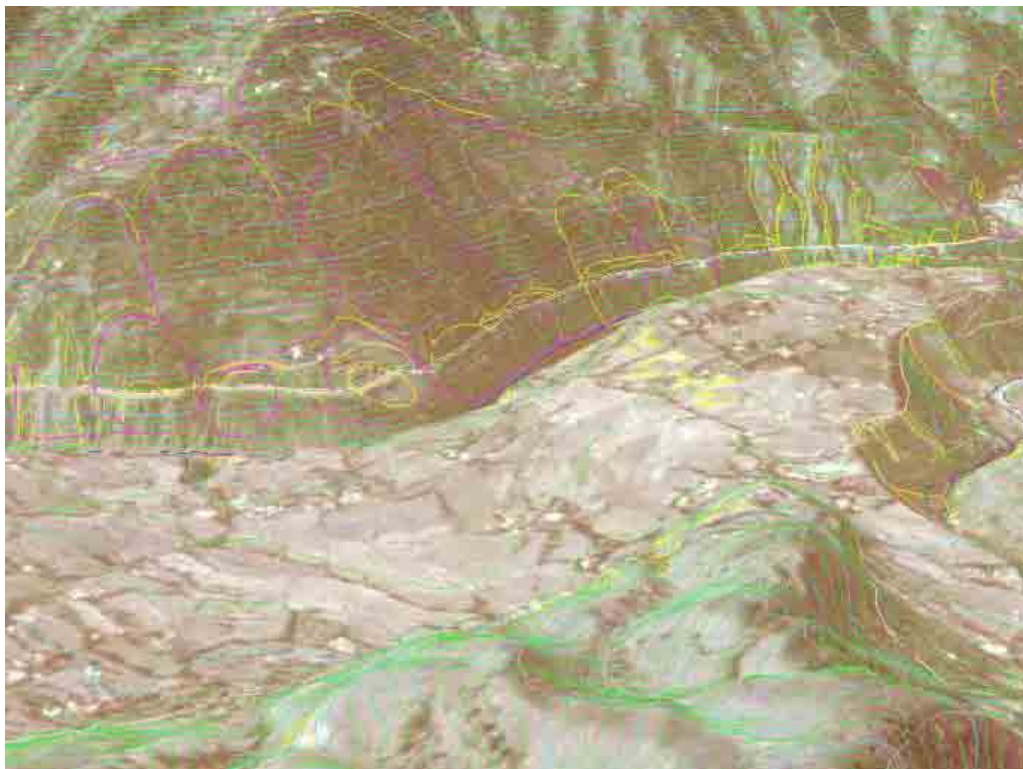
Figure 3.2.13 A series of Jaskool landslides as one of the active landslides

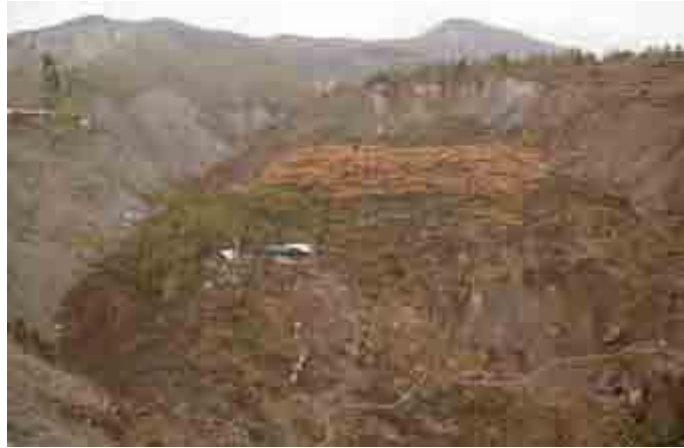
Photo 3.5.1 Deep landslide (rotational landslide) northeast of Muzaffarabad city

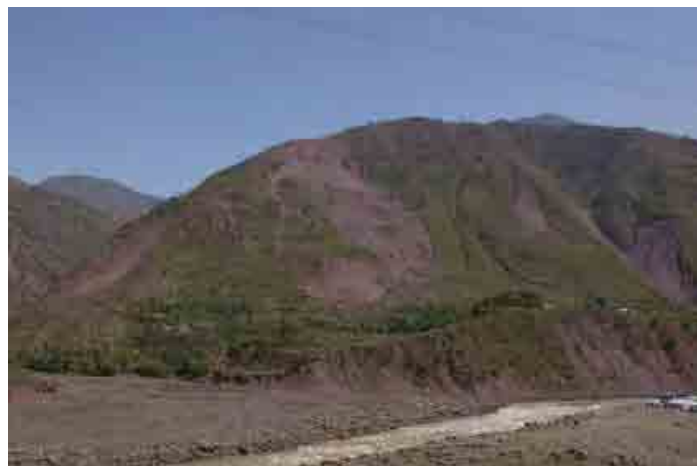
Photo 3.5.2 Slope failures (shallow landslide) at Kulori

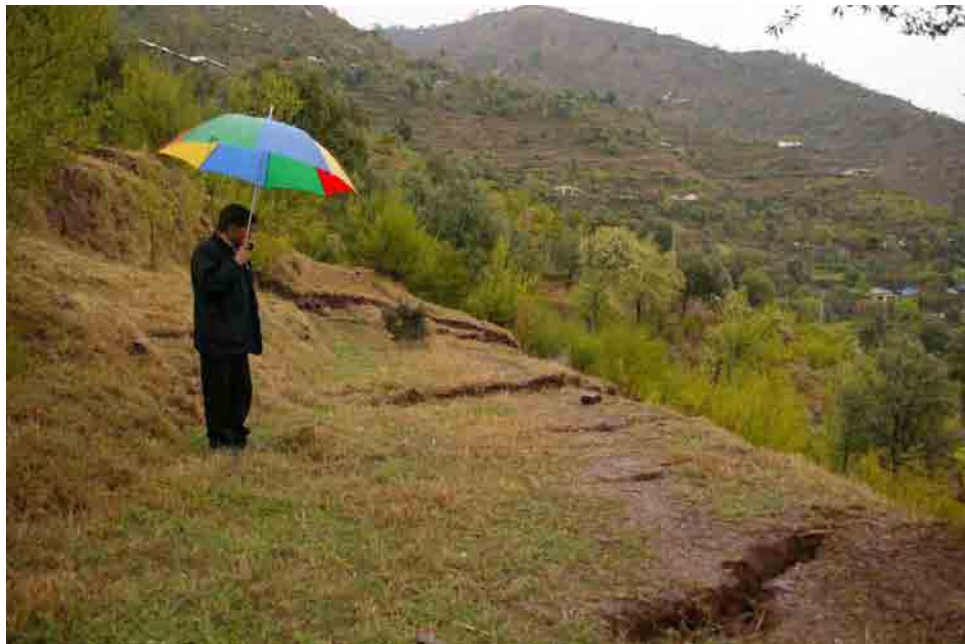
Photo.3.5.3 Tension cracks developed on the flexural scarp

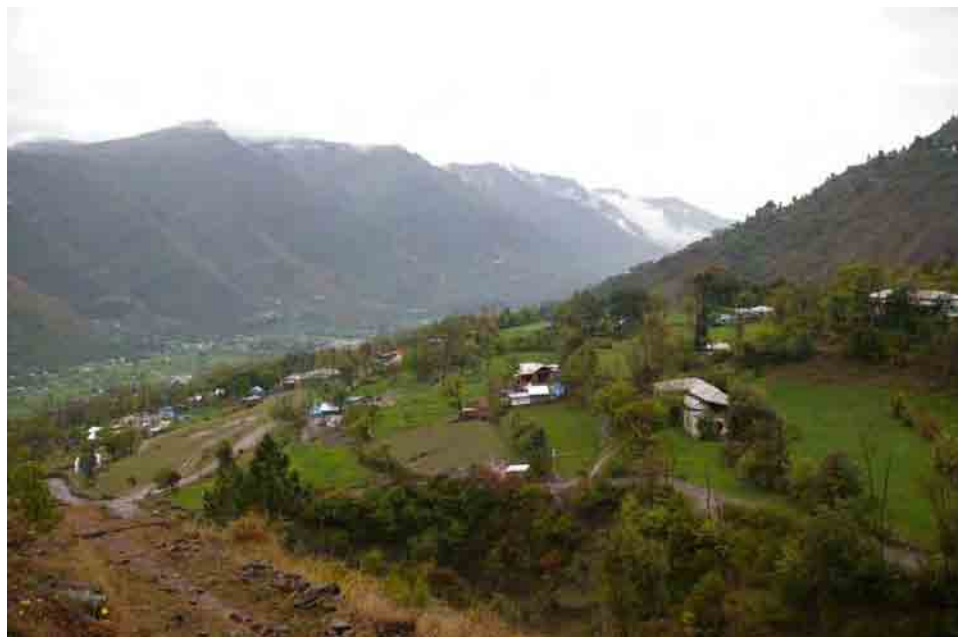
Photo.3.5.4 Tension cracks developed on the flexural scarps at Dopatha

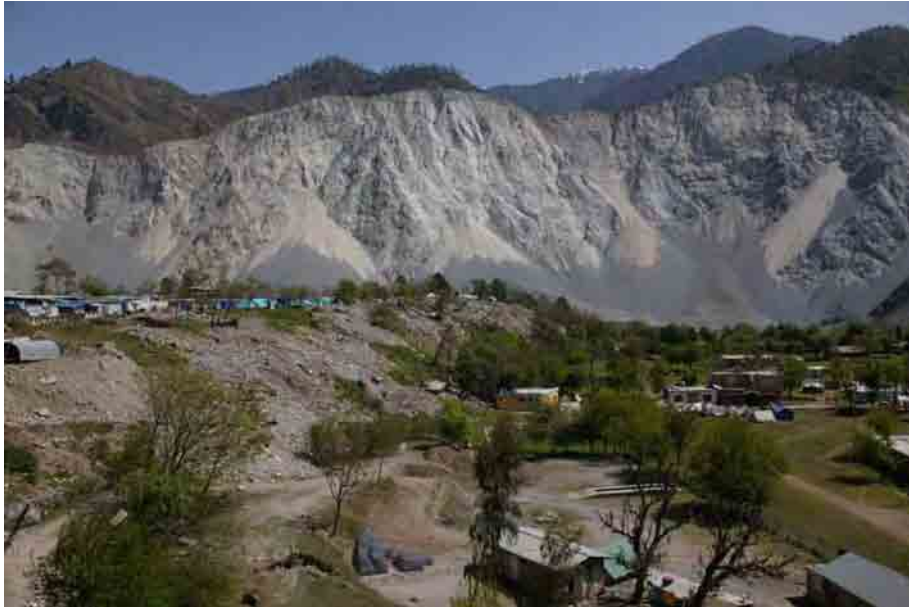
Slope failures caused by the 2005 Northern Pakistan Earthquake are strongly impressed by white big walls along the Balakot-Garhi Fault just behind Muzaffarabad city (Photo 3.5.5). They occurred on steep dolomite cliffs as marginal slopes fringing Muzaffarabad city to the north.

Photo.3.5.5 Slope failures on dolomite wall north of Muzaffarabad

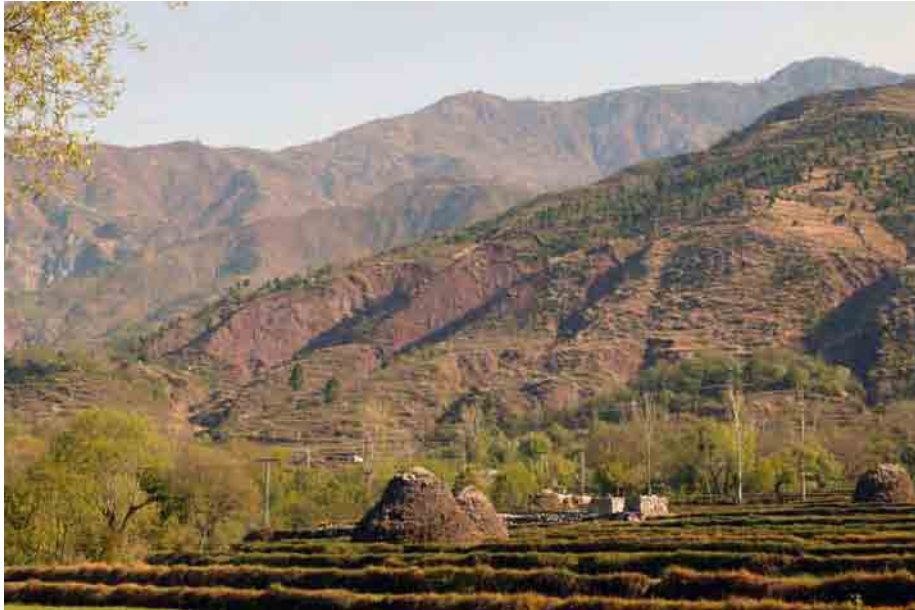
In this study area, slope failures are marked as red colored bared slopes or scars (Photo 3.5.6). They are dominantly distributed along steep side slopes of tributaries that join to the Jhelum River and along terrace cliffs adjacent to the Jhelum River (Figure 3.5.2). They also occurred at toe parts and main scarps of old landslides. Large slope failures occurred on undercut slopes along the main stream of the Jhelum River. Photo 3.5.7 is a view of large slope failure on the undercut slope at Sugli. Slope failures do not much depend on geological condition (Figure 3.5.3) except unconsolidated terrace gravel, however, they frequently occurred on anti-dip slopes steeper than 35 degrees along the valley.

Photo.3.5.6 Red colored bared slope and scars

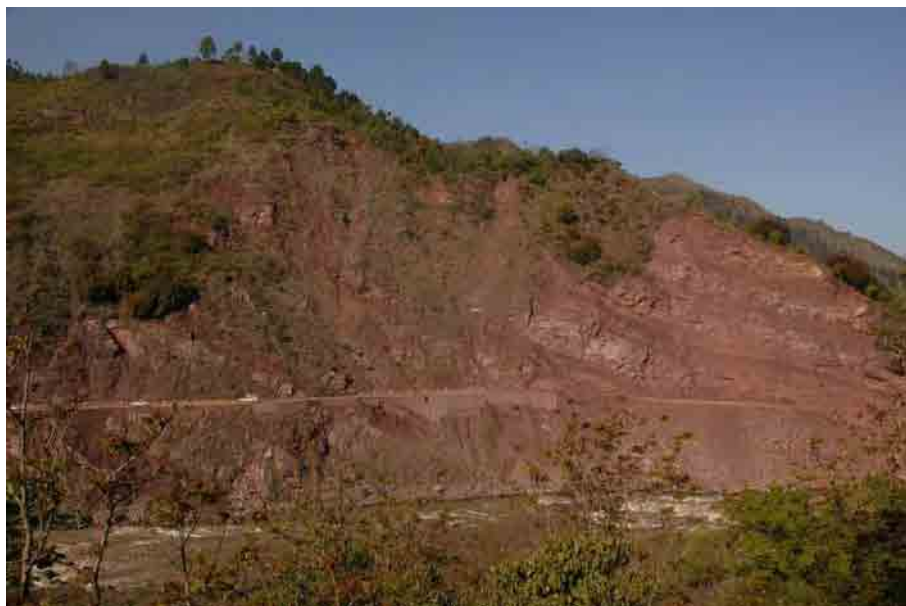
Photo.3.5.7 Large slope failure on under cut slope at Sugli

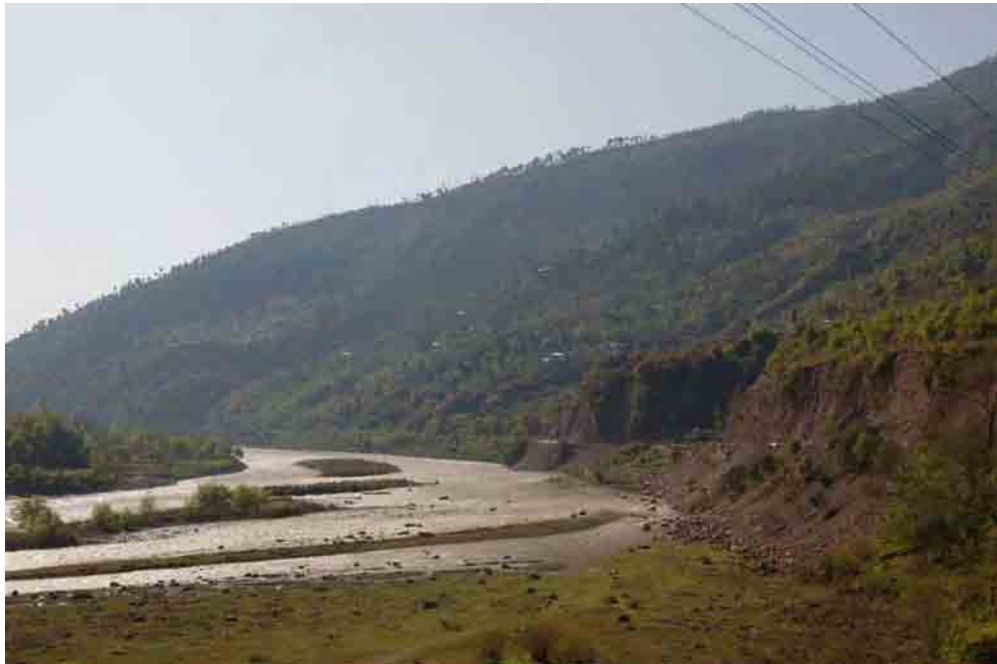
Photo 3.5.8 Old landslides near Kuloch

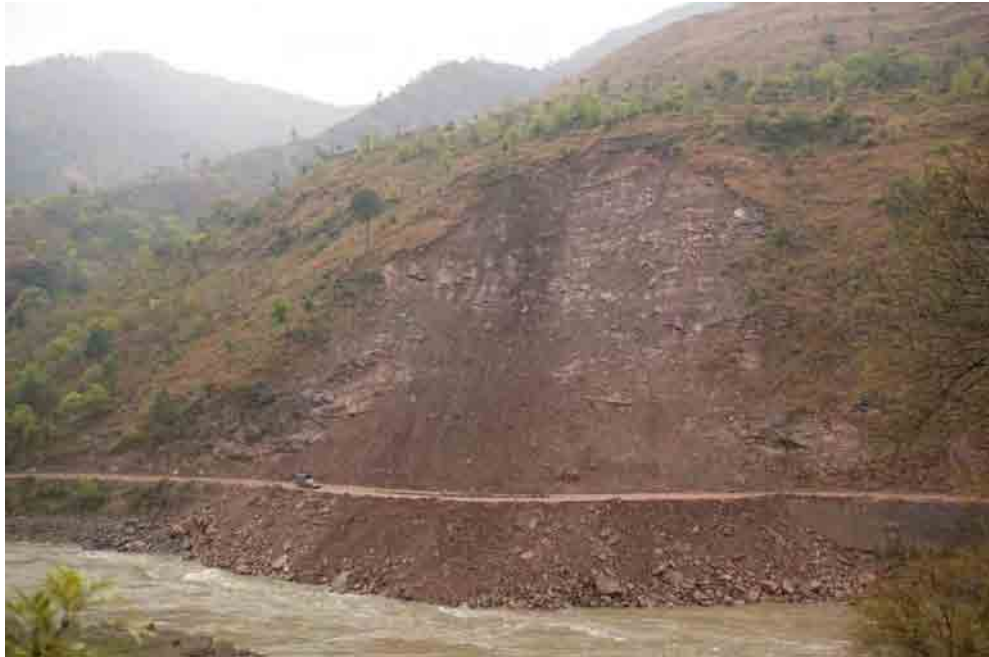
wedges. We should deliberate the cause of landslides on anti-dip slope in the Muree Formation area in the lower course of the valley. Initial stage of a rock slide is just occurring on an under cut slope at Badihara where is underlain by the Muree Formation and is developing as the anti-dip slope (Photo 3.5.9). This implies that the Muree Formation is prone to landslide on anti-dip slopes under the condition of sever under cutting at the present. And it also suggests that old landslides had initially occurred under same erosional conditions in the incision process along the Jhelum Valley in the past.

Photo 3.5.9 landslide on anti-dip slope at Badihara

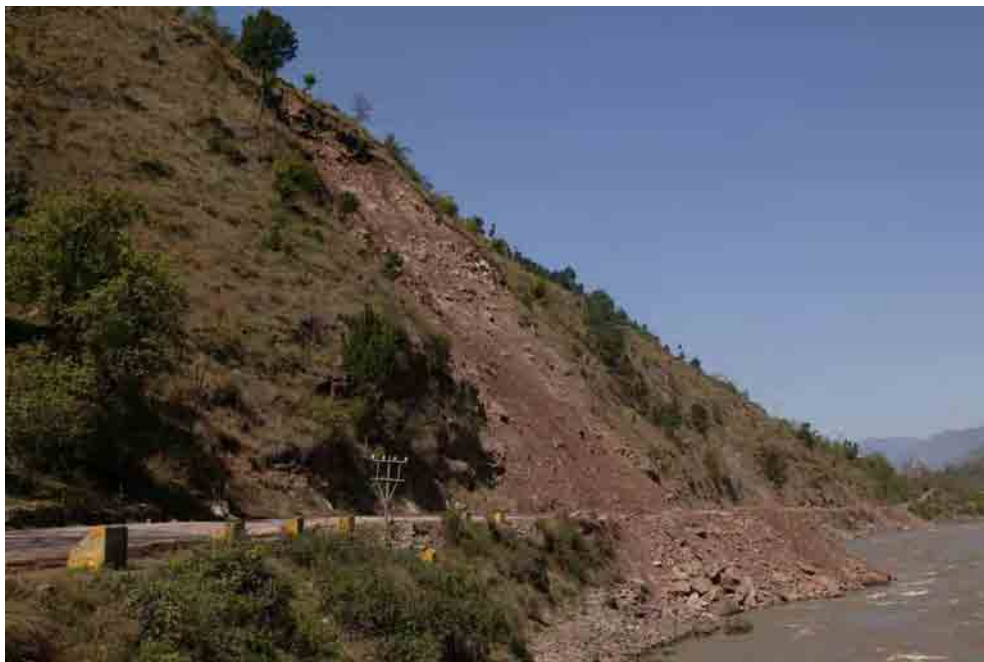
Photo 3.5.10 Reactivated landslide due to toe erosion

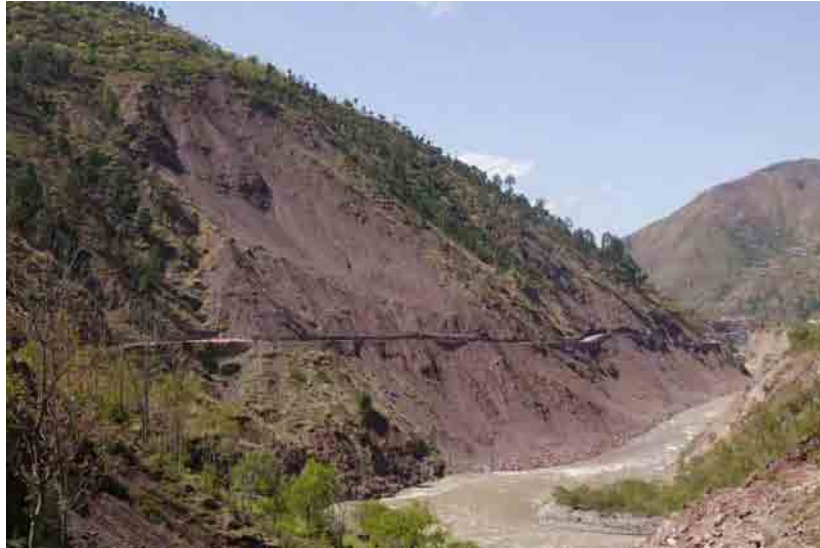
Photo.3.5.11 Active landslide due to under cutting and civil works at Jaskool

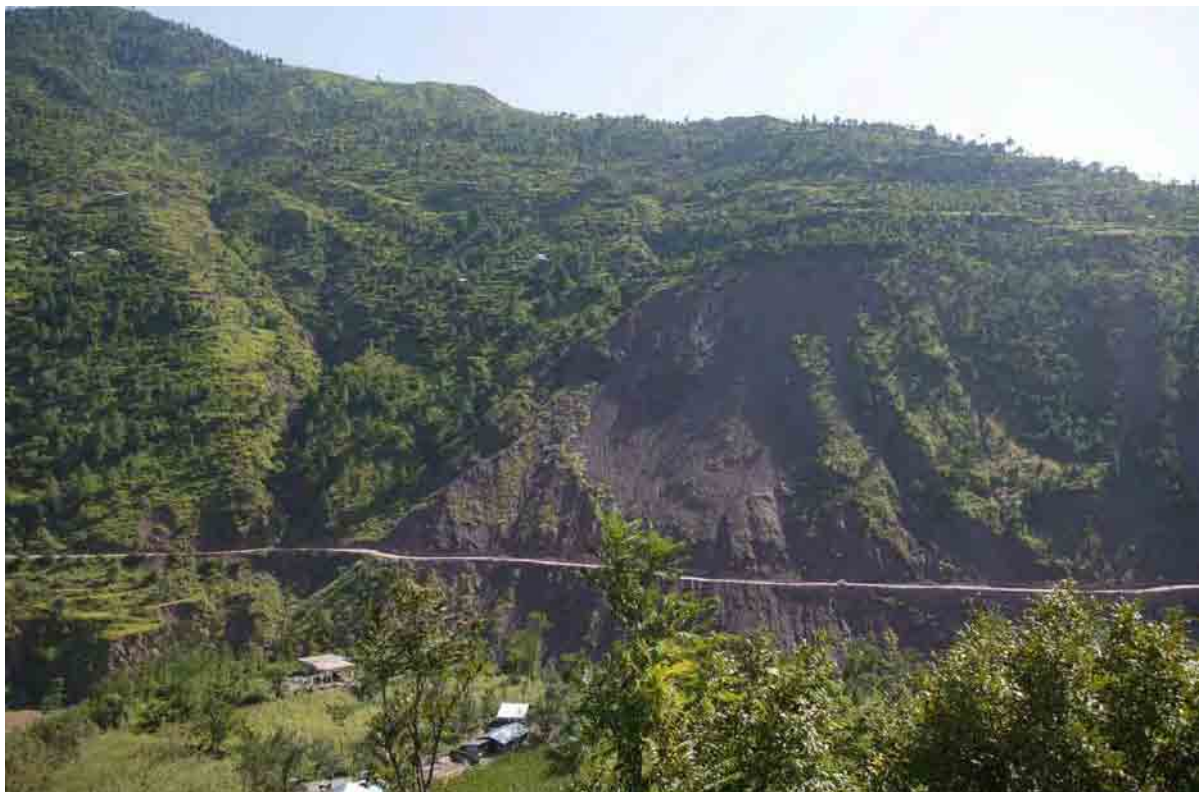
Photo.3.5.14 panoramic view of Nail landslide active part(front) & old part(behind)

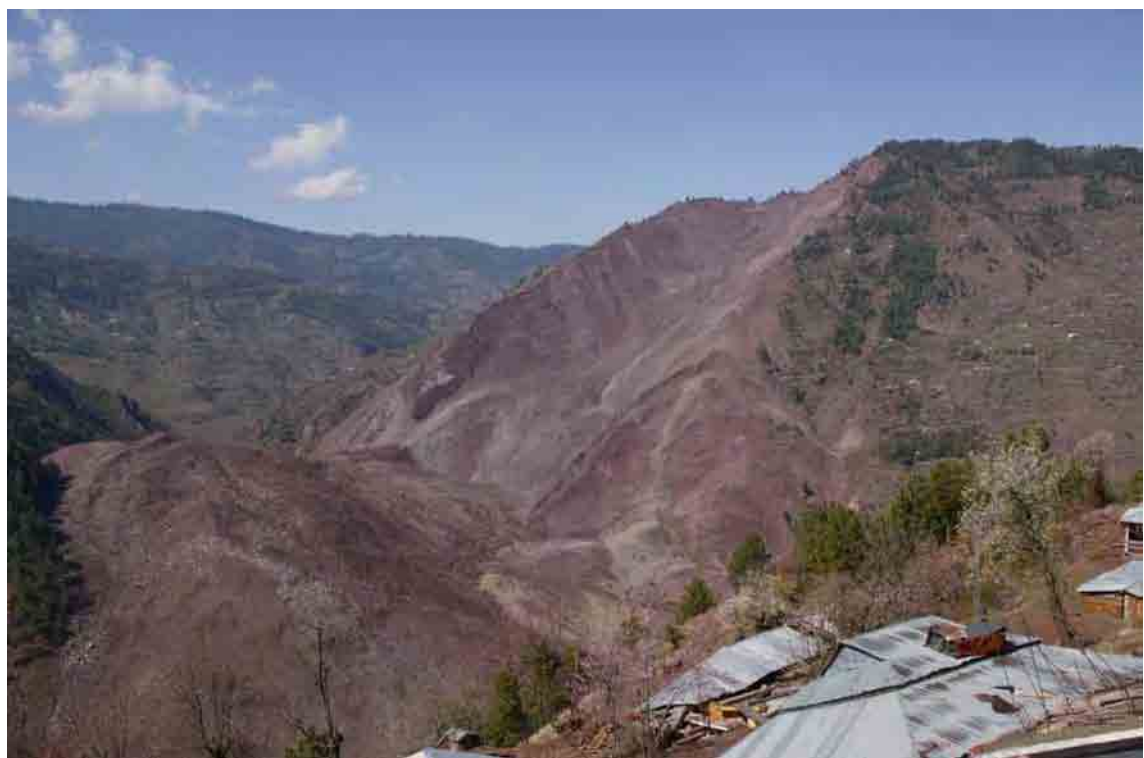
The most distinct example of the reactivated landslide is the Dandbeh landslide (Photo 3.5.15). Geomorphological map made by interpretation of aerial photographs taken in 1978 clearly shows pre-existed slope dislocation marked by cracks and small cliff on the original slope and ridge (Figure 3.5.8).

Photo 3.5.15 Dandbeh landslide as a reactivated landslide

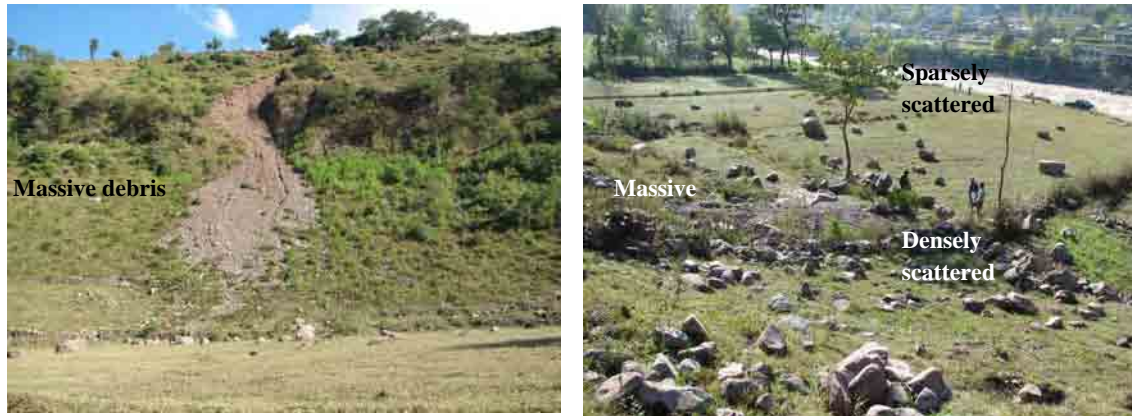
Figure 3.9.3 Slope failures on the terrace scarp of site 7.

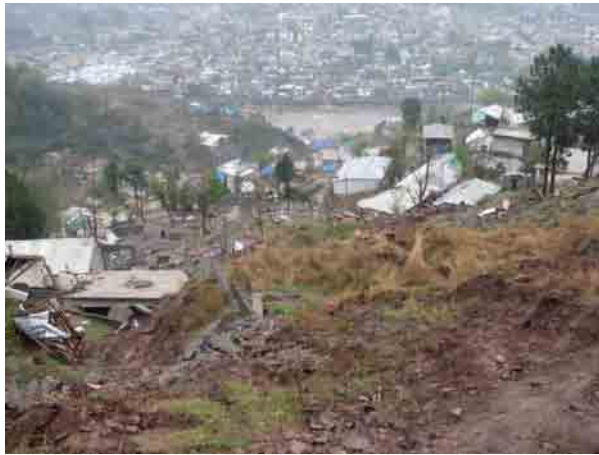
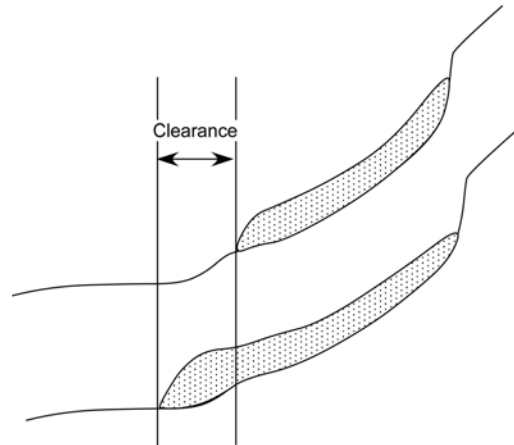
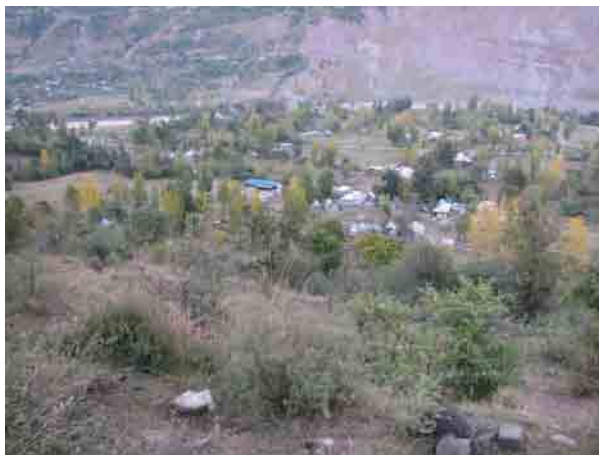
Figure 3.9.6 Damaged area near the toe of a landslide occurred in February, 2006 in Muzaffarabad (upper left) and the schematic sketch showing the necessity of clearance in front of the toe of a slide (upper right).
