# **CHAPTER 4**

# **RECOMMENDATION**

### 4.1 Recommendation about mitigation measures against landslide hazards along the national highway near the Jhelum River

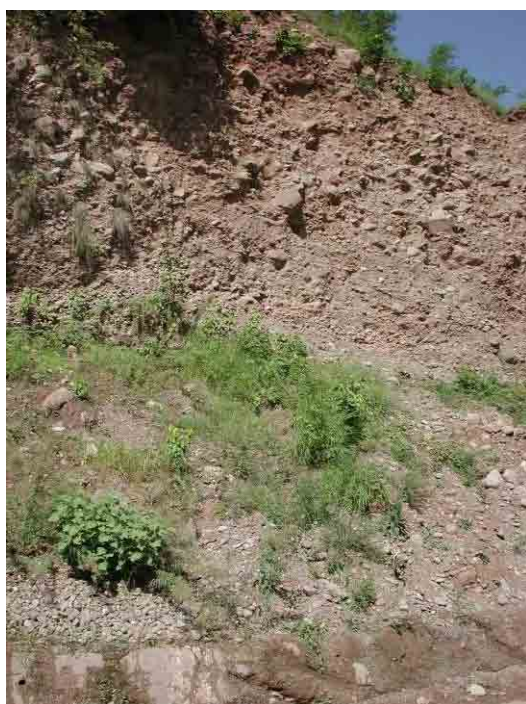
(A) Gravel bed of river terrace

Photo 4.1.1 Roadside slope gravel bed near Dhanni

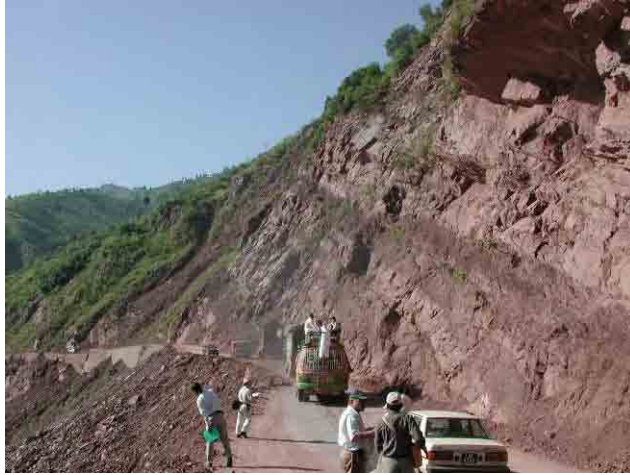
**(B) Crack rich sandstone**

**Photo 4.1.2 Crack rich sandstone near Dhanni**

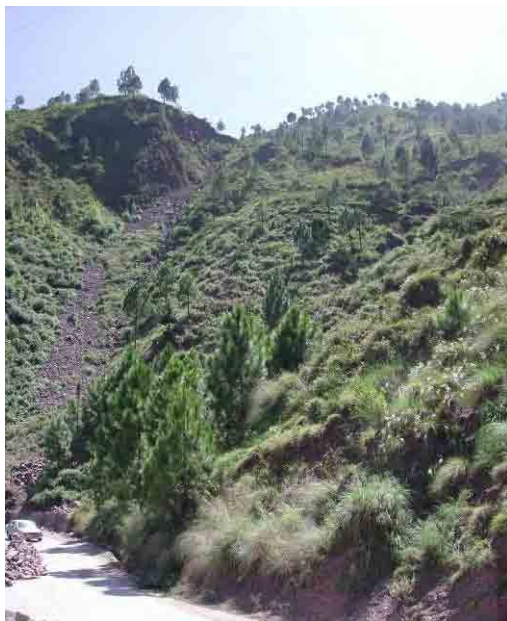
**(C) Thick debris on a steep slope**

**Photo 4.1.3 Debris slide near Dhellan**

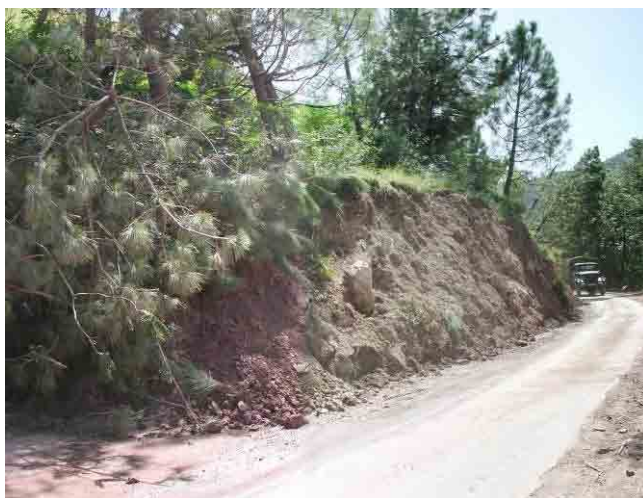
**Photo 4.1.4 Active middle size landslide near Dhellan**

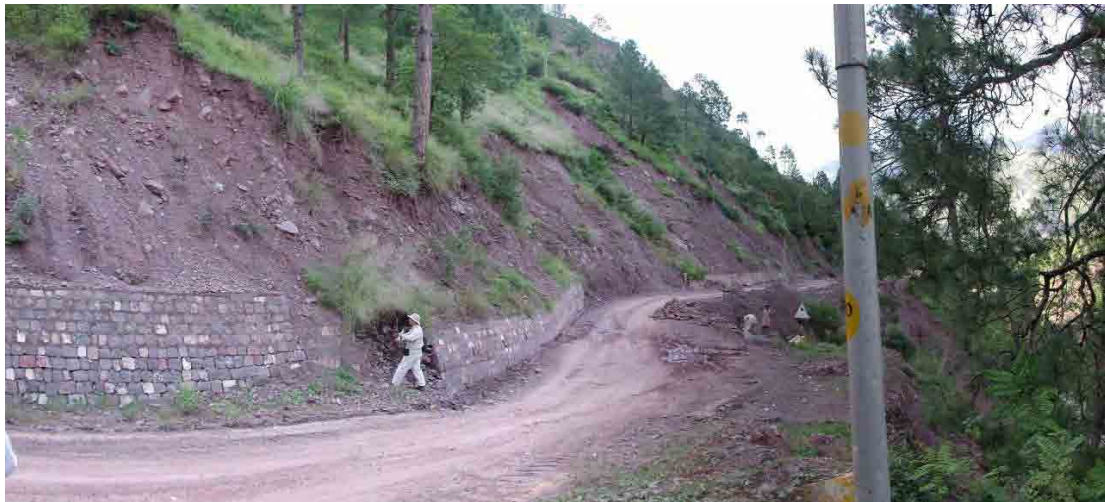
Photo 4.1.6 shows a right flank toe part of a landslide. The landslide was induced by unloading at the toe part that was caused by cutting work for road construction.

**Photo 4.1.6 A Right flank of a landslide induced by a road construction near Jaskool**

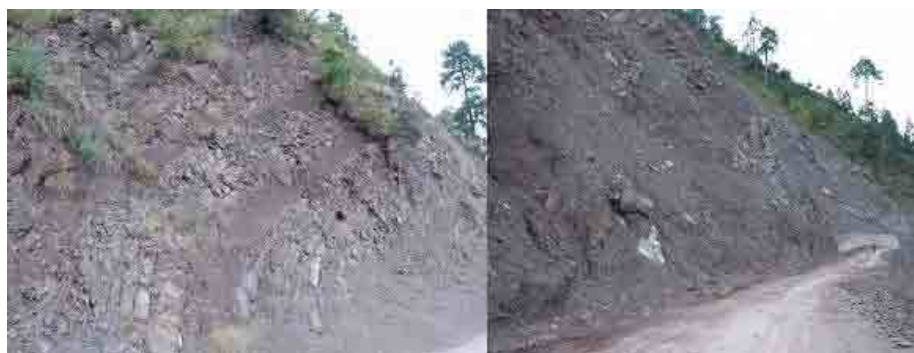
Slope failures occurred mostly in the lower part of the gravitationally deformed slopes (Figure 4.1.4) and the displaced soil masses consist of toppled rock mass and overlying debris. Toppled rock mass is more or less fractured, fragmented and loosened (photo 4.1.11), but these fragments still keep their interlocking. The topography can therefore keep steep slopes in comparison with common depositional debris. However, if the toe of the slope of toppled rock mass is removed, the slope will be destabilized. Finally, in addition to the conditions mentioned above, earthquake shaking triggered failure of the surface parts of the slopes.

**Photo 4.1.11 Typical flexural toppling and failure of alternating beds of sandstone and mudstone in Jaskool**

Toppled rock mass generally sustain large strain in its inside, so it is to be recommended to remove unstable part of rocks and construct some retaining wall at the toe of the slopes (Figure 4.1.5). However, toppling is expected to continue slowly in general and temporarily accelerated by earthquake shaking, so it is necessary to pay attention to the slope condition. Traffic control according to slope deformation and rainfall should be arranged in case of necessity.

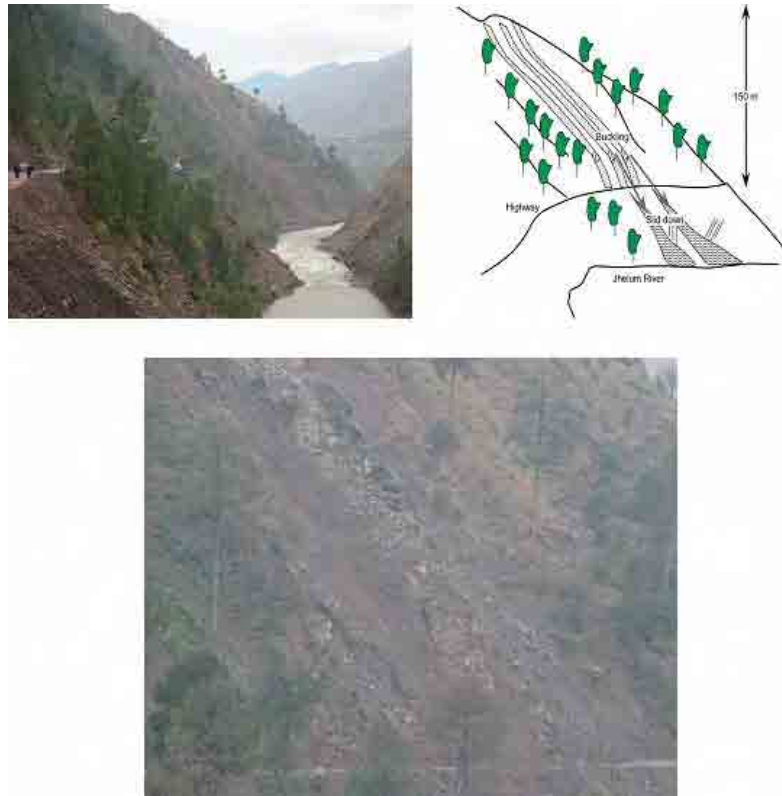
Two high slopes failed near Chinari Failed slope No.37 in Yagi and Mayumi's report. These slope failures were accompanied by buckling of strata, as shown in Figure 4.1.6. The displaced rock mass removed was a long slab of beds dipping steeply downward; lower part of the bed was buckled. The strata just above the road are still steeper than the strata in the upslope by buckling and fracture, but still hard and not so much loosened. Therefore, the upslope strata now exposed would not fail soon, but if the steeper strata at the foot slope would fail, the whole upslope strata should slide down and similar buckling structure should be newly exposed.

**Figure 4.1.6 Slope failure with buckling of beds in the north of Jaskool:**  
Buckled part 10 m above the road (upper right and lower photos).

It is to be recommended to monitor the deformation of the strata exposed by the road and to pay attention to adjacent slopes and the road surface after execution of partial soil removal works and vegetation works. If significant movement is observed, traffic control should be arranged.

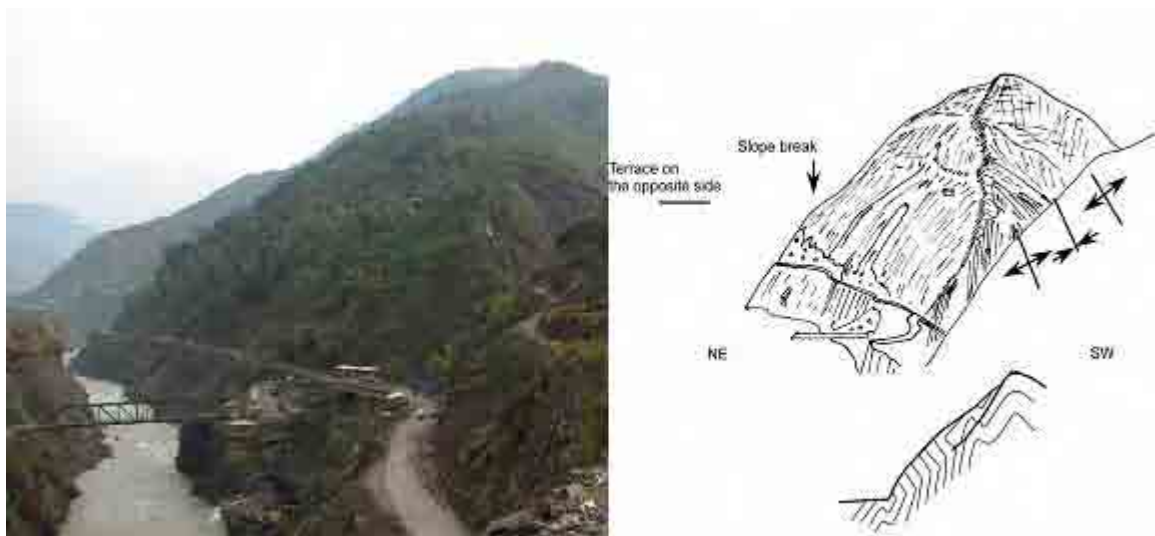
**Figure 4.1.12 Slope deformation in Naili, looking upstream**

Ridge-top scarp, which indicate the deformation of whole slope on its left, is clearly seen

Schematic sketch of this slope deformation is shown in Figure 4.1.12. Ridge-top scarp indicates that sliding occurs there, but the morphology and geologic structures downslope indicate that this sliding does not extend to the foot of the slope. So, this slope deformation seems to be complex, including sliding upslope and toppling downslope.

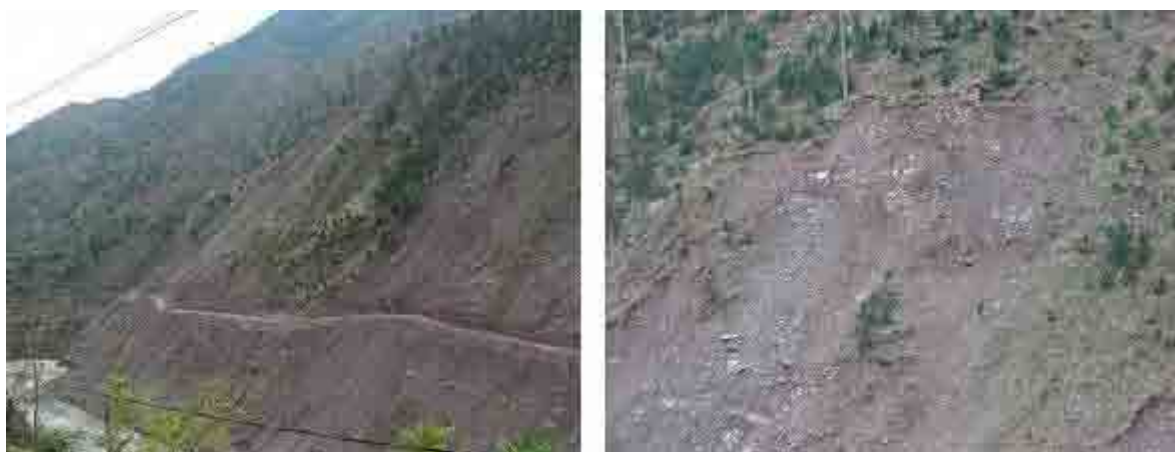
**Figure 4.1.13 Slope failures at the Naili area;**

Slope failures 30-A (left) and 29-A (right) are seen in the left photo. Right photo is the upper part of 29-A, where alternating beds of sandstone and mudstone are toppled and fractured.

These slope failures have similar geologic features. The strata in the slopes are toppled and intensively fractured, providing debris for near surface (Figure 4.1.13). The loosened rock mass and debris failed during the earthquake. Important point is that the failed slopes have narrow but horizontally long gentle slopes on top of them and they are the result of gravitational flexural toppling. Toppled rock mass is exposed along the highway almost continuously. They are fractured but still hard and keep interlocking. Therefore, they would not fail suddenly. However, the toppling deformation would continue for a long time, even slowly.

Rerouting is recommended if it is possible, because the deformation would continue for long time and the maintenance cost may not decrease. If it is not possible soil, removal works and vegetation with partial grating crib works should be installed to the slope where a risk of rock fall is extremely high. Monitoring of the failure scars and traffic control should be arranged (Figure 4.1.14).

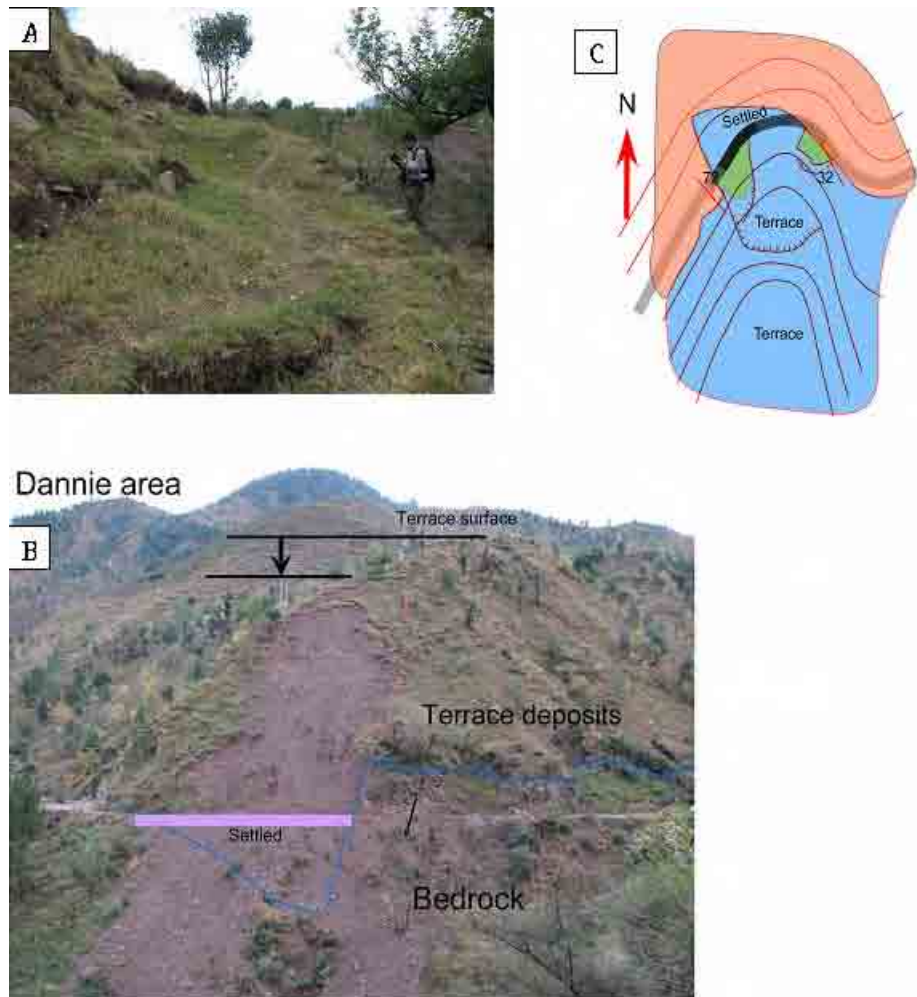
The ridge-crossing crack bounded the south of a slope failure on the west-facing slope, but disappeared on the east-facing slope of the ridge (Figure 4.1.15C). Therefore, the crack does not indicate the sliding of the whole ridge, but indicates that the deposits below the western slope, which is a free face to a river, subsided more than in the eastern slope.

**Figure 4.1.15 No. 21 Slope failure at the Dannie area**

“A” shows cracks crossing the ridge top in “B” “C” is a plan view. Note that the crack terminates in the middle of east-facing slope.

Slope failure of the terrace deposits, cracks on the road, and bumpy deformation of the road are due to the subsidence described above. Unstable materials still remain on the upper part of the scar and would slide down.

Removing the unstable materials and vegetation works are recommended. If possible, grating crib works at the lower parts of landslide is effective for increase of stability. After then monitoring the cracks and traffic control should be arranged.
