APPENDIX - B

B-1: As Build Drawings (Summary)

Technical Assistance for Reconstruction Project
of Bridges Damaged by October 8th Earthquake
on The Jhelum Valley Road
SITE NO.1 BRIDGE WORKS

The No.3 Seri Bridge on Km31+200 is situated on the left bank of the Jhelum River. As a consequence of the October 8 Earthquake (M-7.6), the approach road of the No.3 Seri Bridge was either destroyed by landslides or blocked by landslide materials. Even now some collapse-prone slopes are the existent hazard along the road.

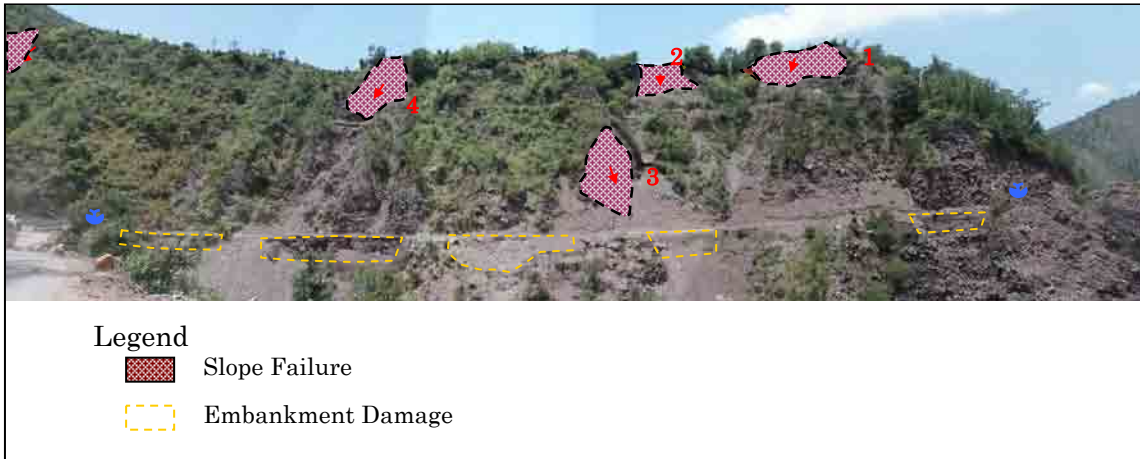
Figure 1 Slope Failure during October 8th Earthquake

Four small scale collapses occurred at the study site during October 8th Earthquake. Relatively a large scale slope failures is observed about 70 m upstream of the Seri Bridge. Slope failures are summarized in Table 1 and the locations are illustrated in Figure 1.

The characteristics of the slope failures during the October 8th Earthquake are as follows:

- Convex slopes or slope shoulders were damaged.
- Almost of collapse at the slope is flaking of 2-3 m in thickness.
- Visible slipped planes indicate open cracks had occurred before the earthquake.

- Cutting the convex slope and smoothening the surface of the slope
- Removing loose zone of the slope shoulders or overhangs where open cracks are observed.

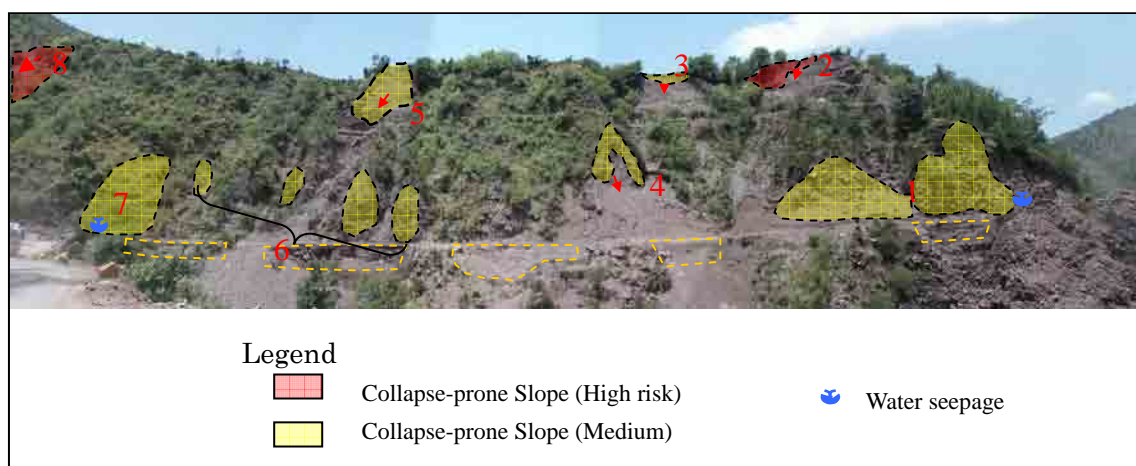
Figure 2 Present Slope Condition

All collapse-prone slopes at the project site are relatively small sized and can be removed by excavation work.

However, water seepage is observed at the foot of the collapse-prone slope No.7, where the materials of the sediment are relatively soft. Construction of a retaining wall at the foot of the cut slope is necessary

Although collapse-prone slope No.8 is situated out of the project area, several open cracks, about 2 to 5 cm wide, are observed on the top plain surface. These cracks are parallel to the cliff face.

The cracks on the cliff face are likely to collapse again in the future earthquakes and during heavy rainfall.

- Removal of collapse debris at the lower portion of the slope.
- Crack filling with clay to prevent infiltration of surface water through these open cracks.
- Gabion work at the foot of the slope (about 100 m long).

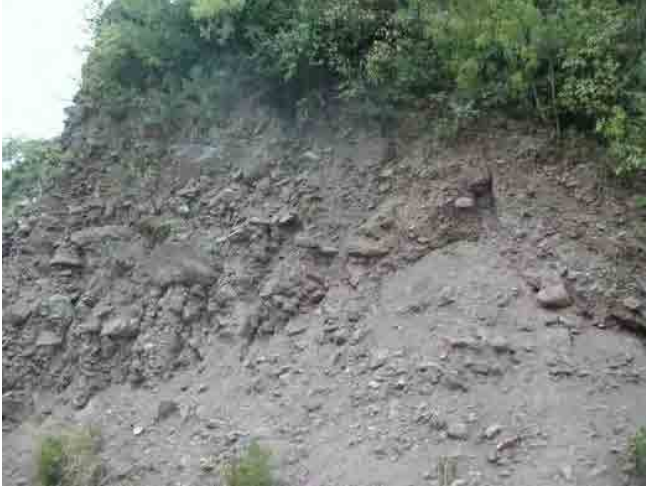
No.1

Flaking, open cracks are observed.

Collapse area will gradually expand.

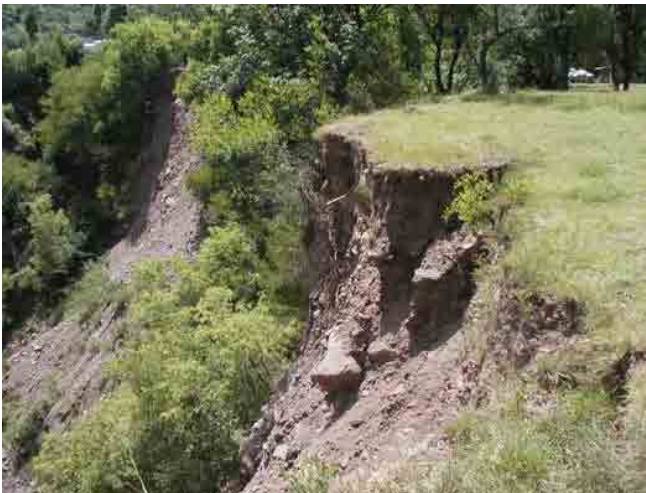
No.2

An open crack is visible at the top of cliff. About 2 m thick and 5 m wide mass is suspected to collapse.

Gradient of natural slope is 60-70 degrees.

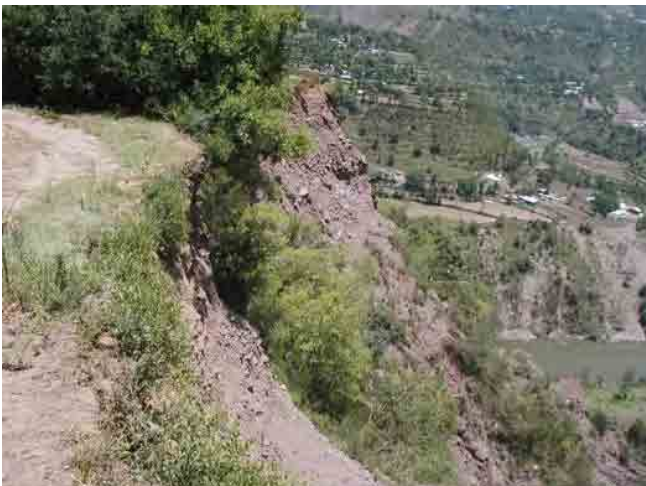
No.3

Expected collapse area at the top of the slope. Gradient of natural slope is 60-70 degrees.

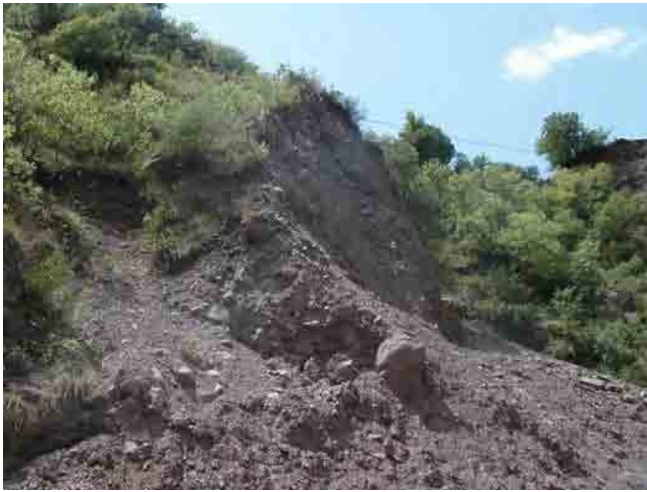
No.4

A relatively wide collapse-prone slope, forming overhang. Some open cracks are observed.

2-3 m thick mass might slide.

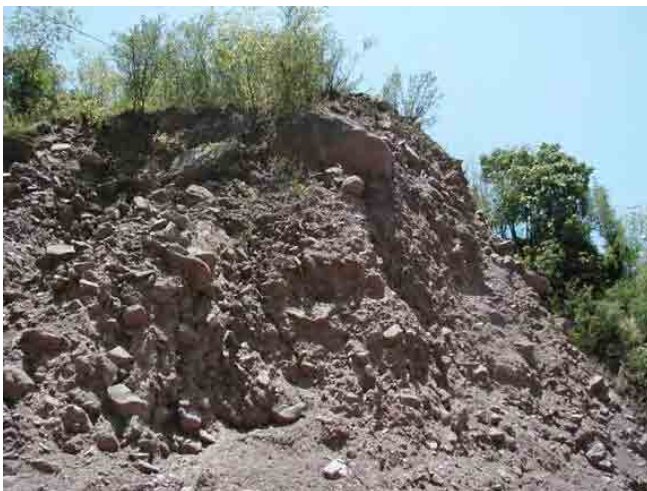
No.5

Expected collapse area forming overhang. Some open cracks are observed.

2-3 m thick mass will slide.

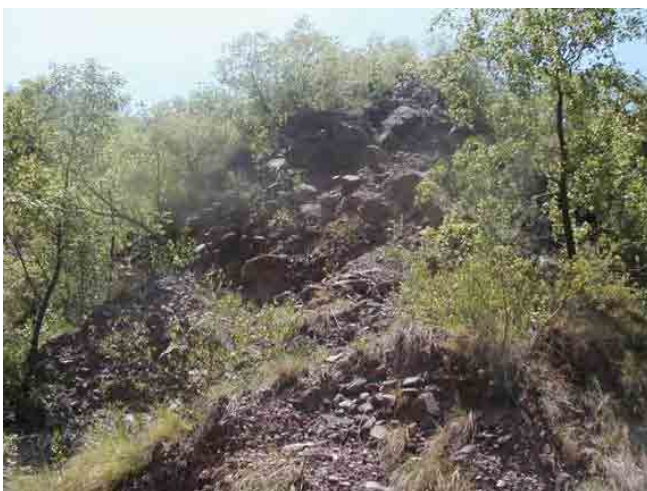
No.6

A loosened convex slope, about 5 m in width, forming overhang, rock falls and 1-2 m thick flaking is feared to collapse.

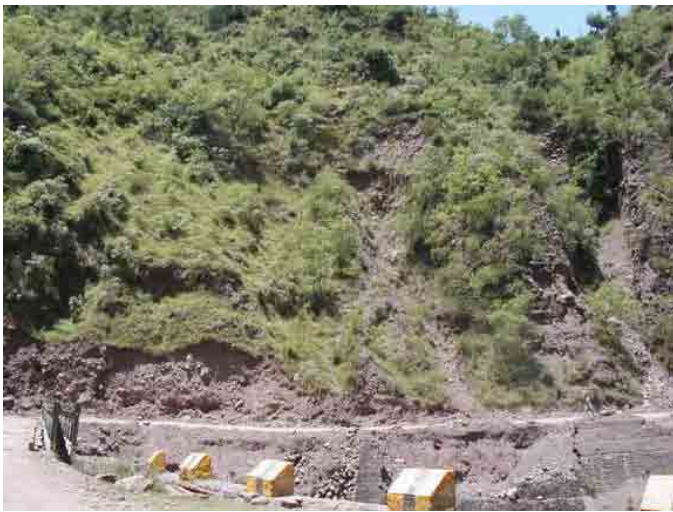
No.7

About 20 m long and 20 m wide collapse-prone slope. Water seepage is observed at the foot of the slope. The deposits are relatively soft.

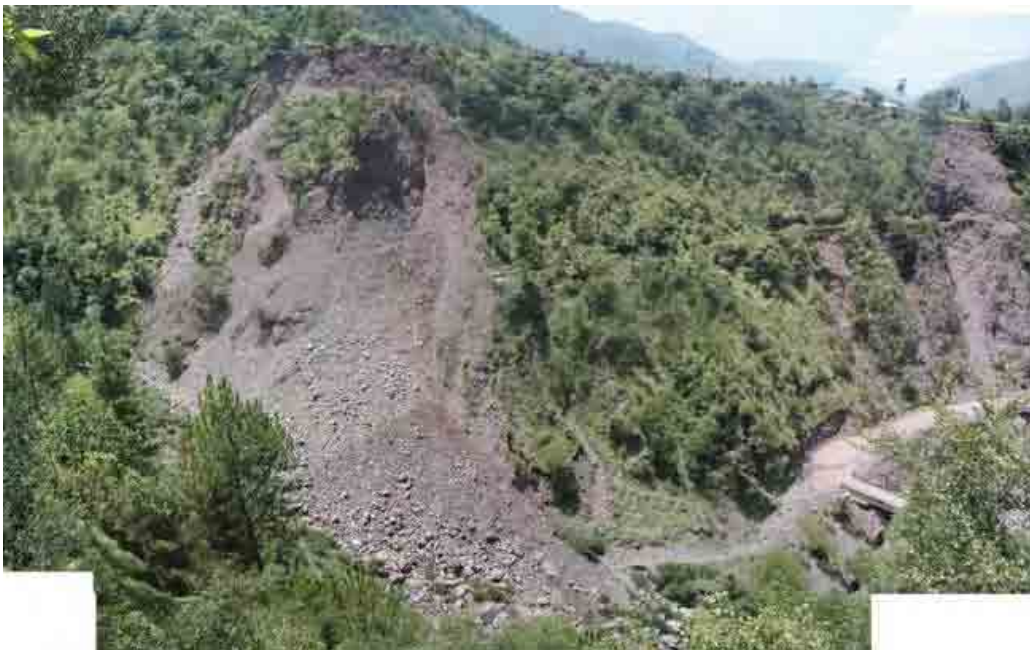
No.8

The collapsed debris partially dammed the stream. During a rainy season, the collapsed materials are muck likely to form a debris flow, which will cause a considerable damage to the bridge. Further, the cracked portions of the valley wall have a high potential for collapse during rainfall or earthquakes.

A landslide approximately 70 m upstream of the Seri Bridge. The size of collapsed mass is about 40 m wide, 40 m long and 7-10 m thick. The collapsed debris partially dammed about 100 m long section of the stream.

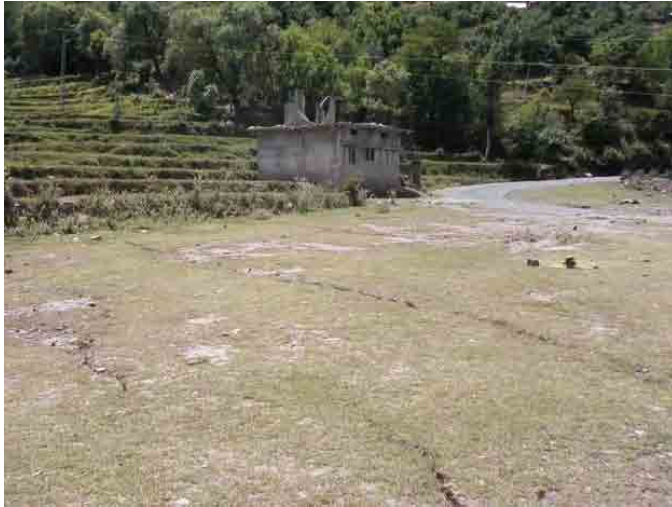
Six lines of open crack, about 2 to 5 cm wide, are observed on the top plain surface. These cracks are parallel to the cliff face.

The cracks on the cliff face are likely to collapse again in the future earthquakes or during heavy rainfall.

This collapsed area is situated in a transition between mountain and terrace. The bedrock and ground water level in this area are relatively shallow. The above geological condition and submerged soft soil probably might have caused to multiply the damage in this area during October 8th Earthquake.

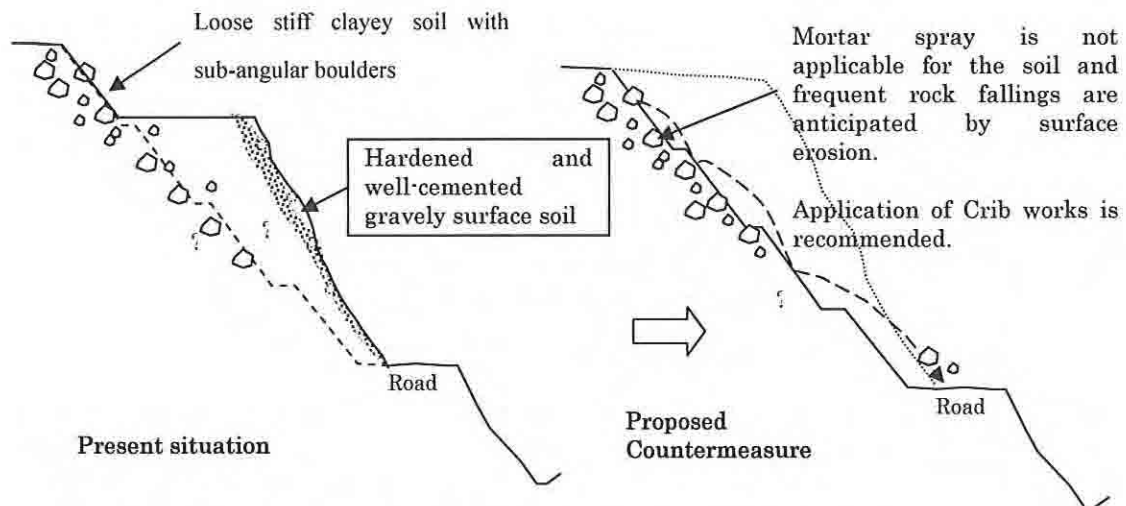
Figure 3 Actual geological condition and proposed countermeasure

However, excavation of the slopes revealed that it consisted of loose stiff clayey soil with sub-angular boulders having diameter between 0.3 to 2.0m at the top step of the cut slope instead of the hardened and well-cemented gravelly soil.

For such loose stiff clayey soil with sub-angular boulders, Mortar Spray Work is not applicable and the Crib Works should be selected as the countermeasure for slope stabilization in consideration to frequent rock falling due to erosion of soil surface as described in Figure 2 and Table 1 below.

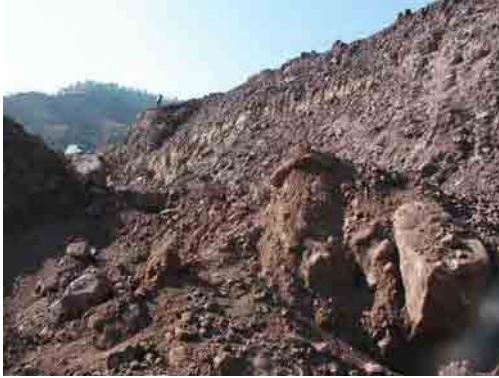
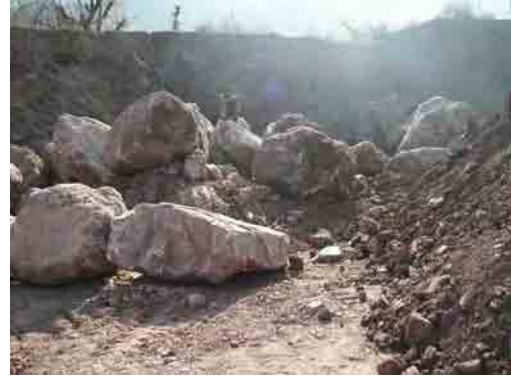
Above photographs show the actual cut slope condition with boulders of 1-2 m in diameter.

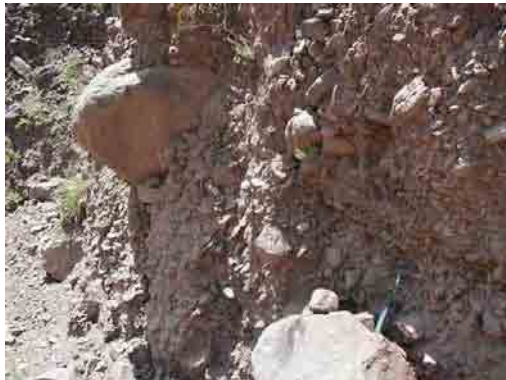
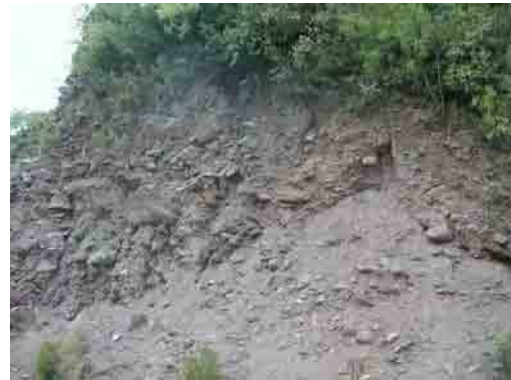
Above photographs show the surface condition observed along the existing road. The slopes are covered by sub-angular to sub-rounded gravels (average size: 2-10 cm in diameter, maximum: 200 cm in diameter) with hardened and well-cemented gravelly soil.
