CHAPTER 2 CREEK CONDITIONS

2.2 River / Creek Condition

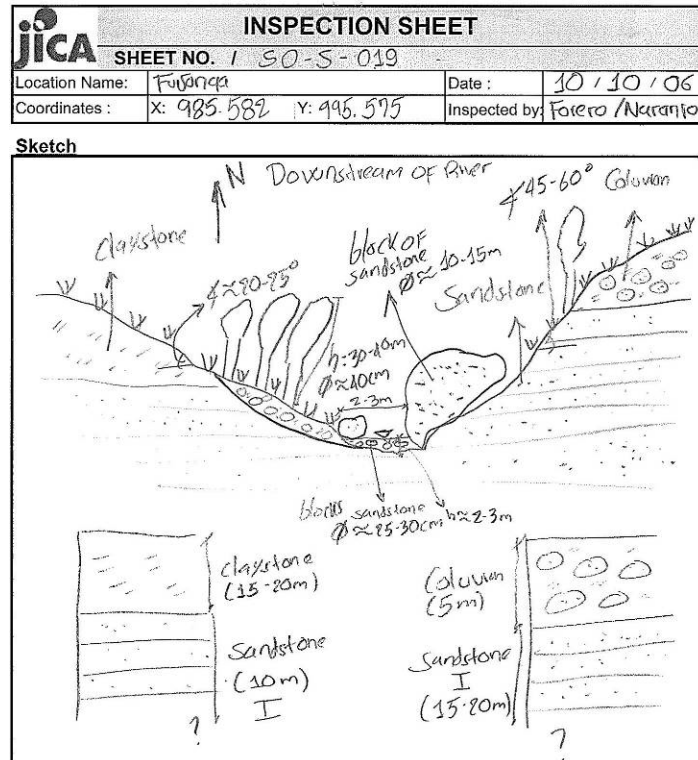
Figure S3-2-5 Sketch of River Section of Soacha River (SO-S-009)

The river bed conditions of the Soacha river are shown in the sketch point ; SO-S-001, SO-S-002, SO-S-004, SO-S-006, SO-S-007, SO-S-009, SO-S-013, SO-S-016, SO-S-018, SO-S-019 and SO-S-020. The common features of these sketches are glacial deposit on river bed and high vegetation such as tree on the slope of the river bank.

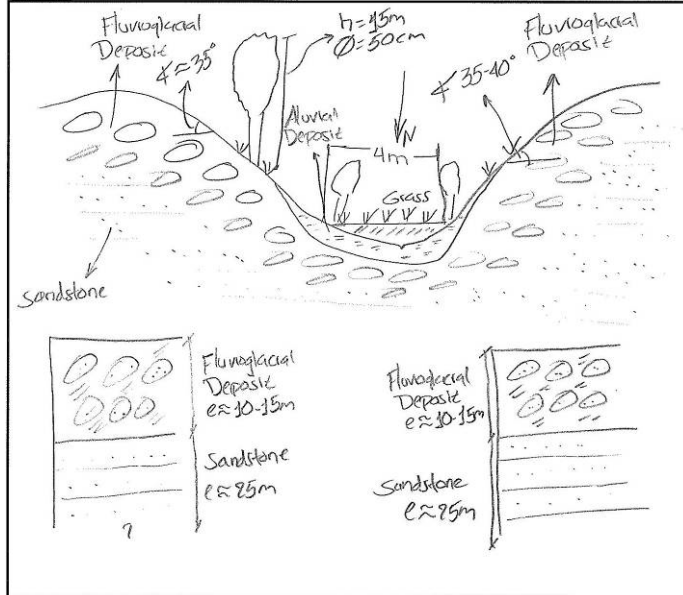
Figure S3-2-6 Sketch of River Section of Tibanica River (TI-S-004)

In the Tibanica River, boulder deposit is not found on the river bed. Figure S3-2-6 and Figure 3-2-7 show the typical cross sections of the upstream and downstream of the Terreros Dam site, respectively. In the upstream of the dam, the river channel is that eroded fluvial glacial deposit. The bed material is composed of fine sediment. In the downstream of the dam, the sediment generation is quite limited obviously by the dam.

As a whole, the unstable sediment deposit on the river bed is few in the Tibanica river.

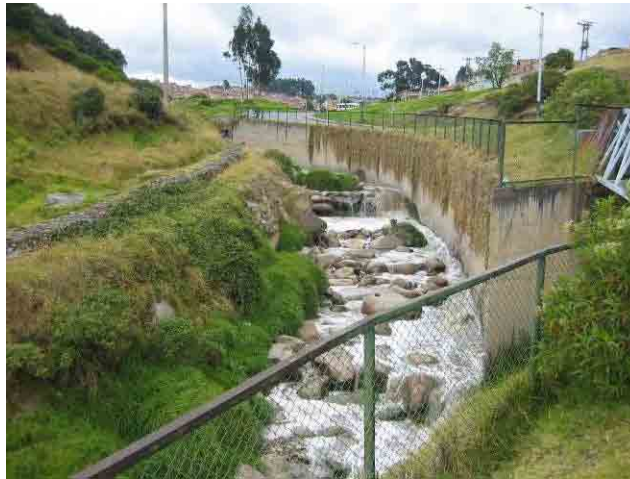
In Chiguaza creek, Los Puentes has a bed slope of 3 degree, which means debris flow from transporting to stopping reach. In fact, round boulder on the riverbed and round boulder layer in the bank can be seen.

Photo S3-2-1 Chiguaza Creek (confluence point of Qda. Nutria)

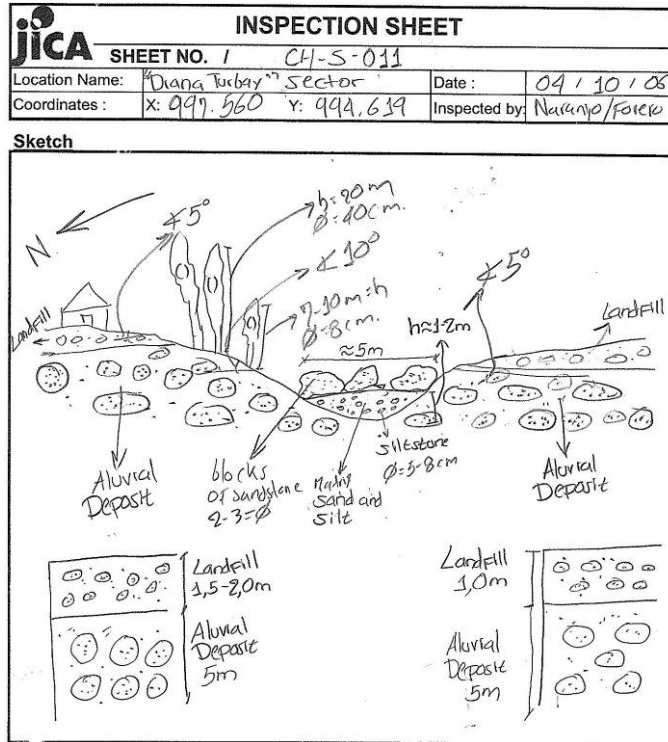
Figure S3-2-8 Sketch of Cross Section of Chiguaza Creek (CH-S-011)

Figure S3-2-8 is the cross section of the Chiguaza creek just upstream of Los Puentes. The alluvial deposit layer has been eroded and on the eroded creek bed there are fine sediment and boulders. These fine sediment and boulders can be regarded as transported materials by flood water. It is understood that the alluvial deposit layer was developed in geological time scale, and the present creek course was created by the degradation process by water. Different from alluvial fan area suffered from frequent sediment runoff in tropical countries, the Chiguaza creek generally does not have sediment deposition layers on the creek bank which means debris flow (the creek filled by transported sediment and the flow width beyond the creek with) is not significant flood phenomenon. The boulders themselves can be transported by flood from upstream and remain on the mild slope reach (for example, Los Puentes).

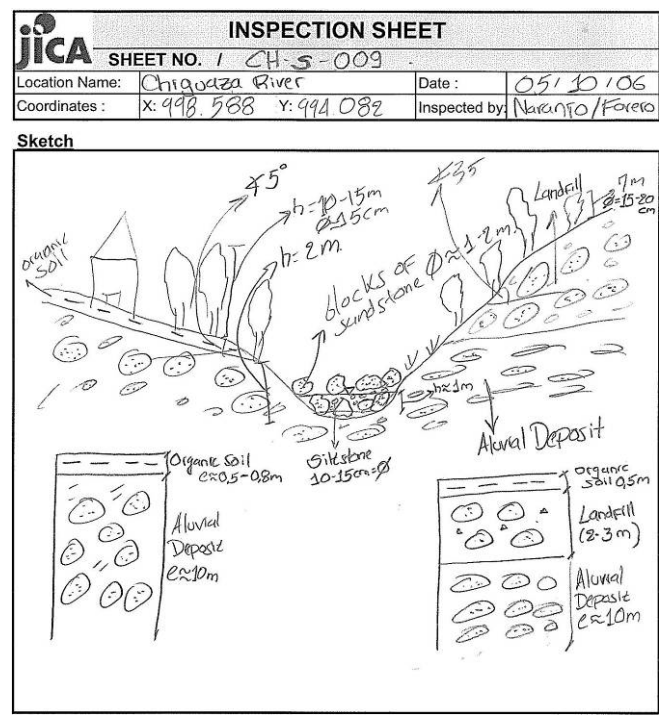
Figure S3-2-9 Sketch of Cross Section of Chiguaza Creek (CH-S-009)

Figure S3-2-9 is the cross section of the Chiguaza creek near La Gloria. This has similar feature with CH-S-011.

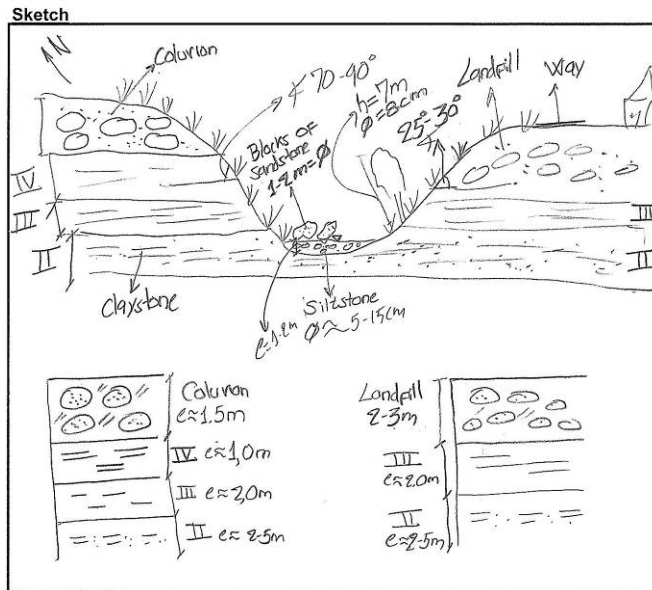
Figure S3-2-10 Sketch of Cross Section of Chiguaza Creek (CH-S-008)

Figure S3-2-10 is the cross section of the Chiguaza creek just upstream of Carrera Oriente. This section is called Zuque creek. In this creek the deposited sediment went downstream at the flood of May 1994. The present condition shows less sediment deposit on the creek bed and the bank slopes are covered by tall trees and vegetation. It is assumed that since the last large scale flood (May 1994), significant floods have not occurred in this creek.

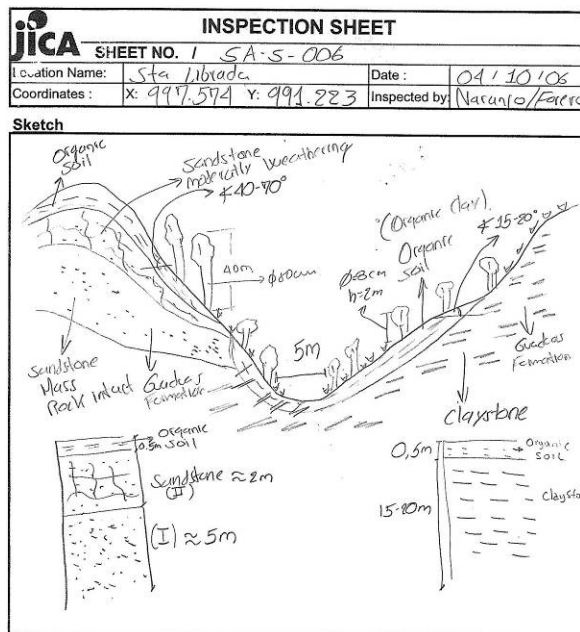
Figure S3-2-15 Sketch of Cross Section of Santa Librada Creek (SA-S-006)

As shown in Chapter 1, in the Santa Librada creek there is little new slope failure according to the aerial photo interpretation. Figure S3-2-15 shows the cross section of middle reach of the Santa Librada creek. The both banks are covered by vegetation. On the creek bed there are few sediment deposit. It can be regarded that comparatively said the creek has not experienced large scale flood recently.

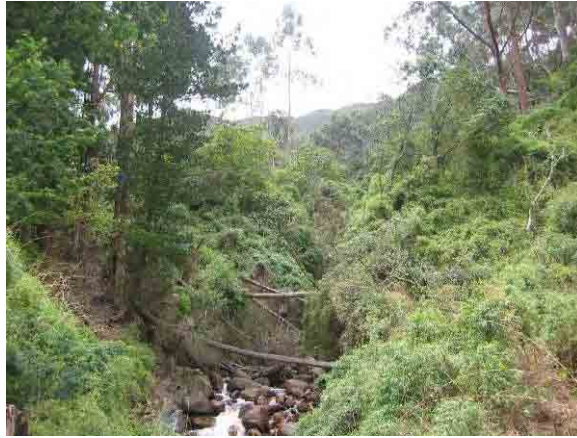
Photo S3-2-2 Yomasa Creek (near Carrera Oriente)

In Yomasa creek, Aleman is located on the mild slope reach having lower than 3 degree. In this reach the debris flow deposits. The bed materials are composed of large boulder and smaller ones such as cobbles. Figure S3-2-16 is the longitudinal profile of the Yomasa creek in which the creek condition survey points are indicated. One of the important features of the Yomasa creek is that it has a mild slope reach in the upstream area. YO-S-003 which is located on the downstream end of the mild slope reach is shown in Figure S3-2-17. Because of its mild slope, the deposit on the creek is few although the upper area has a lot of new slope failures. The surrounding area is said to have security problems so that the detailed site investigation was very difficult.

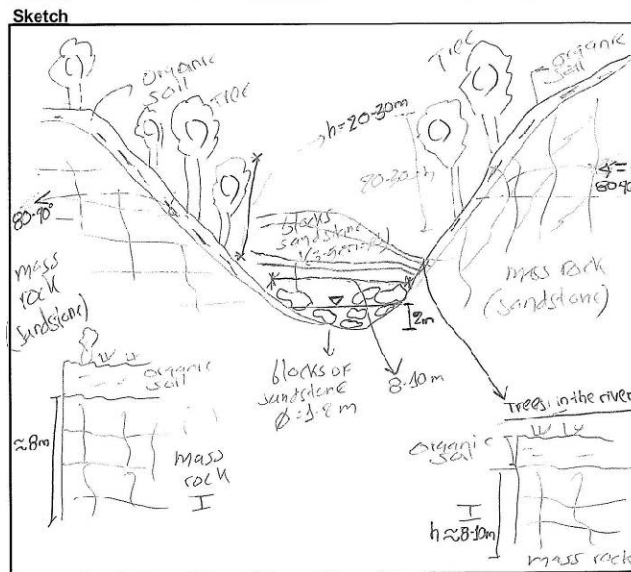
Figure S3-2-18 Sketch of Cross Section of Yomasa Creek (YO-S-004)

The next downstream point is YO-S-004 (6K+800), located upstream side of Carrera Oriente. The cross section is shown in Figure S3-2-18. In this cross section, the sediment deposition nearly 4 meter thickness can be recognized together with drift wood. Since it is located on the strep slope reach (refer to Figure S3-2-16). This kind of sediment deposition can be regarded as unstable deposition which could cause debris flow.

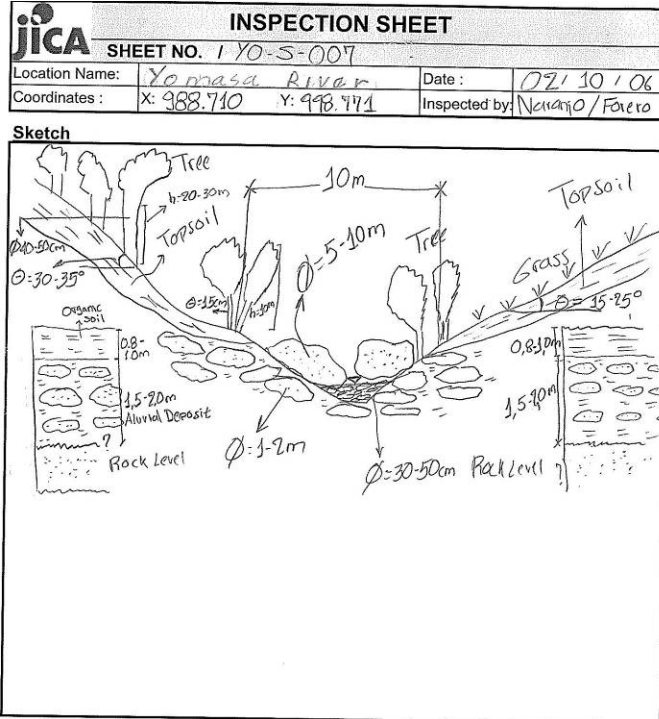
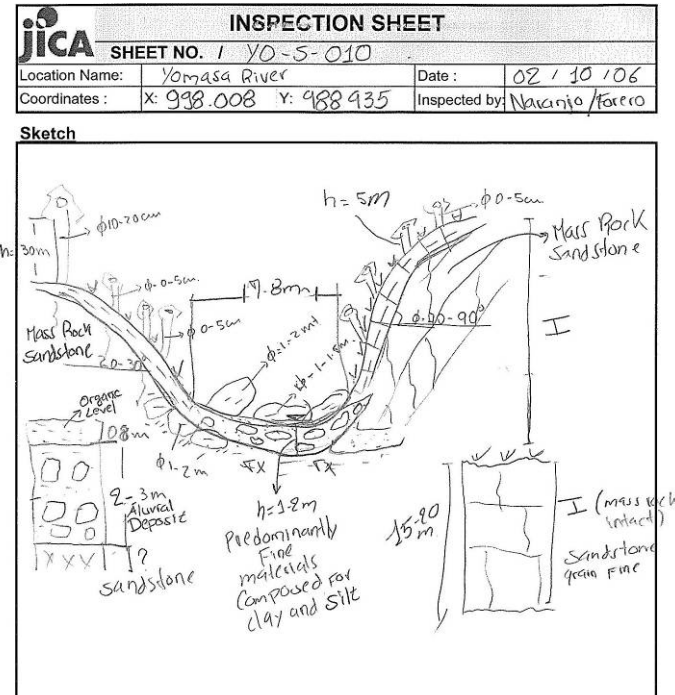
Figure S3-2-19 and Figure S3-2-20 are the cross sections downstream of Carrera Oriente. YO-S-010 is located just on the creek bed slope changing point as shown in Figure S3-2-16. This kind of point is generally said to be sediment deposition area. The alluvial deposit has been eroded and on the eroded creek bed further sediment deposition can be recognized including boulders.

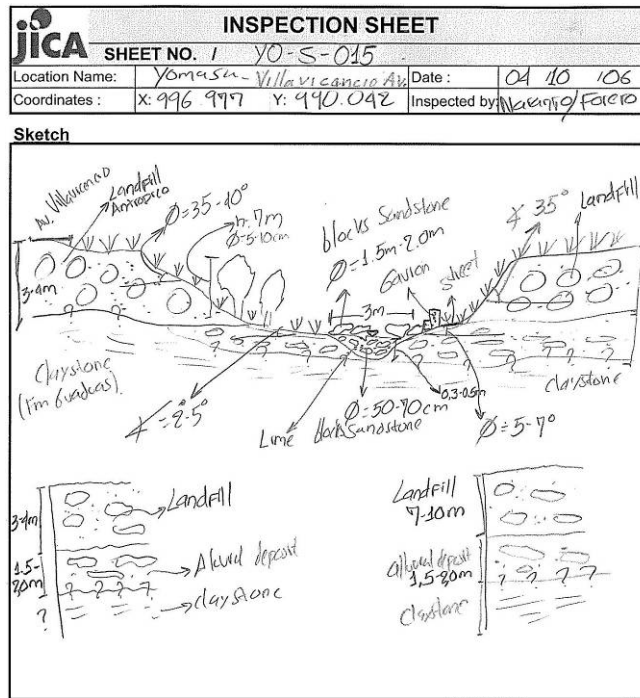
Figure S3-2-21 Sketch of Cross Section of Yomasa Creek (YO-S-015)

Figure S3-2-21 is the most downstream point of the cross section of the Yomasa. The alluvial deposit has been eroded and on the eroded creek bed further sediment deposition can be recognized including boulders. On the bank slope, sediment deposit layers can be recognized on clay stone.

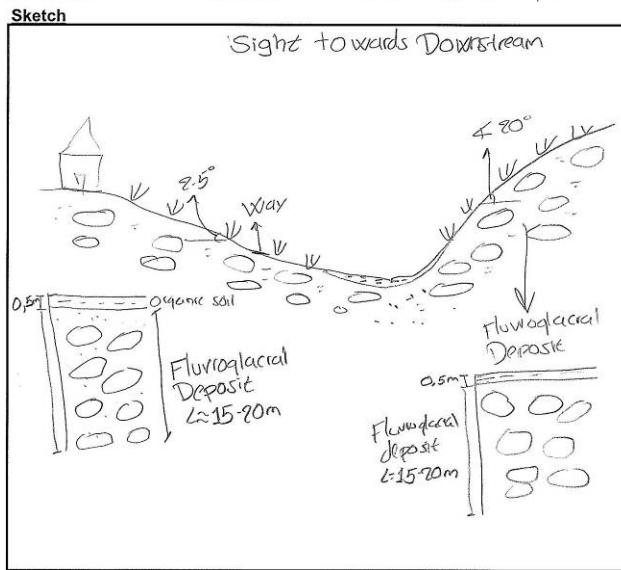
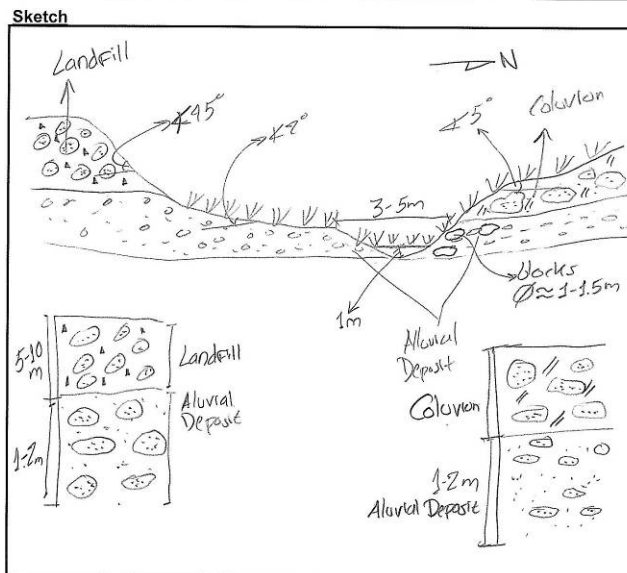
Figure S3-2-22 and Figure S3-2-23 show the cross section of the Trompeta creek. TR-S-001 is that of upstream section and glacial deposit is dominant. TR-S-005 is the downstream side, in which the alluvial deposit is dominant. In the deposit on the creek there are little large boulders and is only fine sediment. According to the aerial photo interpretation, in the upper part of the Trompeta creek catchment, comparatively large new slope failures were recognized, however, it can be concluded that such new slope failure did not contribute to the large size sediment deposition on the creek.

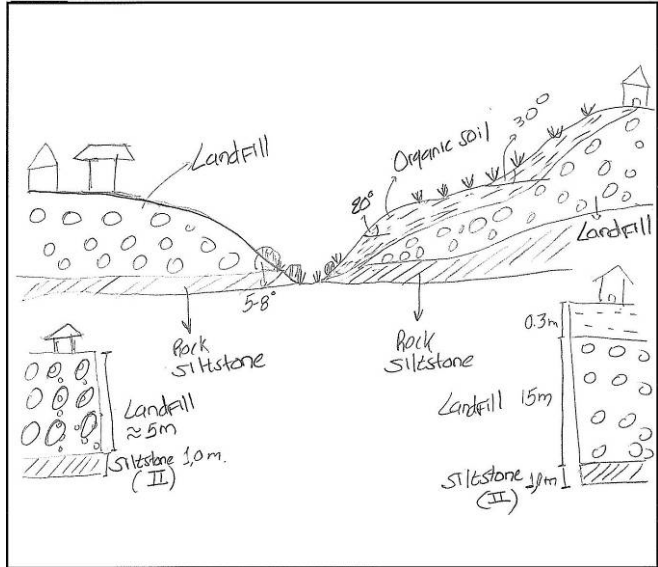
Figure S3-2-24 Sketch of Cross Section of La Estrella Creek (ES-S-003)

Figure S3-2-24 is the cross section of La Estrella which is located at the downstream of new slope failure identified by the aerial photo interpretation. Sediment deposition is not recognized on the creek bed. It can be concluded that such new slope failure did not contribute to the large size sediment deposition on the creek.
