CHAPTER 2 Landslides in Soacha Municipality

## 2.3 Study Results (Hazard Maps)

### 2.3.2 Steep Slopes in Abandoned Quarry

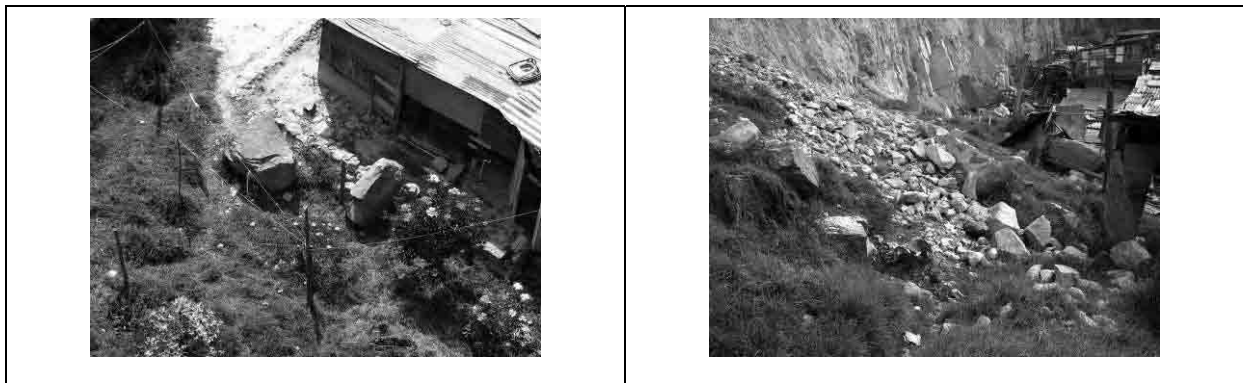
- a) Quarries which were operated in 1950's and 1960's were open cut to obtain sand and clay from geological layers, therefore slopes in abandoned quarries are mostly very steep, and above and below the slopes are mostly gentle.
- b) Because above and below the slopes are gentle, it is easy to build houses there. Therefore there are many residential houses close to steep slopes. Most of these residential houses are illegal, and most of residents in the houses are not well-off economically.
- c) Small rock falls and small collapses occur frequently on the slopes.

Photo S5-2-2 Rock Falls from Steep Slopes

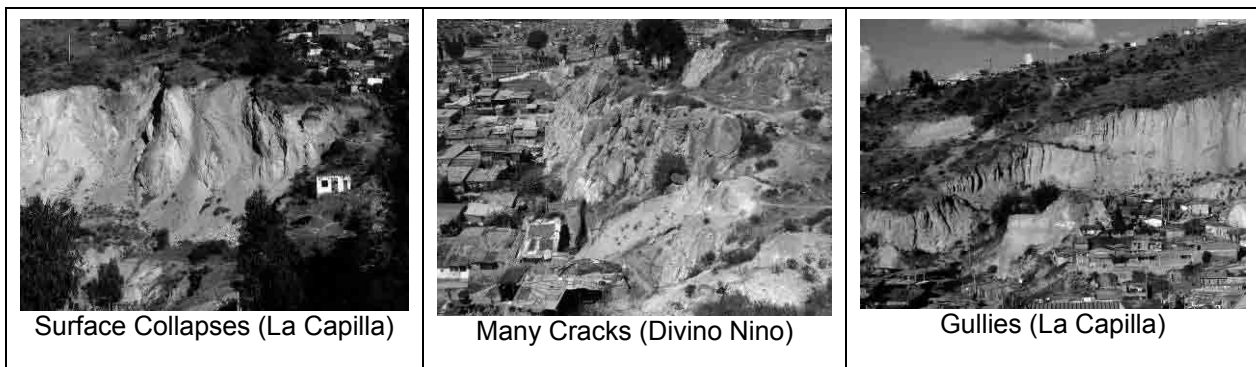
- d) The areas are underlain by alternation of sandstone and mudstone as base rocks in the areas. The base rocks exposed on the steep slopes are soft rocks (geotechnical term; compression strength ( $q_u$ )  $< 40\text{N/mm}^2$ ) with cracks. It is easy for soft rocks to be weathered, and sometimes gully erosion can be seen on the slopes.
- e) Therefore rock falls or small collapses could occur in future and larger collapse or mass movement may occur on steep slopes. The residents close to the slopes are put in jeopardy.

Photo S5-2-3 Steep Slopes with Surface Collapses, Many Cracks, and with Gullies

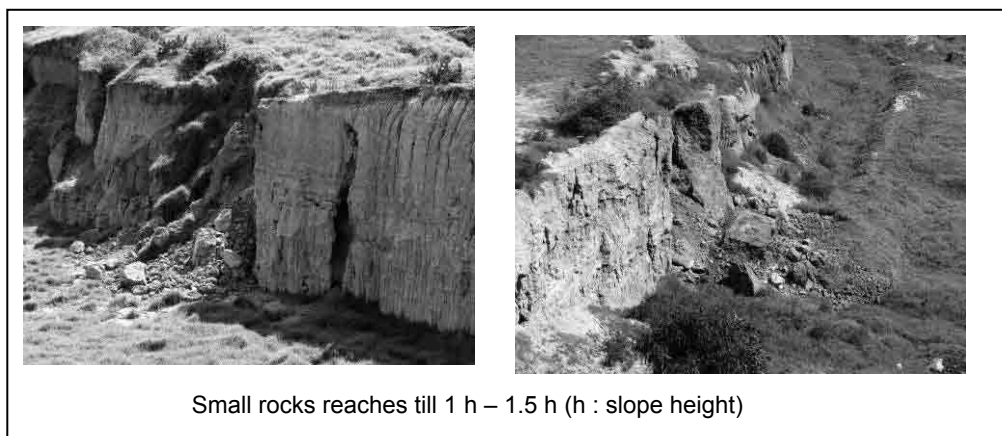
- a. Critical Zones are set 2h from toe of the slope in Japan as shown in Figure S5-2-10, and
- b. Existing collapses on slopes in abandoned quarry in Soacha city show that debris reach almost 1 h to 1.5 h of slope heights from the slopes as shown in Photo S5-2-4.

The reason why Critical Zone set 1h from top of the slope is existing collapses show that collapses invaded into top of the slope till 0.5 h of slope heights.

Photo S5-2-4 Collapse on steep slopes in abandoned quarry (near Llano Grande, Comuna 6, Soacha)

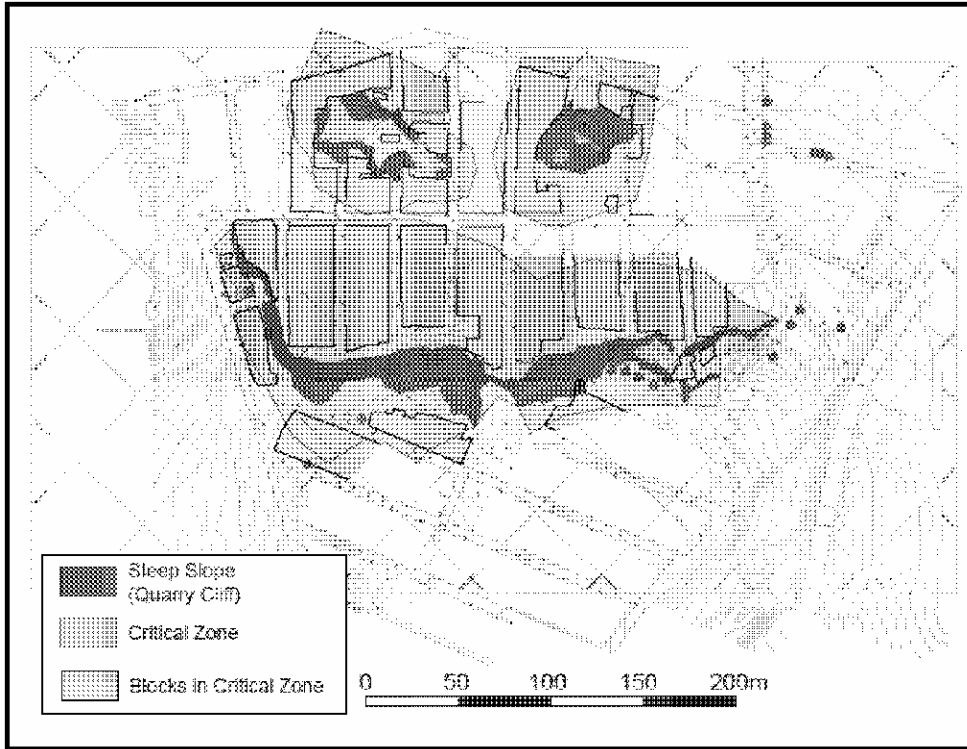
Figure S5-2-11 Critical Zones in El Divino Nino

Critical Zone in El Divino Nino is shown in Figure S5-2-11. Maxim height of the steep slope is about 40 m, and Critical Zone is extended to a maxim of 80 m from the slope. Many houses are involved in Critical Zones.

It is recommendable to evacuate from Critical Zones as measures against slope disasters on steep slopes in abandoned quarries. The houses close to the steep slopes should be relocated to safe areas, out of Critical Zones. But it could take long time to evacuate from Critical Zones because there are many steep slopes in abandoned quarries and houses in Critical Zones. The following measures are recommended.

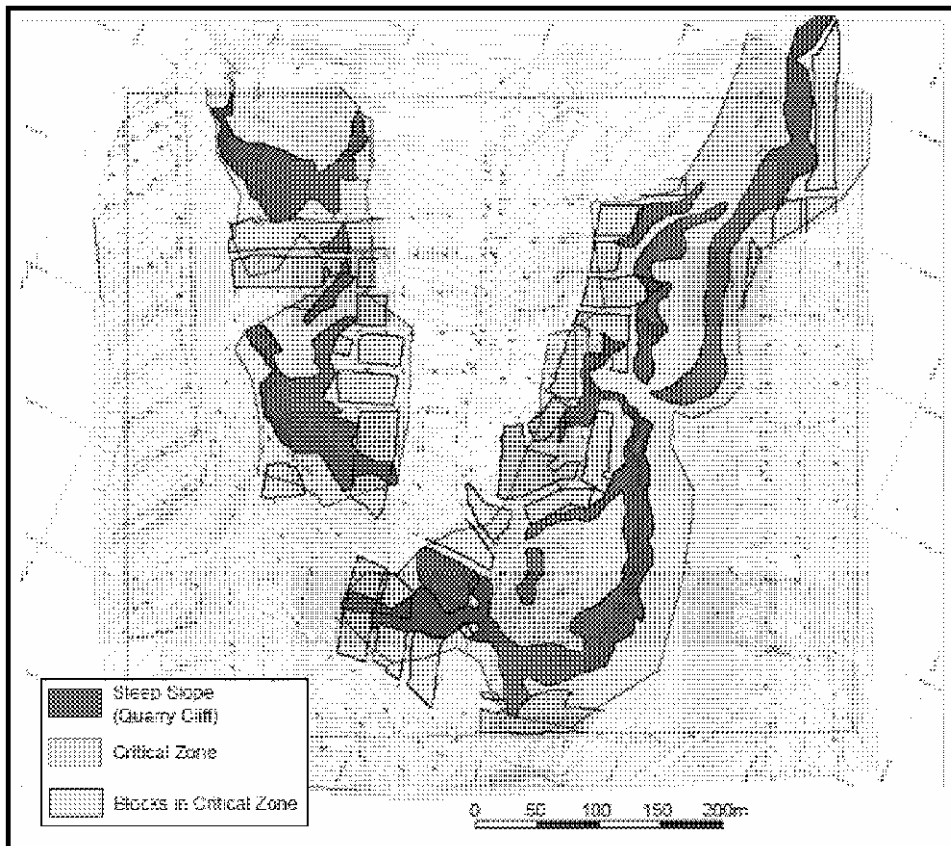
Figure S5-2-12 Critical Zones in La Capilla in Altos de Cazuca

Critical Zone in La Capilla is shown in Figure S5-2-12. Maxim height of the steep slope is about 40 m, and Critical Zone is extended to a maxim of 80 m from the slope. Many houses are involved in Critical Zones.

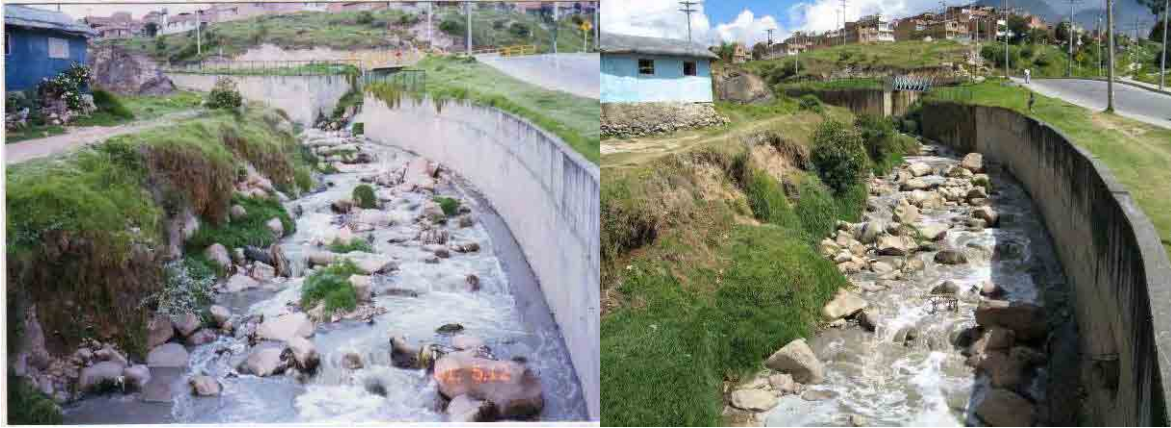
Figure S6-1-19 is the comparison between 1968 and 1998 in Upper Part of the Chiguaza creek. The urban area expanded and became dense. Some creeks were replaced by culvert in the underground. In the case of the Chiguaza creek itself, since the river bed slope is quite steep, the position of the creek has not been changed, however, it is regarded that due to the increase of rainwater runoff, the natural bank is eroded while the river bed is eroded resulting into that only big rocks which can not move by flood water remain on the river bed (Photo S6-1-1).

Photo S6-1-1 Riverbed Condition at Los Puentes in Chiguaza creek  
(Left: May 12, 2001, Right: January 16, 2007)

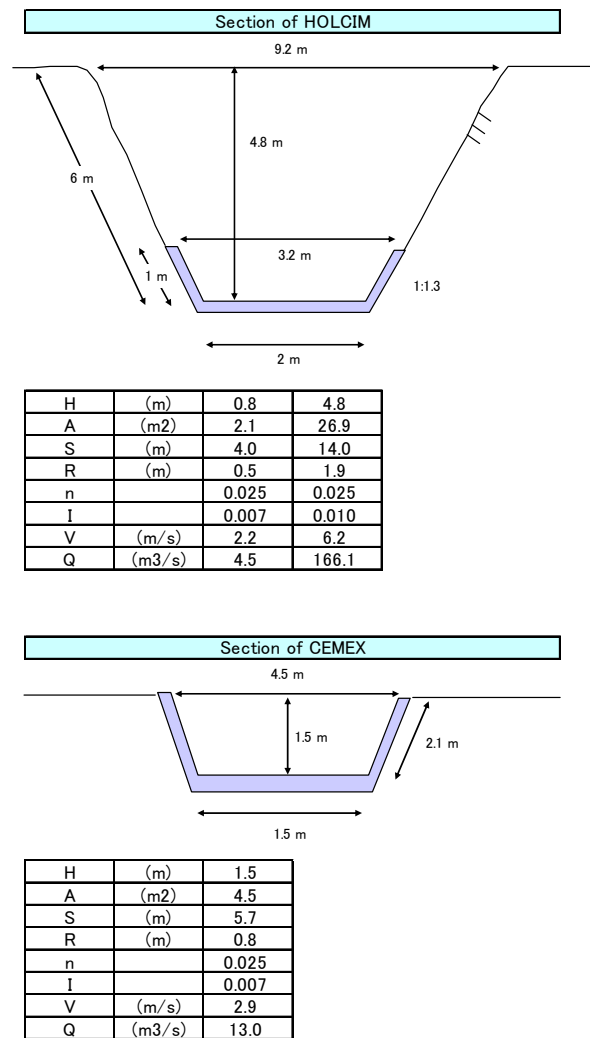
Figure S6-1-28 Cross Section and Channel Capacity inside HOLCIM and CEMEX

The 100 year return period discharge of the downstream end of the Trompeta creek is 64 m<sup>3</sup>/s. During flood, the flood water is distributed into both HOLCIM side and CEMEX side. The flow capacity of the HOLCIM side is enough for the 100 years return period, so the section downstream of 0+000 of the Trompeta has high safety level.
