THE EMERGENCY STUDY
ON
URBAN TRANSPORT
IN
BUJUMBURA
REPUBLIC OF BURUNDI

SUPPLEMENTAL REPORT

MARCH 2008

PHOTOGRAPHS OF EXISITING CONDITION (1/2)

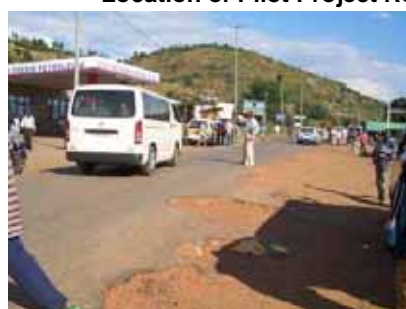
Deteriorated Shoulder

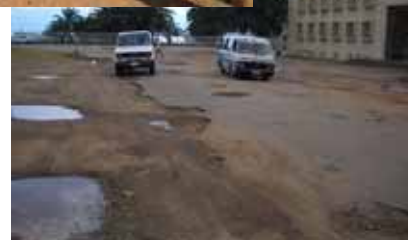
Many Potholes

There are innumerable potholes on entire project section; their causes are considered to be poor drainage and unevenness of surface. Some potholes are filled by unsuitable articles such as concrete mass and clay soil. Those articles should be removed one by one carefully by the EWPP's work. Shoulders at the ending point are also heavily damaged and their road beds have already been washed away by storm water.

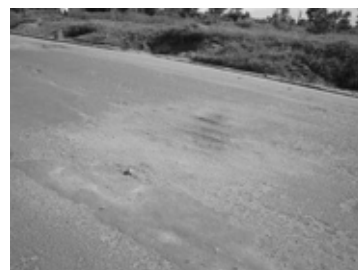
Pavement condition around starting point (Pothole was filled by unsuitable articles)

There are innumerable potholes on entire project section; their causes are considered to be poor drainage and unevenness of surface finish due to lack of workmanship at initial construction. Some potholes are filled by unsuitable articles such as concrete mass and clay soil. Those articles should be removed one by one carefully by the EWPP's work.

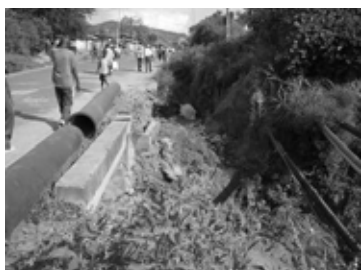
Heavy eroded road shoulder at No.2 +40 (near by cross box culvert)

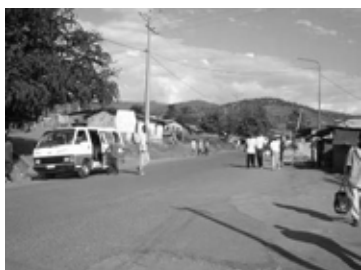
Mini bus tends to stop at junction with access road because there have more space than others

Instead of provision of proper shape of the busbay, the design provides the U-drainage cover on exiting open drainage at near the junction of feeder roads so as to secure some space for the bus passenger.

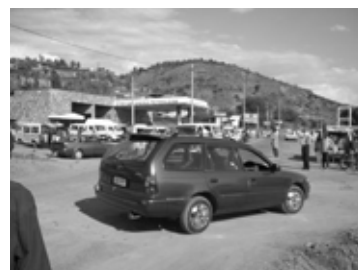
Since the width of the road is not wide enough, there is some conflict between running vehicle and stopping mini bus and taxi at end of proposed section. Moreover, there are many illegal kiosks around bus stopping point with many customers. These situations cause the disturbing smooth traffic flows.

Big confusion caused by mini bus and Taxi parking together with business of Kiosks at the roadside

The Busbay is provided in the design at the ending point where the stopping mini bus and taxi overflow into carriageway. The length of busbay shall be designed in consideration of land limitation and size of bus, the transition for in and out is also designed so as the vehicle to approach smoothly.

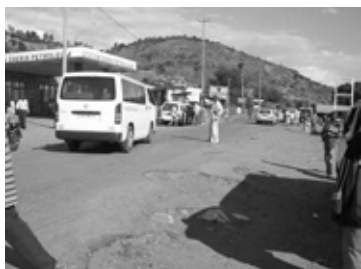
Deteriorated shoulder at No.15+40

Shoulders at the ending point are also heavily damaged and their road beds have already been washed away by storm water.

For the section where the road beds were washed away (after No.15), the construction from the subbase shall be introduced. The Ministry of Works and Equipments, Burundi recommended to adopt the minimum thickness of the National Road in Burundi to be 15cm and 25cm for base course and subbase course. So the design provides the cross section for the section as shown in below;

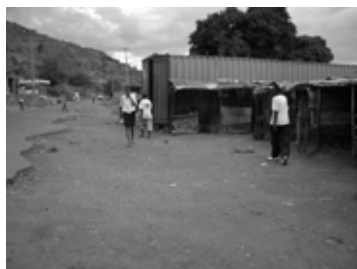
Mis positioned private property (Container) at No.16+20 on RHS

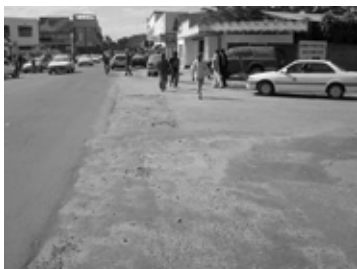
Provided pothole patching (not in good condition) at stating point of the road

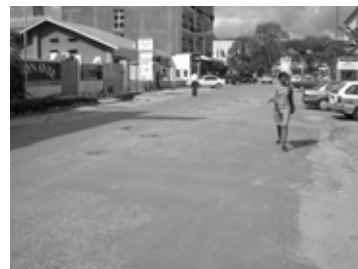
Evenness of pavement surface was not maintained ,that created pothole

Existing pavement condition at most of the stretch is relatively good with exception of the part where is near the junction with Bld. Patrice Lumumba. The damaged part is almost 70m in length, it is without proper evenness of the surface and some large size of pothole can also be observed. Accordingly the rehabilitation work shall be required to this damaged part only.

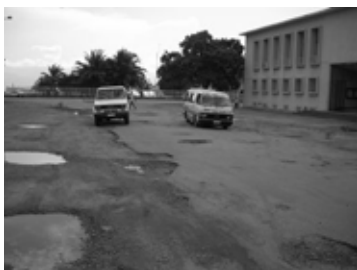
Many Potholes on entire road

This road is located on in front of the Ministry of Interior and there is a parking space for the Ministry adjacent to the road. The entire stretch is heavily damaged due to poor drainage and lack of maintenance. There is no rehabilitation method other than re-construction from sub-base course.

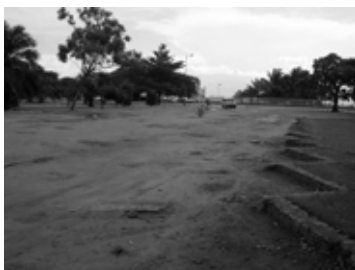
Parking spaces next to carriageway were provided but they does not look good condition

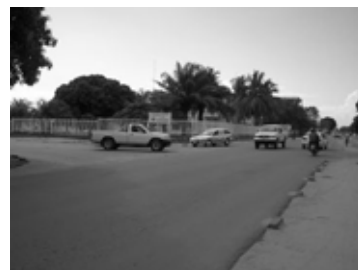
Two T junction were located without necessary clearance, traffic accidents occurs frequently

There are many traffic accidents at junction with Bd. Mwezi Gisabo. The junction is shaped like a step so that it is not well-visible for incoming traffic.

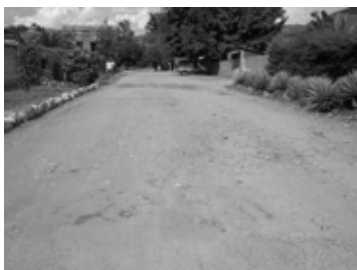
No tarmac pavement existed
