PART III: FEASIBILITY STUDY

D: OLD DUMP SITE SURVEY

PART III-D: OLD DUMP SITE SURVEY

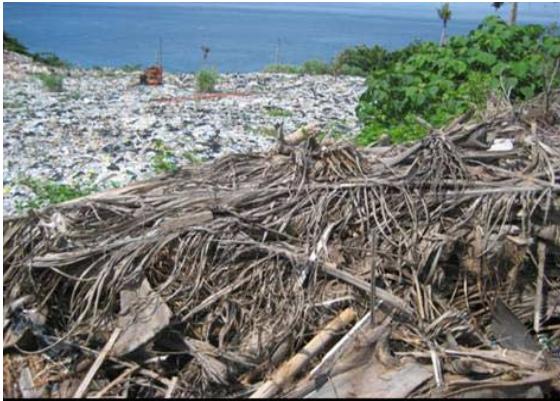
North Side View at Old Dump Site

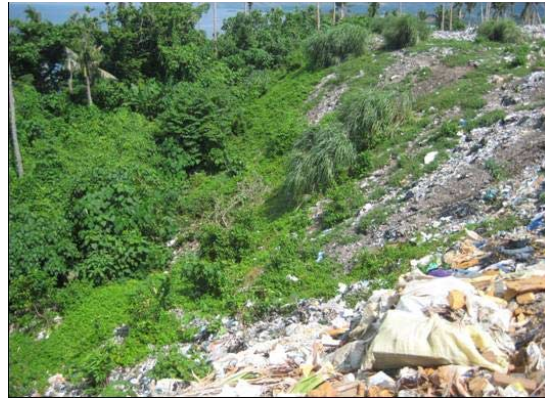
North Slope of Old Dump Site Covered by Garbage

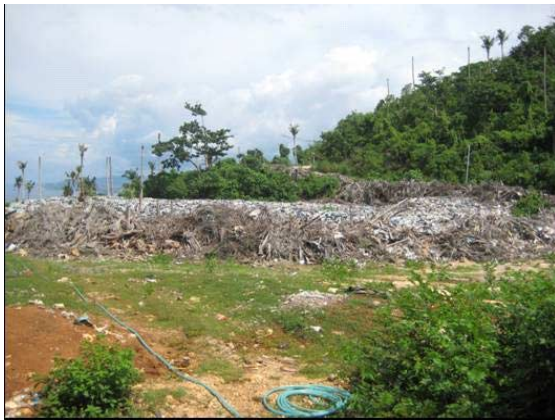
East Side View at Old Dump Site
