*GATES OF ROLEANG CHREY REGULATOR AND
OTHER STRUCTURES*

**THE STUDY
ON
COMPREHENSIVE AGRICULTURAL DEVELOPMENT
OF
PREK THNOT RIVER BASIN
IN
THE KINGDOM OF CAMBODIA**

**FINAL REPORT
Volume-VI: Appendixes for Master Plan
Appendix-E
Gates of Roleang Chrey Regulator and Other Structures**

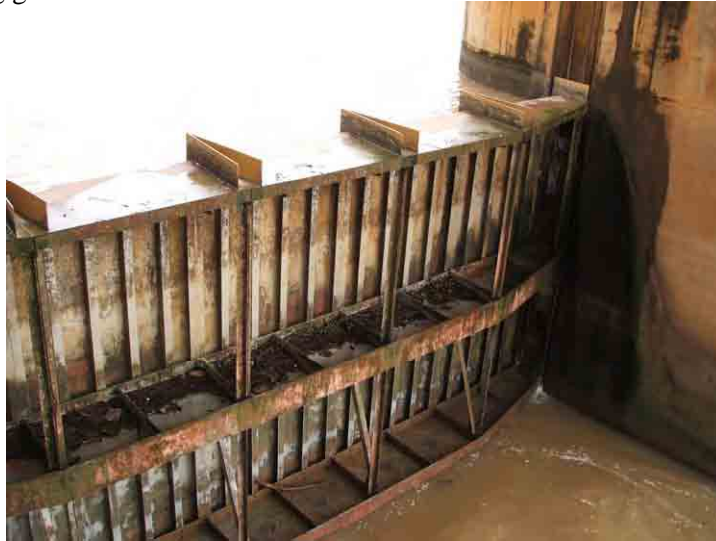
- Almost all main wheels are not able to rotate because of rotation resistance increased due to rusting of shafts. Gate is therefore stopped on the way of closing and cannot be closed fully when the upstream water level is high. Also, the hoist mechanisms are overloaded while the gate is opening, so that the fuse burns. This is a fatal problem of the gates. (See Attachment 1)
- A lot of water leakage is observed due to aging and crack of the rubber seal.
- Painting of the gate leaf is peeled off.
- Four wheel installed in a side girder could not smoothly rotate, which results in obstructing gate movement.

Downstream of Gate Leaf

(a) Overhaul and repair of wheels

Main wheels may be reused, but bearing metals shall be replaced by oilless bearings and wheel shafts by corrosion resisting steel shafts. If the gates are installed as shown on the detailed drawings prepared by Snowy Mountains Hydro-Electric Authority attached in Attachment 3, it is anticipated that the disassembling and repairing would be technically hard works. Thus, beforehand research and sufficient preparation of the works are essential for smooth overhaul and repair of wheels.

(b) Gate leaf shall be painted after cleaning by sand blast.

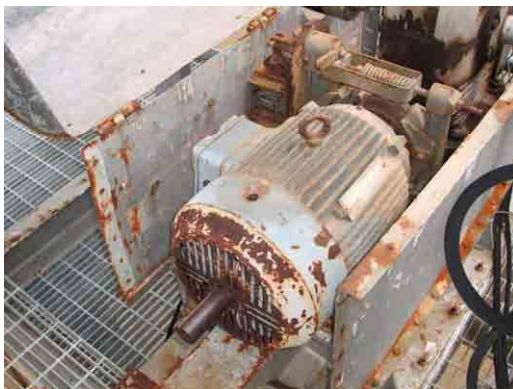
- Electric motors, speed reducers, counter shafts and winding drums are still in running condition in spite that those are heavily aged.
- Brakes, position indicators and limit switches do not function at all. The operation of them is carried out by only means of experience and sense of the operator.

Electric Motor and Speed Reducer are in running condition, but heavily aged. Brake does not function.

(d) Replace of hoist

The whole hoisting equipment shall be replaced with newly designed ones. For the convenience and safety of the operation, it is proposed to employ the remote control system at control room with local operation.

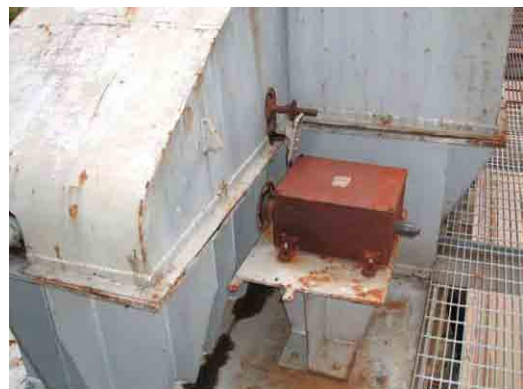
Limit Switch Box is broken.

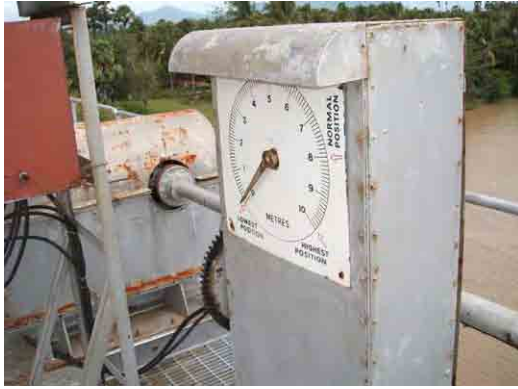
Position Indicator does not function.

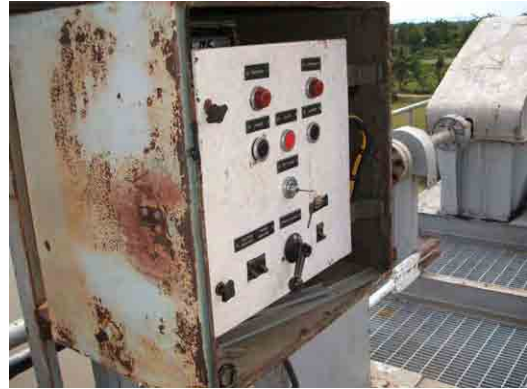
Control Panel is in working condition but heavily aged.

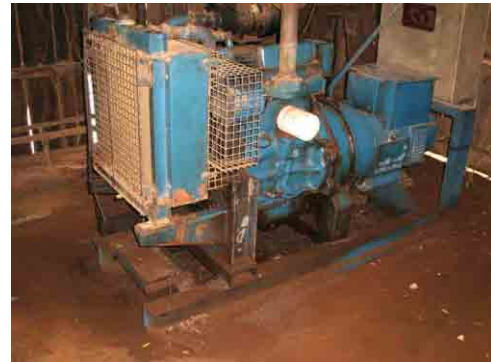
- A diesel generator of 23.9 kVA is aged, but still in working condition.
- As the output of this generator is small, more than two gates cannot be operated simultaneously. At installation of the gate in 1974, two sets of 75 kVA generator were installed, however both generators have been removed.
- The operator is anxious about the anomalous operation that no back up power source is installed.

Diesel Generator is still working, but aged. No backup electric power source is available.

- Replace of the wire rope for counter weight. Ten numbers for 5 gates are required.
- Installation of one additional diesel generator of 75 k VA as a main power source. The existing generator will be used as an auxiliary electric source.
- Spare parts such as fuses, magnetic switch and air filter of diesel generator
- Standard maintenance tools such as wrenches, screw drivers, hammers and grease gun.
- Cost estimate and work period
- Estimated cost: US\$45,000
- Work period: 3 months after order

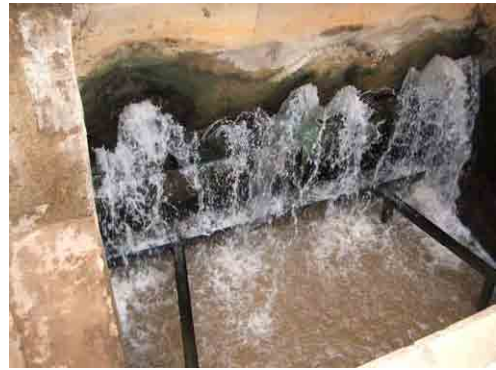
Water is leaking through seals due to damage of the seal rubber. Essentially, this type of gate i.e. four edge sealed radial gate is opt to have problem on the sealing characteristics. In this case, the leakage is inevitable through the wire rope holes of the gate leaf.

Leakage through Gate Top Seal

Gate height shall be increased by about 1.5m, and four-side seal shall be changed into from three-side seal. This modification may require one additional arm in both sides. Existing gate leaf shall be repainted after sand blast cleaning.

Rubber seal shall be replaced to improve leakage.

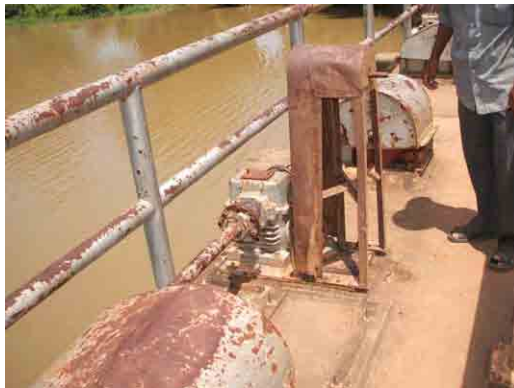
The electric parts such as motor and control cabinet gates No.3 and No.4 were removed. These gates can be operated by manual crank in limited openings because hoisting wire ropes are temporarily repaired using steel wires connected with arm of the gate leaf.

Removal of Electric Motor and Control Panel

Hoist mechanism shall be replaced for smooth gate opening and closing.

Local control panel and remote control panel shall be furnished for easy gate operation

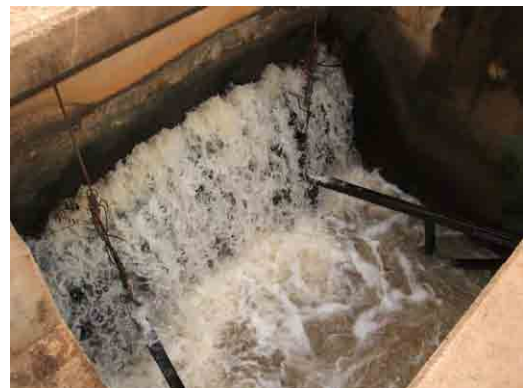
Temporarily Hoisting Wire

- (1) Temporary measure
- Replacement of wire ropes for gate No.3 and No.4.
 - Cost Estimate and Work Period
 - Estimated cost: US\$ 2,500
 - Work period: One month after order

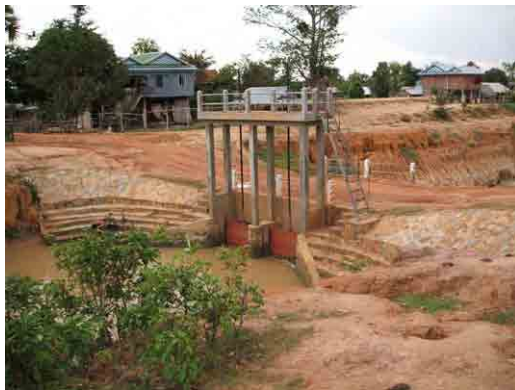
Unnecessarily Long Spindle

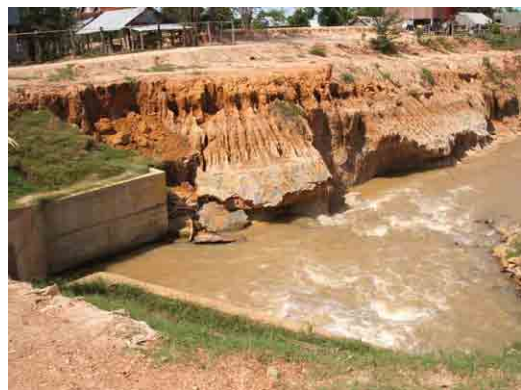
A part of downstream side slope is severely eroded and structure would become unstable , so that repair works are required urgently.

Severe Side Slope Erosion

As mentioned above, no repairs are required for the gates. But, approach passing over the culvert and downstream side slope of canal should be repaired as soon as possible.

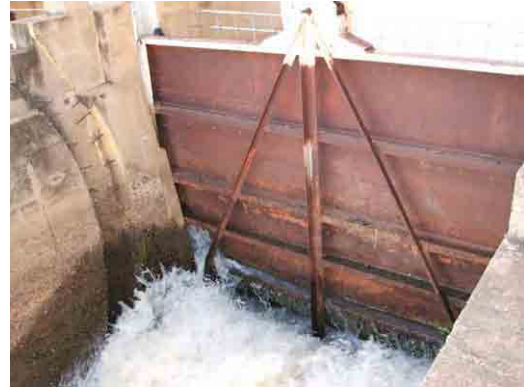
Paintings are damaged and thus corrosion is proceeding.

Leakage was observed through damaged rubber seals.

Corrosion and Leakage

The gate leaf shall be repaired after sand blast cleaning.

Rubber seals shall be replaced due to their damage.

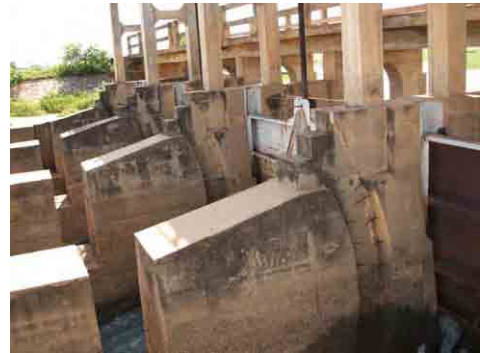
It is considered that the gates were originally designed as radial gate, but the slide gates were installed using the guide frames for stoplog. Due to this change, the guide frames were not equipped with seal seat of stainless steel, which became one of the reasons for severe leakage.

Box-out for side seal seat remains without filling concrete

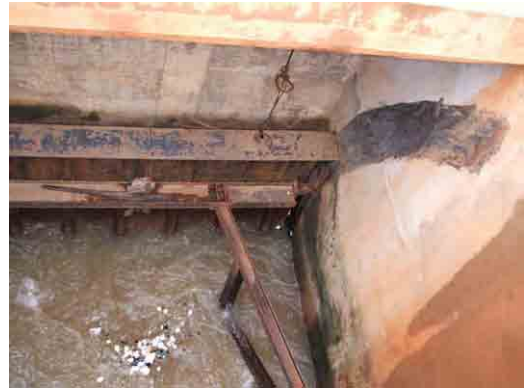
There is no problem on the hoist itself but the hoisting wire ropes are temporarily repaired

using the steel wire.

Temporary Measure for Wire Rope

Replacement of hoisting wire rope is recommendable. In this connection, it is proposed to use stainless wire rope in view of maintenance free operation.

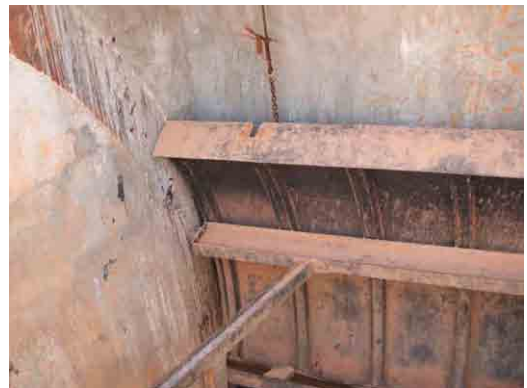
There finds no problem on the hoist itself but hoisting wire ropes are temporarily repaired using steel wire and chain.

Temporary Treatment by Wire Rope and Chain

Hoisting wire rope for radial gate shall be replaced. It is recommended that stainless wire rope should be used in view of maintenance free operation.

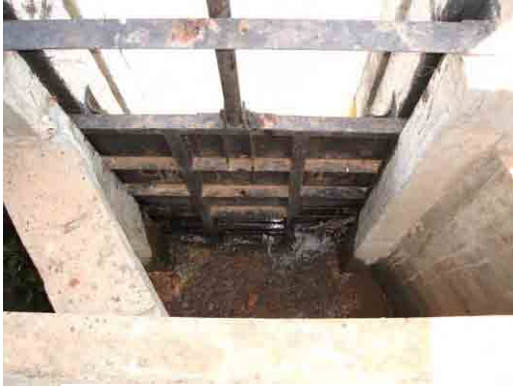
The metal seal seat is not provided. The rubber seal touches and slides on the uneven concrete surface. Clearance between concrete surface and rubber seal is a cause of leakage. One of the operators strongly wants to stop the leakage.

No Provision of Metal Seal Seat

An example of seal seat using stainless steel is given in the right side photo for reference. Similar design is recommended as the standard design for its sealing characteristics and long life with small cost increase.

Metal seal seat shall be provided to protect leakage.

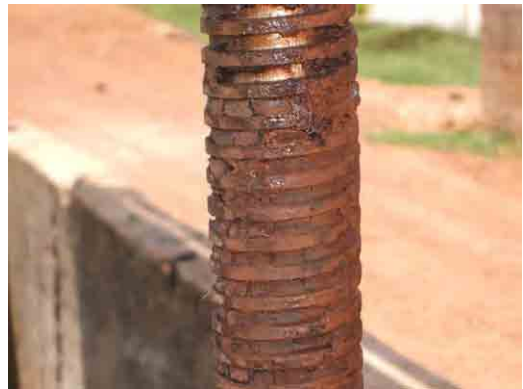
Maintenance is insufficient. For example, some debris and no lubricant are found in spindle screw. As the protector of the spindle, a spindle cover pipe on the top and a bellows on the bottom are used sometimes. Since the fitting work of the protector is not easy after installation of the hoist, those are not included in the scope.

Debris in Spindle
