Attachments IIIC-1
Inventory of Existing Irrigation Facility
on South Main Canal

Inventory of Existing Irrigation Facilities on the South Main Canal

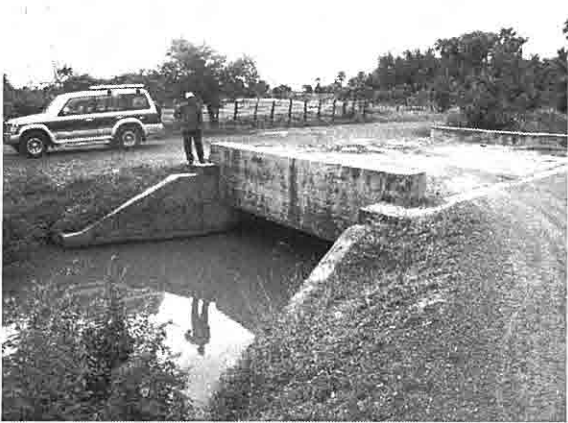
Photo-1	view from the upstream			Photo-2

Description of the Structure					
<p>Since axis of the bridge is consistent with a route of power-transmission line, the bridge must be provided for construction and maintenance of the power-transmission line. The elevation of top slab is EL.37.443m; Elevation at bottom is 34.075m.</p>					
Observation					
<p>Height of the bridge road surface is same with the canal bank level. On the survey date, water level at the bridge was 1.6 m lower than the bridge road surface. On the same date, overflow from the Roleang Chrey Regulator gate was estimated at 20cm and it seemed maximum water level. Higher water level than this level make the upstream area of regulator submerged.</p>

Improvement Plan					
<p>Width of the south approach channel at this bridge is not enough for let design discharge flow. Clearance between water level and top slab is also not enough. It is required to re-construct new concrete bridge with width of 3.5m after demolishing the existing bridge.</p>

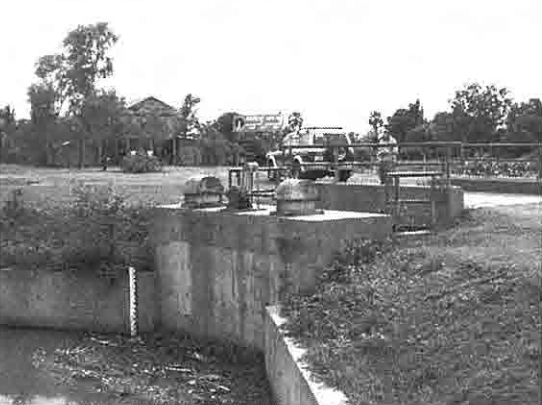
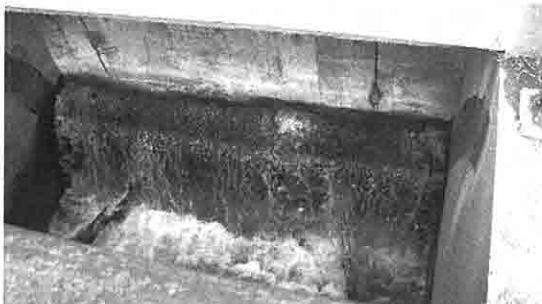
Photo-1	view from the upstream		Photo-2	condition of the radial gate

Description of the Structure					
<p>The Vat Krouch intake was constructed to regulate inflow to the South Main Canal from the Roleang Chrey Regulator.</p>					
Observation					
<p>According to PDOWRAM staff, the gate is working well at present. However, gate wire rope was damaged and repaired with temporary manner.</p> <p>The existing gate with four sealing edges contributes to the head loss at this intake. This is one of the reasons to be difficult to introduce the gravity irrigation.</p>					
Improvement Plan

<p>The new intake with two gates of 4.0m wide will be re-constructed at same place after demolishing the existing structure.</p>

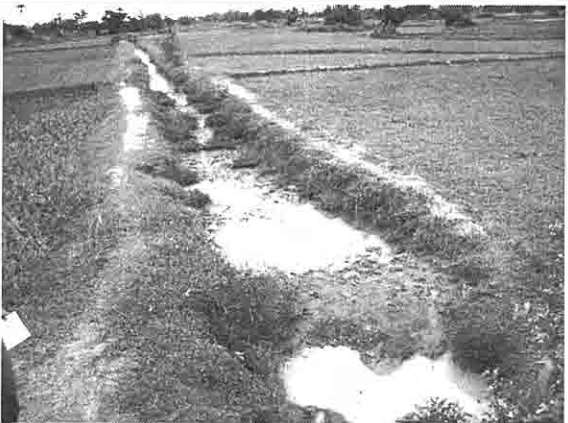
Photo-1	view from the upstream		Photo-2

Description of the Structure					
The secondary canal (RS-0) was excavated from the South Main Canal to the paddy field.					
Observation					
The secondary canal was not used yet, since no turnout structure was provided.					
Improvement Plan					
The new turnout will be constructed to conduct water to tertiary canal. The existing canal will be rehabilitated by proper way using adequate soil. This canal will be tertiary canal named SMC-T-①.

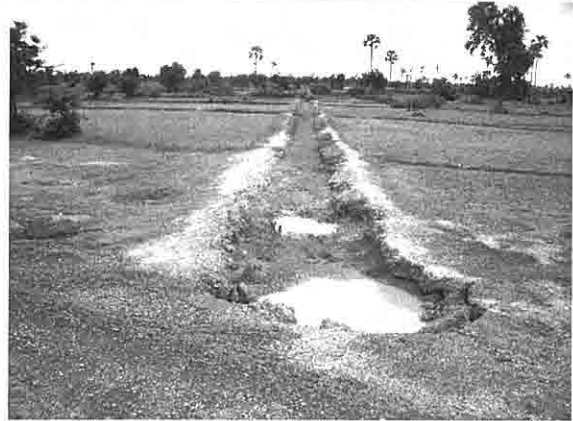
Photo-1	view from the upstream		Photo-2

Description of the Structure					
The secondary canal (RS-0.1) was excavated from the South Main Canal to the paddy field.					
Observation					
The secondary canal was not used yet, since no turnout structure was provided.					
Improvement Plan

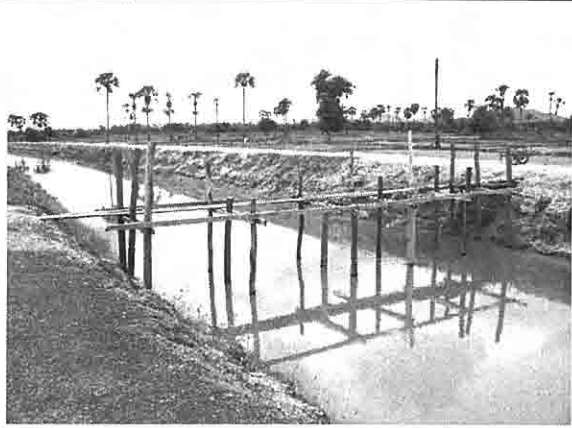
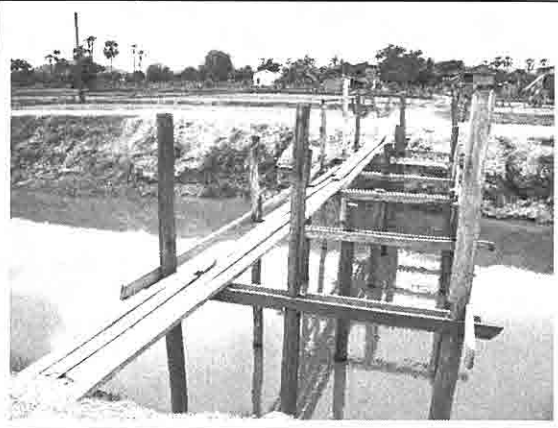
Photo-1	view from the upstream		Photo-2	short-distance view

Description of the Structure					
The bridge was provided by Ou Veaeng village people by their own effort to go across the South Main Canal to the irrigation area.					
Observation					
Height of the bridge is same as the canal bank level. It is dangerous to go across the bridge.					
Improvement Plan					
The concrete foot path with effective width of 2.2m will be constructed with canal protection by concrete lining at upstream and downstream of 5m each. The foot path should have a clearance of 1.0m above design water level.

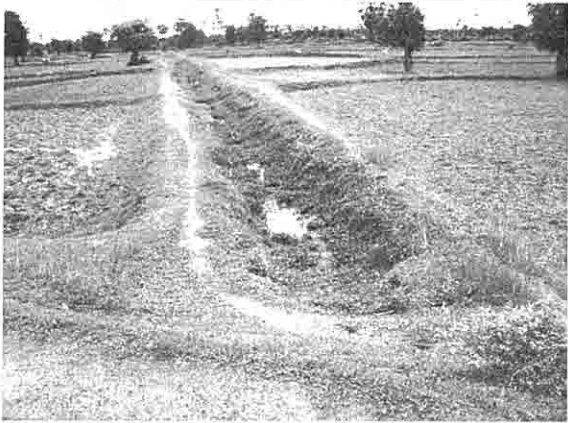
Photo-1	view from the upstream			Photo-2

Description of the Structure					
The secondary canal (RS-1) was excavated from the South Main Canal to the paddy field.					
Observation					
The secondary canal was not used yet, since no turnout structure was provided.					
Improvement Plan

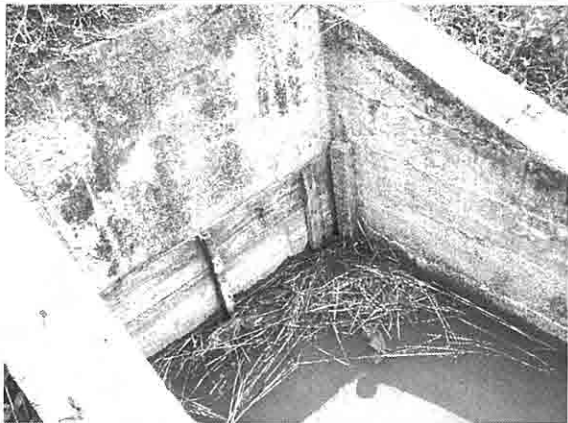
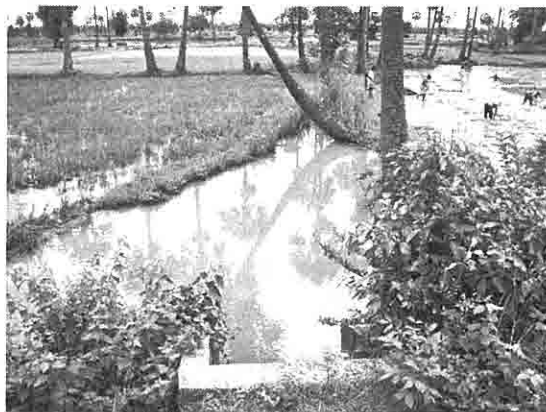
Photo-1	view from the main canal		Photo-2	view from the upstream

Description of the Structure					
<p>According to PDOWRAM staff, the turnout structure was used before. However, it is not used any more. The concrete pipe with diameter of 0.8m is installed.</p>					
Observation					
Improvement Plan					
<p>The new turnout with a concrete pipe with diameter of 0.5m will be constructed after demolishing of existing structure. The existing canal will be rehabilitated by proper soil, and is used as tertiary canal named SMC-T-②.</p>

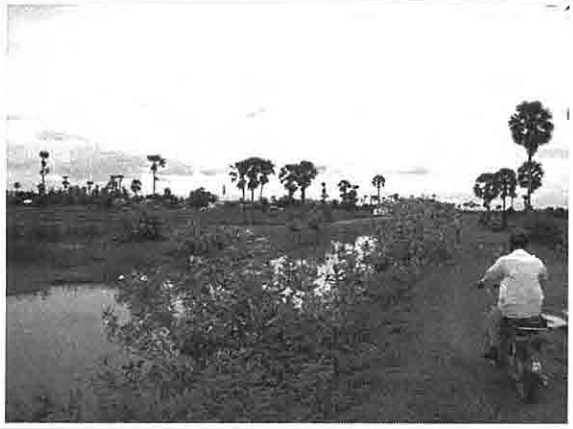
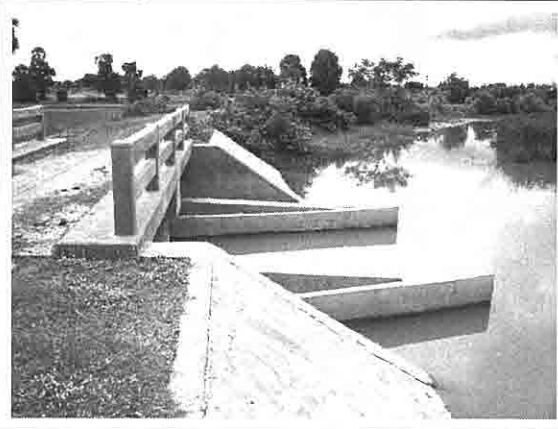
Photo-1	upstream of the spillway (end of the right bank)	Photo-2	view of the spillway

Description of the Structure					
<p>According to MOWRAM and PDOWRAM staff, before construction of the South Main Canal, a labyrinth type spillway was provided to spill out flood water from the Ou Veang pond. However, it was not used after the main canal construction.</p>					
Observation					
<p>Height of the spillway crest is about at 35.28m. (About 1 meter lower than left bank elevation).</p>					
Improvement Plan					
<p>The design water level at this spillway is 35.44m. The crest of spillway should be heightened about 20cm.</p>

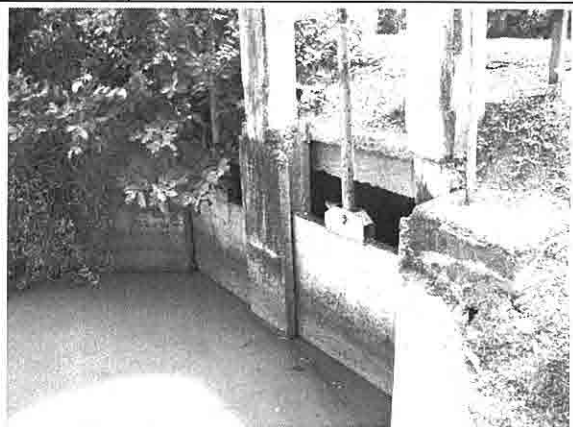
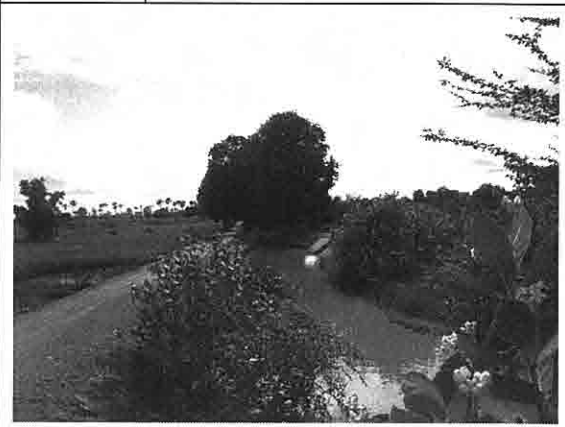
Photo-1	view from the Ou Veang pond		Photo-2	secondary canal (RS-3)

Description of the Structure					
Turnout structure with two slide gates (size: 1.0m width x 1.6m height x 2 nos.) was provided to divert water from the South Main Canal to the secondary canal No. RS-3.					
Observation					
It was observed that upstream gate is always closed and inflow to the secondary canal is regulated by the downstream gate. The bed elevation of gate is 33.59m.					
Improvement Plan					
The height of existing gate is not enough to design water level. The new gate with 1.0m width and 1.85m height will be installed. The existing canal will be rehabilitated with proper way, and is used for secondary canal named SMC-S-1.

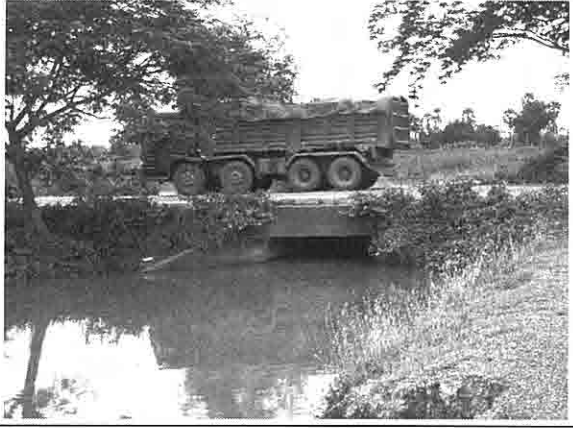
Photo-1	view from the downstream		Photo-2

Description of the Structure					
The road crossing culvert with 3 m in width and 2 m in depth (according to PDOWRAM staff) was provided at the crossing point of the South Main Canal with national road No. 4.					
Observation					
The size of existing box culvert is too small for design discharge.					
Improvement Plan					
The new box culvert will be constructed along the existing one.

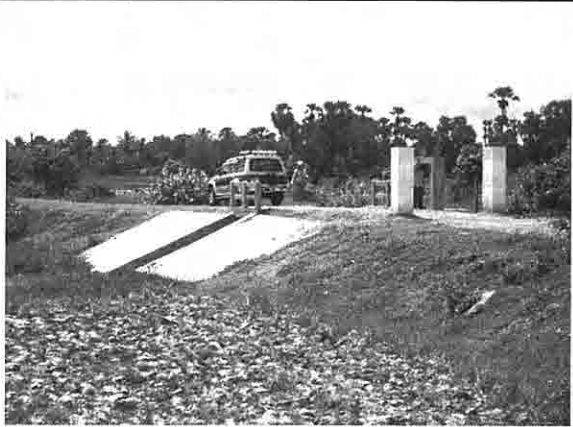
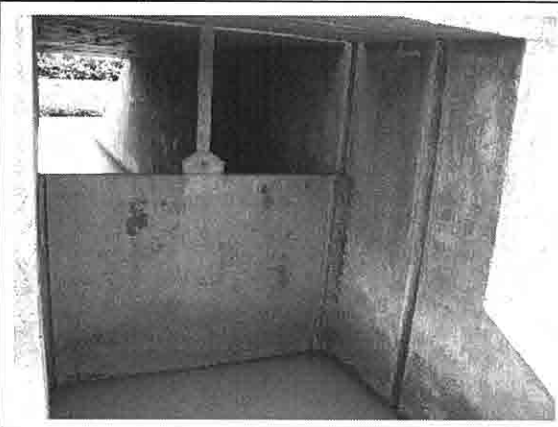
Photo-1	overview		Photo-2	Gate of the spillway

Description of the Structure					
<p>According to MOWRAM and PDOWRAM staff, before construction of the South Main Canal, a gate type spill way (size: 1.6m width x 1.2m height x 1 nos.) was provided at the downstream end of the Ou Veang pond to spill out the flood water from the pond. However, it was not used after the main canal construction.</p>					
Observation					
Improvement Plan					
Existing structure will be used without rehabilitation.

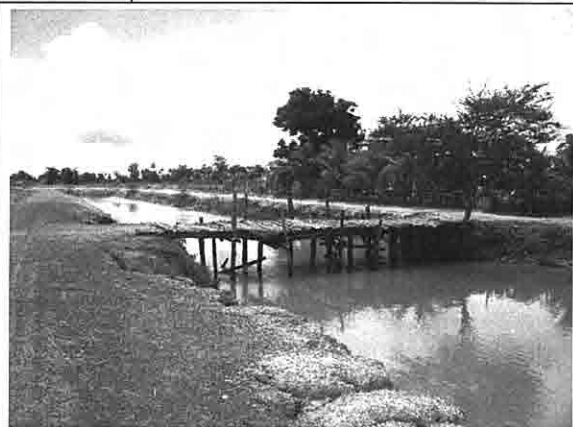
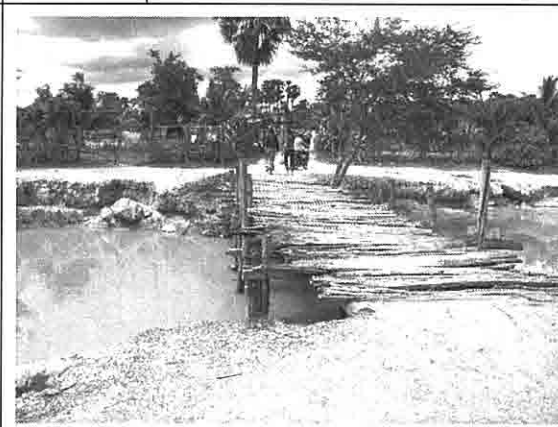
Photo-1	view from the upstream		Photo-2

Description of the Structure					
Wooden bridge was provided by villagers to connect village road from the south with the village road from the north.					
Observation					
Height of the bridge is same as the canal bank level. It is dangerous to go across the bridge.					
Improvement Plan					
The concrete Bridge with effective width of 3.5m will be constructed with canal protection by concrete lining at upstream and downstream of 5m each after demolishing of existing wooden bridge. The concrete bridge should have a clearance of 1.0m above design water level.

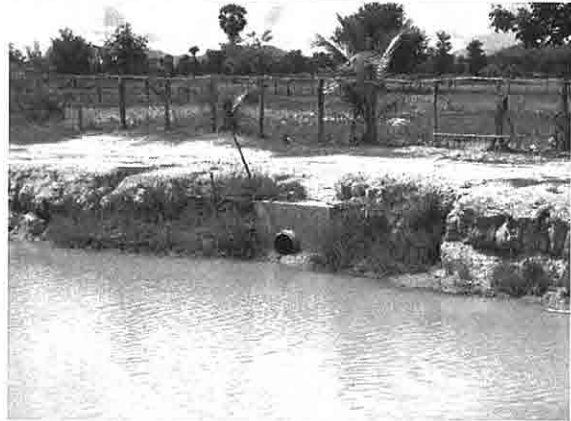
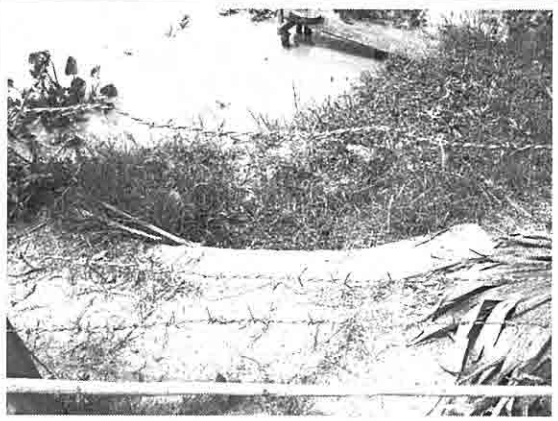
Photo-1	view from the upstream		Photo-2	view of the inlet

Description of the Structure					
<p>Drain inlet structure was provided on the right bank of the South Main Canal to drain unnecessary water from the paddy field to the canal.</p>					
Observation					
<p>The structure is not functioning since the inlet part was clogged up by siltation. The canal slope around outlet has eroded heavily.</p>					
Improvement Plan					
<p>The small rehabilitation with canal slope protection such as masonry works will be done.</p>

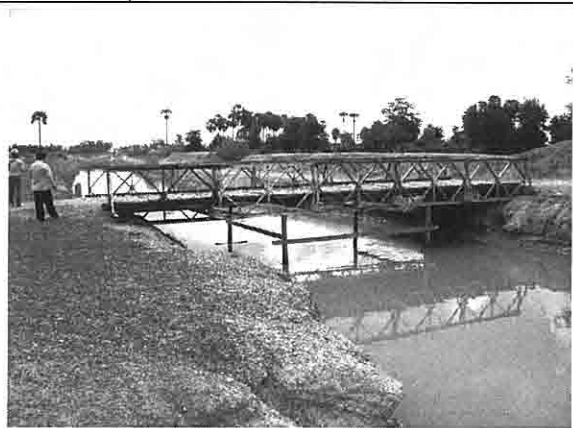
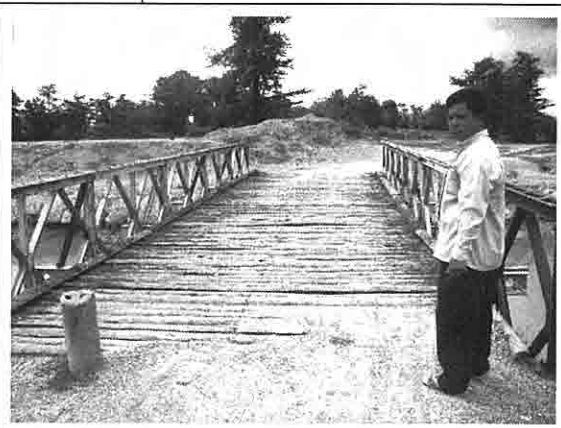
Photo-1	view from the upstream		Photo-2	view from the left bank

Description of the Structure					
The bridge was provided to connect Bos Ta Ney village located the left bank of the South Main Canal to the right bank of the canal.					
Observation					
Height of the bridge is same as the canal bank level. It is dangerous to go across the bridge.					
Improvement Plan					
The concrete Bridge with effective width of 3.5m will be constructed with canal protection by concrete lining at upstream and downstream of 5m each after demolishing of existing bridge. The concrete bridge should have a clearance of 1.0m above design water level.

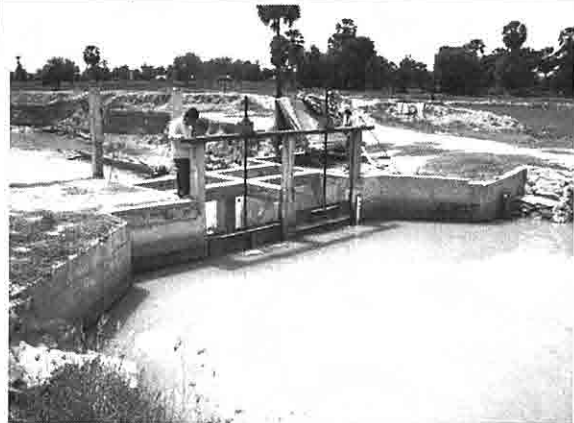
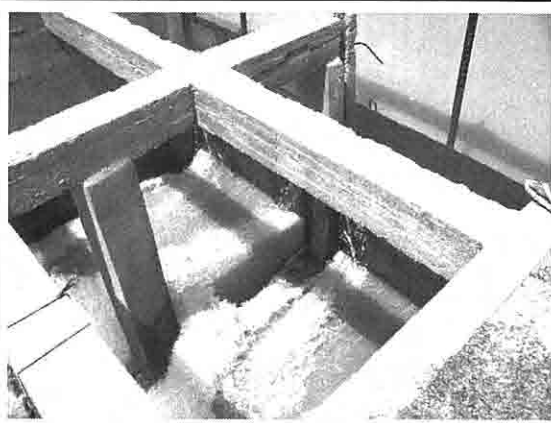
Photo-1	view from the upstream		Photo-2	view from the downstream

Description of the Structure					
<p>The check structure was provided by owner of the pig raising farm located right bank of the South Main Canal. Two numbers of steel gates of which sizes 1.8m width x 1.7m height are provided. A turnout for pig raising farm was also provided on the left bank.</p>					
Observation					
<p>The side slope at downstream has eroded heavily.</p>					
Improvement Plan					
<p>To be removed. The side slope at both upstream and downstream should be rehabilitated by embankment using clayey soil.</p>

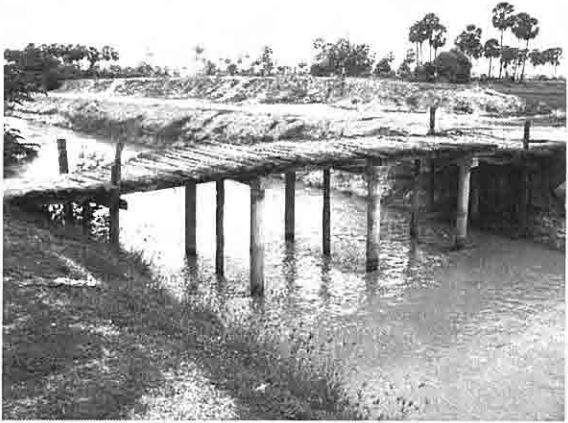
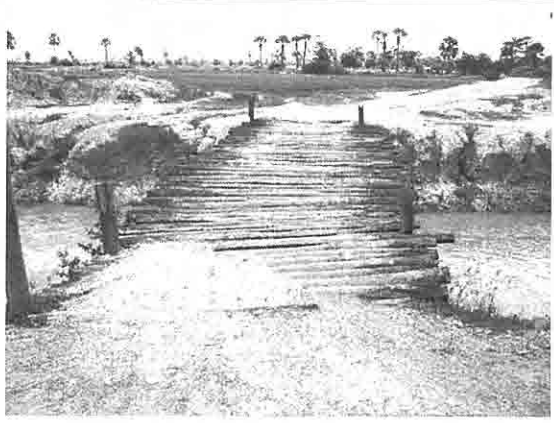
Photo-1	view from the upstream		Photo-2	view from the left bank

Description of the Structure					
The wooden bridge is supported by concrete column.					
Observation					
Height of the bridge is same as the canal bank level. It is dangerous to go across the bridge.					
Improvement Plan					
The concrete Bridge with effective width of 3.5m will be constructed with canal protection by concrete lining at upstream and downstream of 5m each after demolishing of existing wooden bridge. The concrete bridge should have a clearance of 1.0m above design water level.

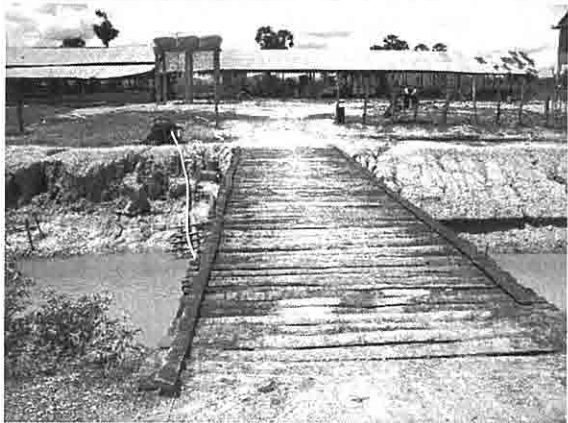
Photo-1	view from the left bank		Photo-2

Description of the Structure					
Observation					
<p>Height of the bridge is same as the canal bank level. The side slope at downstream has eroded heavily. It is dangerous to go across the bridge.</p>					
Improvement Plan					
<p>The concrete foot path with effective width of 2.2m will be constructed with canal protection by concrete lining at both upstream and downstream of 5m each. The foot path should have a clearance of 1.0m above design water level.</p>

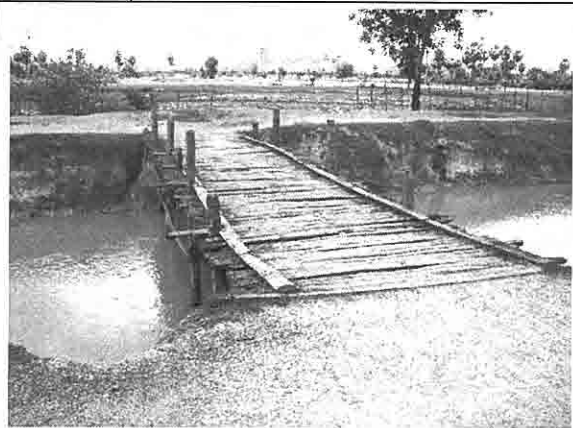
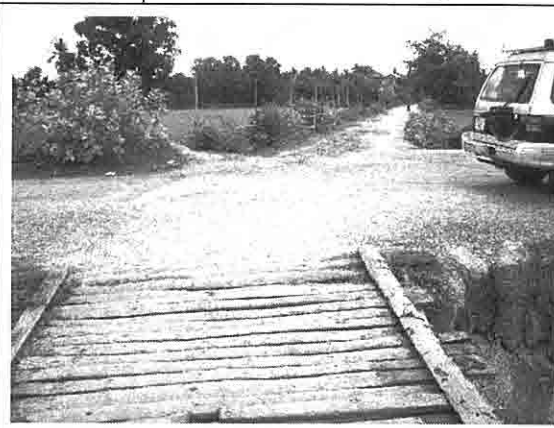
Photo-1	view from the downstream		Photo-2	view of the left bank village road

Description of the Structure					
Observation					
<p>Height of the bridge is same as the canal bank level. The side slope at both upstream and downstream has eroded heavily.</p> <p>It is dangerous to go across the bridge.</p>					
Improvement Plan					
<p>The check structure with three gates of which sizes 2.0m wide x 3.2m height and two overflow weir will be constructed at this place to regulate water. The concrete foot path will be constructed also on check structure.</p>

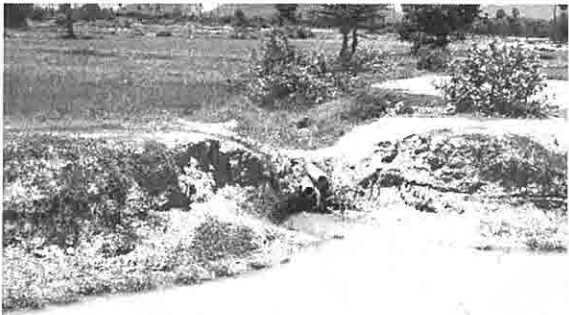
Photo-1	view from the left bank			Photo-2

Description of the Structure					
Drain inlet structure was provided on the right bank of the South Main Canal to drain unnecessary water from the small stream to the canal.					
Observation					
The side slope of main canal around outlet has eroded heavily.					
Improvement Plan					
New drainage inlet with concrete pipe will be constructed. The canal slope protection will be also constructed.
