CHAPTER 3

HAZARD AND RISK ASSESSMENT ON SLOPE DISASTERS

3.1 Slope Disaster Types along Narayangharh – Mugling Highway

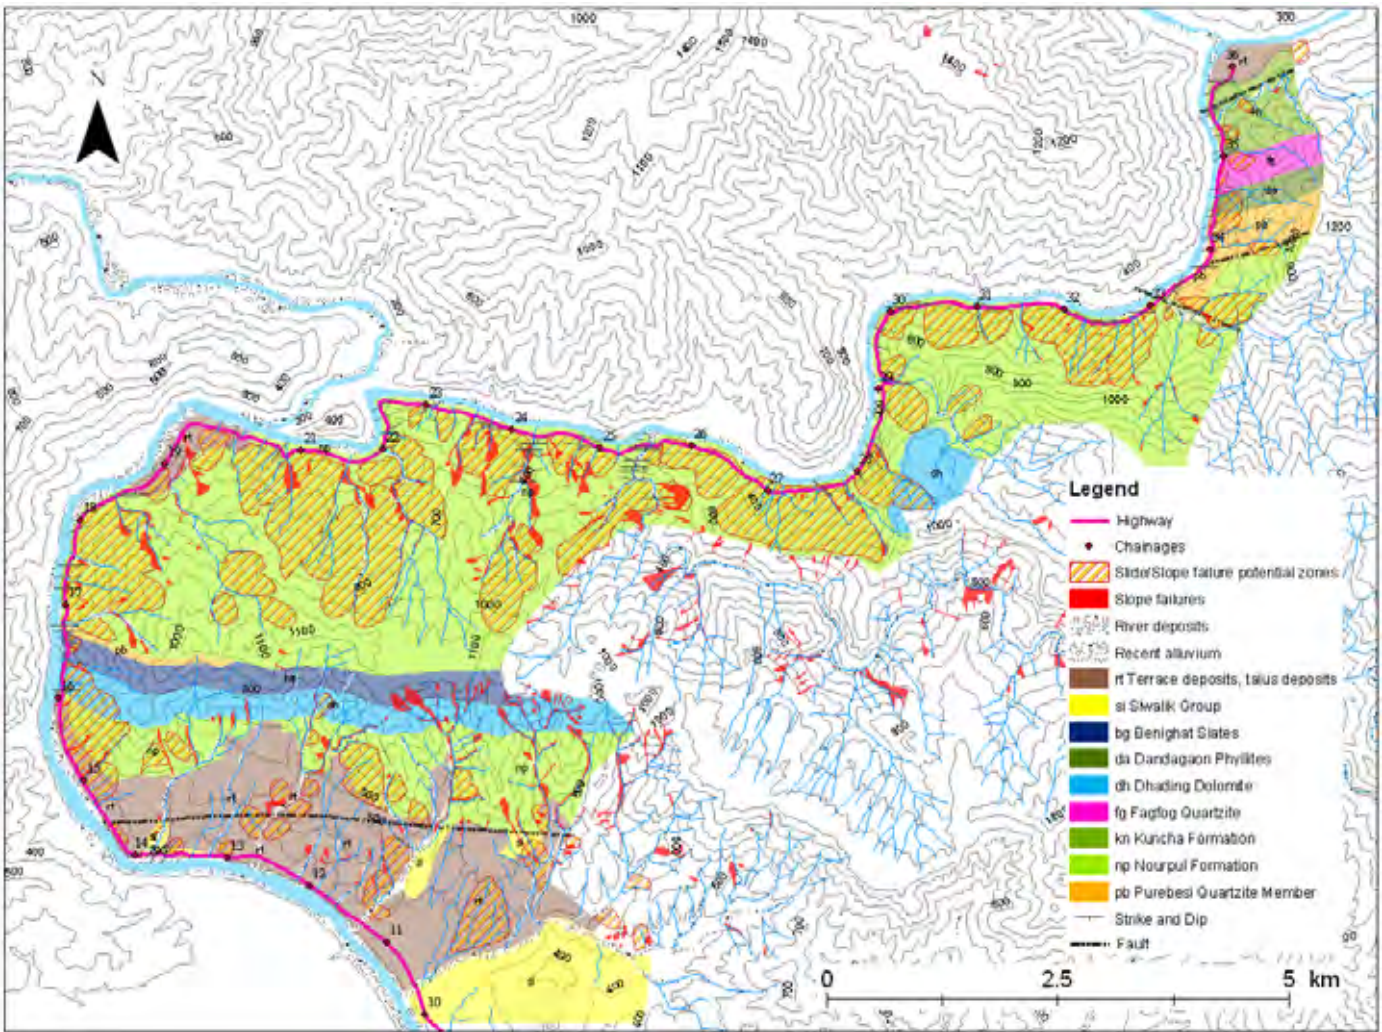
Figure 3.1.2 Hazard Map for CH 10 – CH 36 of N-M Highway

There are about 30 slopes having slide potential along the highway as shown in Figure 3.1.2. It means that most of 26 km (CH 10 – CH 36) section of the highway is adjacent to slide potential zones. Finally, locations of major slope hazards (and potential areas) were plotted comprehensively on topographic maps with a nominal scale of 1:25,000.

There are about 15 photo-interpreted lineaments along the highway. Some of the lineaments seem to coincide with the major faults such as the MBT. The interpreted lineaments are considered to imply boundaries of rocks, cracks related to slides, and other active/inactive (historic) faults, too.

Various sizes of slope failures are recognized on high resolution satellite images at nominal scales of 1:5000 – 1:10,000. Many locations of slope failures are located in both sides of landslide potential slopes (both sides of mountain streams).

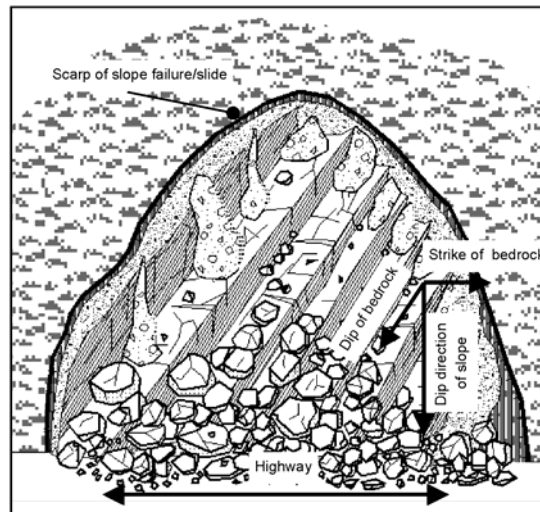
Figure 3.1.8 Typical Slope Failure in between CH 22 – 22+500

A section of CH 22+000 – CH 22+500 is located on west and northwest-facing and transverse-slip slopes. Road slope geology of this section comprises of phyllites and sandstone of the Nourpul Formation.

Within this section of 500 m, typical slope hazard is slope failure as shown in Figure 3.1.8 and Figure 3.1.9 below.

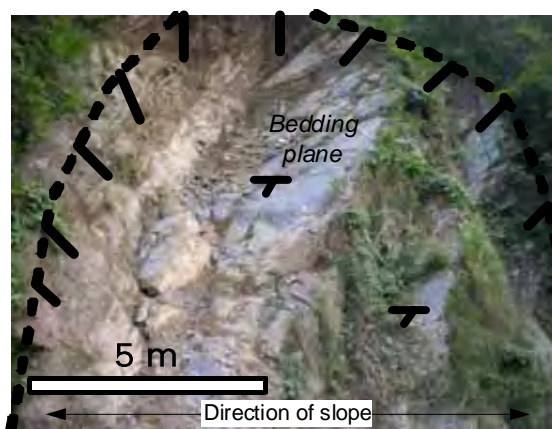
Figure 3.1.9 Wedge-shaped Rock Slides forming a Slope Failure

Wedge-shape rock slides are also observed.

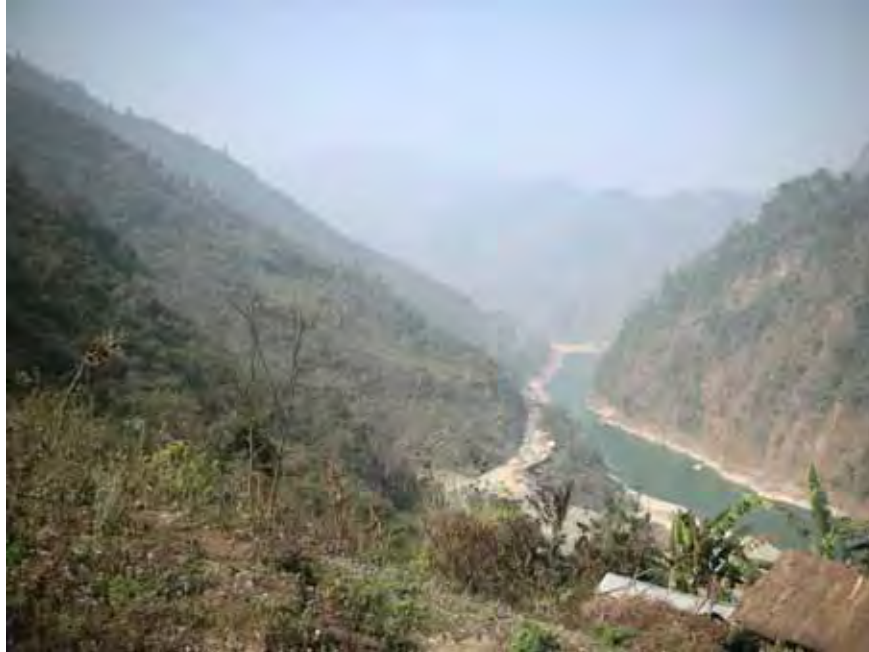
Figure 3.1.10 North-facing Dip-slip Slope and Highway along Trishuli River

A section of CH 22+500 – CH 23+000 is located on north-facing and dip-slip slopes. Road slope geology of this section comprises of phyllites and sandstones of the Nourpul Formation.

Small-scale slope failures and landslides are common within this section of 500 m.

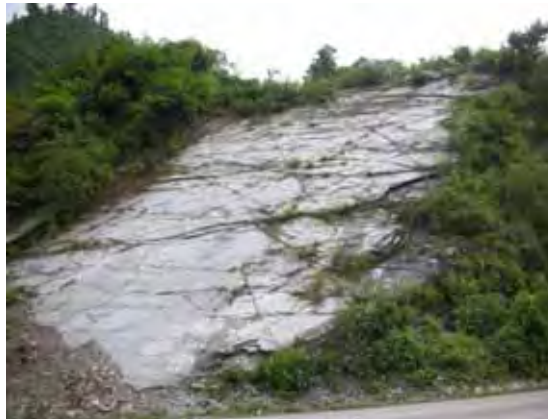
Figure 3.1.12 Typical Dip-slip Slope formed by Bedding-parallel slip of bedded rock (CH 25+500, near the Rigdi Khola)

Within this section, there are three slopes having landslide potential. They are named SL-2, SL-3, and SL-4 respectively, and studied in detail as the F/S sites as well as SL-1. Excluding these selected sites, there are many bedding-slip landslides (rock slides) and can be observed along the highway as shown in Figure 3.1.11 and Figure 3.1.12.

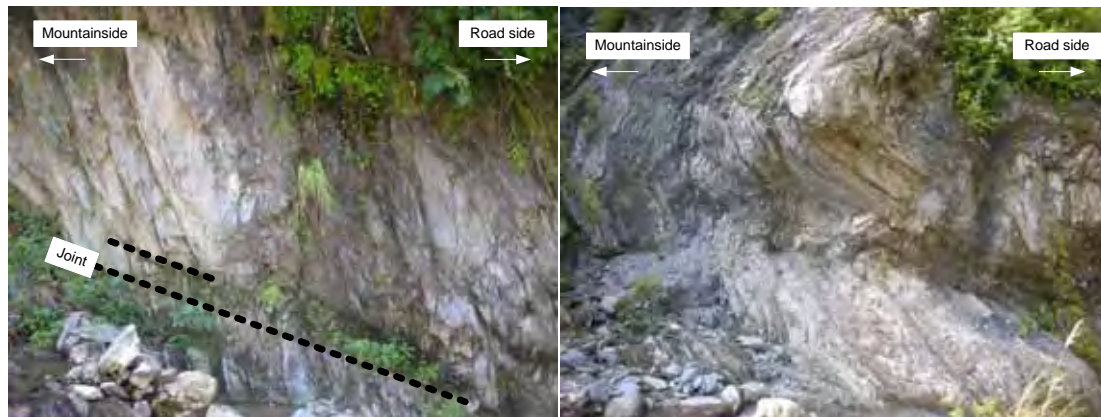
Figure 3.1.13 Non-tectonic deformations of phyllites of the Nourpul Formation (Left: road side-dipping joints, Right: gravitational fold of phyllites)

The bedrocks are mainly alternating beds of phyllite and sandstone (sometime quartzite). Weathering seems to penetrate deeply into the rocks there. The rocks have many non-tectonic deformation suggesting gravity creeps, and frequently sheared tectonically. Low-angle joints are developed through phyllites as shown in Figure 3.1.13 below.

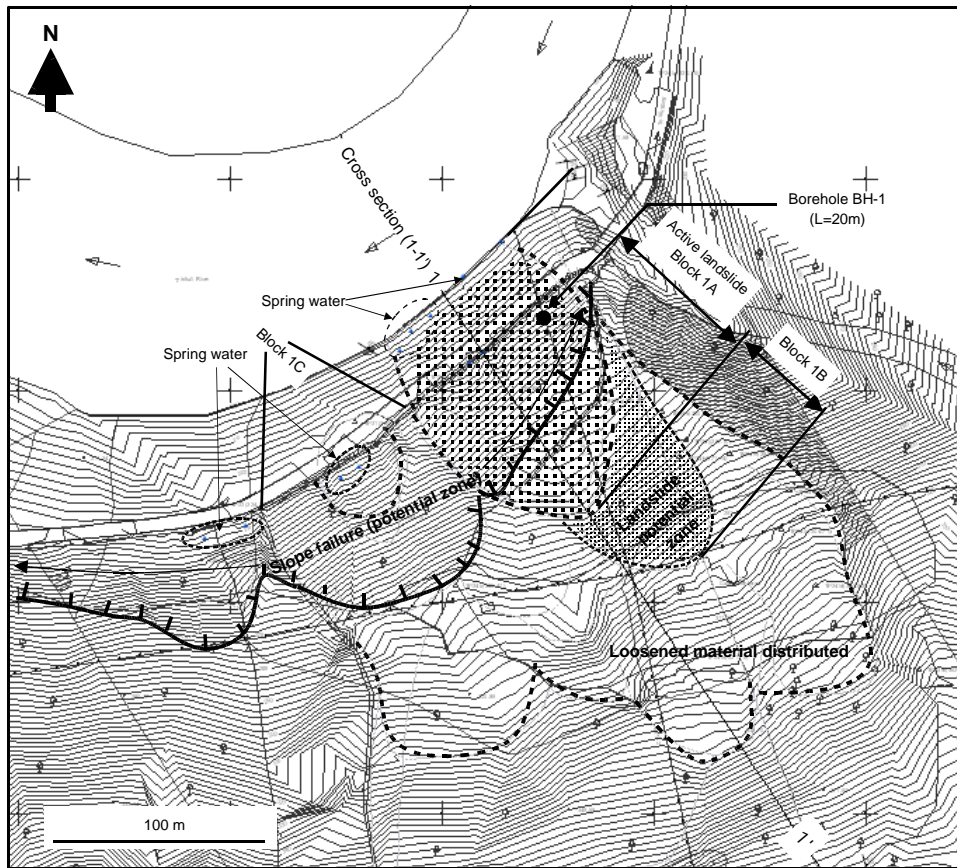
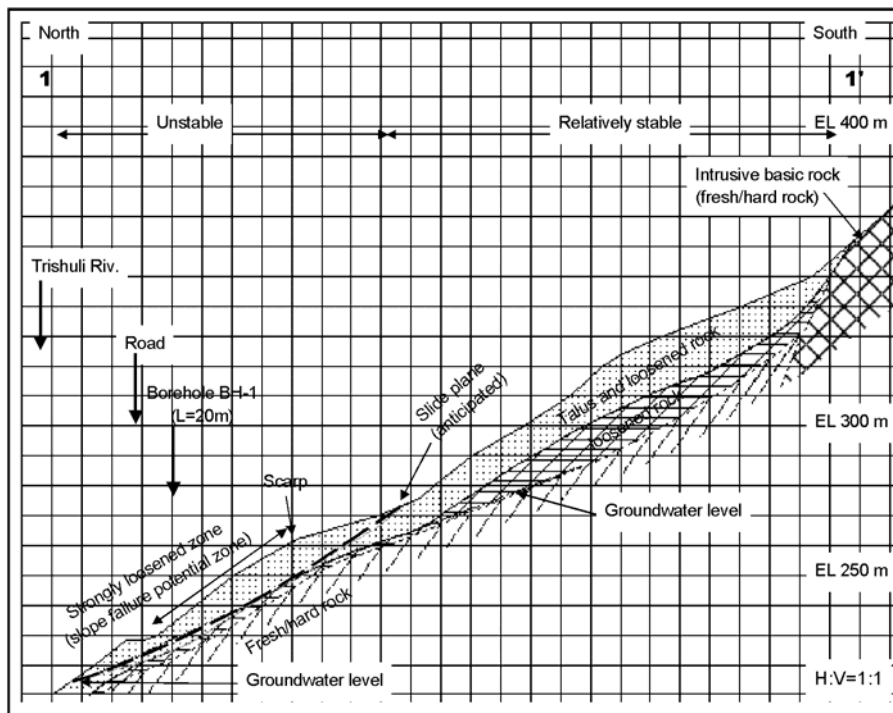
Figure 3.2.2 Plan View and Cross Section of SL-1

Figure 3.2.2 shows a plan view and a cross section of the SL-1 slope respectively, as a result of comprehensive study. As shown in Figure 3.2.2, a continuous scarp existing along contour lines of E.L. 230 m – 250 m. The scarp is the top portion of slope failure facing the highway. Above the scarp, topographic features suggesting landslides are interpretable. Especially, the most visible landslide block is shown as Block 1A in Figure 3.2.2 which should be targeted.

A landslide block (1A) comprises of talus/colluvial deposits and loosened phyllites, and has dip-slip structure. These unconsolidated deposits and loosened bedrock have landslide potential material. Fresh and hard rocks seem to lie approximately 10 m under the ground.

Average groundwater level is around GL -3 m in the Borehole BH-1. This level almost coincides with a mountain stream located in right side of SL-1. Many points of spring water were found in 2007 monsoon season.

The landslide (Block 1A) is related to a dip-slip structure. Loose material of lower slope has been pushed by material of upper slope towards the road.

Landslide at SL-1 was originally caused by a bank erosion at the Trishuli River. Consequently, the landslide and related slope failures are considered to have been activated by the cutting of the landslide potential slope (Block 1A) during the construction of the highway. Once Block 1A starts sliding down to the highway, sliding of block (Block 1B) is expected to occur.

Among the selected sites, SL-1 has the highest hazard potential, and is a typical landslide site.

For preventing hazard, groundwater should be drained appropriately with suitable countermeasure, e.g., provision of additional horizontal drain holes.

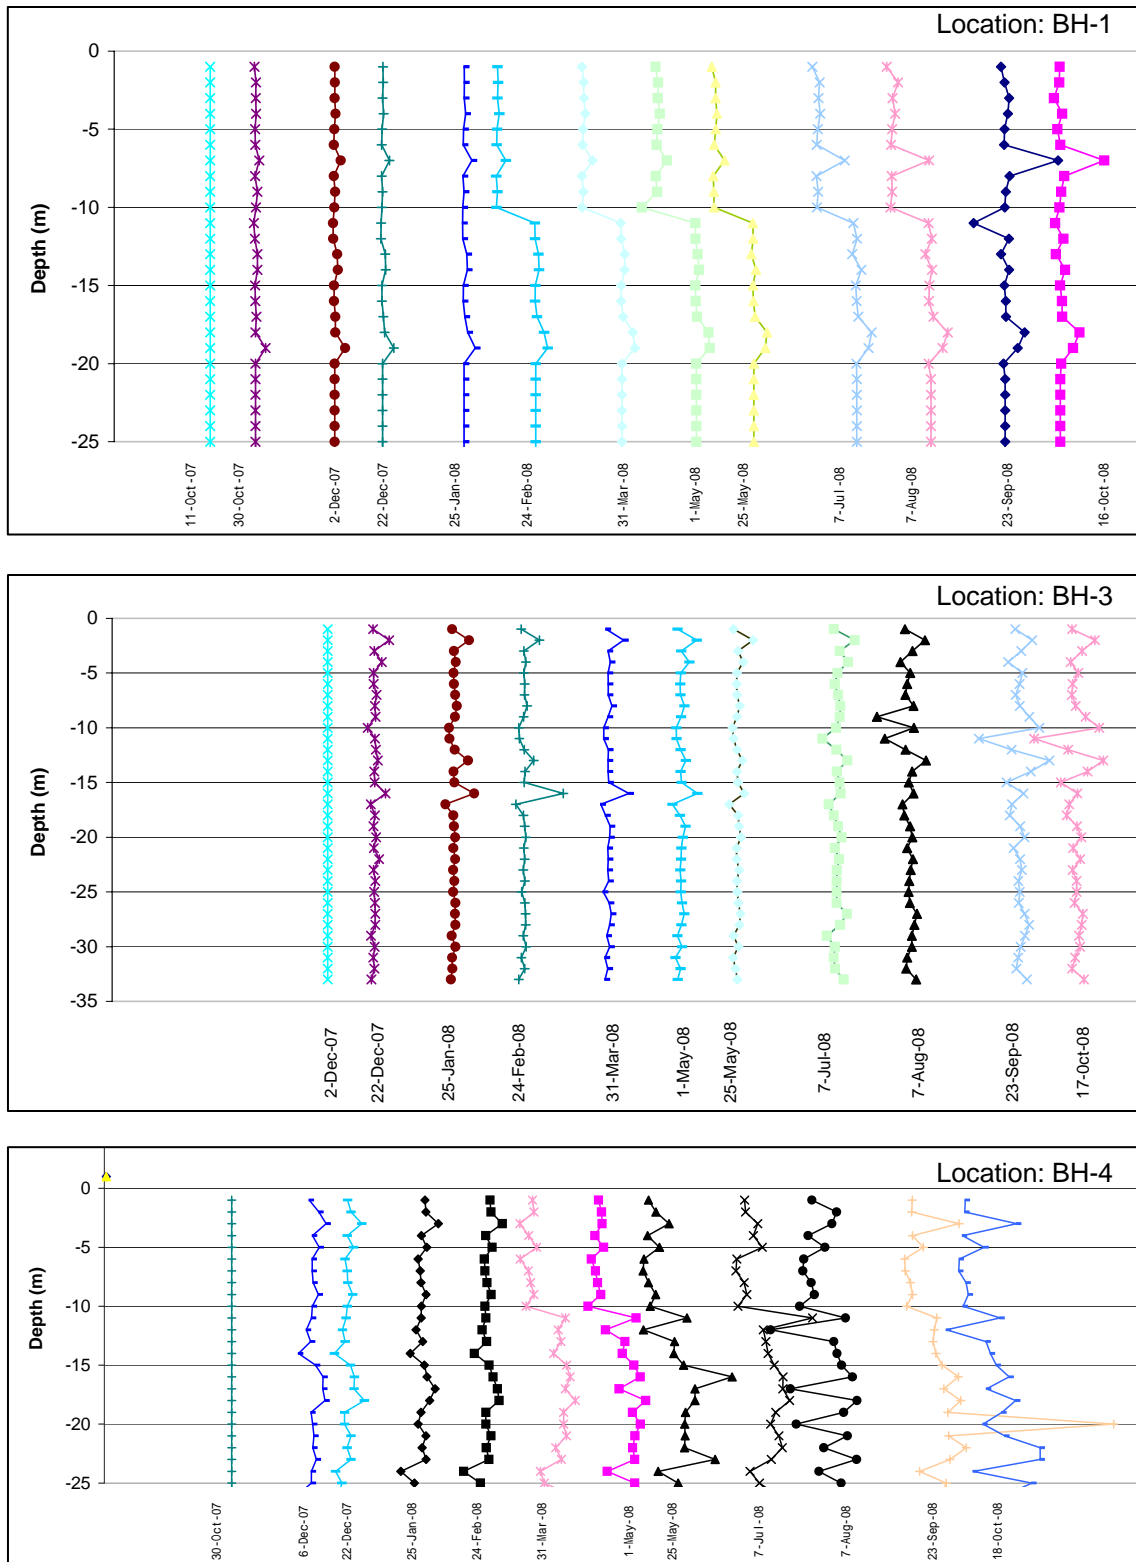
Figure 3.2.3 Pipe Strain Measurement Records of BH-1, BH-3, and BH-4

A pipe strain meter was not installed in this study. However, deformation and failure of a road-side retaining (masonry) wall suggests that there has been a certain level of downward movement of the block 2A (See Figure 3.2.3 above).

The pipe strain meter installed in the BH-3 has not shown any kinds of hazardous movement (See Figure 3.2.3). However, an unstable rock mass (Block 3B) has been pushing a masonry wall by the road that was collapsed in 2007.

The pipe strain meter installed in the BH-4 has not shown any kinds of hazardous movement (See Figure 3.2.3). Retaining walls were not damaged.

Many landslide-related slope failures have occurred in the SL-1 site and the SL-3 sites. However activeness of landslide main bodies in both sites cannot be recognized currently, based on pipe-strain measurement as shown in Figure 3.2.3.

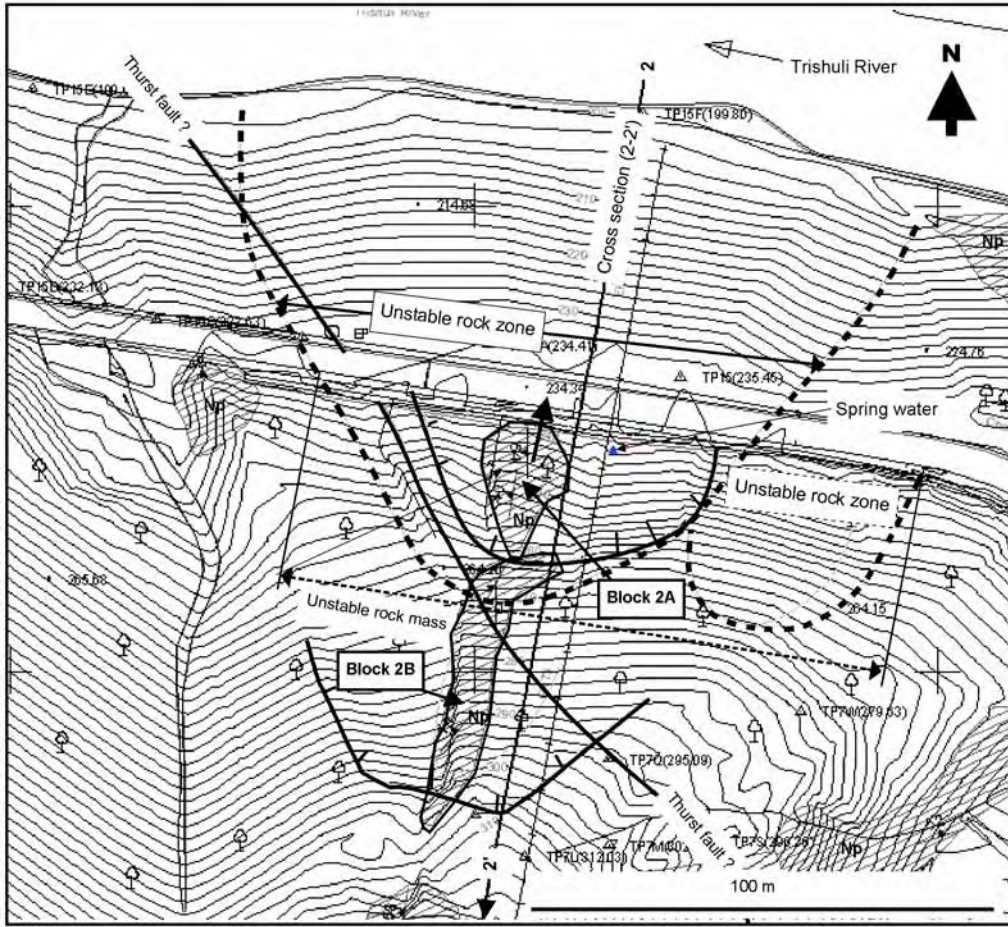
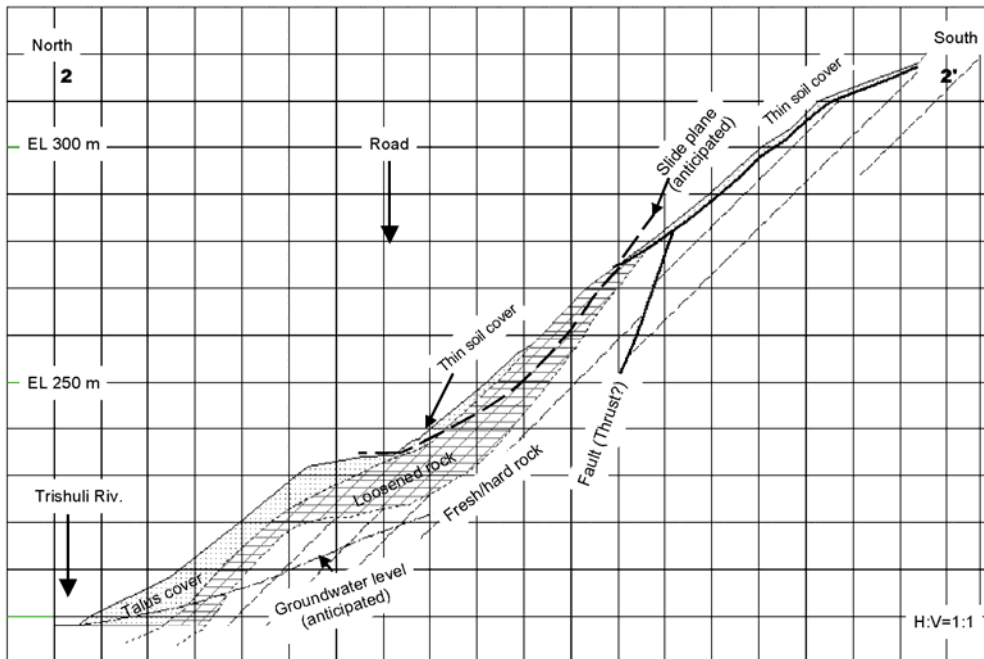
Figure 3.2.4 Plan View and Cross Section of SL-2

It is considered that the movement of the Block 2A was initiated during the slope-cutting prior to opening of the highway. The unstable rock mass movement is related to geological structure, i.e., dip-slip structure. An assumed sliding plane is a bedding plane of the bedrock (probably made up of sandstone). Once Block 2A collapses, Block 2B will move towards the road.

However, the size of Block 2A is only about 600 m², which is considered relatively small for a landslide. Such occurrence is common along the highway, but not considered serious. For the mountain-side slope, loose rocks (shown in Figure 3.2.4) beneath the ground surface should be retained with suitable countermeasures. On the other hand, the river-side slope below the road seems to be currently stable. The target for countermeasures is the road-side slope as shown in Figure 3.2.4.

The slope SL-2 has unstable bedded rock block (400 m²) sliding gradually toward the road. This unstable block does not seem to be a landslide that has potential of serious damages to the road. However, if the unstable block begins to move, deeper parts of loosened bedrock below the block will have potential of deformation.

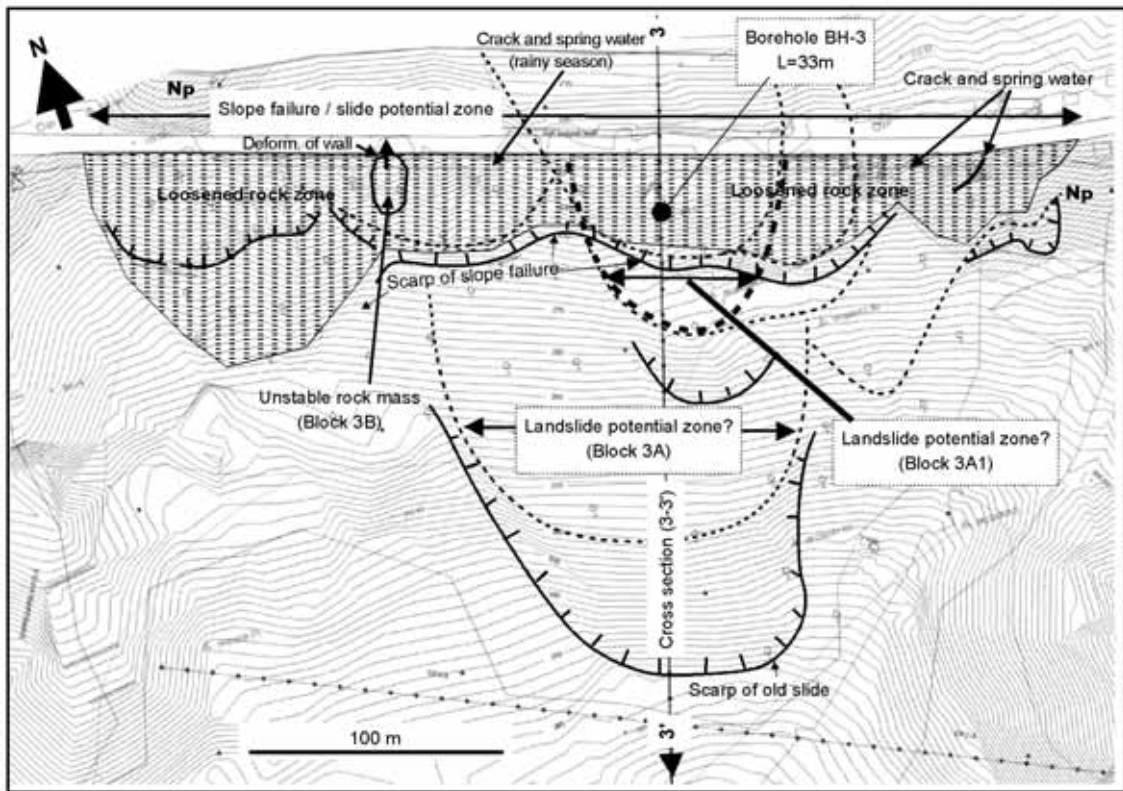
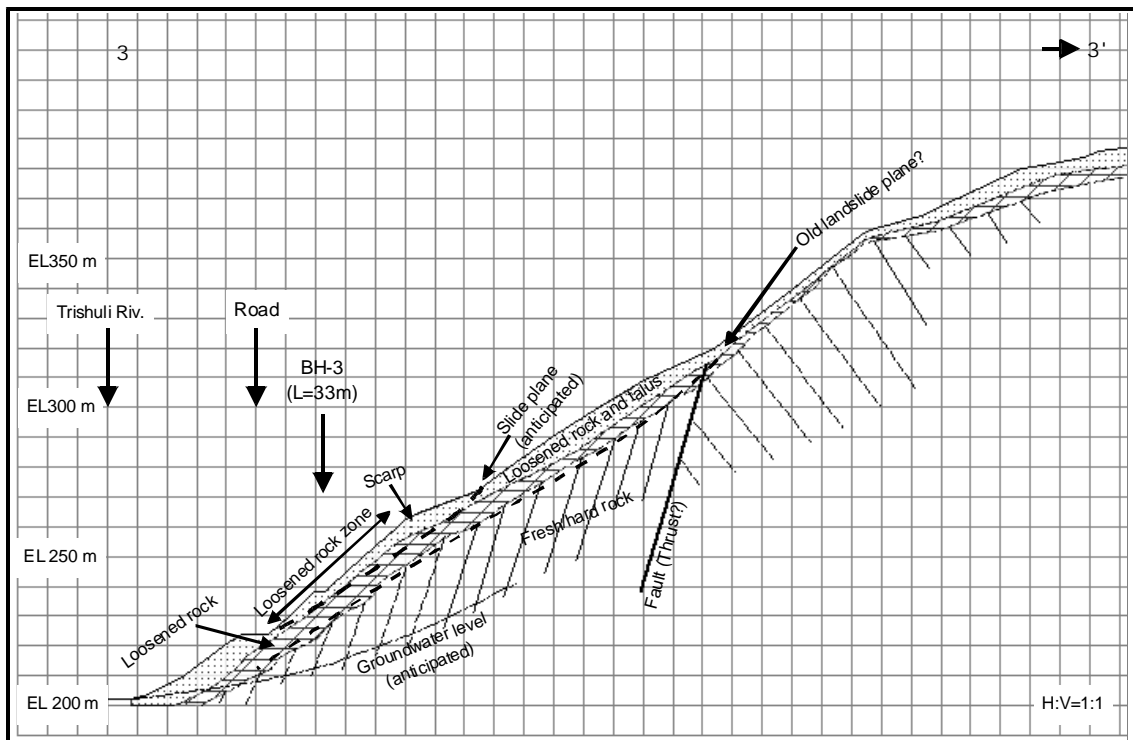
Figure 3.2.5 Plan View and Cross Section of SL-3

The slope is facing north and has dip-slip structure as shown in Figure 3.2.5 lower. At the borehole BH-3, loosened material (composed of talus and weathered/loosened bedrock) lies up to a depth of 13 m. Phyllites in the SL-3 site shows green or greenish-gray. At the mountainside of the road, these rocks have many open-cracks or joints. In the rainy season in 2007, many points of spring water could be observed on these cracks and joints.

Average groundwater level is around GL -25 m in the Borehole BH-3. This level is 5 m above a water level of the Trishuli River below the site. Many points of spring water were found in 2007 monsoon season as mentioned above.

On the other hand, rock-sliding along bedding planes or slope failures within shallower depths (up to 5 m depth) of the cut slope are more active than the big landslides (Block 3A including Block 3A1). Such current slope behavior is considered as a landslide-related movement. Furthermore, slope failures on the cut slope below E.L. 260 m seem to extend to both sides of the Block 3A1 along the road.

The countermeasure should be planned with reviews mentioned above.

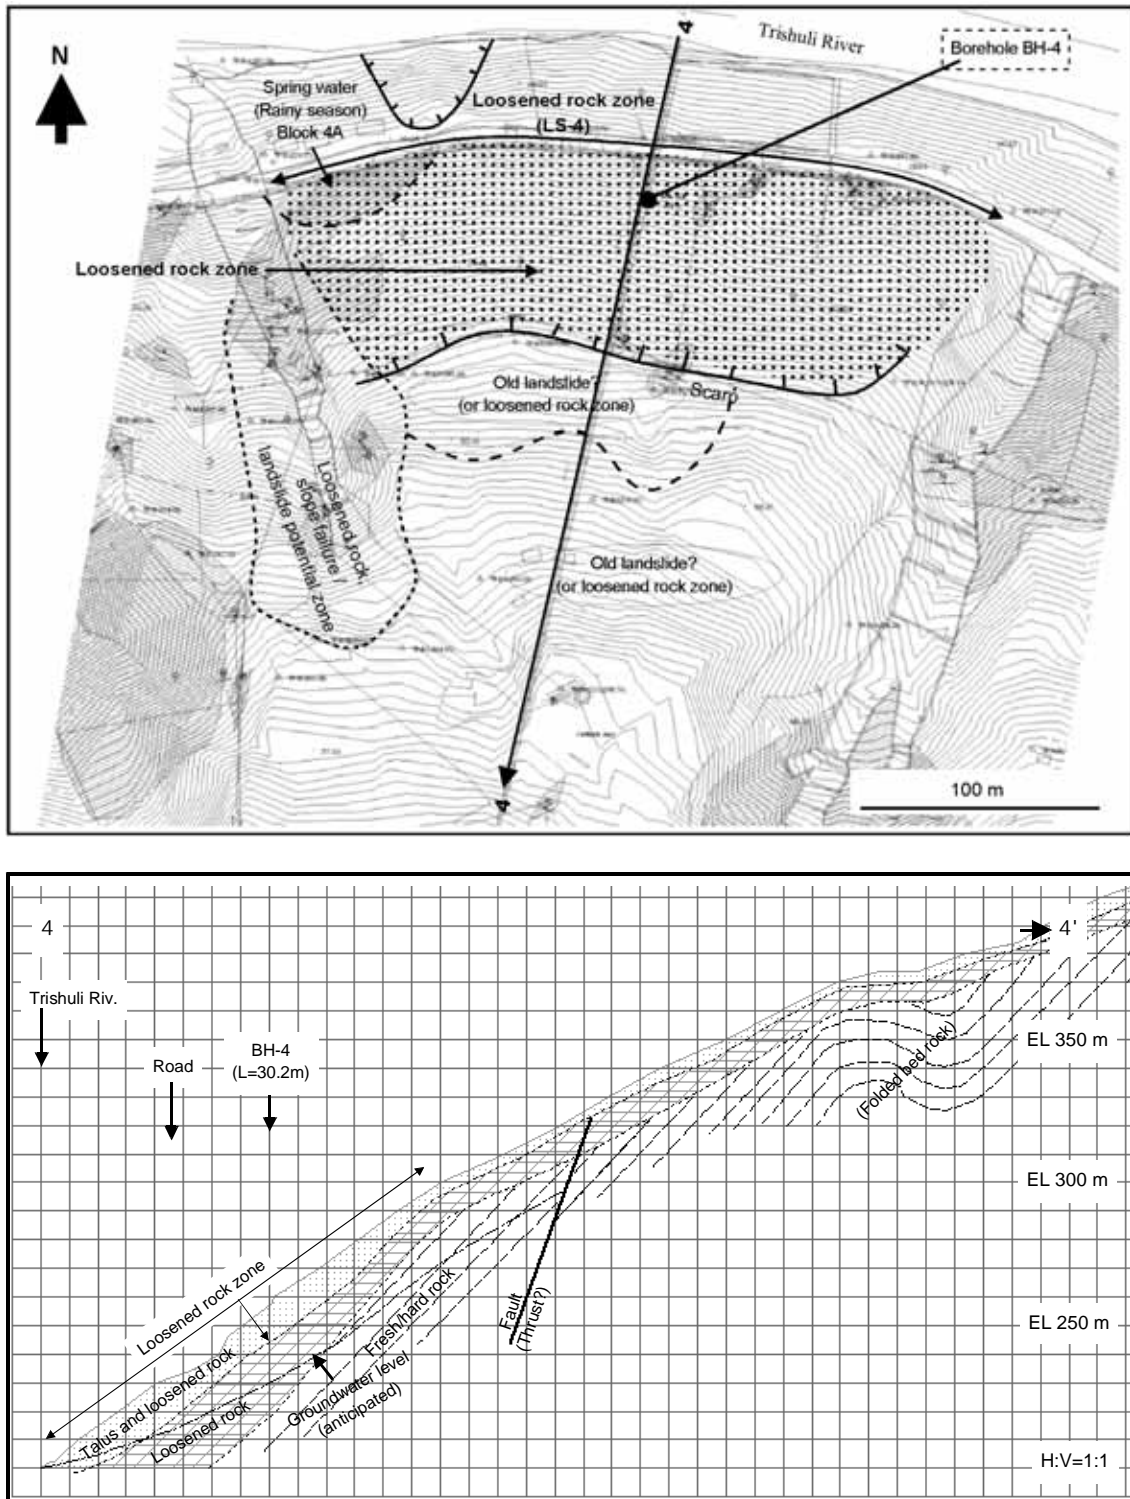
Figure 3.2.6 Plan View and Cross Section of SL-4

The slope is facing north and has dip-slip structure as shown in Figure 3.2.6 lower. At the borehole BH-4, bedrocks are loosened deeply, and the borehole wall had been collapsed at about a depth of 24 m many times when drilling. Any positive evidences suggesting that this site is a landslide are not recognized in the field reconnaissance.

However the slope above the mountain side retaining wall, loosened and unstable rocks and rolling stones of phyllites are often observed. This condition is considered to suggest slope failures. They are often observed on the natural slope located between E.L. 230 and E.L. 300

Risk of a big landslide moving towards the highway is low. Potential hazards to the highway are slope failures and rock falls from Block 4A and its adjacent slopes. These slope failures seem to be initiated by the cutting of the slope during the opening of the road.
