資料 7. その他資料/情報

7-4 橋梁健全度調査結果

点検調査(その1)橋梁の諸元と総合検査結果															
橋梁名	アシン プラソ橋		路線名	国道8号線		管轄	ガーナ道路公社		橋梁コード						
所在地	自	アシン・プラソ地先	距離標	自				調査更新年月日	2008年10月16日						
	至			至											
供用開始日		橋長	82m	活荷重・等級		適用示方書	BS		調査年	2003年					
上部構造形式	単純トラス		幅員	全幅員	地覆幅	歩道幅	車道幅・車線	車道幅・車線	歩道幅	地覆幅	中央帯	中央分離帯	交通条件	交通量	2600台/日
			有効幅員	0.15m	0m	5.5m	1							大型混入率	40%
下部構造形式	重力式		備考											荷重制限	トラック12ton
基礎形式	直接基礎														
総合検査結果	<p>1. 本橋は、竣工後72年を経過している。制限荷重が示されており、トラック12トン、トレーラー18トン、群衆荷重100ポンド/ft²である。現在の交通状況は、大型トレーラー大型車両を含めて日当たり2600台走行しており、また制限荷重を大幅に越えている。</p> <p>2. 下部構造については、右岸側橋脚の支舞台座部のコンクリート水平打ち継ぎ目の処理が不適切であったことが原因で、水がしみ出ており、この位置でコンクリートの縁が切れている。コンクリート強度については問題ないと思われる。</p> <p>3. 上部工において、トラス上弦材のラチアル材が撤去され天端にアングルが簡易的に設置されている。手摺りパイプはとところろ変形しており、車両が何度も衝突したことを示している。縦主材が1箇所変形しているが、これも車両の衝突によるものである。また、建設当時は全てリベット継ぎ手であったと思われるが、一部を除きハイテンションボルトで補修されている。</p> <p>4. 全ての排水工は橋面の舗装修復時に、アスファルトで塞がれている。また地覆においては、全ての横桁位置でクラックが入っている。雨水はこのクラックから床版下の横桁に浸入し、横桁の腐食を誘発、進行させている。</p> <p>5. 主橋の支台位置は土に覆われ、雑草が生えている。縦桁の支承は車両荷重の衝撃が大きく、一部を除いて支台に埋没しており、桁が直接支台に乗っている状況である。</p> <p>6. 大型トレーラーの走行時は、橋中央部では、かなりの揺れを感じる。</p> <p>7. 2003年10月15日にGHA(ガーナ道路公社)は、健全度調査を行っている。その調査では、特に問題なし。と報告されているが、今回の調査を踏まえて上記の各項目を総合して所見を述べれば、床版下の横桁および縦桁の腐食が

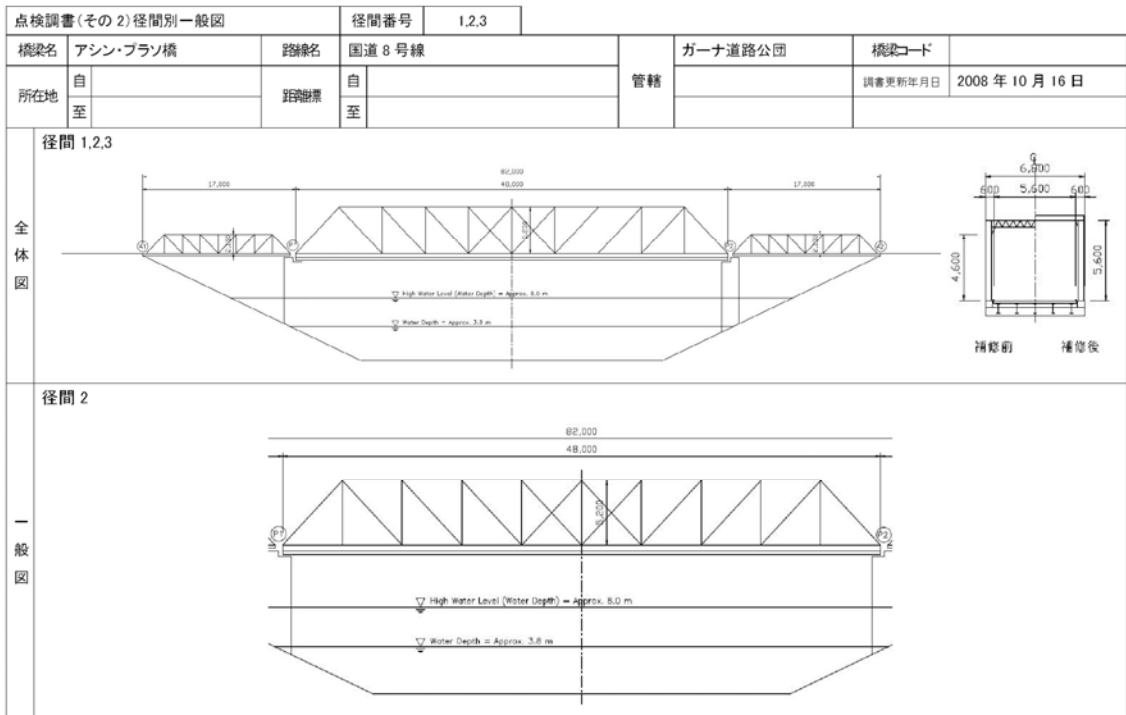
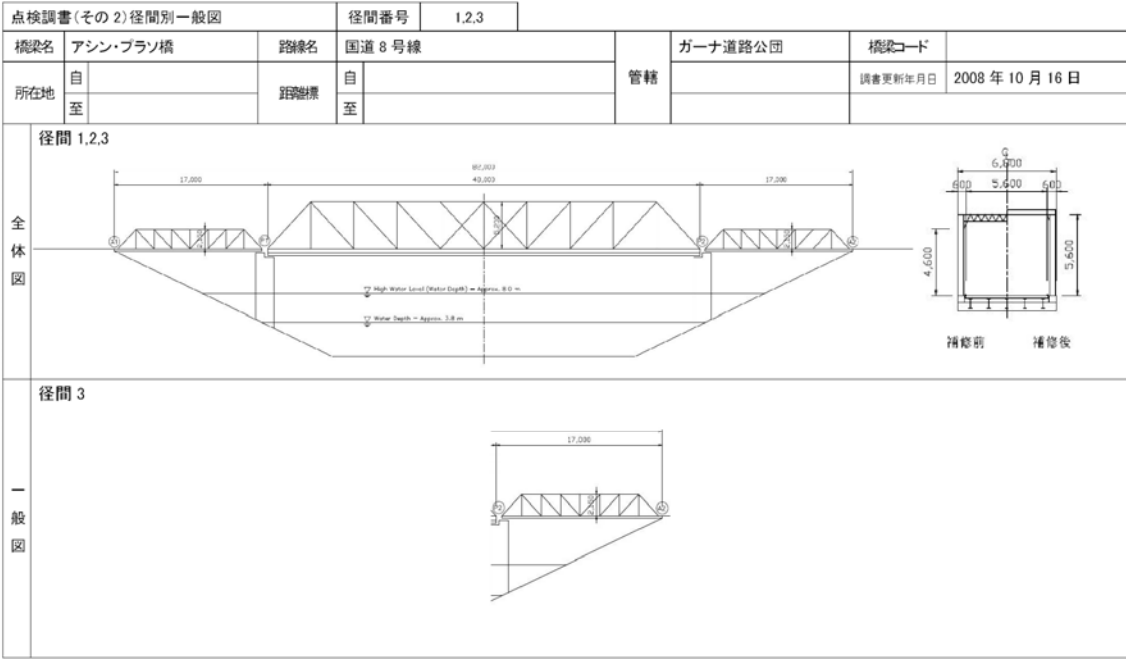
点検調査(その2)径間別一般図			径間番号	1,2,3						
橋梁名	アシン・プラソ橋		路線名	国道8号線		管轄	ガーナ道路公社		橋梁コード	
所在地	自		距離標	自				調査更新年月日	2008年10月16日	
	至			至						
全体図	<p>径間 1,2,3</p>									
	<p>径間 1</p>									
一般図
