**THE STUDY
ON
COMPREHENSIVE FLOOD MITIGATION
FOR CAVITE LOWLAND AREA
IN
THE REPUBLIC OF THE PHILIPPINES**

FINAL REPORT

Volume 4: Appendix

Appendix-1
Inventory of Existing Irrigation Dams

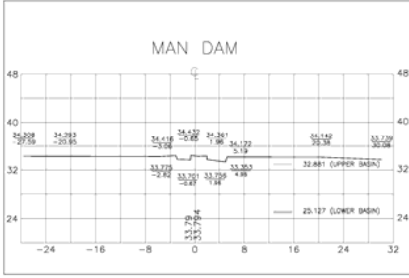
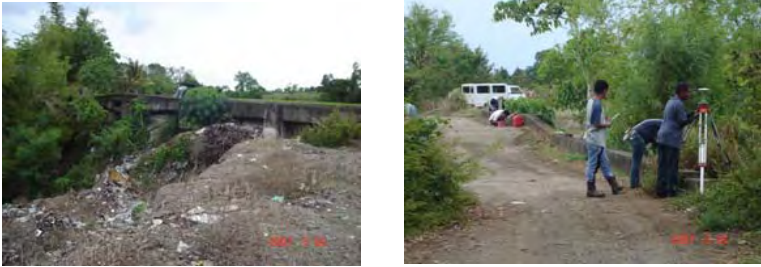
Name of Dam	Man Dam (No.C3)	Drawing(Elevation): Year of Survey : May 2007	Photo (taken on May 22 2007)
Location of Dam	Bunga, Tanza

<i>General</i>	1	2	3	4	5
Date of Inspection					
Status of Inspection	After Flood*Earthquake / <u>Periodical</u>	After Flood*Earthquake / Periodical	After Flood*Earthquake / Periodical	After Flood*Earthquake / Periodical	After Flood*Earthquake / Periodical
Name of Inspector	SUZUKI, Kazuto (JICA Study Team)				
Administration					
Name of Estate	Sta. Cruz De Malabon Estate				
Site					
Dam					
Leakage	None				
Scouring of Footing	None				
Cracking	None				
Stripping of Surface	None				
Others	None				
Side Ground					
Leakage	None				
Scouring of Footing	None				
Cracking	None				
Collapse of Slope	None				
Sliding of Slope	None				
Basin Risk in DamBreak	<u>Low</u> / Medium / High				
Necessity of Repair	<u>Low</u> / Medium / High				
Assumed Cost of Repair					
Signature

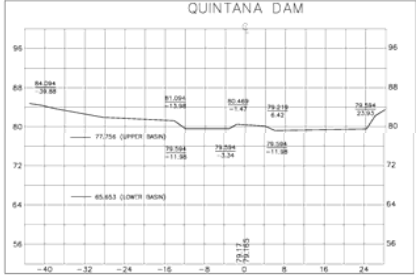
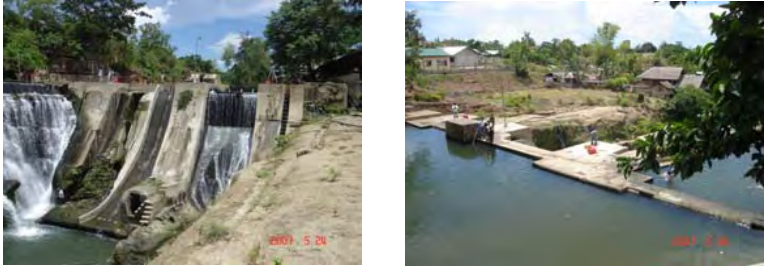
Name of Dam	Quintana Dam (No.C7)	Drawing(Elevation): Year of Survey : May 2007	Photo (taken on May 22 2007)
Location of Dam	San Agustin, Trece Martires City

1	2	3	4	5
General					
Date of Inspection					
Status of Inspection	After Flood*Earthquake / Periodical	After Flood*Earthquake / Periodical	After Flood*Earthquake / Periodical	After Flood*Earthquake / Periodical	After Flood*Earthquake / Periodical
Name of Inspector	SUZUKI, Kazuto (JICA Study Team)				
Administration					
Name of Estate					
Site					
Dam					
Leakage	None				
Scouring of Footing	On the left side				
Cracking	None				
Stripping of Surface	Left part of the surface				
Others	Broken left side footing				
Side Ground					
Leakage	None				
Scouring of Footing	None				
Cracking	None				
Collapse of Slope	Scouring on revetment at both side				
Sliding of Slope	Due to collapse of revetment				
Basin Risk in DamBreak	Low / Medium / <u>High</u>				
Necessity of Repair	Low / Medium / <u>High</u>				
Assumed Cost of Repair					
Signature

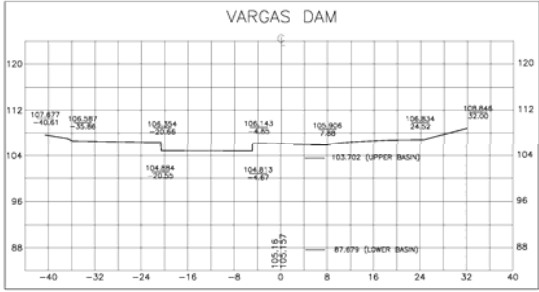
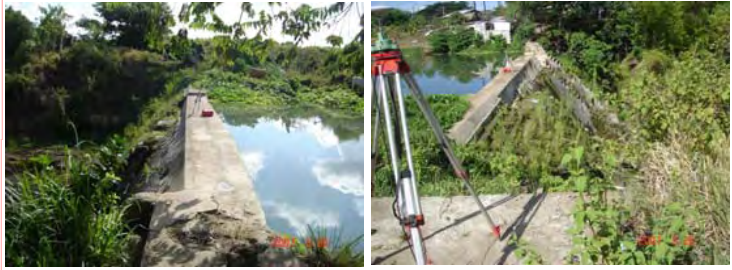
Name of Dam	Vargas Dam (No.C8)	Drawing(Elevation): Year of Survey : May 2007	Photo (taken on May 22 2007)
Location of Dam	Manggahan, General Trias

General	1	2	3	4	5
Date of Inspection					
Status of Inspection	After Flood*Earthquake / Periodical	After Flood*Earthquake / Periodical	After Flood*Earthquake / Periodical	After Flood*Earthquake / Periodical	After Flood*Earthquake / Periodical
Name of Inspector	SUZUKI, Kazuto (JICA Study Team)				
Administration					
Name of Estate	San Francisco De Malabon Estate				
Site					
Dam					
Leakage	None				
Scouring of Footing	None				
Cracking	None				
Stripping of Surface	small part of the surface				
Others	None				
Side Ground					
Leakage	None				
Scouring of Footing	on the left side				
Cracking	None				
Collapse of Slope	Due to scouring				
Sliding of Slope	Due to no revetment				
Basin Risk in DamBreak	Low / <u>Medium</u> / High				
Necessity of Repair	<u>Low</u> / Medium / High				
Assumed Cost of Repair	about 1 million peso				
Signature

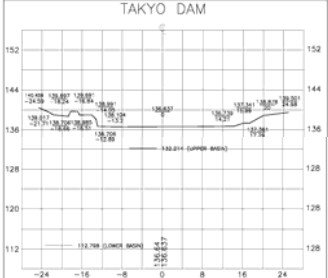
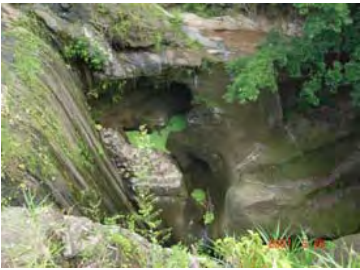
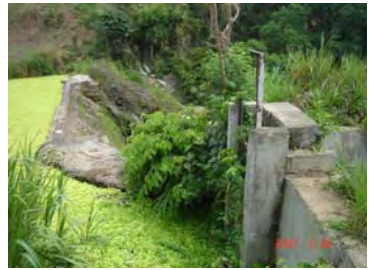
Name of Dam	Takio Dam (No.C9)	Drawing(Elevation): Year of Survey : May 2007	Photo (taken on May 22 2007)
Location of Dam	Bidatan, General Trias

1	2	3	4	5
General					
Date of Inspection					
Status of Inspection	After Flood*Earthquake / Periodical	After Flood*Earthquake / Periodical	After Flood*Earthquake / Periodical	After Flood*Earthquake / Periodical	After Flood*Earthquake / Periodical
Name of Inspector	SUZUKI, Kazuto (JICA Study Team)				
Administration					
Name of Estate	San Francisco De Malabon Estate				
Site					
Dam					
Leakage	None				
Scouring of Footing	on both sides				
Cracking	None				
Stripping of Surface	Most of the surface				
Others	None				
Side Ground					
Leakage	None				
Scouring of Footing	on both sides				
Cracking	None				
Collapse of Slope	due to scouring				
Sliding of Slope	No revetment				
Basin Risk in DamBreak	Low / <u>Medium</u> / High				
Necessity of Repair	Low / <u>Medium</u> / High				
Assumed Cost of Repair	about 1 million peso				
Signature

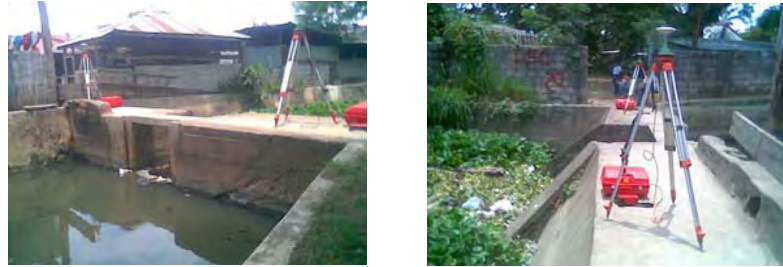
Name of Dam	Julian Dam (No.11)	Drawing(Elevation): Year of Survey : May 2007	Photo (taken on May 22 2007)
Location of Dam	Bayan Luma VI, Imus

<i>General</i>	1	2	3	4	5
Date of Inspection					
Status of Inspection	After Flood*Earthquake / Periodical	After Flood*Earthquake / Periodical	After Flood*Earthquake / Periodical	After Flood*Earthquake / Periodical	After Flood*Earthquake / Periodical
Name of Inspector	SUZUKI, Kazuto (JICA Study Team)				
<i>Administration</i>					
Name of Estate	Imus Estate				
<i>Site</i>					
Dam					
Leakage	None				
Scouring of Footing	None				
Cracking	On both side of the surface				
Stripping of Surface	Minimal portion				
Others	None				
Side Ground					
Leakage	None				
Scouring of Footing	None				
Cracking	None				
Collapse of Slope	None				
Sliding of Slope	None				
Basin Risk in DamBreak	(Low) Medium / High				
Necessity of Repair	(Low) Medium / High				
Assumed Cost of Repair	about 1 million peso				
Signature

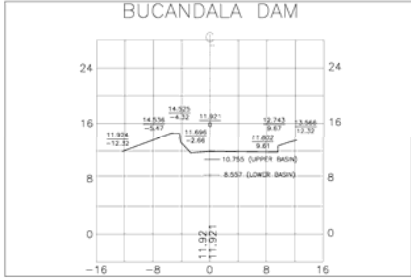
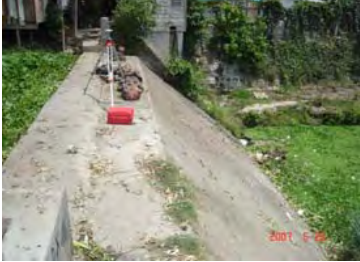
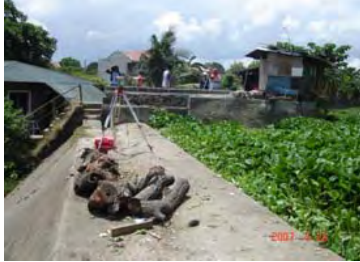
Name of Dam	Bucandala Dam (No.12)	Drawing(Elevation): Year of Survey : May 2007	Photo (taken on May 22 2007)	
Location of Dam	Bayan Luma IX, Imus

1	2	3	4	5
General					
Date of Inspection					
Status of Inspection	After Flood*Earthquake / Periodical	After Flood*Earthquake / Periodical	After Flood*Earthquake / Periodical	After Flood*Earthquake / Periodical	After Flood*Earthquake / Periodical
Name of Inspector	SUZUKI, Kazuto (JICA Study Team)				
Administration					
Name of Estate	Imus Estate				
Site					
Dam					
Leakage	None				
Scouring of Footing	None				
Cracking	None				
Stripping of Surface	None				
Others	None				
Side Ground					
Leakage	None				
Scouring of Footing	None				
Cracking	None				
Collapse of Slope	None				
Sliding of Slope	None				
Basin Risk in DamBreak	Low / <u>Medium</u> / High				
Necessity of Repair	Low / <u>Medium</u> / High				
Assumed Cost of Repair	about 1 million peso				
Signature

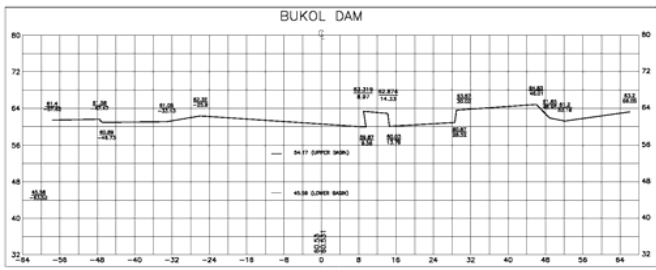
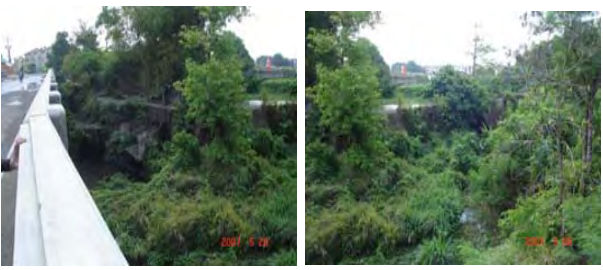
Name of Dam	Bukol Dam (No.13)	Drawing(Elevation): Year of Survey : May 2007	Photo (taken on May 22 2007)
Location of Dam	Tanzang Luma VI, Imus

<i>General</i>	1	2	3	4	5
Date of Inspection					
Status of Inspection	After Flood*Earthquake / Periodical	After Flood*Earthquake / Periodical	After Flood*Earthquake / Periodical	After Flood*Earthquake / Periodical	After Flood*Earthquake / Periodical
Name of Inspector	SUZUKI, Kazuto (JICA Study Team)				
Administration					
Name of Estate	Imus Estate				
Site					
Dam					
Leakage	None				
Scouring of Footing	None				
Cracking	None				
Stripping of Surface	None				
Others	None				
Side Ground					
Leakage	None				
Scouring of Footing	None				
Cracking	None				
Collapse of Slope	None				
Sliding of Slope	None				
Basin Risk in DamBreak	Low / <u>Medium</u> / High				
Necessity of Repair	Low / <u>Medium</u> / High				
Assumed Cost of Repair	about 1 million peso				
Signature

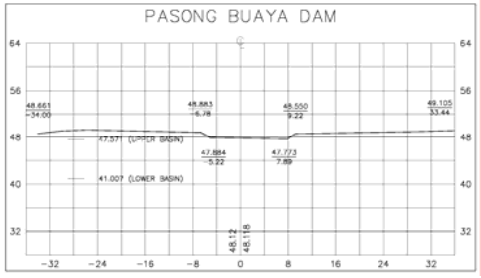
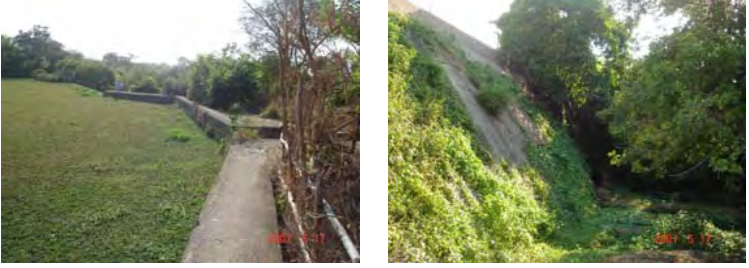
Name of Dam	Pasong Buaya Dam (No.17)	Drawing(Elevation): Year of Survey : May 2007	Photo (taken on May 22 2007)
Location of Dam	Pasong Buaya II, Imus

<i>General</i>	1	2	3	4	5
Date of Inspection					
Status of Inspection	After Flood*Earthquake / Periodical	After Flood*Earthquake / Periodical	After Flood*Earthquake / Periodical	After Flood*Earthquake / Periodical	After Flood*Earthquake / Periodical
Name of Inspector	SUZUKI, Kazuto (JICA Study Team)				
Administration					
Name of Estate	Imus Estate				
Site					
Dam					
Leakage	None				
Scouring of Footing	None				
Cracking	None				
Stripping of Surface	Isolated part of the surface				
Others	None				
Side Ground					
Leakage	None				
Scouring of Footing	None				
Cracking	None				
Collapse of Slope	None				
Sliding of Slope	None				
Basin Risk in DamBreak	Low / <u>Medium</u> / High				
Necessity of Repair	<u>Low</u> / Medium / High				
Assumed Cost of Repair					
Signature

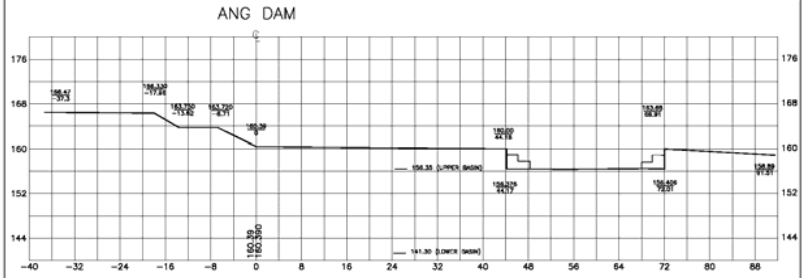
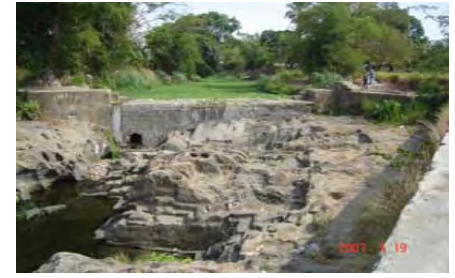
Name of Dam	Ang Dam (No.18)	Drawing(Elevation): Year of Survey : May 2007	Photo (taken on May 22 2007)
Location of Dam	Salitran I, Dasmariñas

<i>General</i>	1	2	3	4	5
Date of Inspection					
Status of Inspection	After Flood*Earthquake / Periodical	After Flood*Earthquake / Periodical	After Flood*Earthquake / Periodical	After Flood*Earthquake / Periodical	After Flood*Earthquake / Periodical
Name of Inspector	SUZUKI, Kazuto (JICA Study Team)				
<i>Administration</i>					
Name of Estate	Imus Estate				
<i>Site</i>					
Dam					
Leakage	None				
Scouring of Footing	None				
Cracking	None				
Stripping of Surface	Minimal portion				
Others	None				
Side Ground					
Leakage	None				
Scouring of Footing	on the left side				
Cracking	None				
Collapse of Slope	None				
Sliding of Slope	None				
Basin Risk in DamBreak	Low / Medium / <u>High</u>				
Necessity of Repair	Low / <u>Medium</u> / High				
Assumed Cost of Repair					
Signature

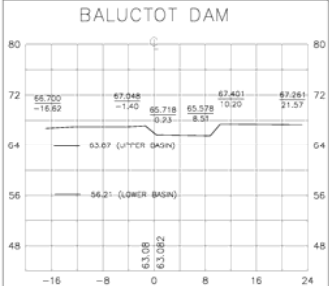
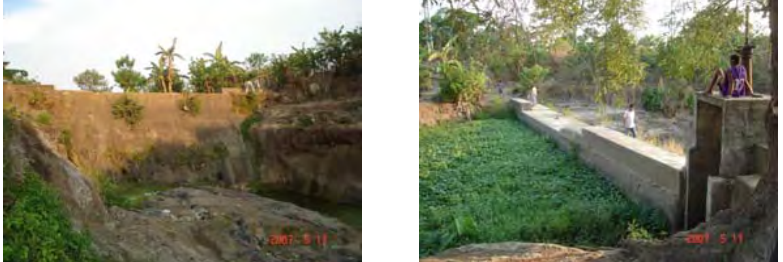
Name of Dam	Baluctot Dam (No.I9)	Drawing(Elevation): Year of Survey : May 2007	Photo (taken on May 22 2007)
Location of Dam	Salawag, Dasmariñas

<i>General</i>	1	2	3	4	5
Date of Inspection					
Status of Inspection	After Flood*Earthquake / Periodical	After Flood*Earthquake / Periodical	After Flood*Earthquake / Periodical	After Flood*Earthquake / Periodical	After Flood*Earthquake / Periodical
Name of Inspector	SUZUKI, Kazuto (JICA Study Team)				
Administration					
Name of Estate	Imus Estate				
Site					
Dam					
Leakage	None				
Scouring of Footing	None				
Cracking	None				
Stripping of Surface	Minimal portion of the surface				
Others	None				
Side Ground					
Leakage	None				
Scouring of Footing	None				
Cracking	None				
Collapse of Slope	None				
Sliding of Slope	None				
Basin Risk in DamBreak	Low / <u>Medium</u> / High				
Necessity of Repair	<u>Low</u> / Medium / High				
Assumed Cost of Repair					
Signature

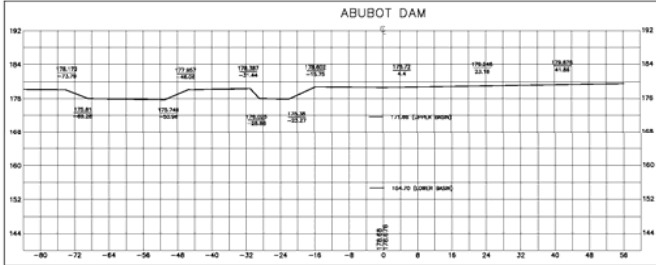
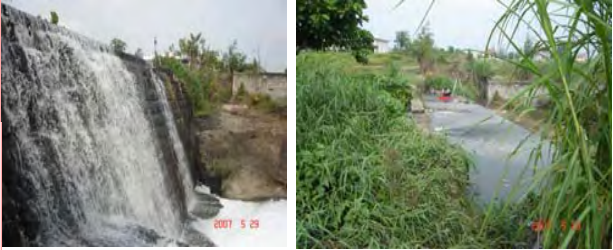
Name of Dam	Abubot Dam (No.I12)	Drawing(Elevation): Year of Survey : May 2007	Photo (taken on May 22 2007)
Location of Dam	Salitran II, Dasmarias

<u>General</u>	1	2	3	4	5
Date of Inspection					
Status of Inspection	After Flood*Earthquake / Periodical	After Flood*Earthquake / Periodical	After Flood*Earthquake / Periodical	After Flood*Earthquake / Periodical	After Flood*Earthquake / Periodical
Name of Inspector	SUZUKI, Kazuto (JICA Study Team)				
<u>Administration</u>					
Name of Estate	Imus Estate				
<u>Site</u>					
Dam					
Leakage	None				
Scouring of Footing	None				
Cracking	None				
Stripping of Surface	None				
Others	None				
Side Ground					
Leakage	None				
Scouring of Footing	None				
Cracking	None				
Collapse of Slope	None				
Sliding of Slope	None				
Basin Risk in DamBreak	Low <u>Medium</u> High				
Necessity of Repair	<u>Low</u> / Medium / High				
Assumed Cost of Repair					
Signature
